## Memorandum

<b>To</b>	Department of Mines, Industry Regulation and Safety (DMIRS)		
<b>From</b>	Damian Jagoe-Banks	<b>Date</b>	27 November 2023
<b>Subject</b>	Backfill Stability Monitoring Progress Report	<b>Project No.</b>	96721.03

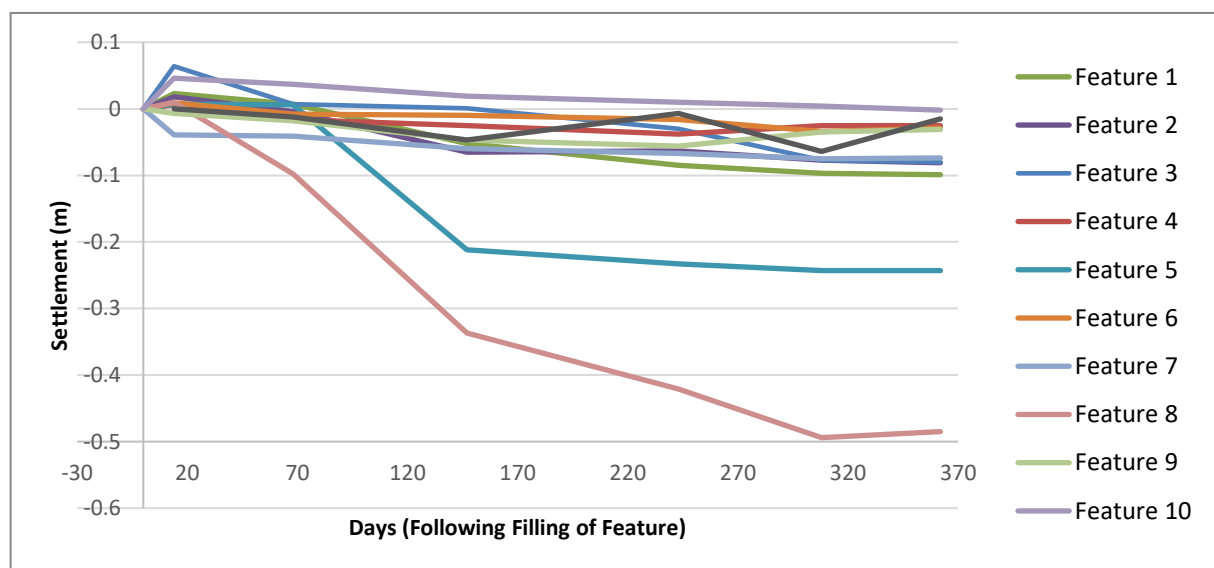
**Figure 1: Observed Settlement History**

Total settlement of not more than 100 mm, which is within expectation regarding self-densification of the backfill, was recorded for features other than Features 5 and 8, over a monitoring period of 1 year.

Settlements of 0.25 m and 0.49 m were recorded at Features 5 and 8 respectively. It is noted that since observations made on the third visit, 5 months following placement of the backfill, the rate of settlement has been slowing. Results of the 6<sup>th</sup> monitoring visit suggest that the majority of the settlement for these two features (like the other features) is likely to have occurred. The greatest settlement at Feature 8 (compared to the other features) is commensurate to the significantly greater depth (17 m) of this feature prior to backfilling. Figure 2 below provides an indication of the condition of this feature at the time of the 6<sup>th</sup> monitoring visit, 1 year following placement of the fill.

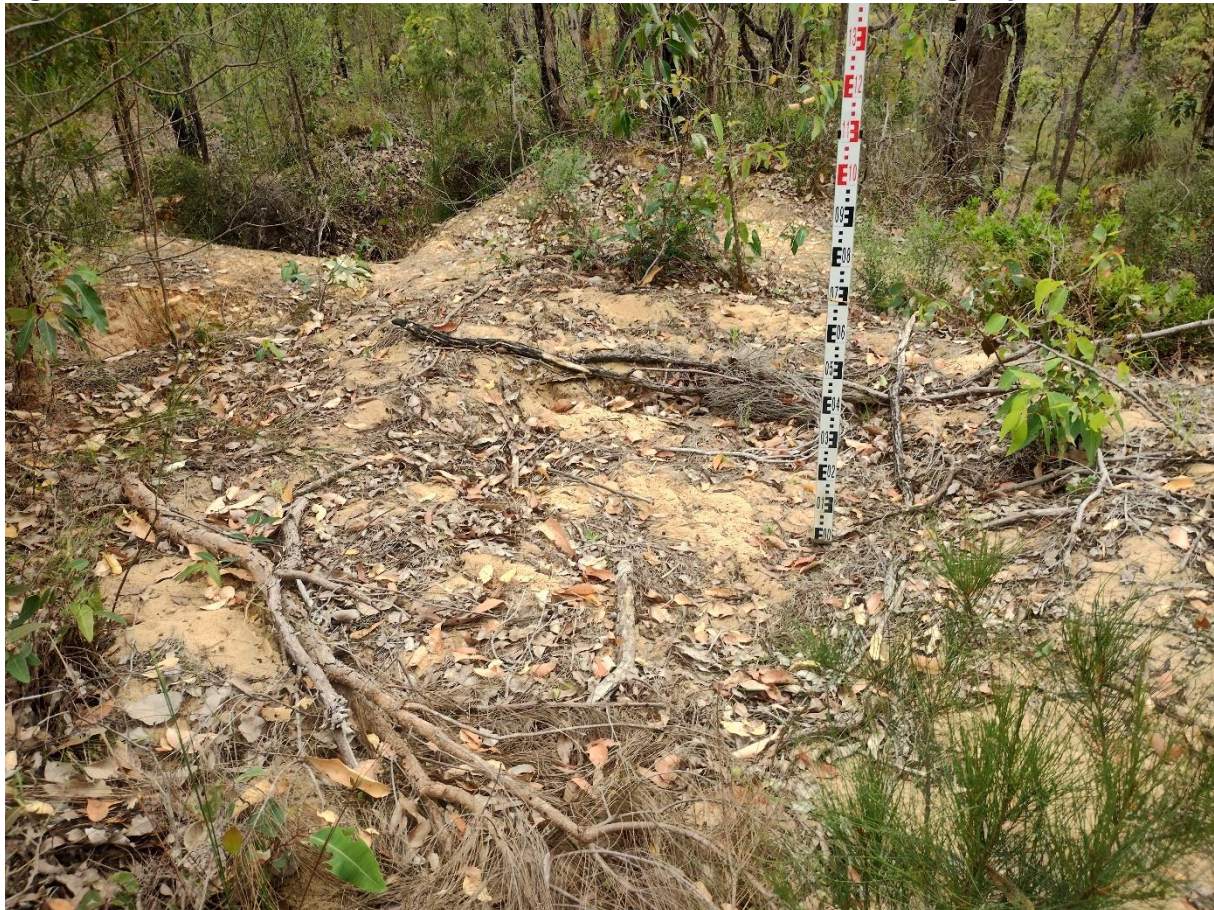
**Figure 2: Condition of Feature 8 on 13 November 2023, 12 months following fill placement.**

backfilled features. Settlement observations indicate that the majority of expected settlement has likely occurred and the backfill within the features can be considered to be stable. No further detailed monitoring of the rehabilitated features is considered warranted.
