CONDITION REPORT

Australind Jetty

Government of **Western Australia**
Department of **Water and Environmental Regulation**

9738

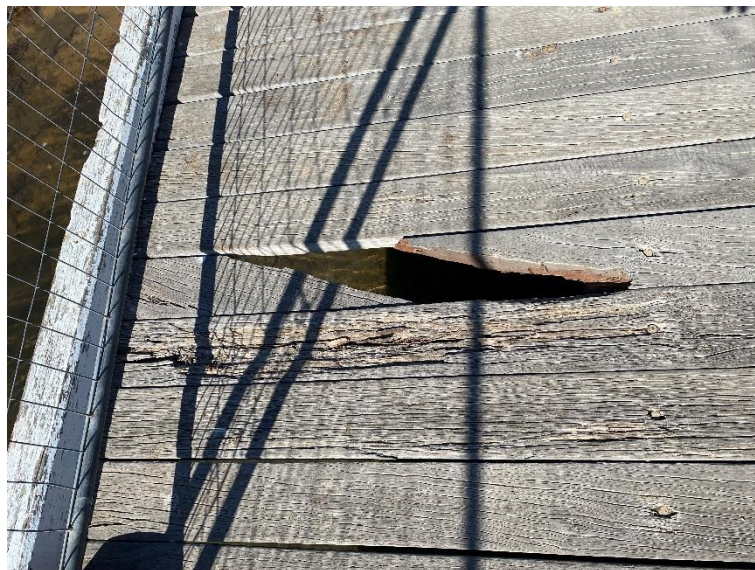
Figure 2. Damaged Deck Board

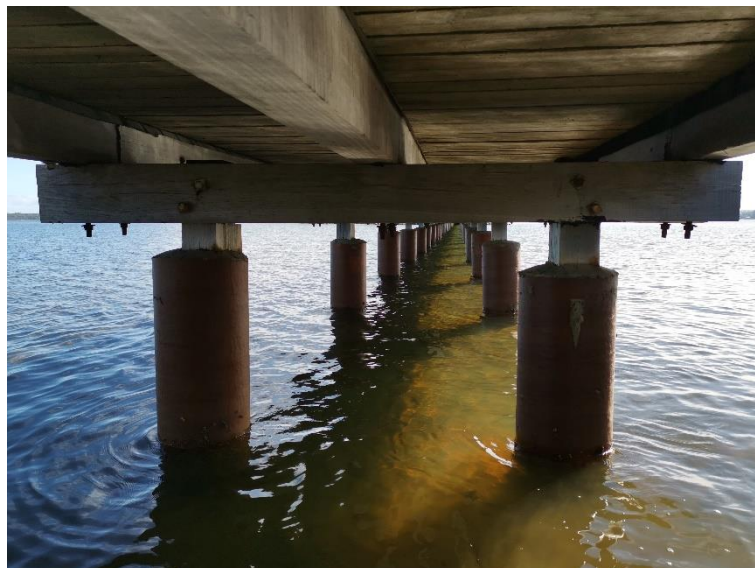
All the bolts observed are rusted. The timber stumps appear to be a bit weathered, but are not affecting the structural performance. Concrete piles seem to be in a good condition because of the wrapping encasing the piles (Figure 5).

Figure 4. Piles and Corroded Bolts

All bolts should be replaced. We recommend that all the new bolts be stainless steel. Otherwise, galvanised bolts are acceptable, subject to a regular inspection regime.

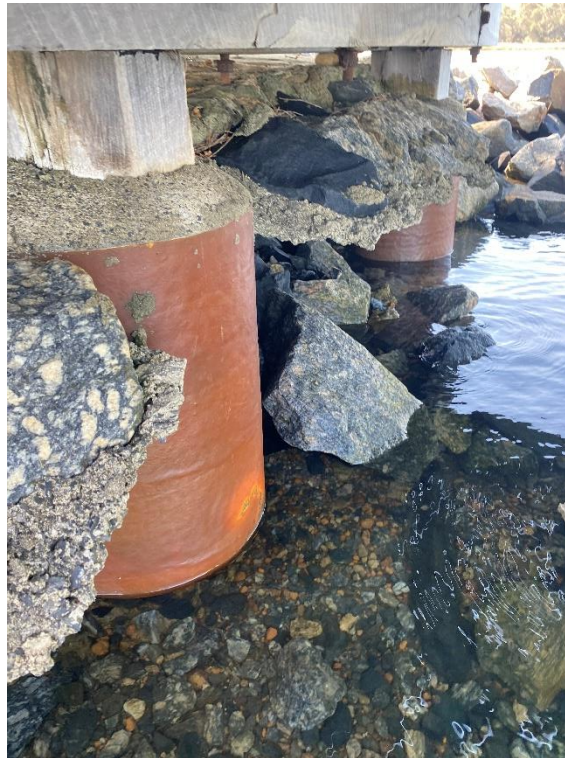
Figure 5. Encapsulated Piles

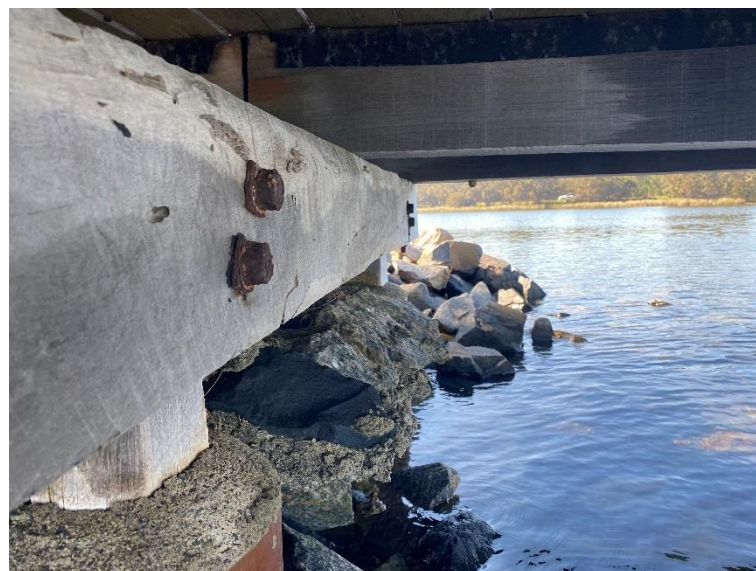
Figure 6. Corroded Bolts

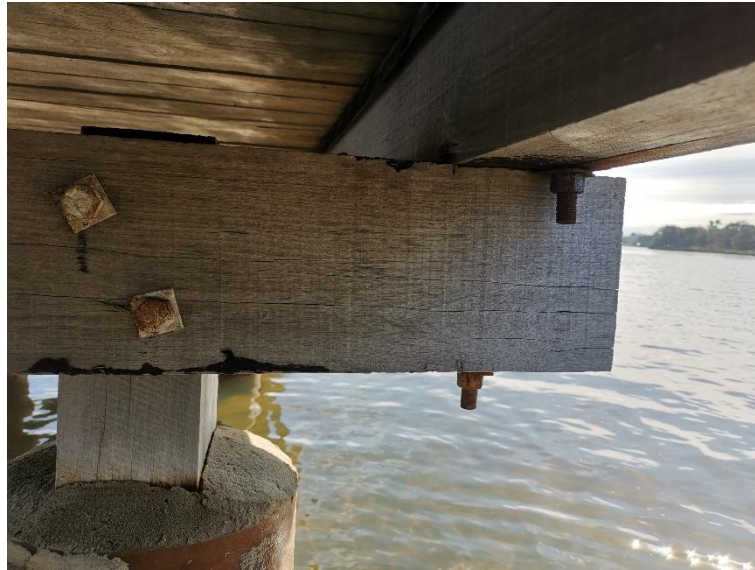
Figure 7. Corroded Bolts

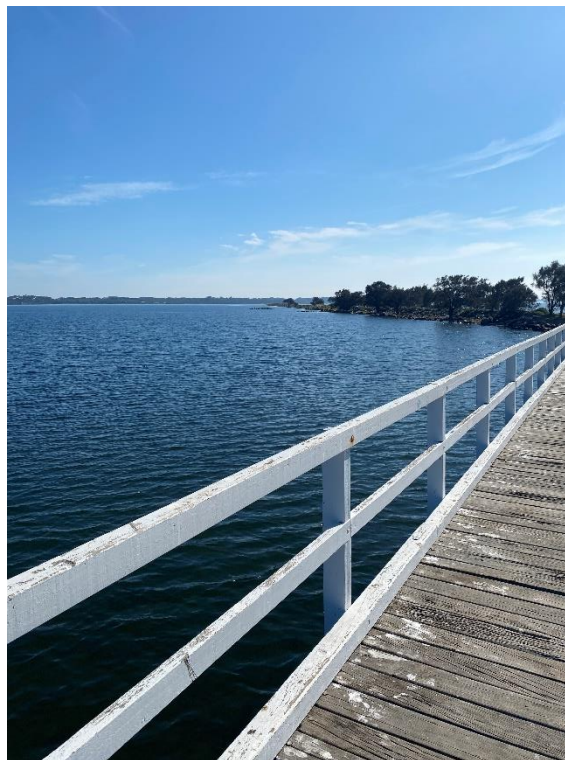
Generally, the timber joists and half-caps appear to be okay, although they are a bit weathered. The decking boards appear to be very weathered and have become soft in places (Figure 8). Several boards have cupped and there is the occasional loose one. One has also broken (Figure 2). However, these are not considered to be affecting the structural performance.

Figure 8. Handrail and Deck Board

Due to the extent of deterioration to the deck boards. We recommend that they all be replaced. It would be prudent, with the boards removed, to inspect and replace the protective barrier over the joists.

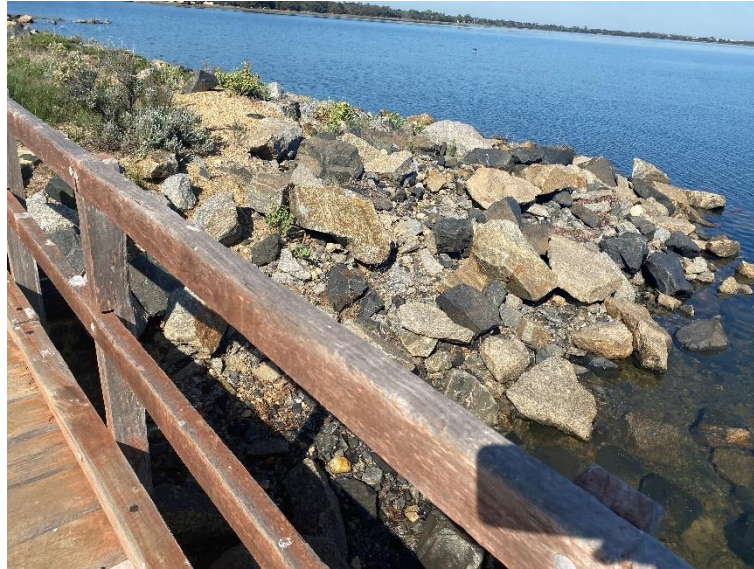
Generally, all the deck boards, and toe boards appear to be okay, but a bit weathered. Several deck boards have cupped or split and there is the occasional loose one (Figure 9). However, these are not considered to be affecting the structural performance.

Figure 9. Weathered Handrail

Due to the extent of deterioration to the deck boards. We recommend that they all be replaced. It would be prudent, with the boards removed, to inspect and replace the protective barrier over the joists.

We recommend the handrail arrangement is reviewed by yourselves, with regard to the extent and type of barrier.

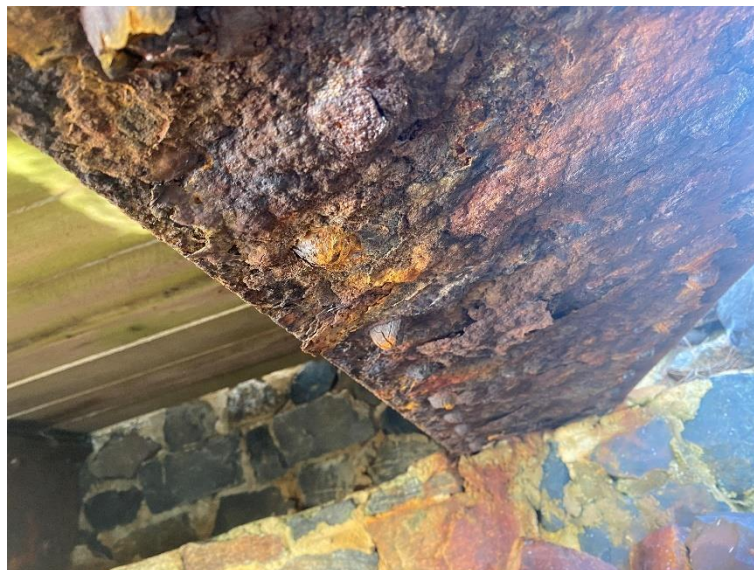
Most of the steelwork is showing signs of corrosion. All the bolts and the steel beams observed are rusted and, in several areas, delaminated (Figure 10, Figure 11, Figure 12, Figure 14).

Figure 10. Rusted and Delaminated Steel Beam

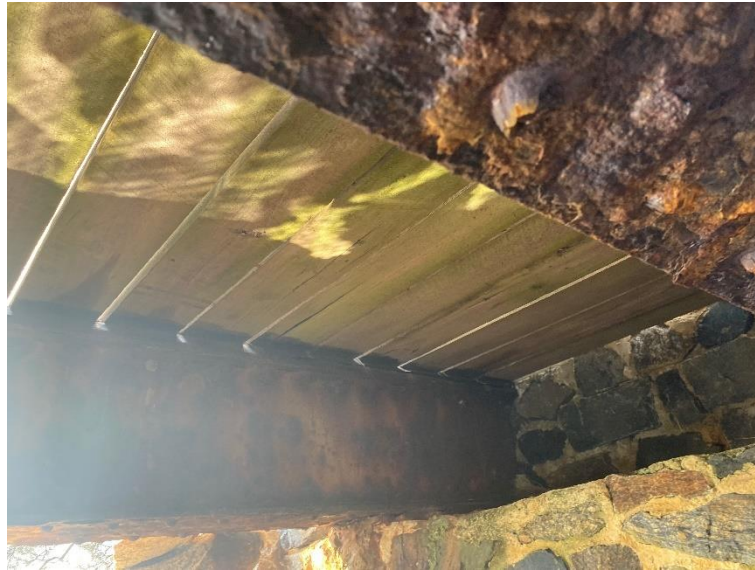
Figure 11. Delaminated and Rusted Steel Beam

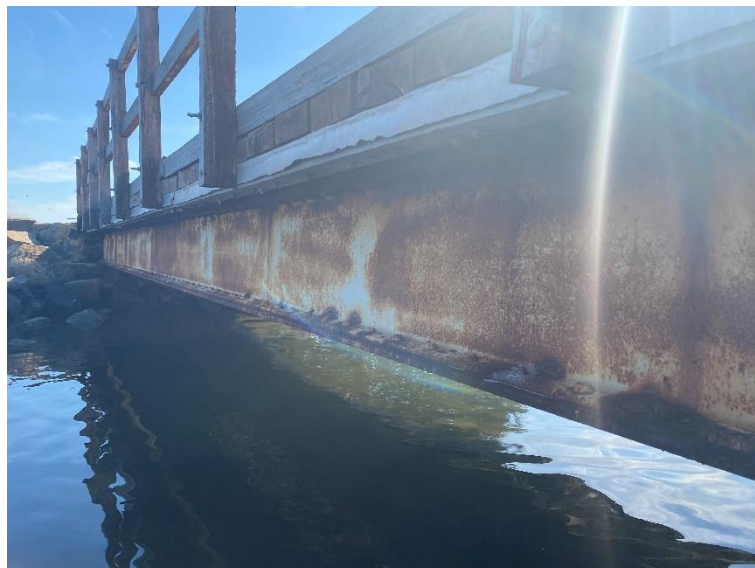
Figure 12. Corroded Steel Beam

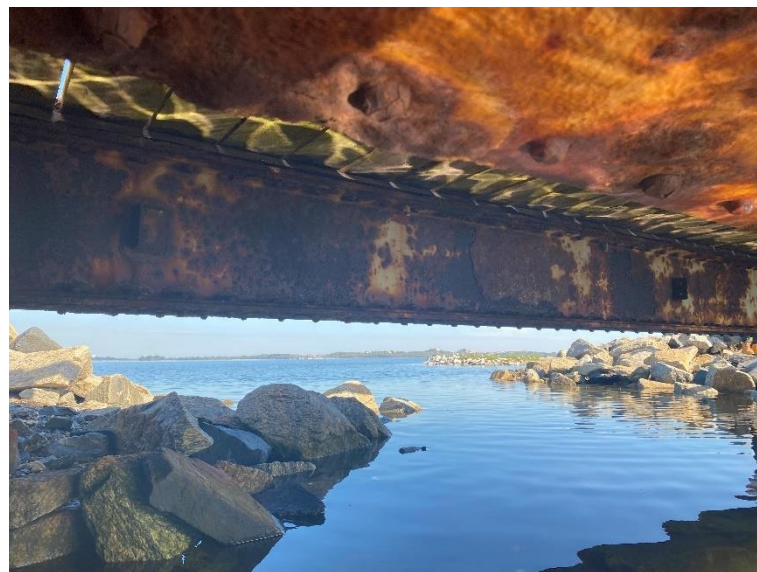
Figure 14. Rusted and Delaminated Steel Beam

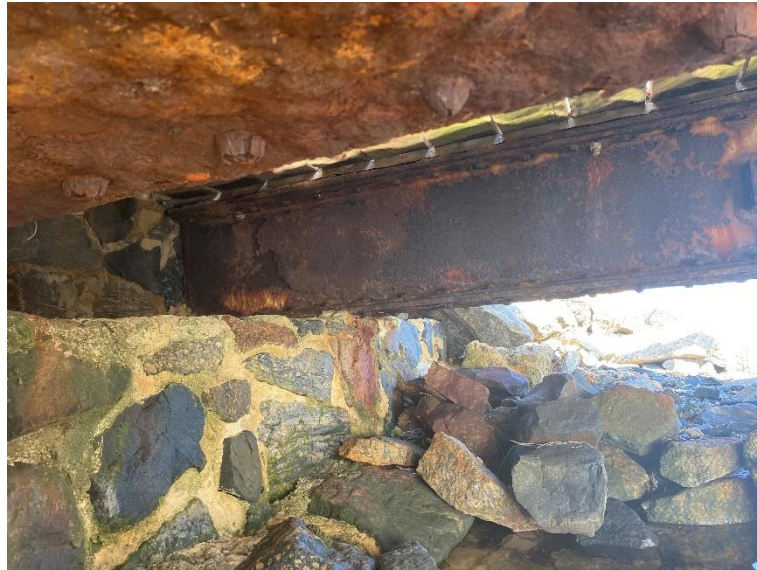
Figure 15. Abutment and Rusted Steel Beam

Whilst the abutment is sound, there has been some erosion behind it. We recommend providing a new surface for an extent beyond the abutment to protect the ground from erosion.

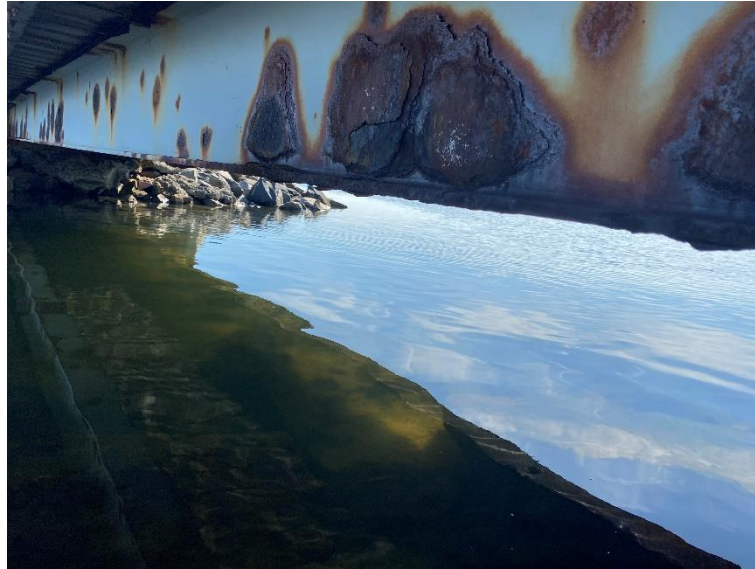
Most of the steelwork is showing signs of corrosion. All the bolts and the steel beams observed are rusted and, in several areas, delaminated (Figure 16, Figure 17, Figure 18).

Figure 16. Corroded Steel Beam

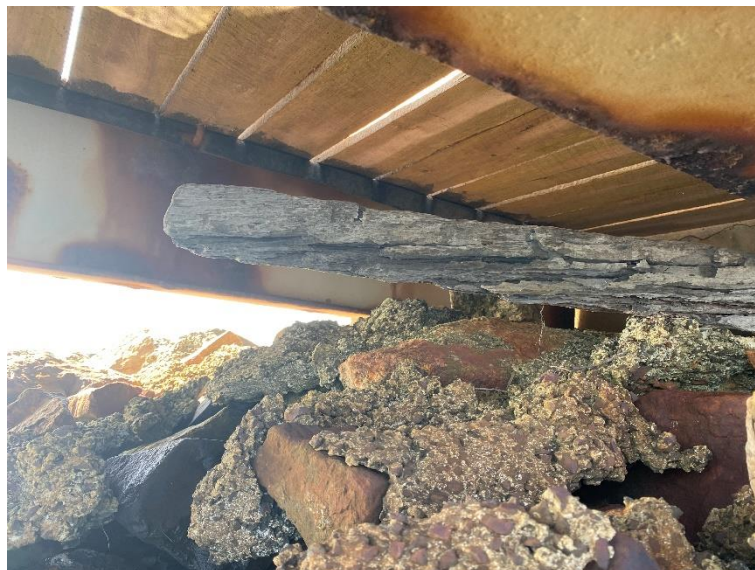
Figure 17. Steel Beam Underside

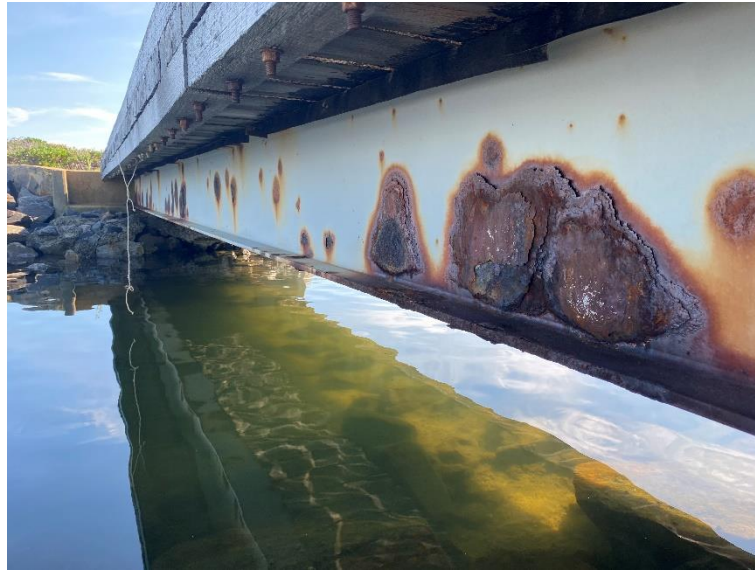
Figure 18. Delaminated Steel Beam

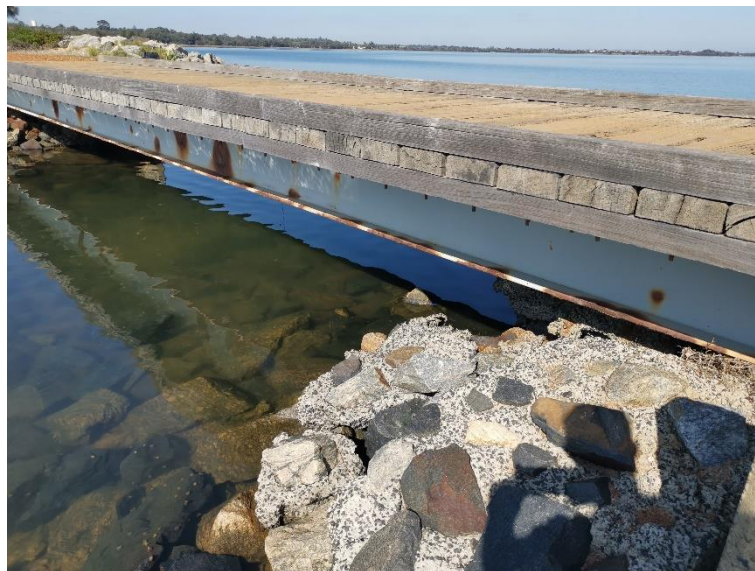
Generally, all the timber deck boards, and toe boards appear to be okay, if a bit weathered. Several deck boards have cupped or split and there is the occasional loose one (Figure 19). However, these are not considered to be affecting the structural performance.

Figure 19. Deck Board

Due to the extent of deterioration to the deck boards. We recommend that they all be replaced. It would be prudent, with the boards removed, to inspect and replace the protective barrier over the joists.

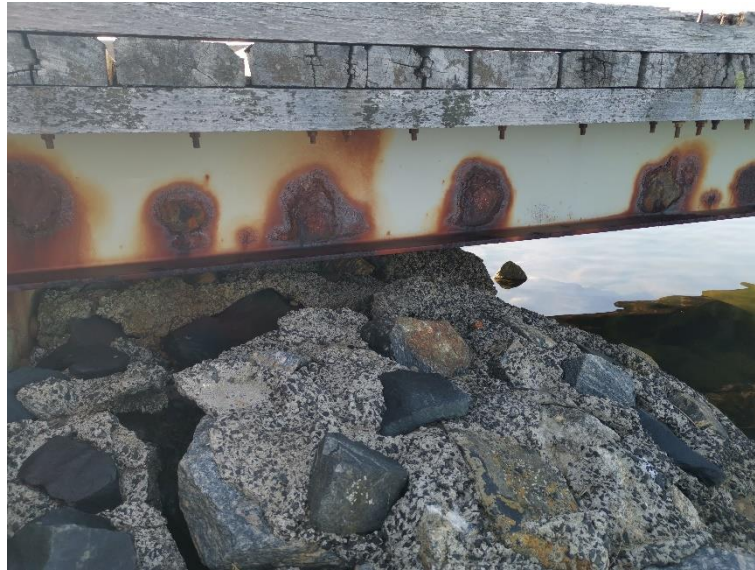
Figure 20. Abutment and Corroded Steel Beam

Whilst the abutment is sound, there has been some erosion behind it. We recommend providing a new surface for an extent beyond the abutment to protect the ground from erosion.

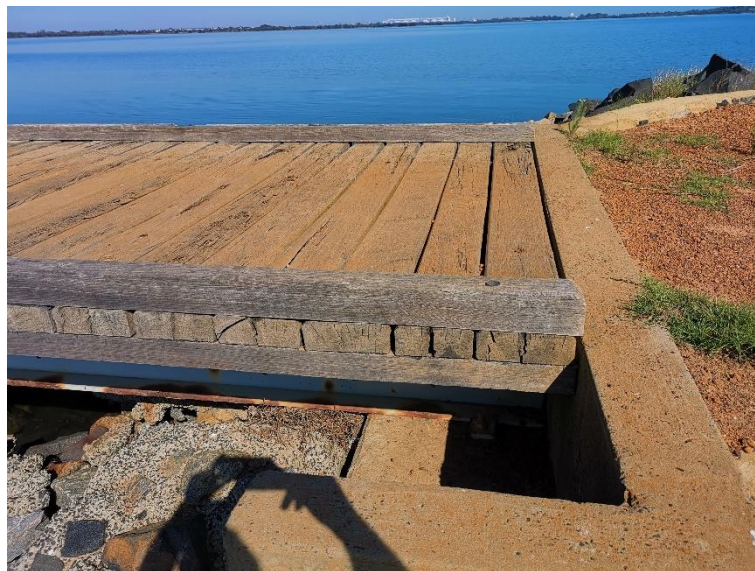
Figure 21. Weathered Deck Board

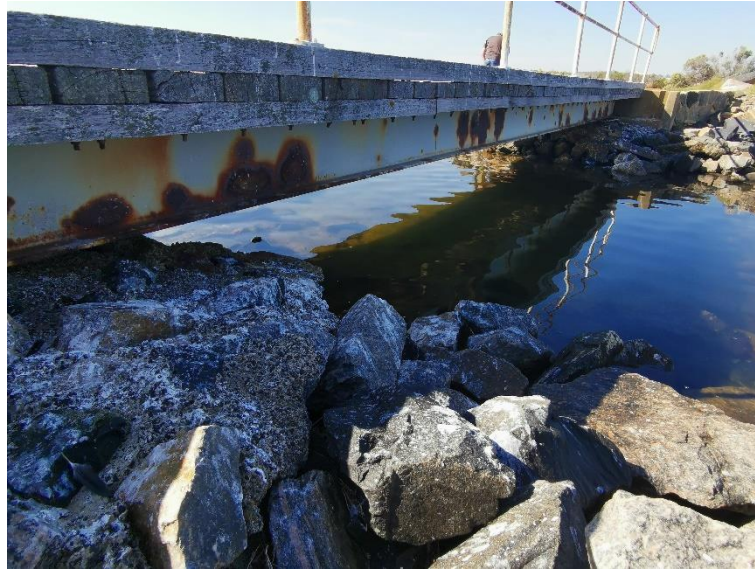
Most of the steelwork is showing signs of corrosion. All the bolts and the steel beams observed are rusted and, in several areas, delaminated (Figure 22, Figure 24, Figure 25, Figure 27).

Figure 22. Corroded Steel Beam

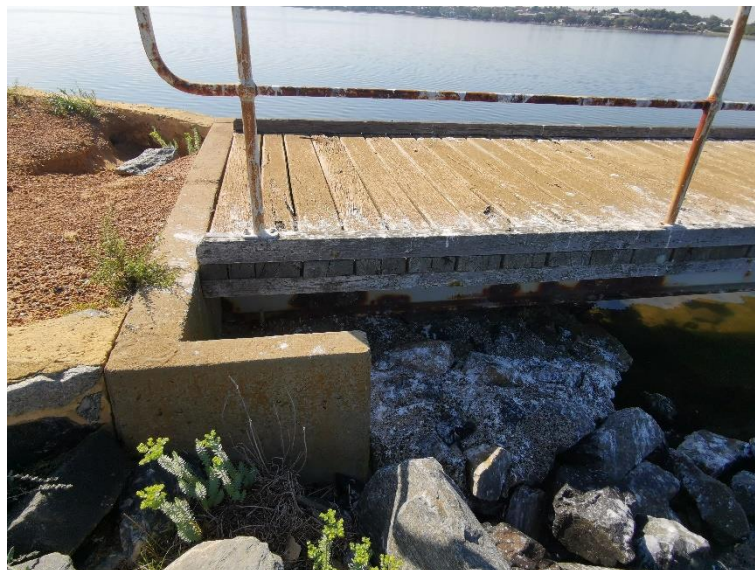
Generally, all the deck boards appear to be okay if a bit weathered. Several deck boards have cupped or split and there is the occasional loose one (Figure 23). However, these are not considered to be affecting the structural performance. Steel fenders were found to be firmly fixed when leant upon.

Figure 23. Corroded Handrail, Weathered Deck Board and Abutment

Due to the extent of deterioration to the deck boards. We recommend that they all be replaced. It would be prudent, with the boards removed, to inspect and replace the protective barrier over the joists.

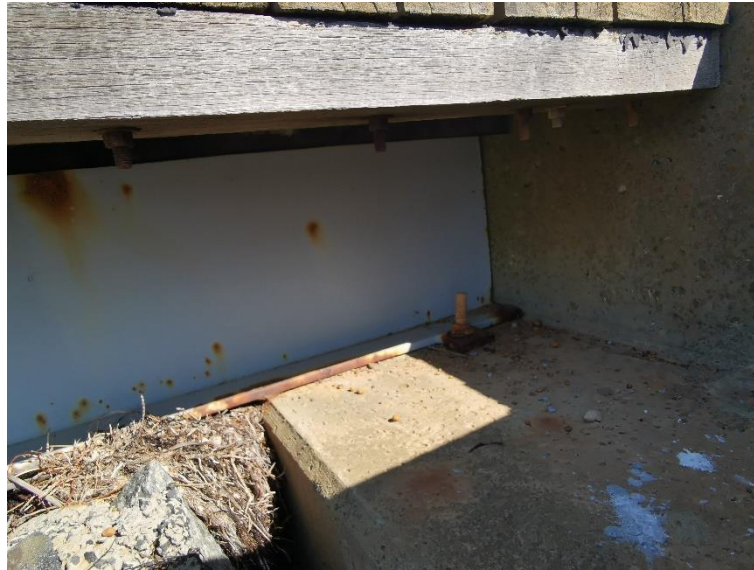
Figure 24. Rusted Bolt

All bolts should be replaced. We recommend that all the new bolts be stainless steel. Otherwise, galvanised bolts are acceptable, subject to a regular inspection regime.

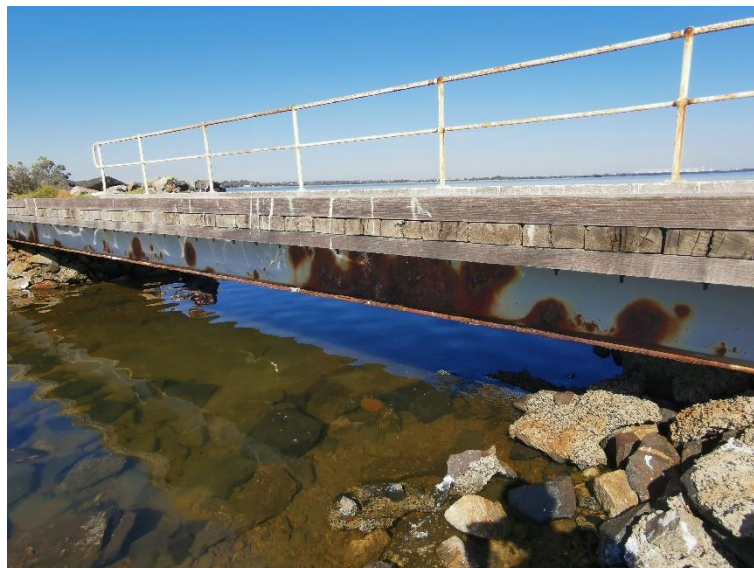
Figure 25. Delaminated and Rusted Steel Beam

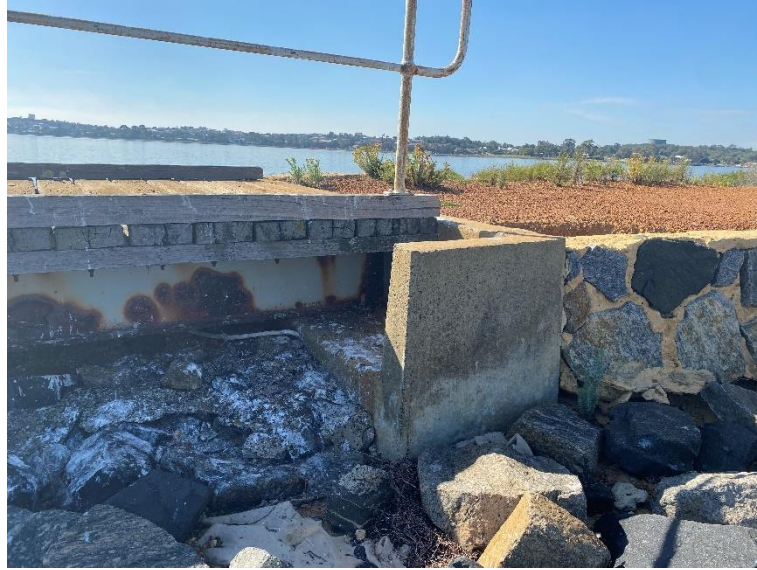
Figure 26. Rusted Steel Beam

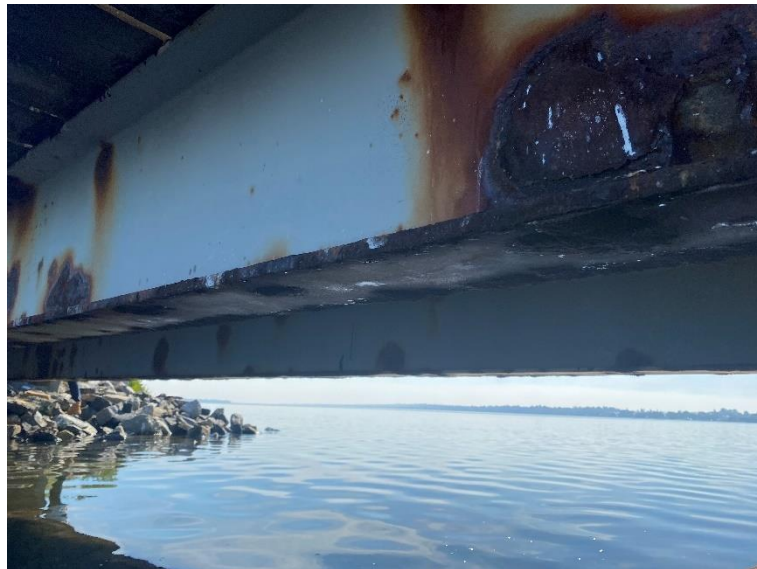
Figure 27. Delaminated Steel Beam

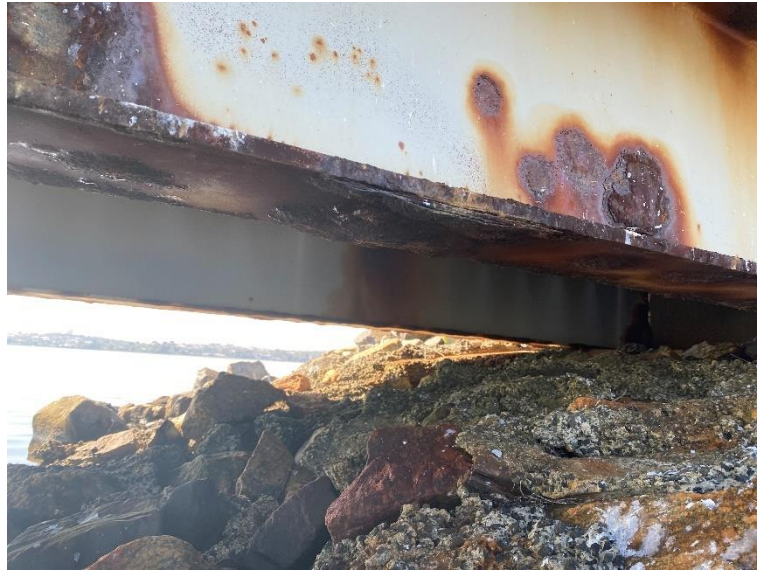
Figure 28. Rusted and Delaminated Steel Beam

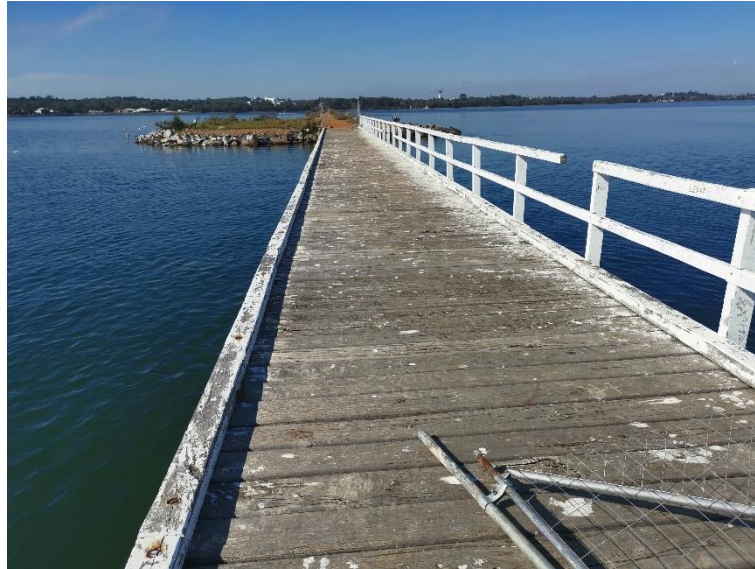
All the deck boards and toe boards appear to be weathered (Figure 29, Figure 31, Figure 33, Figure 35). Several deck boards have cupped or split and there is the occasional loose one. However, these are not considered to be affecting the structural performance of the jetty.

Figure 29. Weathered Deck Board and Broken Handrail

Due to the extent of deterioration to the deck boards. We recommend that they all be replaced. It would be prudent, with the boards removed, to inspect and replace the protective barrier over the joists.

We recommend the handrail arrangement is reviewed by yourselves, with regard to the extent and type of barrier, and the broken items replaced.

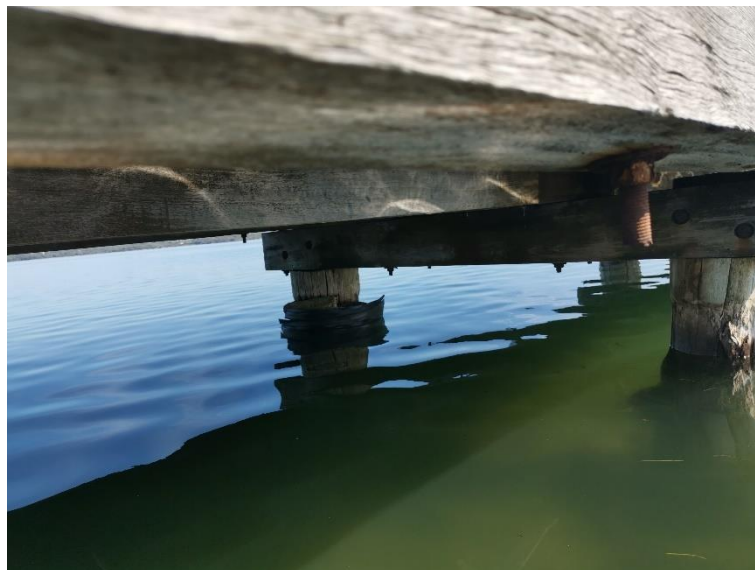
A few timber blocks between the piles and fenders have either split or weathered (Figure 30). Concrete encapsulations were found to be damaged (Figure 30). A more detailed report of underwater structure is attached in Appendix G.

Figure 30. Damaged Encapsulation in Piles

The diver's report has identified that pile encapsulations are in very poor condition. It is therefore recommended that these piles are either be repaired or replaced.

It is the diver's recommendation that all the existing encapsulations will need to be removed entirely, from the top of the column down to minimum of 500mm below the seabed. For a detailed recommendation, refer to diver's report in Appendix G.

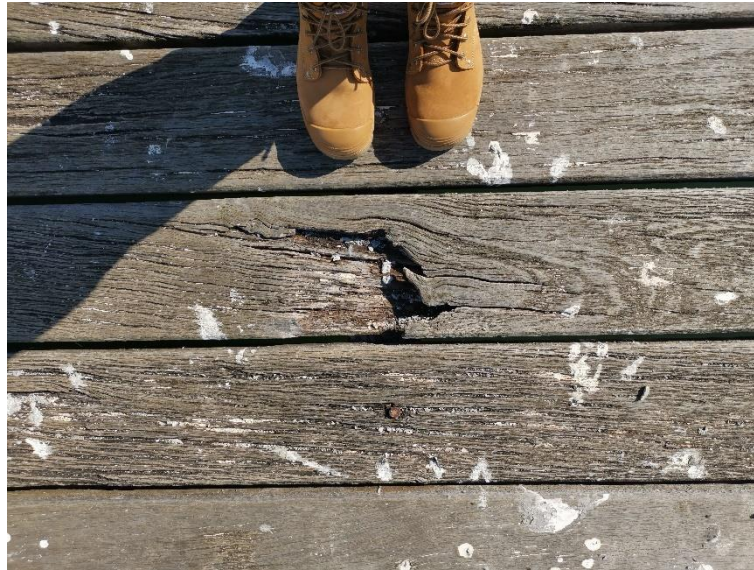
Figure 31. Damaged Deck Board

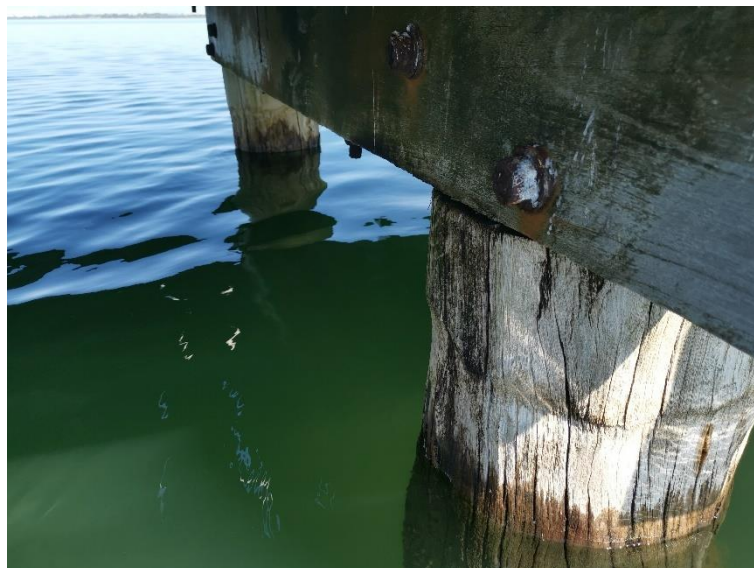
Most of the bolts observed are rusted.

Figure 32. Cracks in Timber Piles, Rusty Bolts

All bolts should be replaced. We recommend that all the new bolts be stainless steel. Otherwise, galvanised bolts are acceptable, subject to a regular inspection regime.

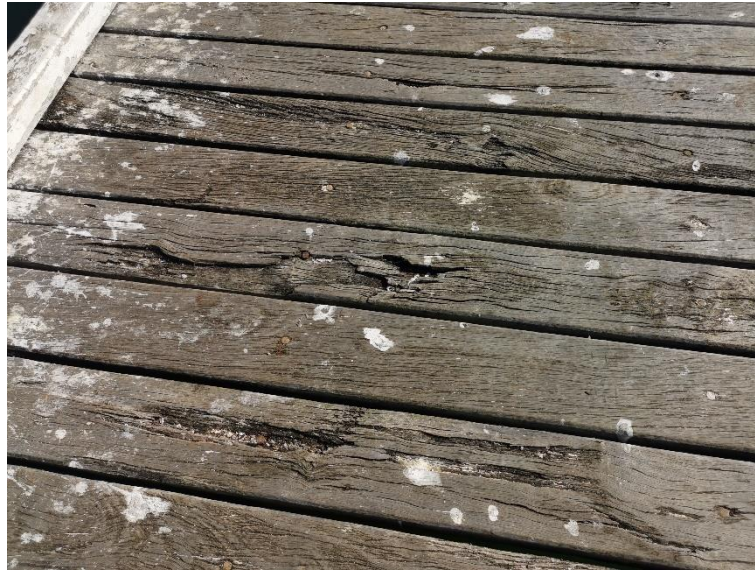
Figure 33. Soft, weathered and Broken Deck Board

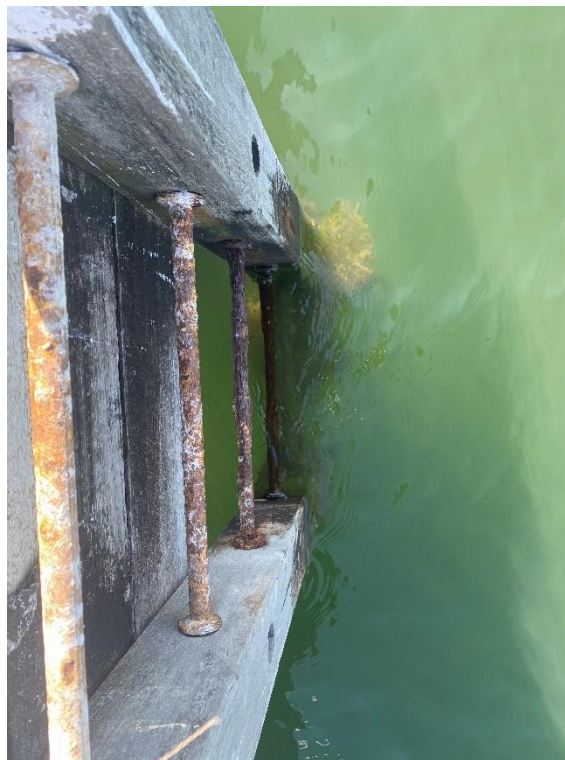
Figure 34. Rusted Ladder

The ladder on the structure has timber styles with steel bars running between to form the rungs. At the time of inspection, severe corrosion was present on the steel bars.

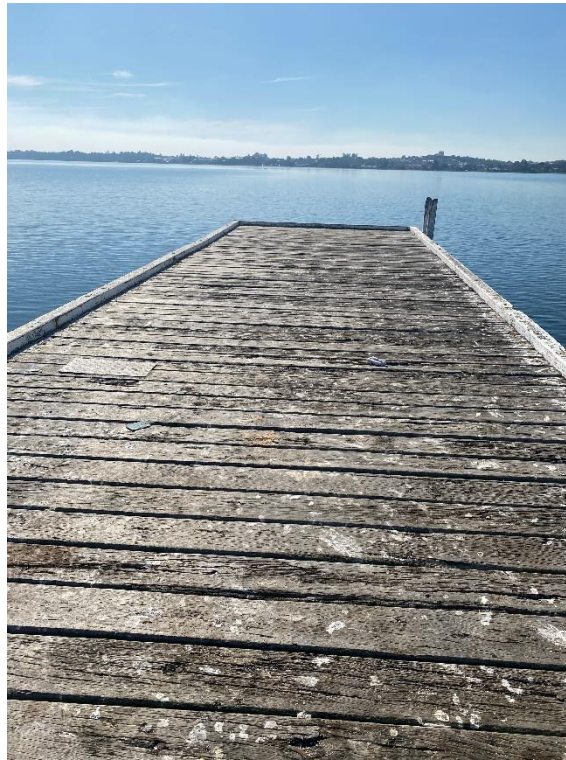
Figure 35. Weathered Deck Board

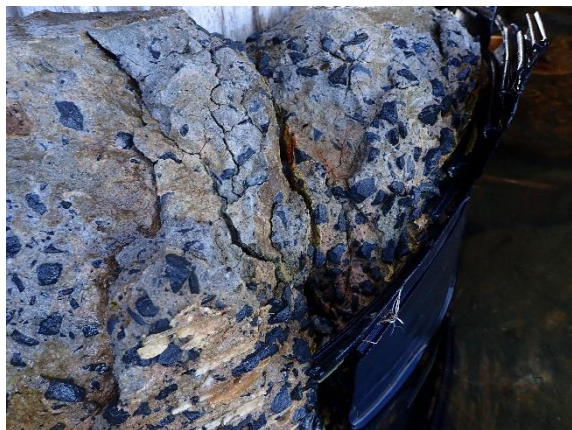
1.4 – Severe cracking and spalling on concrete encapsulation

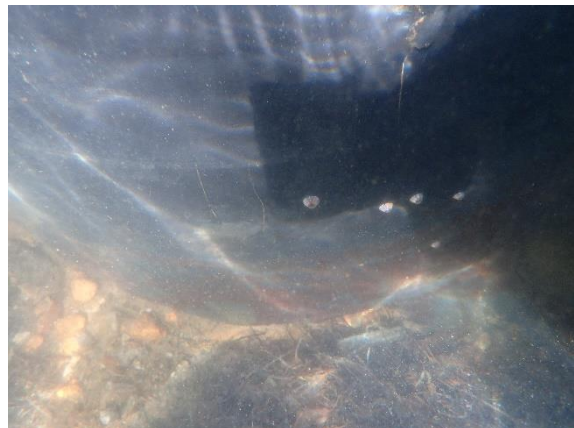
2.6 – Damage to encapsulation formwork near seabed

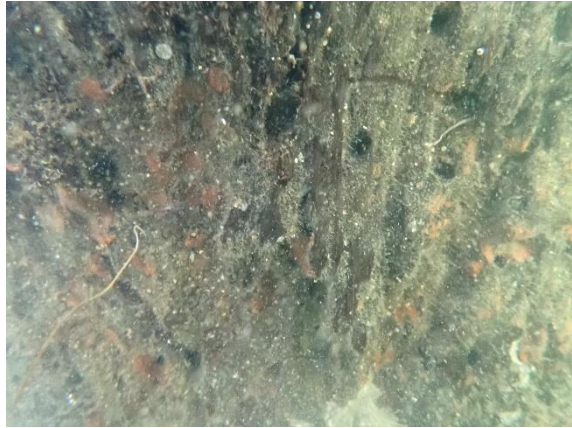
3.3 & 3.4 – Encapsulation has completely failed to seabed level, severe wood rot and marine borer attack

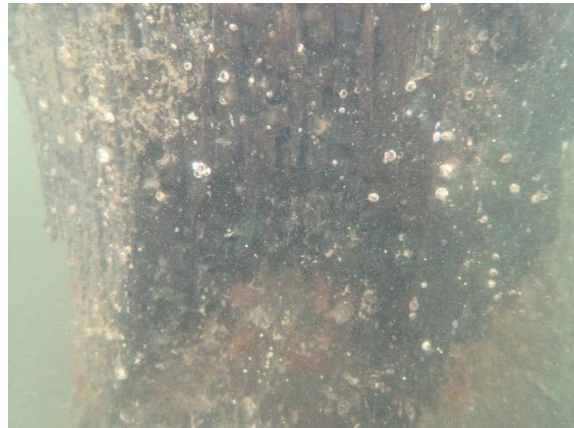
6.4 – severe wood rot & borer on subsea section of timber pile

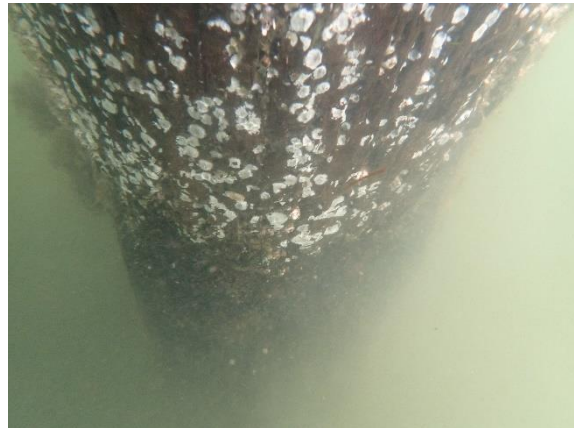
8.4, 8.5 & 8.6 – Severe wood rot & borer present throughout subsea portion of timber pile

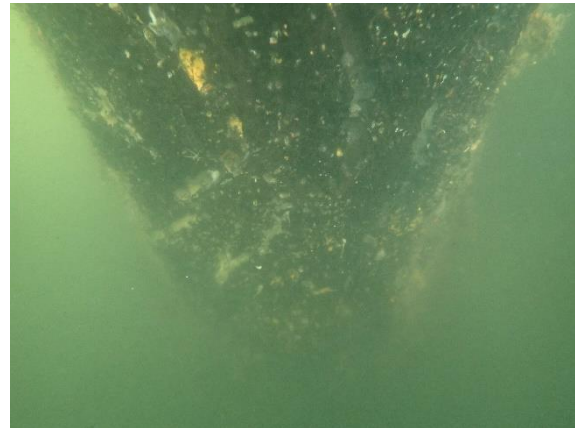
11.4, 11.5 & 11.6 – Pile encapsulation formwork, presenting in fair condition

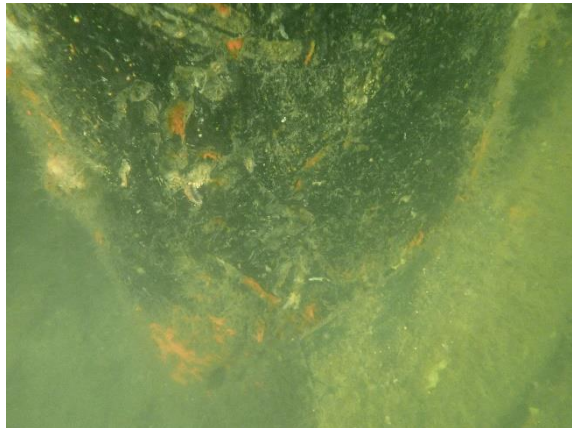
15.6 – Encapsulation has completely failed to 1200mm above seabed and then failed around one half to seabed level

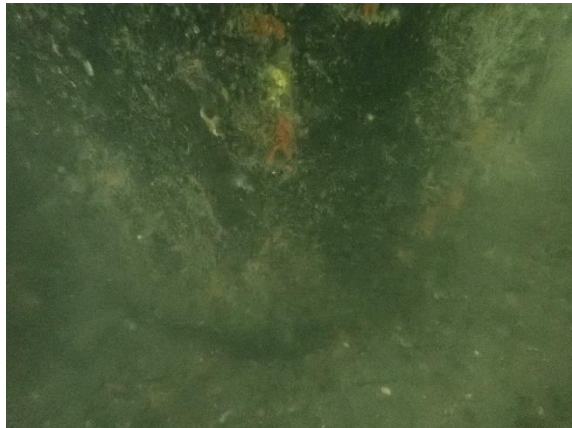
17.2 – 17.6 Moderate timber rot and marine borer attack throughout intertidal area

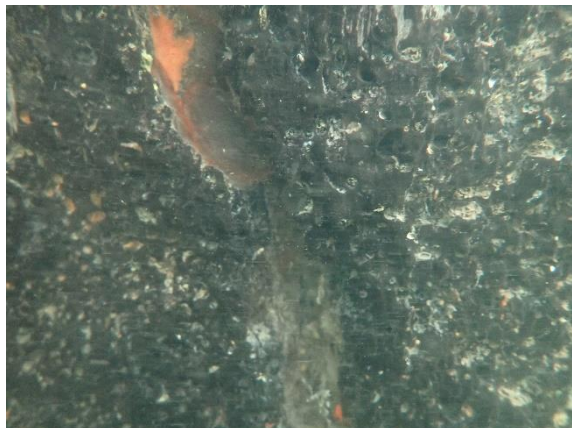
18.5 & 18.6 – Concrete grout column, presenting with absent formwork, and moderate deterioration of concrete.

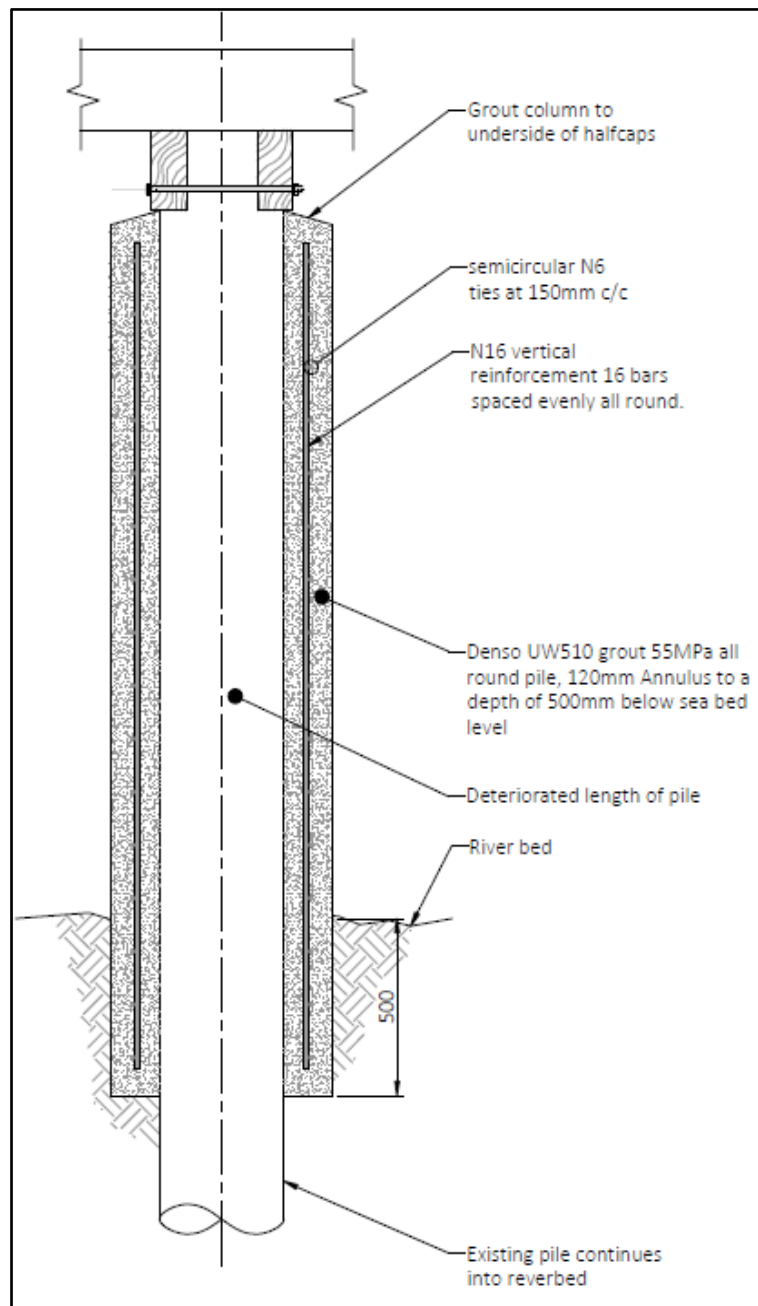
Image 3. Pile Repair Sketch

Although no information could be found on the existing encapsulations, they have proved to be unsuitable and were likely installed in the absence of an appropriate specification. To provide a structural repair on the timber piles, the existing encapsulations will need to be removed in their entirety, from the top of the column down to a minimum of 500mm below the seabed. All piles could then have a suitable encapsulation poured, in accordance with the sketch displayed in Image 2, on the following page. Any future encapsulations should utilize specialist underwater high strength grout and incorporate a reinforcement cage.

It was noted during the inspection works that the pile tops where halfcaps attach remain in good condition, any future encapsulations should finish directly below this level, to ensure all vulnerable sections of the pile are adequately protected by the grout column.
