FORESHORE AND CHANNEL ASSESSMENT OF TALBOT BROOK

WATER AND RIVERS COMMISSION
REPORT NO. WRM 29
2002

The Talbot Brook catchment drains portions of the Shires of York and Beverley into the Dale River which feeds the Avon River. Foreshore and channel assessments along Talbot Brook were undertaken between June and August 2001.

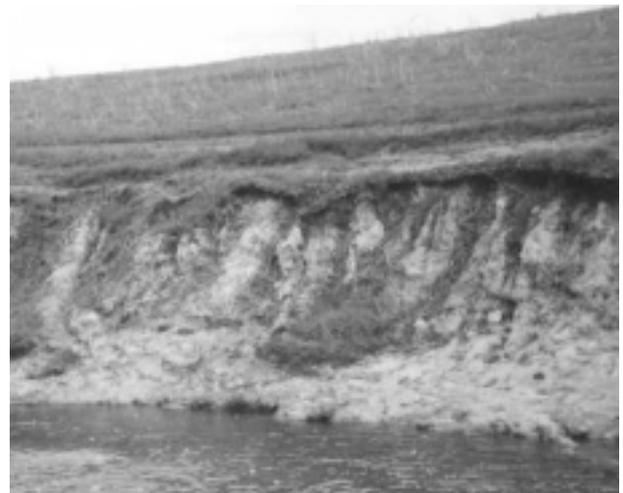
The most significant components were erosion and sedimentation. The overall stability of the channel might be defined as poor (see Table 2) with nearly 75% of survey sections being highly eroded and unstable with large deposits of coarse sand sediment. Sediment deposits were identifiable along many areas of the channel, while there were also some areas along the riverbed that have been eroded down to the underlying clays.

Bank erosion along Talbot Brook

Anecdotal evidence suggests that sediment within Talbot Brook system is mobile. Field observations determined that the floods of January 2000 caused a lot of damage by eroding the bed, banks and foreshore. A lot of fresh sediment was deposited along the banks and foreshore during this period. This was supported by anecdotal reports of changes in foreshore and channel condition.

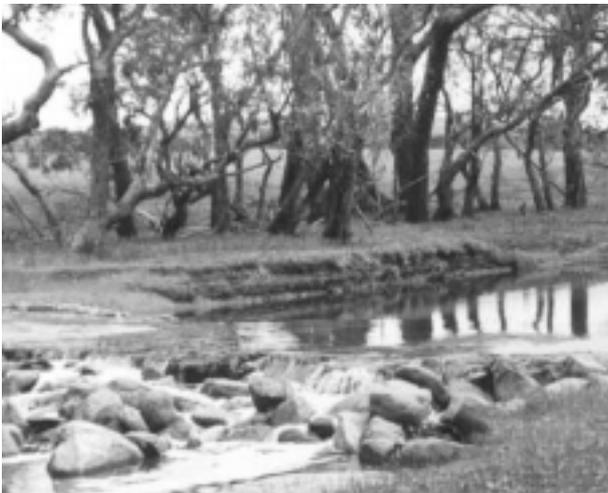
A man-made riffle provides a crossing point for stock and vehicles, acts as a sediment trap and aerates the water

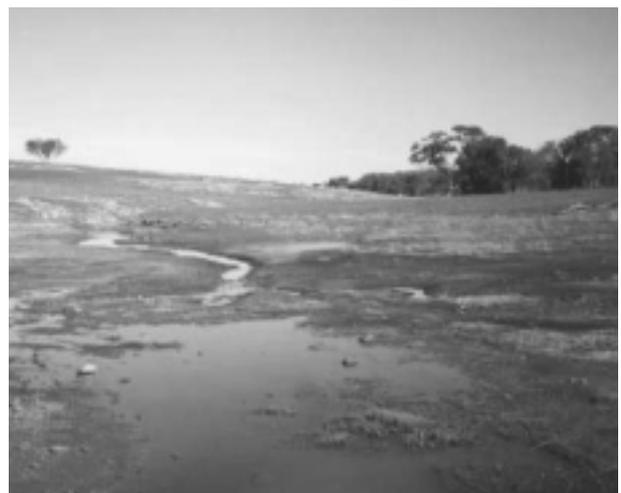
3% of surveyed sections were rated as B-grade and 6% were rated as having a D-grade general foreshore condition rating. B-grade ratings were awarded to those sections that were in slightly better condition than the rest of the brook, with a more diverse cover of native vegetation being invaded by grassy weeds. Sections rated as D-grade were in great need of management, with the stream simply characterised as an eroding ditch or weed infested drain (Pen and Scott, 1995).

A D-grade section of Talbot Brook

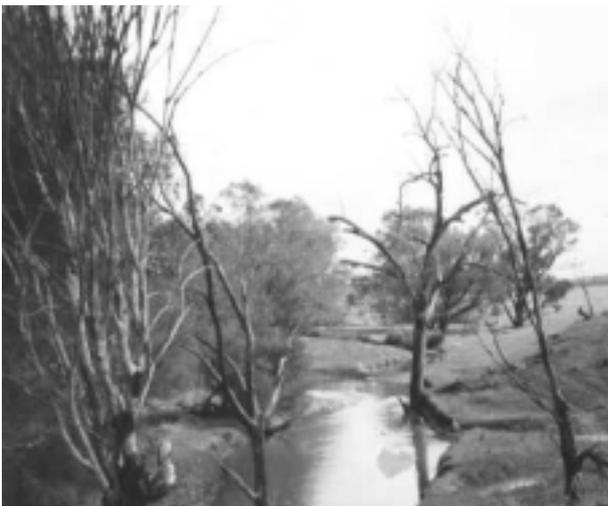
Vegetation health was determined to be moderate along most of Talbot Brook and tree death was obvious in many areas. As described above, there was a lack of middle- storey plants in most areas and the ground cover was dominated in most instances by weed species.

Many factors such as increasing salinity levels, waterlogging, disease and heat stress are responsible for causing the death of foreshore vegetation

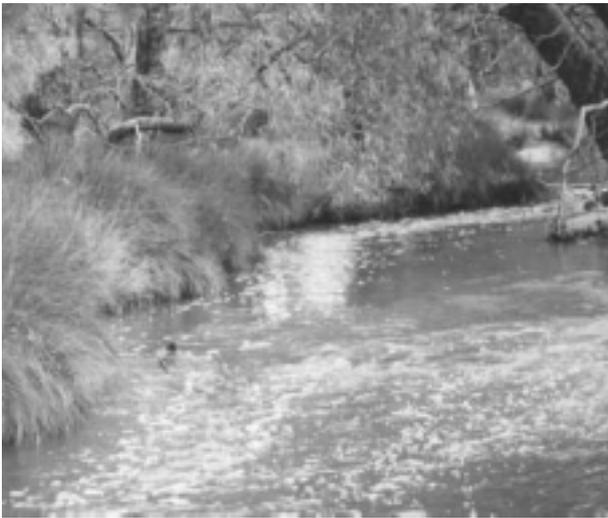
Fringing vegetation provides shade and habitat, and also filters water entering the waterway

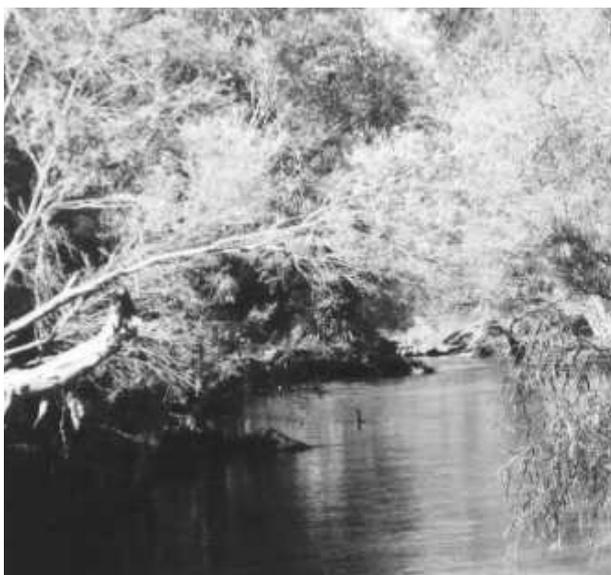
Overhanging vegetation provides shade and habitat for a range of aquatic and terrestrial fauna

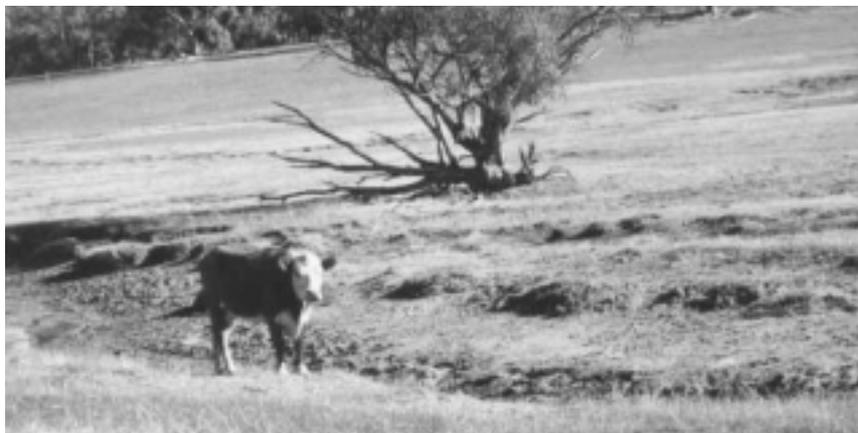
Stock trample and eat native vegetation and cause erosion of the bed and banks

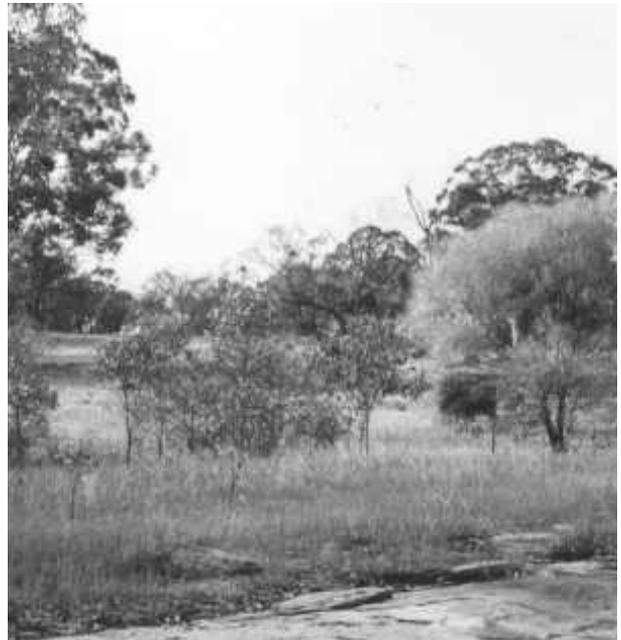
Revegetation of the riparian zone is a common management practice

If revegetation of riparian areas takes place, it is important that stock do not have access to these areas of fringing vegetation. A fence around the revegetated area (or the riparian zone) is the most effective tool to prevent livestock grazing and trampling newly revegetated areas.

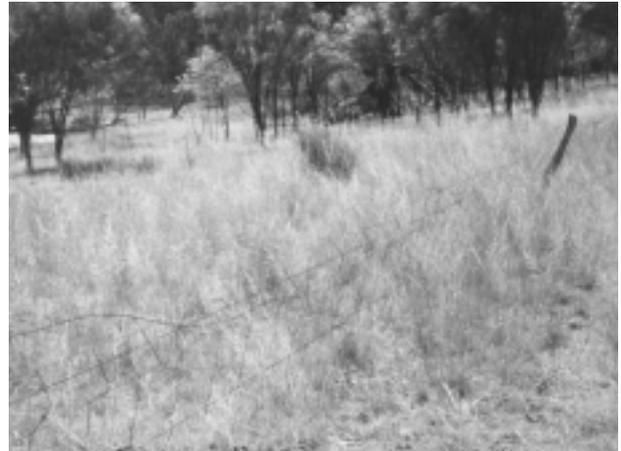
Fence condition: POOR

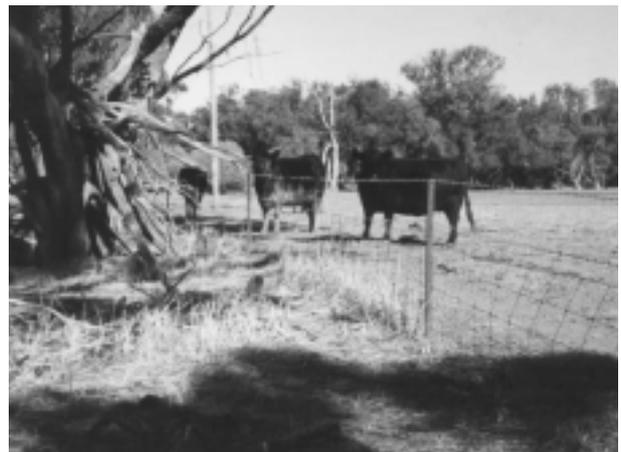
Fence condition: MODERATE

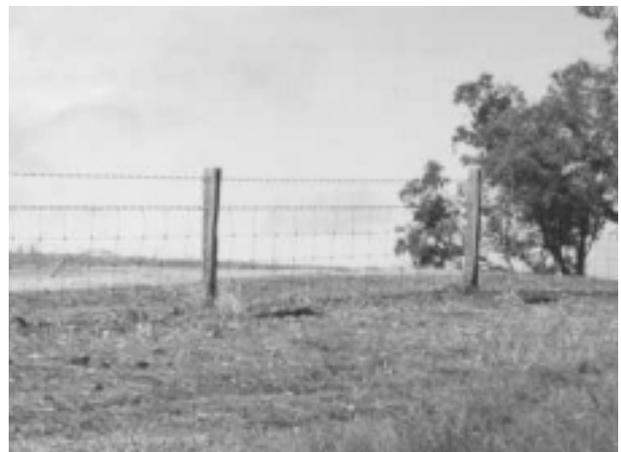
Fence condition: GOOD
