Project 224768.00
31 July 2024
R.001.Rev1
DJB

Report on Subsidence Risk

Reids Ridge Abandoned Mine Site

Yalgoo-Ninghan Road, Paynes Find WA

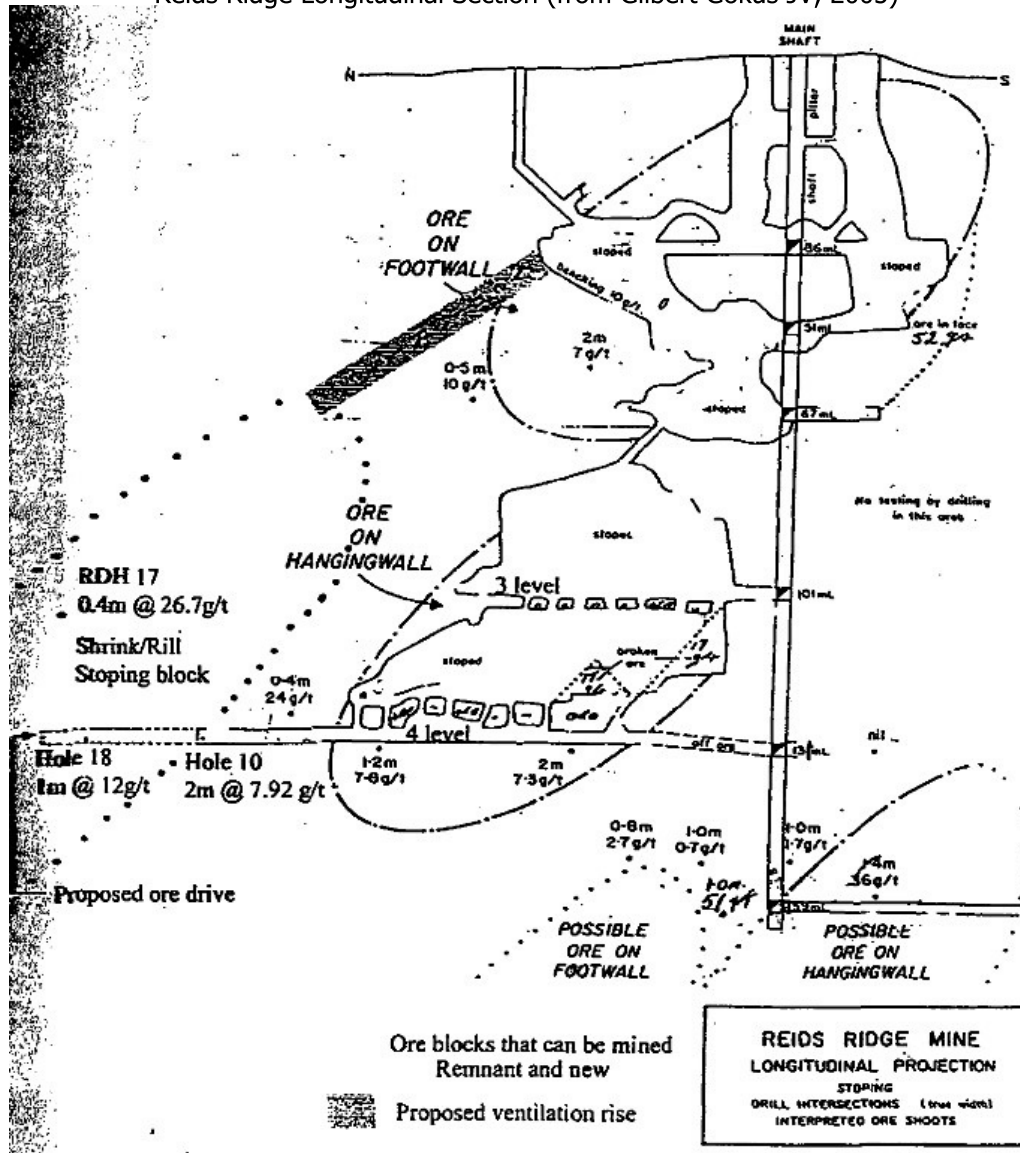
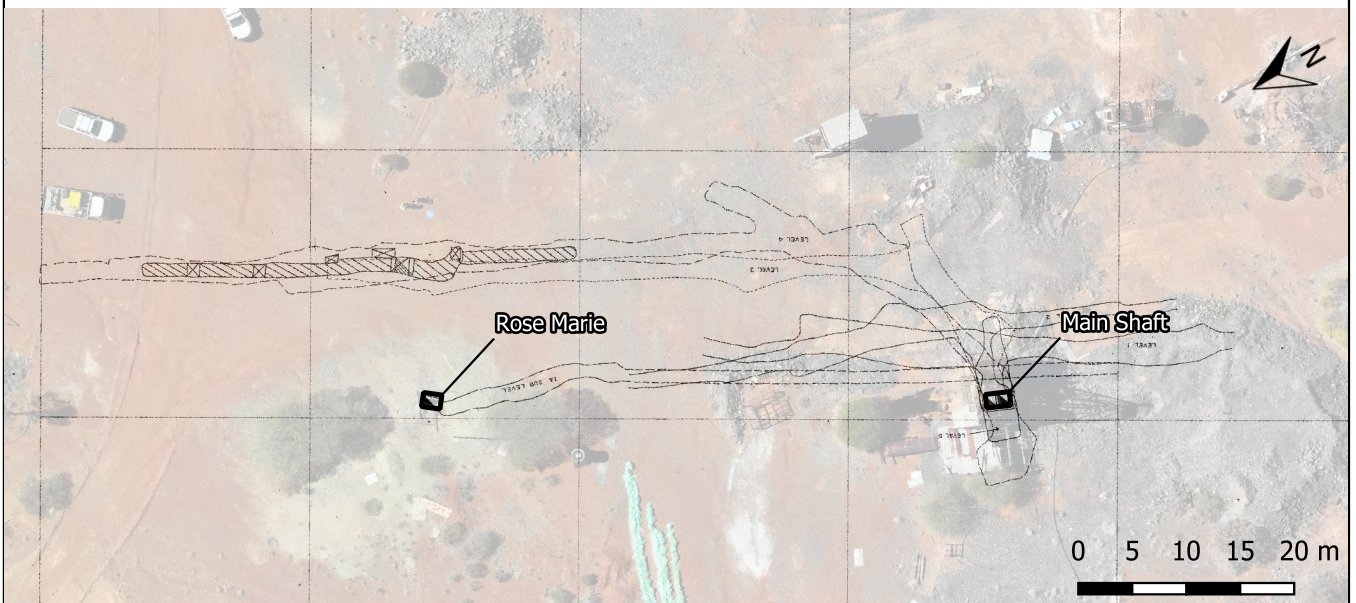
PROJECT: 224768.00
Drawing No: 1
REV: 0
DATE: 21/6/2024

Drawing 1 appended reproduces a longitudinal section attached to a Notice of Intent (Gilbert Gokus Joint Venture, 2005) outlining the scope to reactivate operations of the existing Reids Ridge underground mine in 2005. The interest of this drawing includes that it forms the most complete longitudinal mapping of the mine developments identified during this study, and it shows two near vertical stopes above Level -36 m that are not shown on former survey plans but whose evidence was observed during the field work for this study. It is noted that further

proposed underground developments are also shown; their completion (or otherwise) post 2005 are unknown but would have involved deeper levels with no impact for this study. The accuracy of this longitudinal section is uncertain because its source is unreferenced, however it is noted that this longitudinal mapping is consistent with previous referenced surveys and field results made during this study.

- Excavating a trench to expose the ground conditions across the subsided zone to the south of the main shaft, where a 2005 longitudinal section (Drawing 1) shows a possible former stope.

Survey plans indicate the northern stope extends from the surface vertically down to Level 1A at -36 m depth, laterally connecting other stopes via lateral workings and winzes to Level 4 at -131 m depth. Available plans (e.g. Drawing 1) also indicate a link between the main shaft and the northern stope, however evidence of this was not observed in video footage recorded from the main shaft. LiDAR data collected within the main shaft indicates possible void to the north of the main shaft from between depths of approximately 6 m and 16 m (which is consistent with the 2005 longitudinal section in Drawing 1), however this part of the shaft is tightly lined with wooden lagging that strongly masked such a void and mostly precluded Lidar data acquisition behind the lagging.

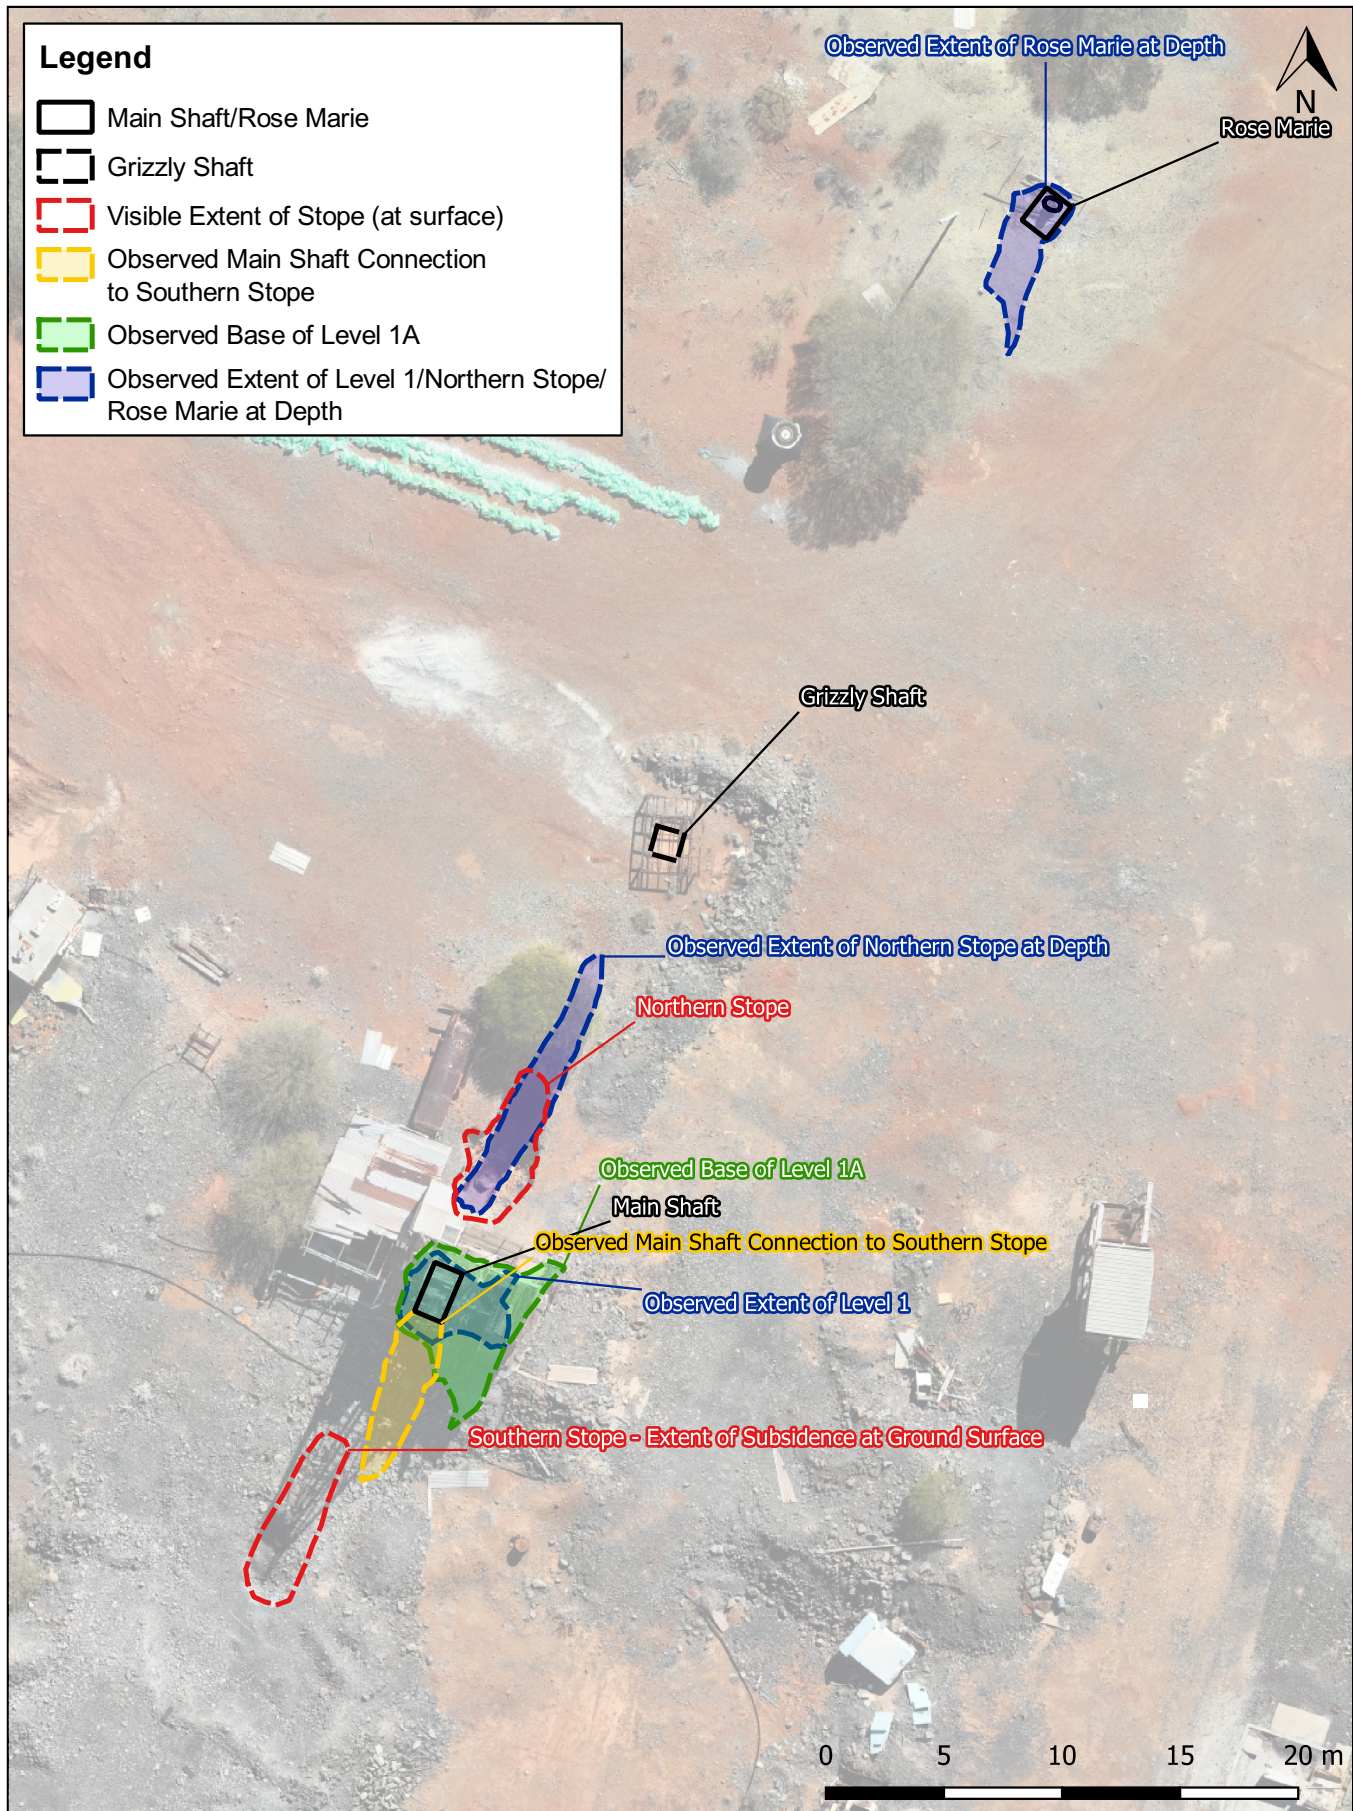
| | Subsidence Risk | Drawing No: 2 |

Drawing 2 appended shows an aerial view of the Reids Ridge mine site and relevant features discussed in this report. A plan view showing the underground developments of the mine available from survey plans prior to 1985 is given in Drawing 1.

Review of desktop information, visual field observations, photos, video recordings, LiDAR data and geophysical survey interpretation indicates that that no high-risk areas for ground instability are located to the east or west of the lode alignment passing by the main shaft and Rose Marie shaft. It is considered that subsidence risk is limited to be along or close to this alignment between the main shaft and Rose Marie shaft and near the ground surface depression to the south of the main shaft. The condition of the various existing features along this alignment in the vicinity of the main shaft are detailed in the sections below and the location and extent of the features are shown on Drawing 2, appended.

The northern stope was open at the surface for a length of 7.0 m and a width ranging between 2.0 m and 3.5 m. From a depth of 2.5 m however, the stope width narrows to 1.0 m. A secondary horizontal void, with an opening that was 0.6 m high was visible from a depth of 1.7 m on the northern wall of the stope. Owing to the geometry of the narrow opening, limited data could be obtained within this secondary void, however LiDAR data indicates it extends at least 5 m to the north along the lode alignment and to a depth of at least 4.1 m (RL 319.4) (See Drawing 2).

At the time of the field work, access to the northern stope was deterred along its eastern long side by a rock waste bound, along its northern long side by disused mining equipment (mostly a tank), on its southern short side by the headframe, and on its northern short side by a large bush (all visible on the aerial photo on Drawing 2).

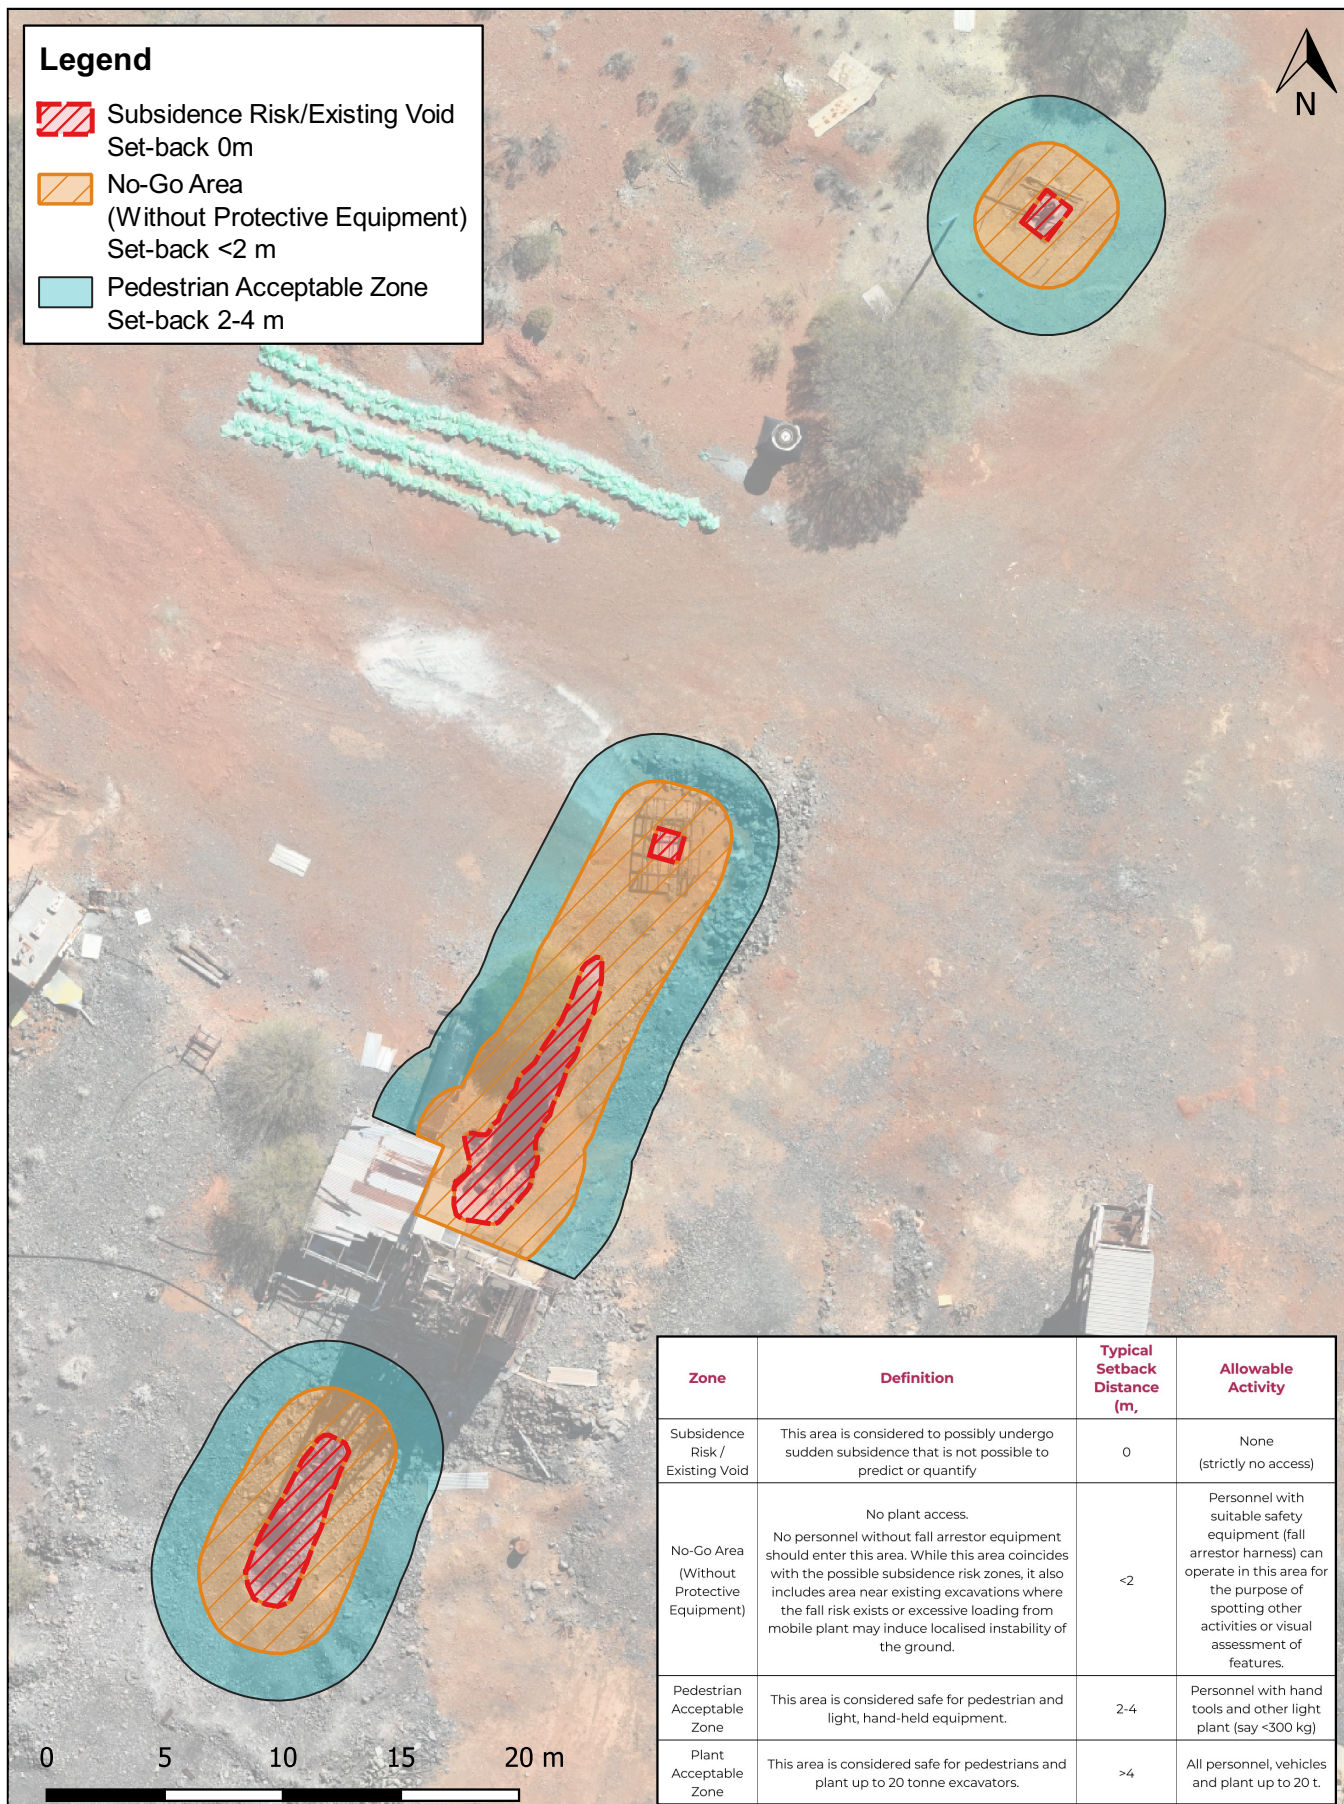
| | Subsidence Risk | | Drawing No: 3 |

For the purpose of future personnel and plant undertaking work in the vicinity of the Reids Ridge mine, several setback zones have been defined and are listed in Table 1 below. This table include typical setback for each defined zone. Table 1 must be read in conjunction with Drawing 3 appended that shows the extent of the zones, considering site conditions specific to each feature.

Notes [1]: These distances are a general guide. Reference must be made to Drawing 3 for the layout to account for areas where lateral workings or voids are not visible from surface and other specific site conditions.
