Erosion at Millstream Chichester National Park

April 2011

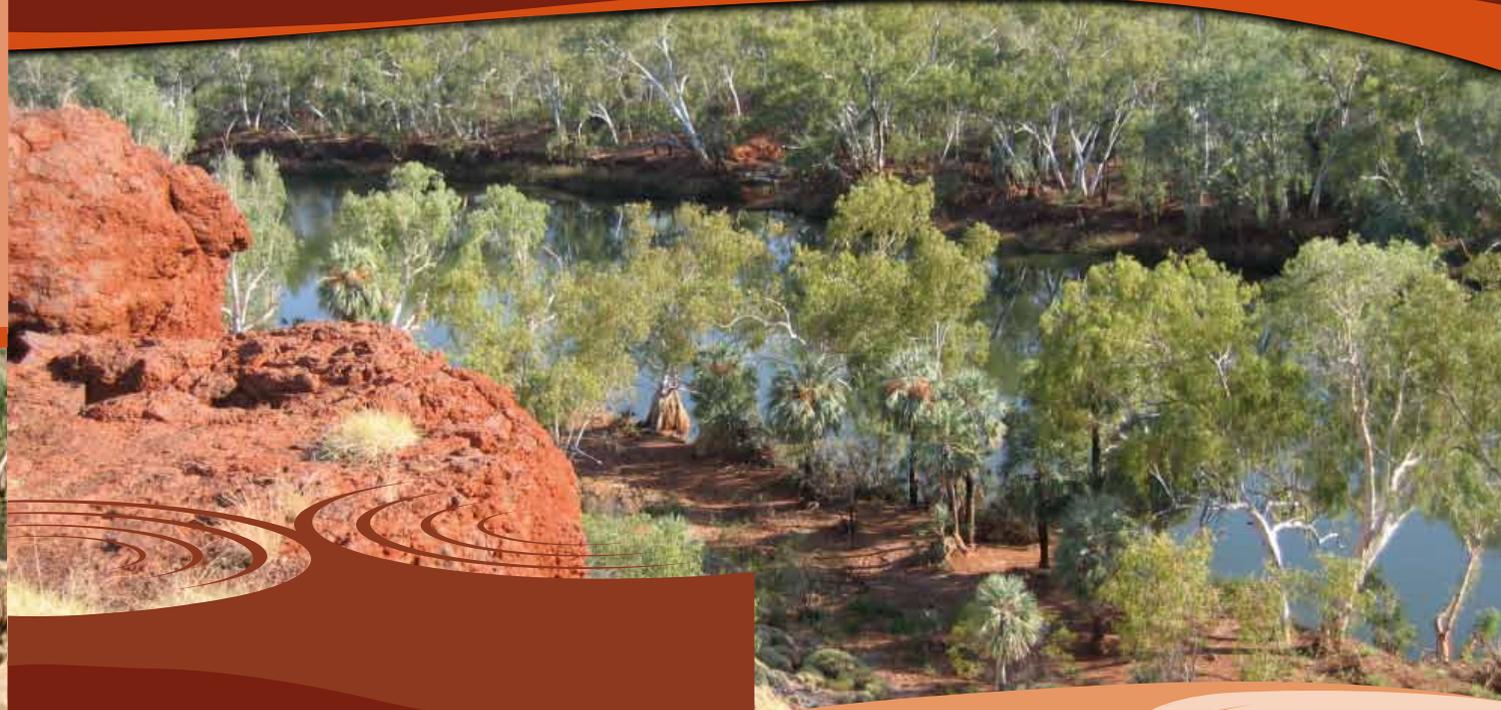
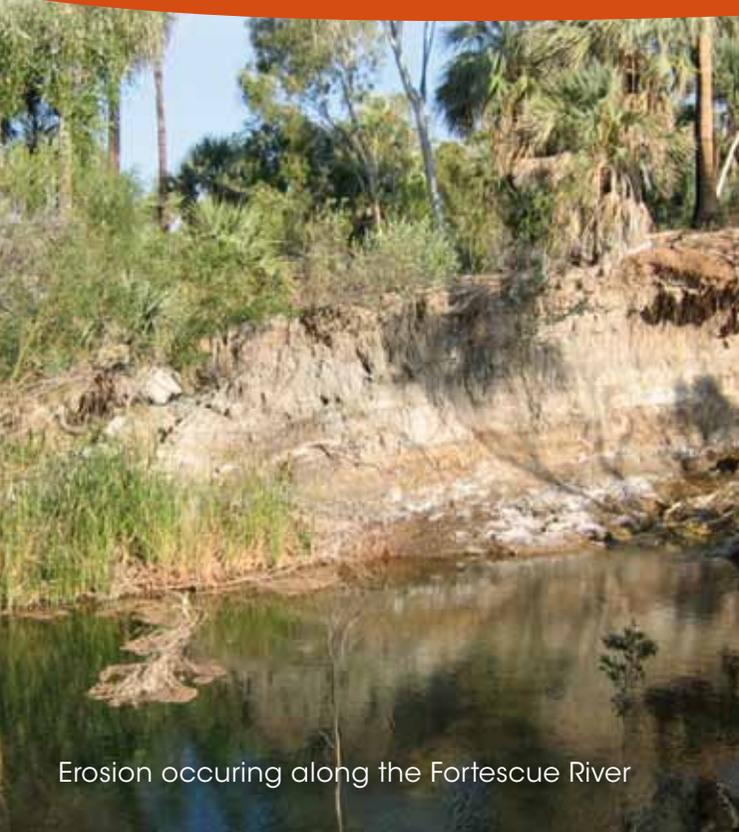
Erosion occurring along the Fortescue River

Erosion occurring along the Fortescue River and its tributaries at Millstream is the continuation of a natural process. However, human activities such as water management, cattle grazing, and construction of roads, weirs and recreational facilities may have accelerated the rate of erosion.

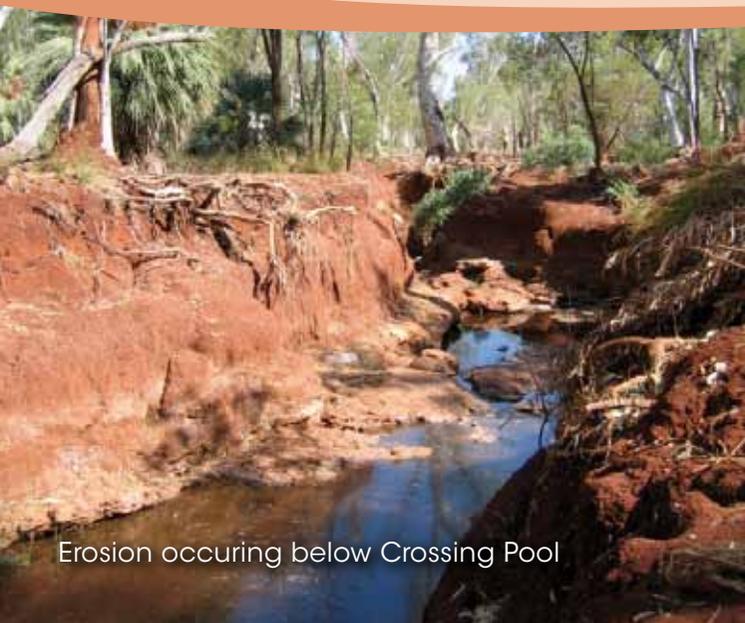
Erosion occurring below Crossing Pool

The major impacts includes loss of riparian vegetation, scouring of river channels and bank erosion at permanent pools. Bank erosion occurred at Crossing Pool in 1988 and more recently in 2009. As a consequence the water level of Crossing Pool is now about 2m lower with obvious impacts to this popular recreation site. Local groundwater levels have also dropped and surrounding vegetation is showing signs of water stress.

Efforts have previously been made to reinstate pool levels at Crossing Pool using sandbags and rubble to slow erosion along channels. These works have only proven effective in the short term and need considerable ongoing effort.

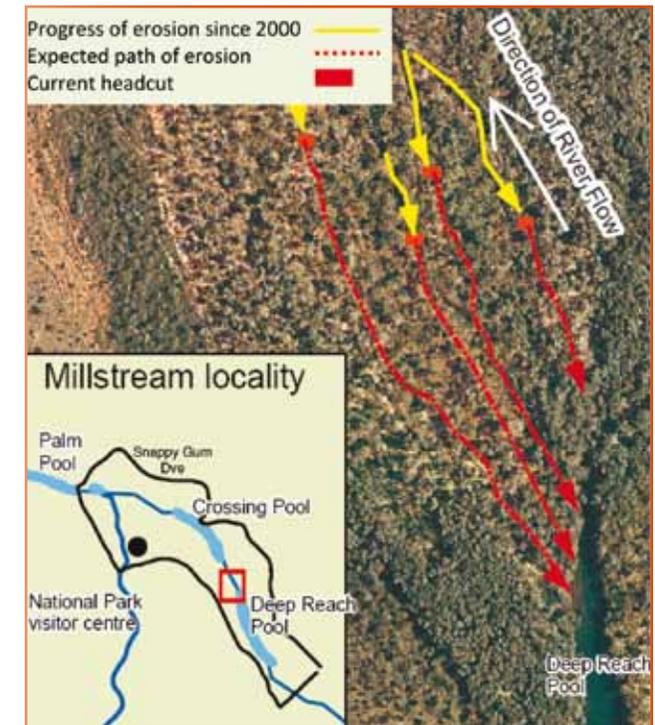
The Department of Water has been monitoring the progress of this erosion since 1979. In 2010 a survey conducted using remote sensing techniques provided a very accurate map of erosion. Erosion was shown to be active downstream of Deep Reach Pool, Palm Pool and Crossing Pool.

Erosion mapping below Deep Reach Pool
Note: erosion is cutting upstream towards the pools
