River Recovery Plan for the Dale River

Incorporating foreshore and channel assessment

REPORT NO. RRP 10
APRIL 2006

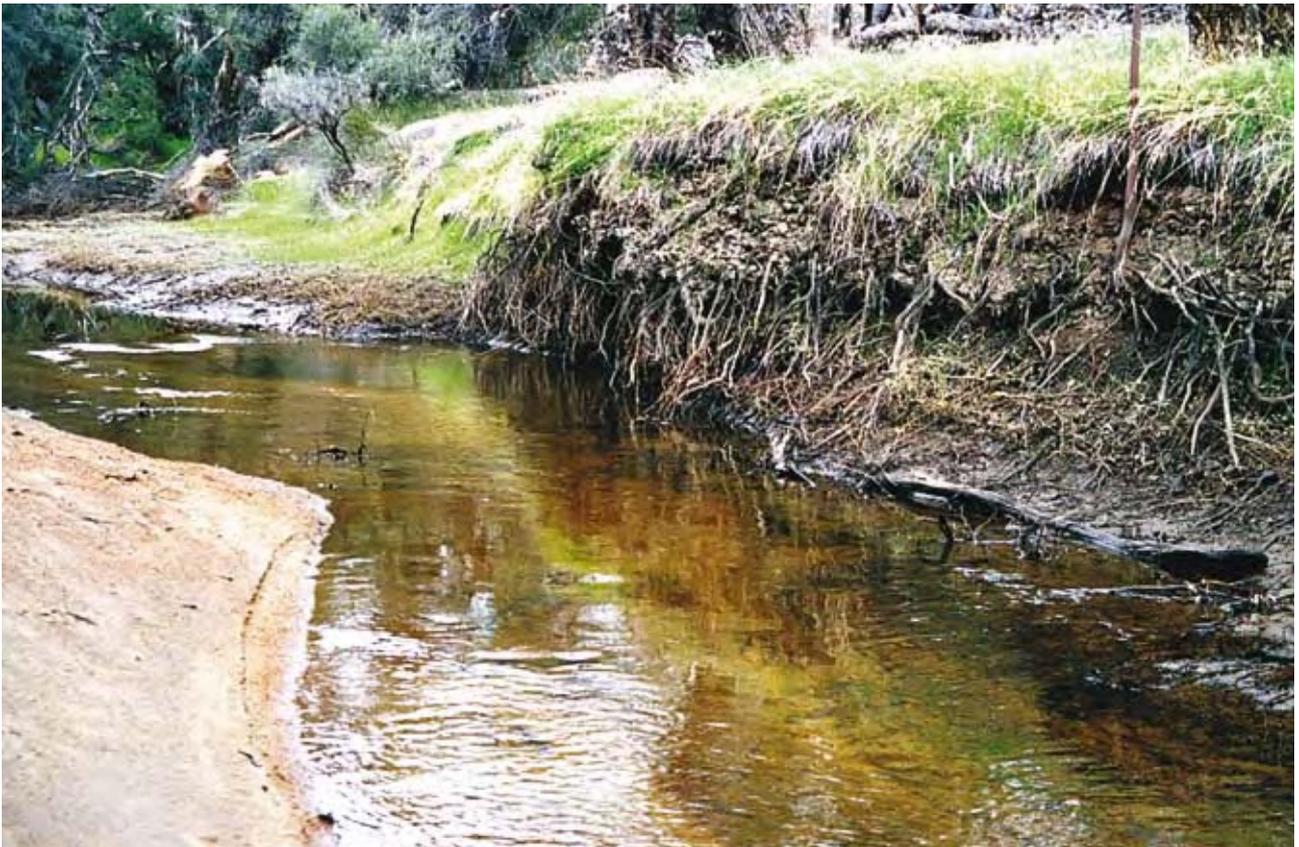
Undercutting (Image 2) occurs on vertical banks where an increase in flow velocity causes the channel to incise. The scouring action of the water against the banks causes the banks to become undercut. Eventually the undercut bank, with no support from below, will collapse. This process is called slumping (Image 3). Subsidence is another form of bank collapse where flows saturate banks and cause them to collapse under the added weight of the water (Pen, 1999).

Image 2. Undercutting of the bank, exposing plant roots

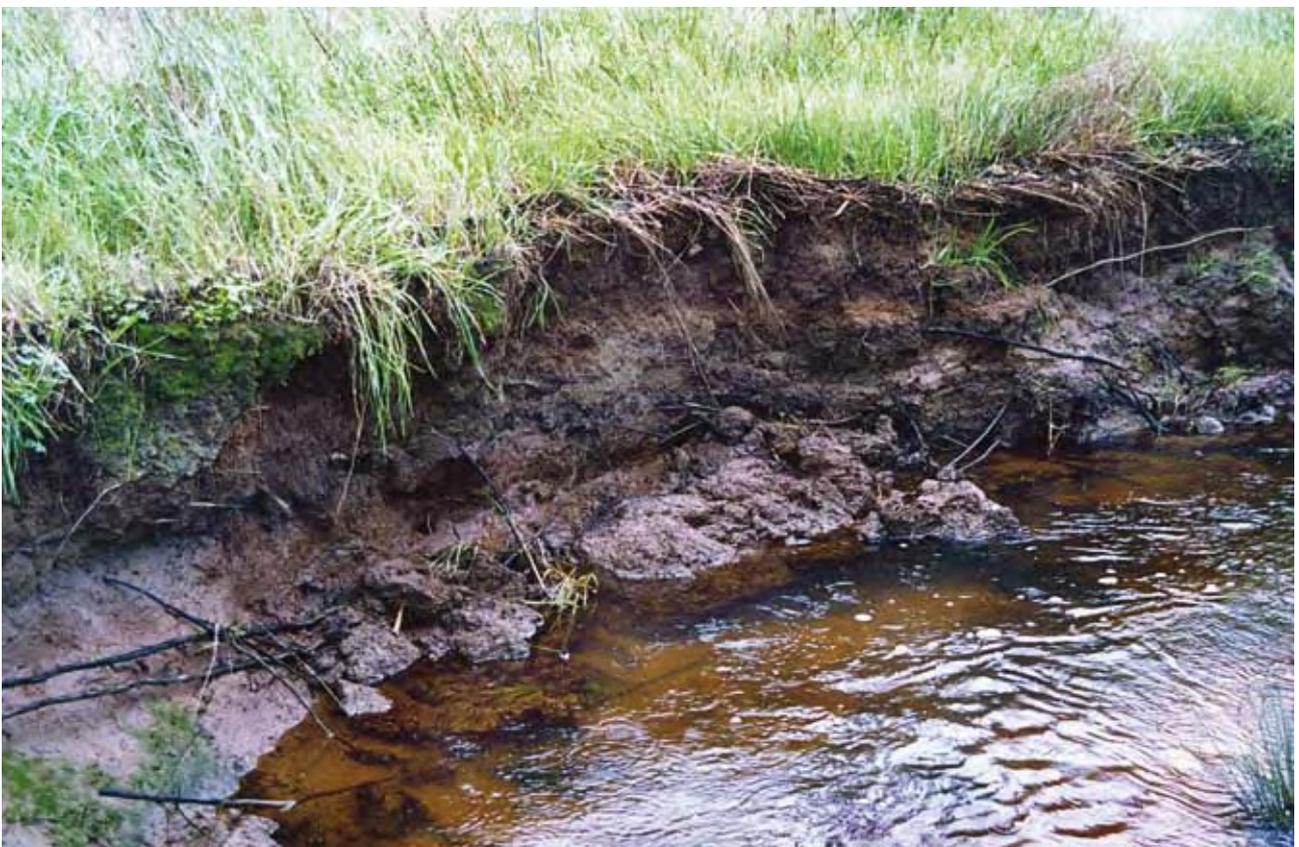
Image 3. Slumping, where an undercut bank has collapsed under its own weight

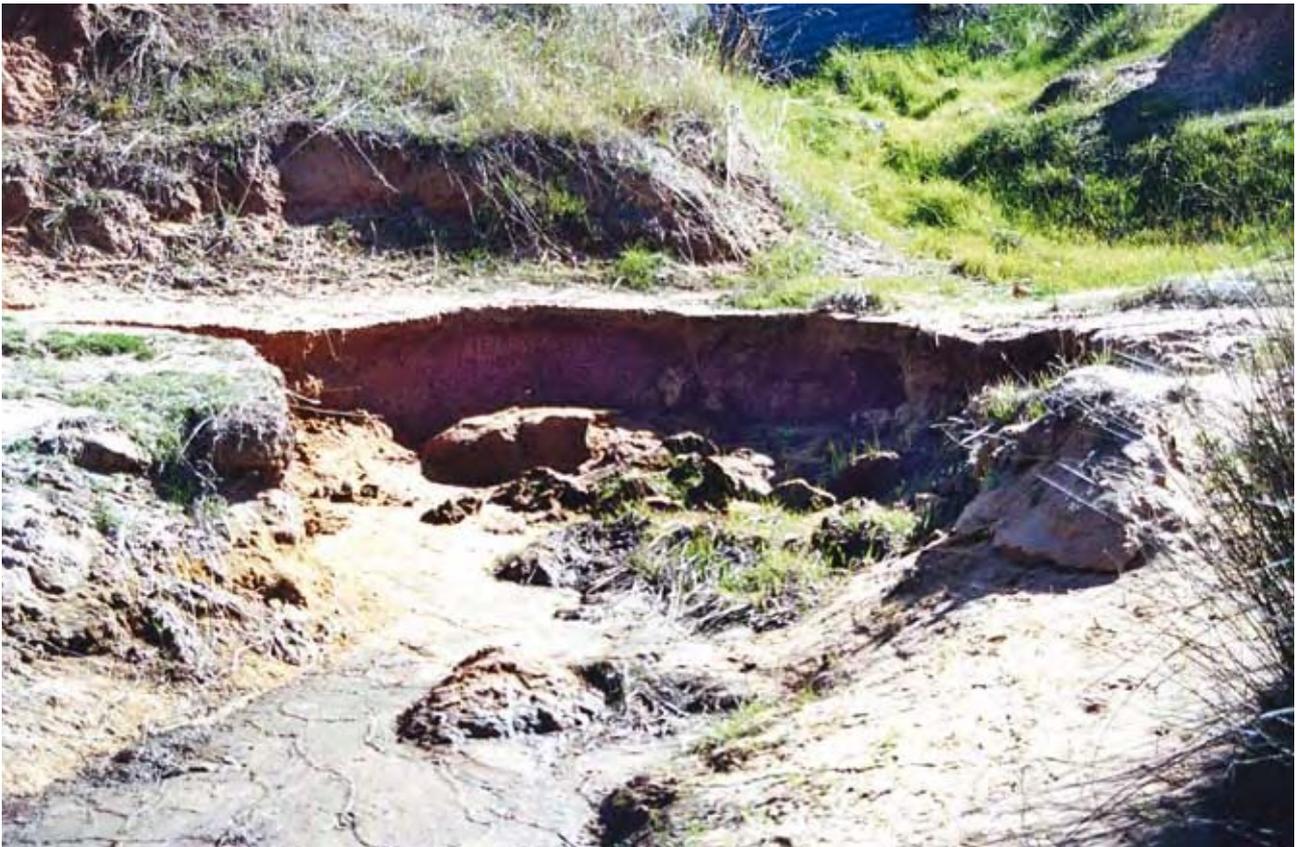
Image 4. A gully, formed by headcutting along a small tributary

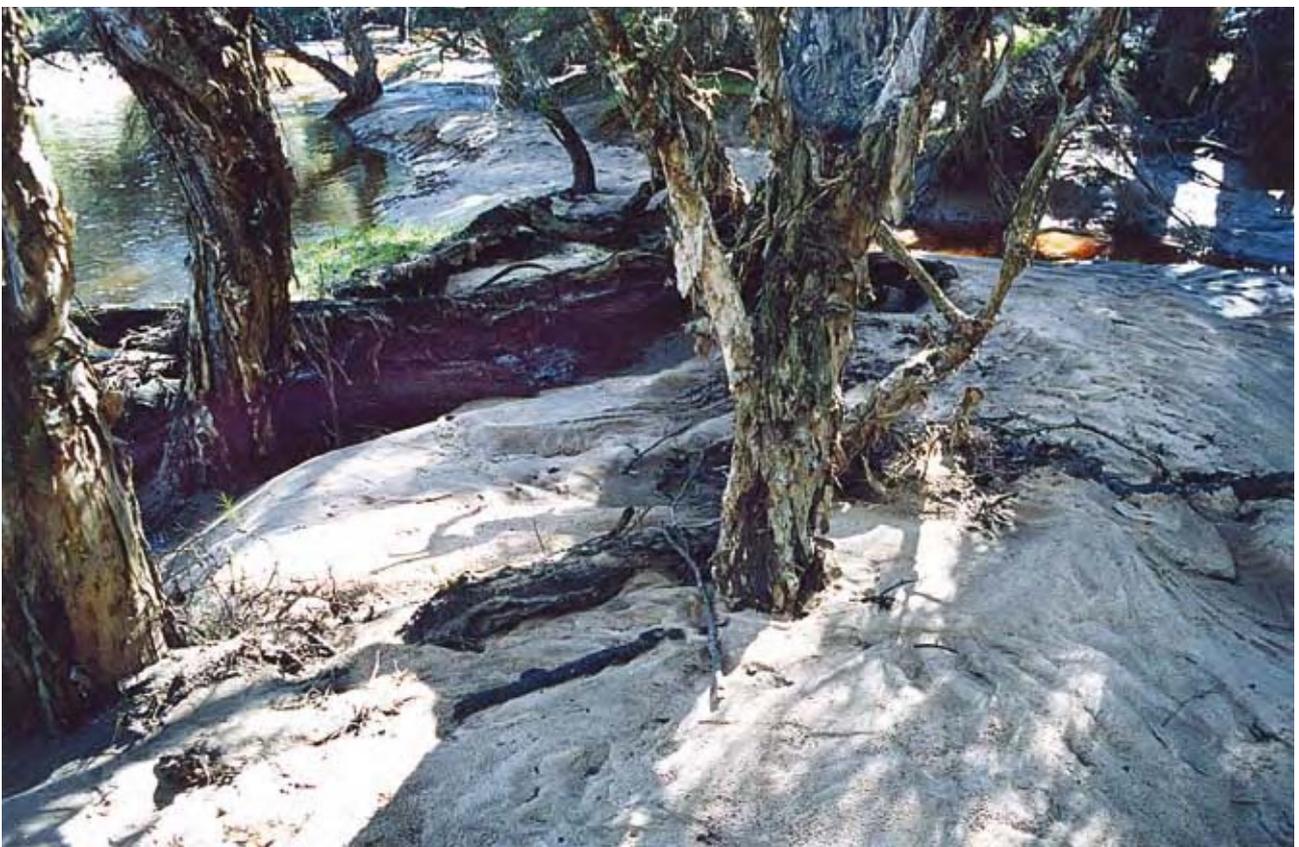
Sedimentation (Image 5) is where coarse sediments, eroded from upstream, are deposited in bars or slugs in the channel or river pools. Sediment slugs smother aquatic habitat and can slow down flow and cause localised flooding upstream as well as redirect flow into banks causing further erosion (Pen, 1999).

Image 5. Severe sedimentation in the main channel of the Dale River

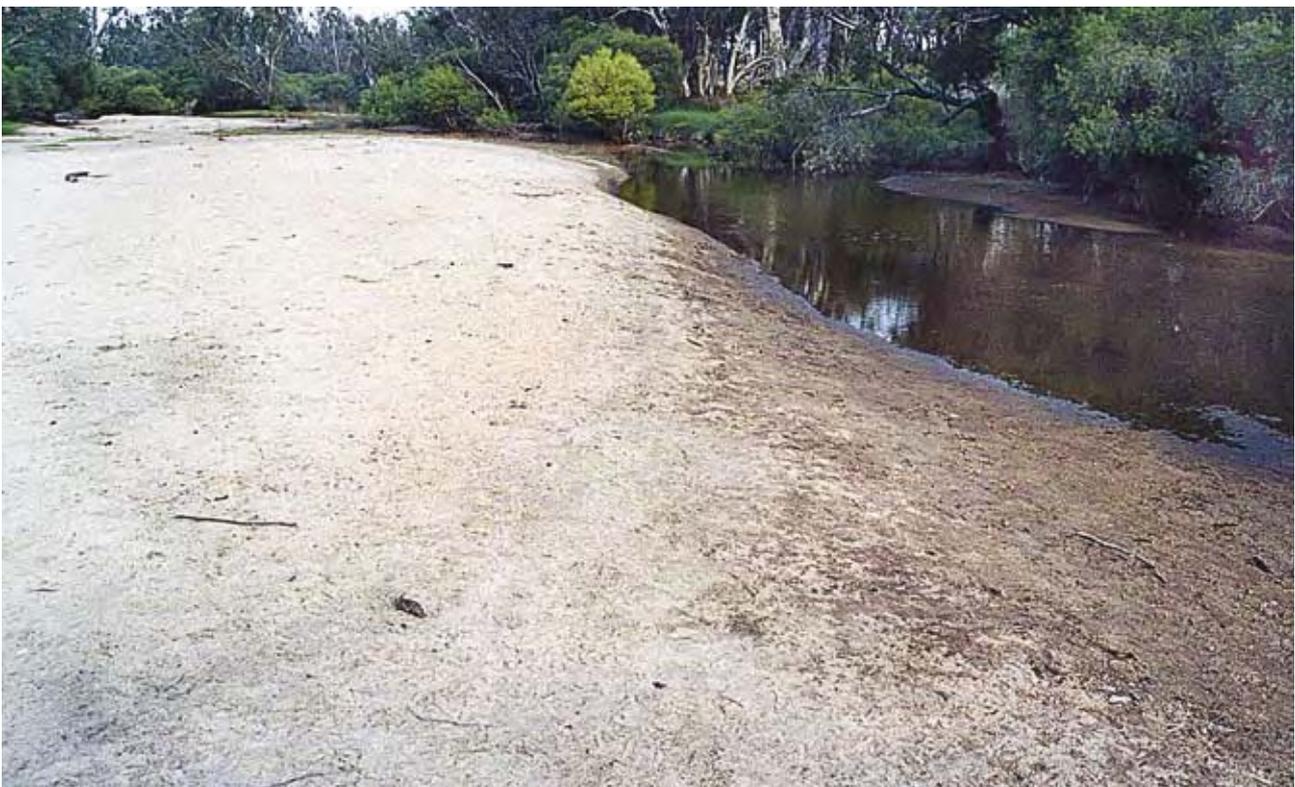
Image 6. Sediment slug smothering Reserve Pool

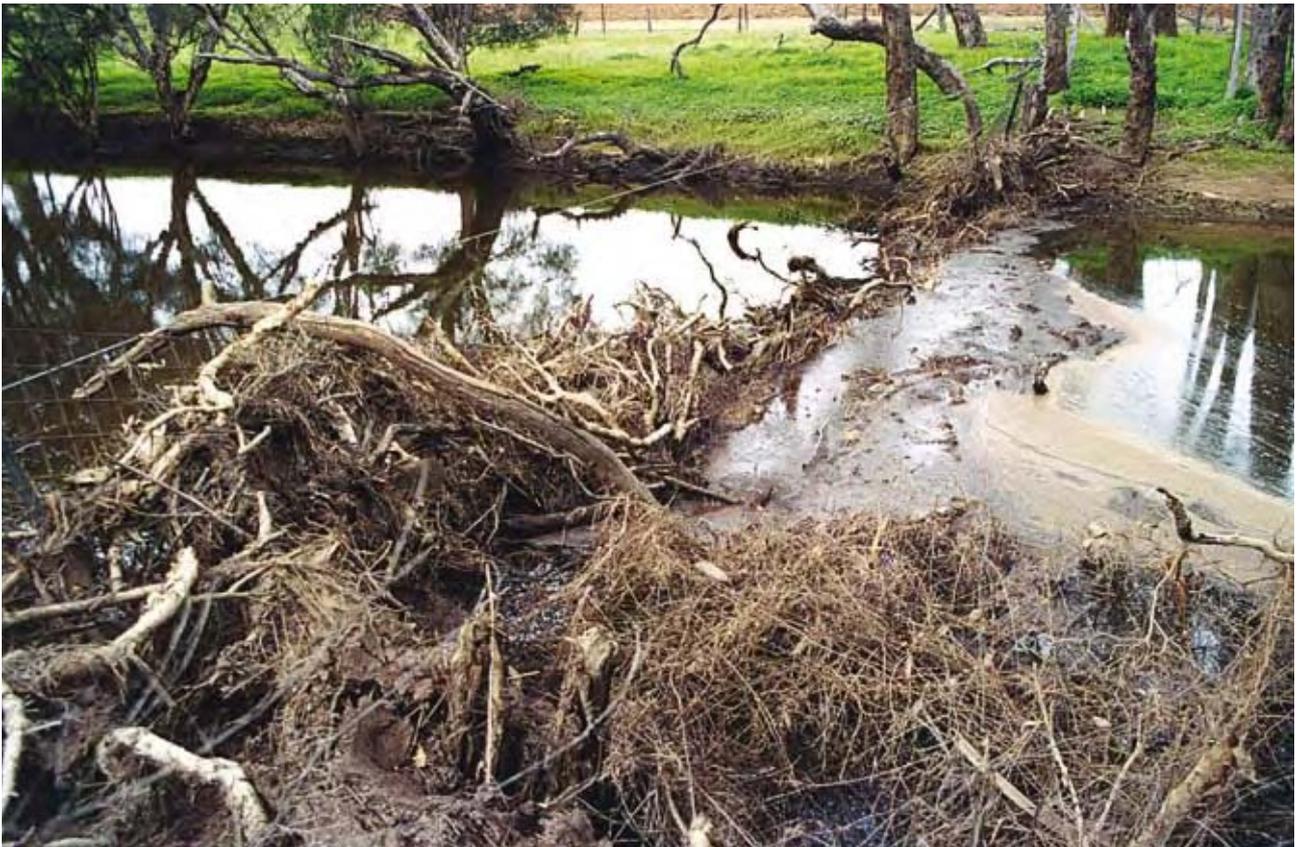
Image 8. Debris caught in a cross-channel fence

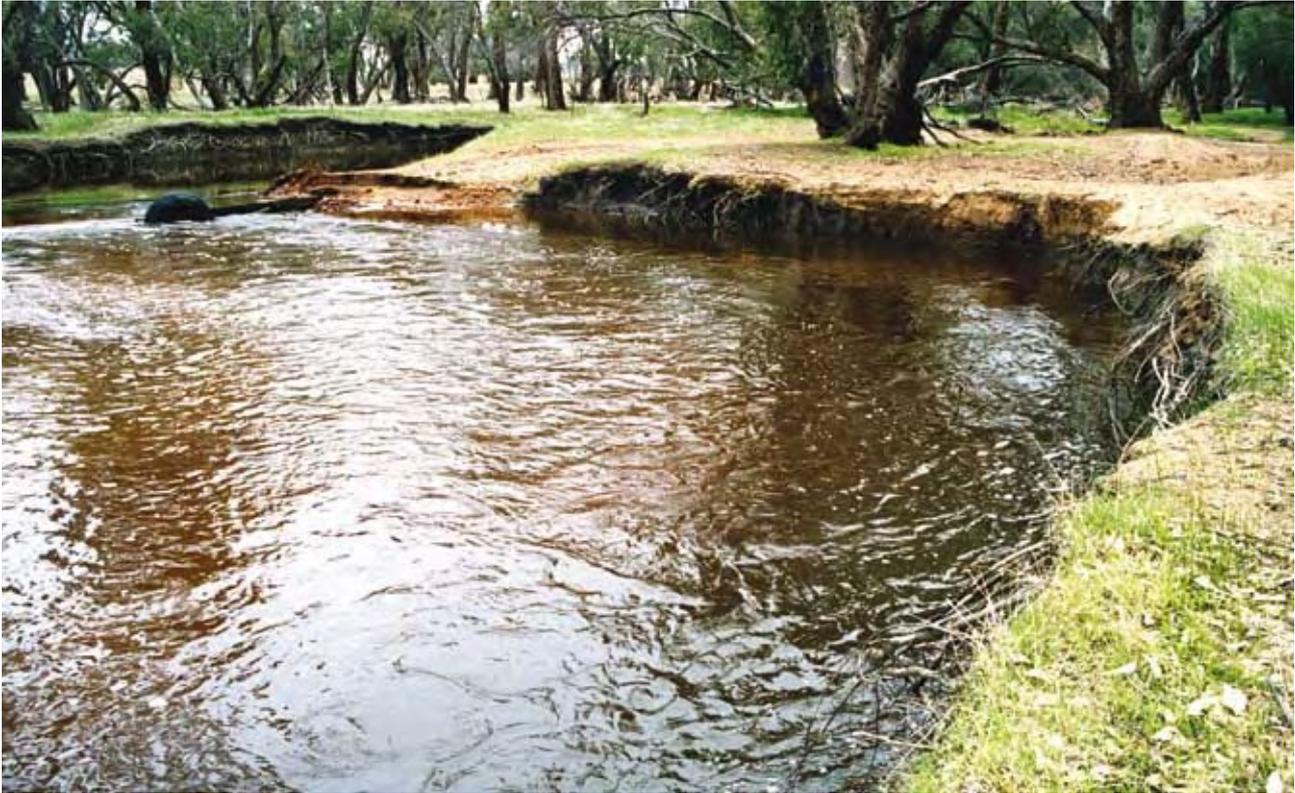
Image 10. Incorrect placement of this crossing has caused it to be washed out and the banks to erode

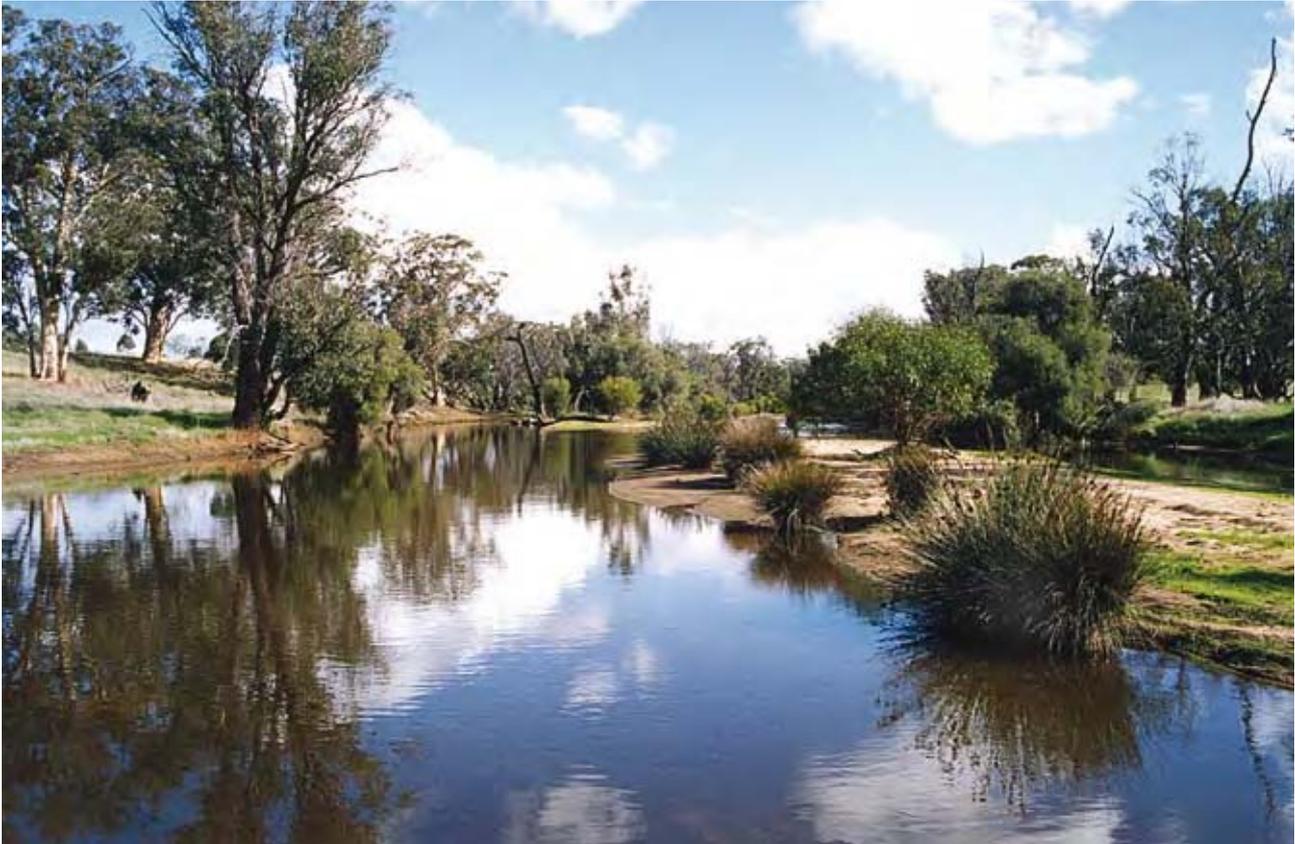
Image 11. Sediment choking Mandiakin Pool

In conjunction with mobilising or stabilising existing sediment slugs, the sediment source also needs to be managed by stabilising banks to prevent further erosion. Where the sediment source is bank erosion, river banks need to be stabilised using techniques such as revegetation, rebuilding pool-riffle sequences and replacing large woody debris. Where soil erosion in nearby paddocks is a significant sediment source, surface water needs to be managed to prevent erosion.

Planting native vegetation increases bank stability and additionally provides habitat and improves water quality by filtering sediment and nutrients. A list of suitable species for riparian revegetation in the Dale catchment is provided in Appendix 10. Severely eroded banks may need stabilising prior to replanting to prevent plants from being washed away.

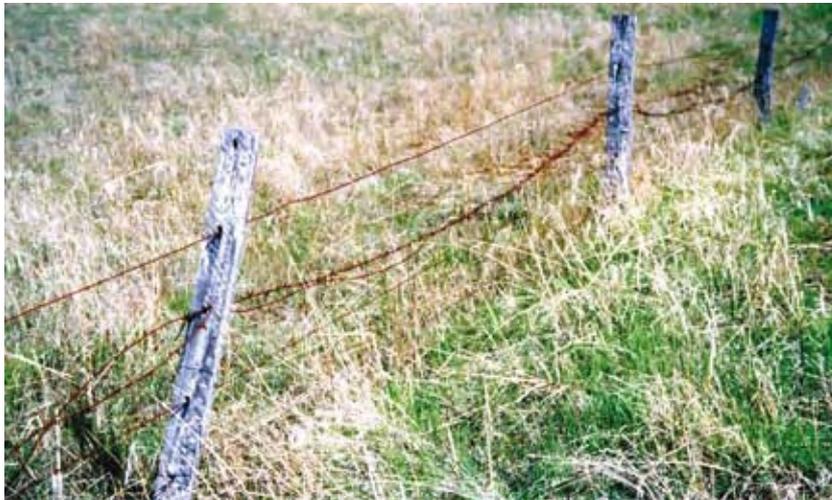
Fence condition:
POOR.

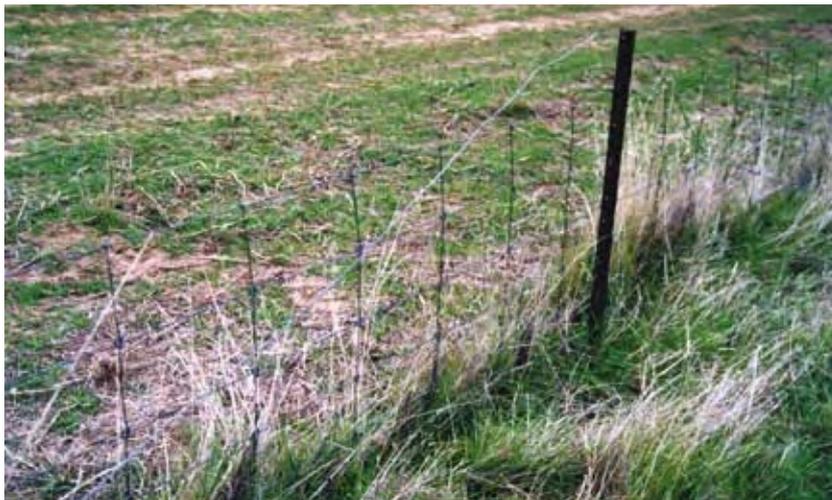
Fence condition:
MODERATE.
