Bulong Tailings Storage Facility

Likelihood of Failure Assessment & Dam Break Study

121085.01 R01 (Rev 0) SEPTEMBER 2021

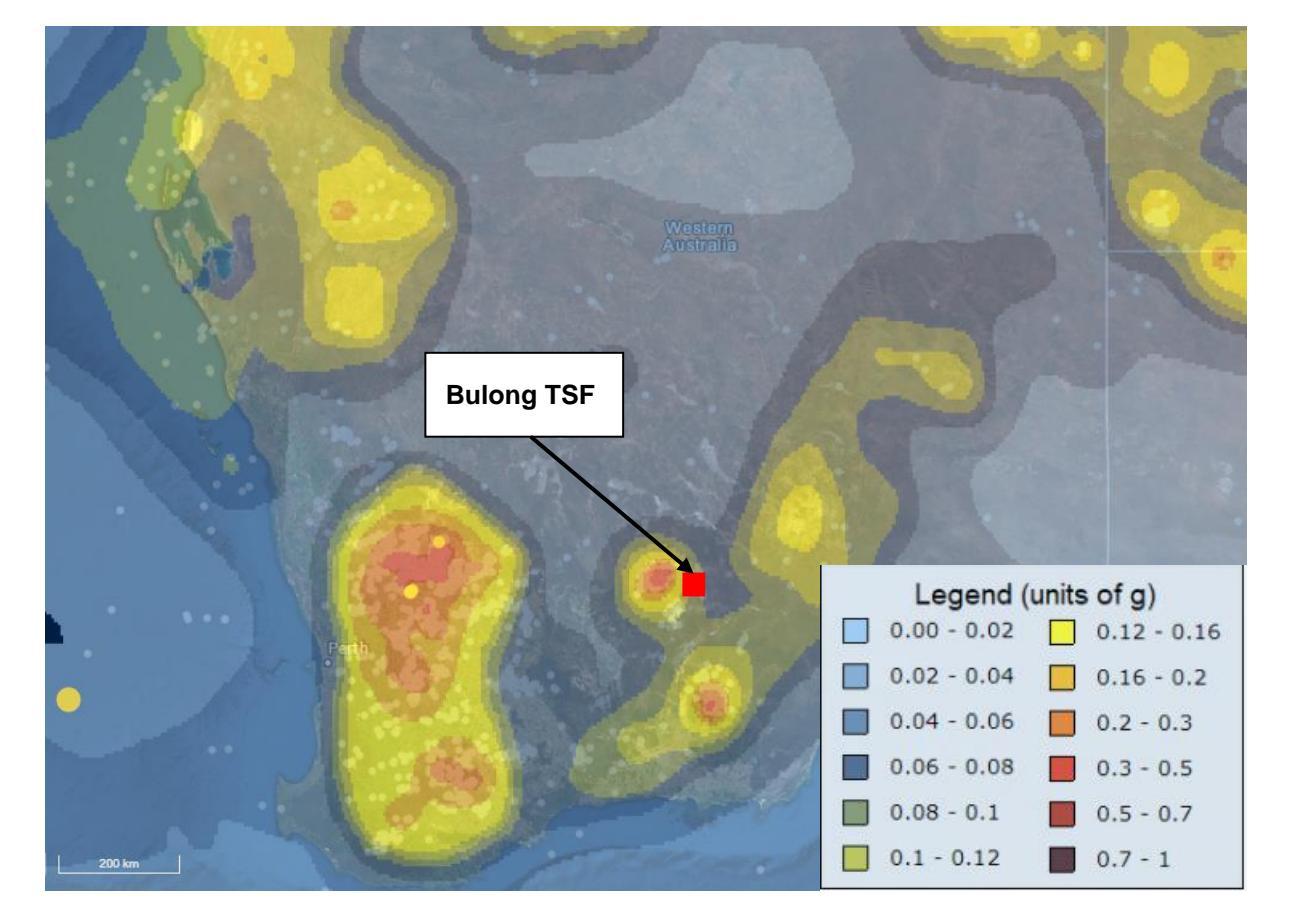
DIAGRAM 2 : NATIONAL SEISMIC HAZARD MAP PGA WITH 2% CHANCE OF EXCEEDANCE IN 50 YEARS

Based on the National Seismic Hazard map shown in **Diagram 2**, the Bulong TSF site is estimated to have a Peak Ground Acceleration (PGA) in the range of 0.12 to 0.16 g for a 2% chance of exceedance in 50 years event. This is equivalent to a return period of 2,500 years. ATCW has performed SHA's for various mine site within WA. Design earthquakes of the same return period for these sites have typical mean magnitudes of roughly 5.5 to 6.0.

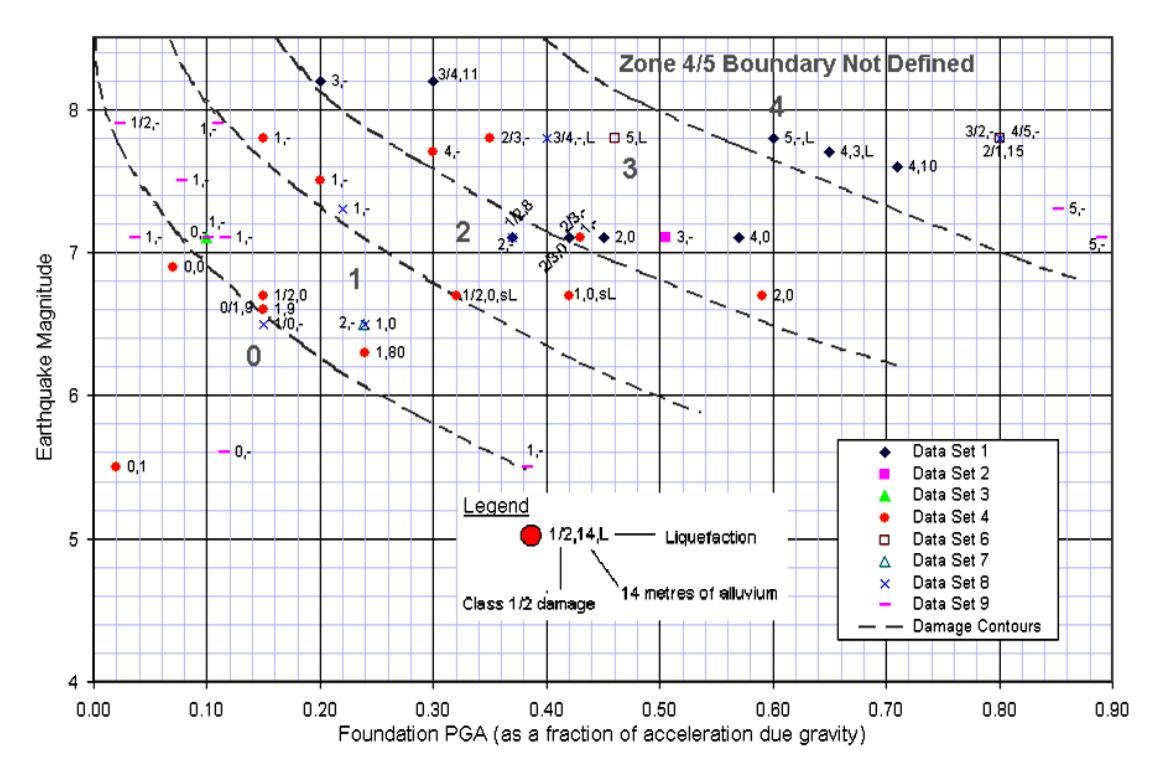
DIAGRAM 3 : CONTOURS OF DAMAGE CLASS (PELLS AND FELL 2003)

The Pells and Fell method **[5]** was utilised to assess the likely damage class and resultant deformation from various seismic events. A chart to establish the 'damage class' to the embankment is presented in **Diagram 3**.

For a 1 in 2,500 yr seismic event at the Bulong TSF site, assuming a PGA of 0.16 g and a magnitude of 6.0, the Damage Class Number is estimated to be '0'. An interpretation of the damage classification system is presented in **Table 6**, in addition to estimated settlement values for Bulong TSF for the various damage classes (based on the maximum 9 m height of the embankment). The Bulong TSF is expected to experience negligible damage and crest settlement under a 1 in 2,500 yr seismic event.

commonly been used within Australia (an area no major active faults). For a seismic event of this magnitude, the Damage Class Number could potentially increase to '3', which is estimated to induce crest settlement up to 135 mm.
