This data report provides a summary of the nutrients at the two Denmark River sampling sites in 2018 as well as historical data from 2004–18. This report was produced as part of the Regional Estuaries Initiative. Downstream of the southern sampling site, the river discharges to Wilson Inlet. Nutrients (nitrogen and phosphorus) are compounds that are important for plants to grow. Excess nutrients entering waterways from effluent, fertilisers and other sources can fuel algal growth, decrease oxygen levels in the water and harm fish and other species. Total suspended solids, pH and salinity data are also presented as these help us better understand the processes occurring in the catchment.

Denmark River Issue 1 Publication date: May 2021 ISSN: 2209–6779 (online only)

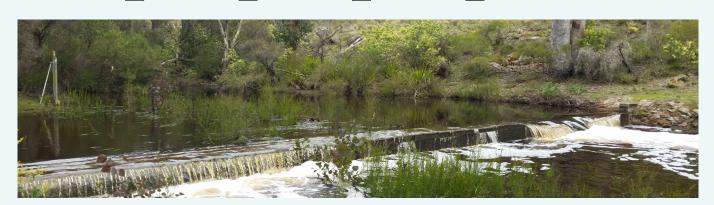
Weir on the Denmark River, September 2016.
