Assessing the 2021
Gascoyne River flood at Carnarvon
Preliminary report

June 2021

Department of Water and Environmental Regulation

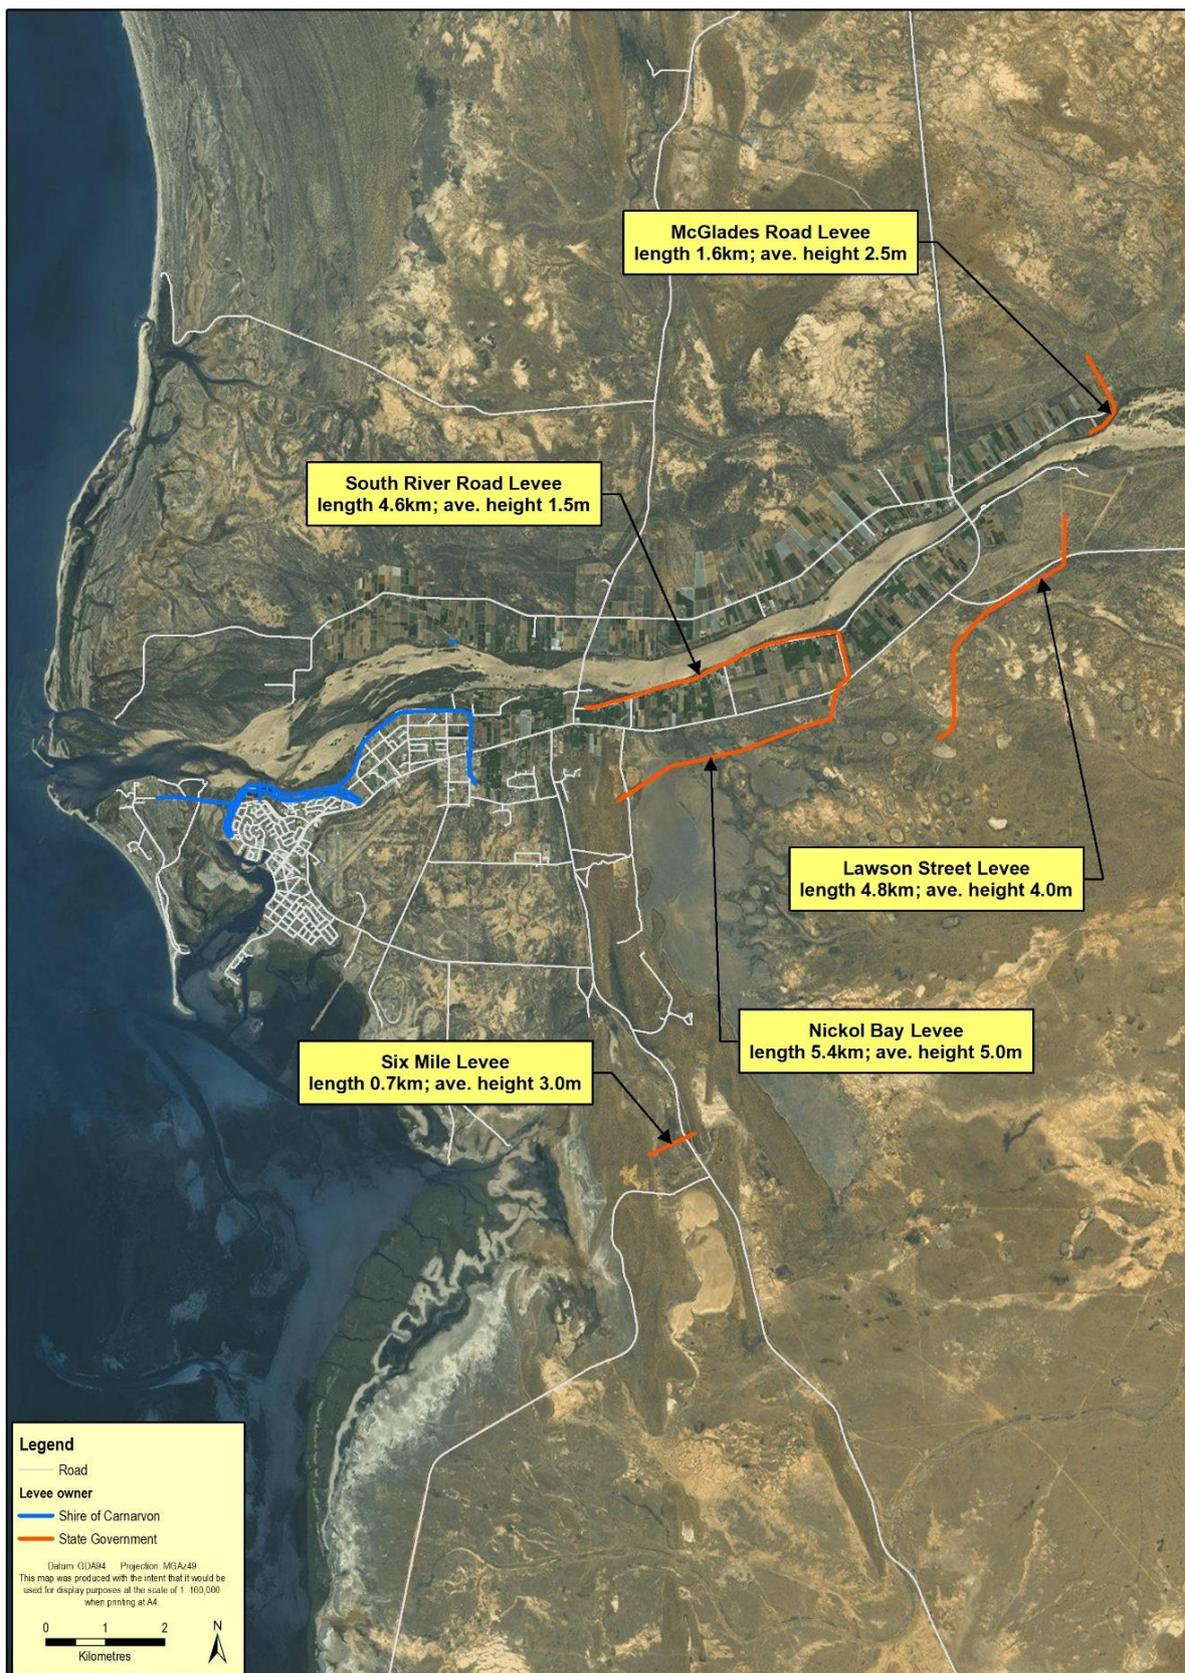
Figure 2 Location of Carnarvon levees

The Carnarvon townsite is protected from river flooding by a network of levees which are maintained by the Shire of Carnarvon. In 2015, the Government of Western Australia constructed additional flood levees to mitigate flooding within the horticultural district adjacent to the town. Figure 2 illustrates the layout of the local government townsite levee system (shown in blue) and the State Government levee system (shown in red). There are also privately owned levees that protect individual properties and infrastructure.

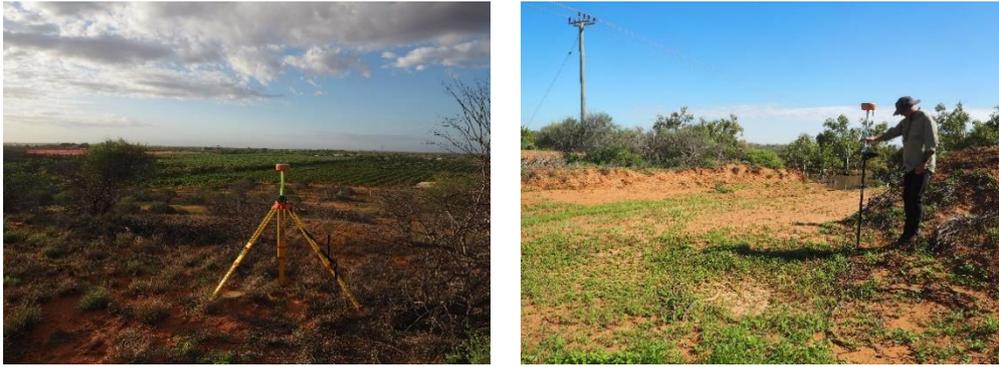
Figure 16 RTK survey (left: base station set up at Landgate survey benchmark, right: rover unit and flood debris mark)

Considering all potential sources of errors, the surveyed flood levels are likely to be within +/- 100 mm (10 cm).

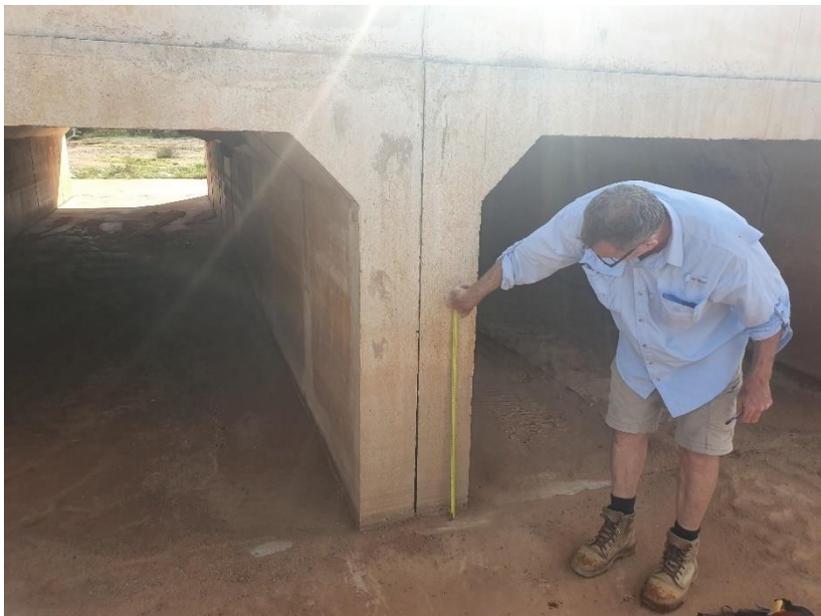
Figure 17 Measuring up from ground to flood mark (downstream side of culverts at Six Mile Creek crossing of North West Coastal Highway)

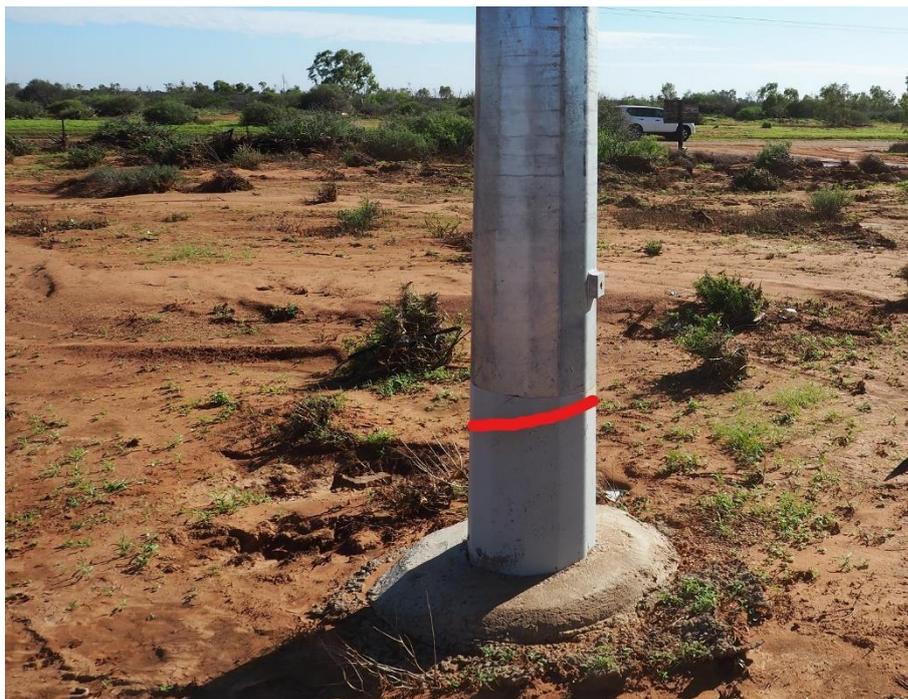
Figure 18 Flood mark on power-pole (difference in upstream [right] and downstream level [left] has been highlighted)

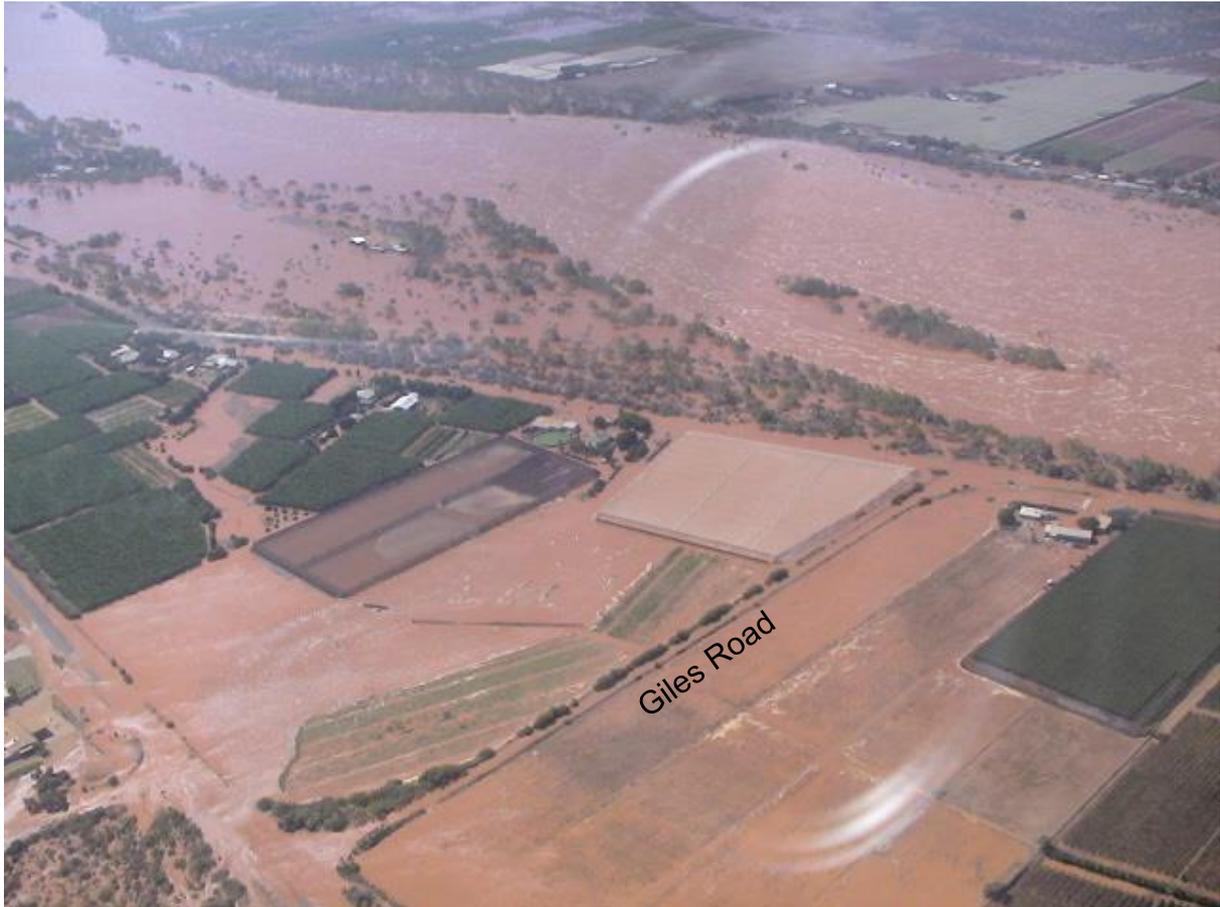
Figure 19 Flooding in January 2009 on the south bank of the Gascoyne River at Giles Road and South River Road intersection

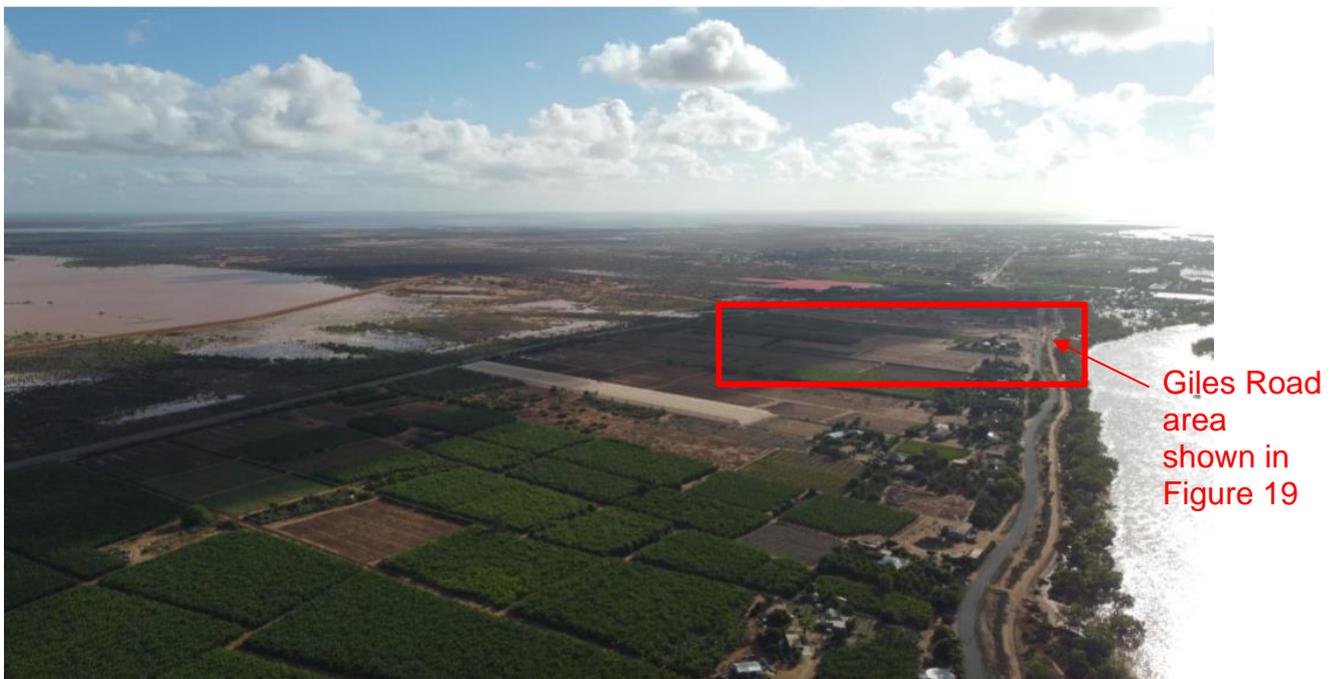
Figure 20 Plantations protected from flooding in February 2021 by levee network

Aerial photography and videos taken during the event indicated that the levee system was effective in protecting the plantations between South River Road and the NWCH from river flooding. Figure 19 shows flooding in January 2009 at the intersection of Giles Road and South River Road, before the levees were built. By comparison, Figure 20 shows that this location and all land behind the South River Road levee remained dry during the February 2021 event. Based on limited survey data, peak levels during the 2009 flood were similar to (within 200 mm of) the peak levels observed in 2021.

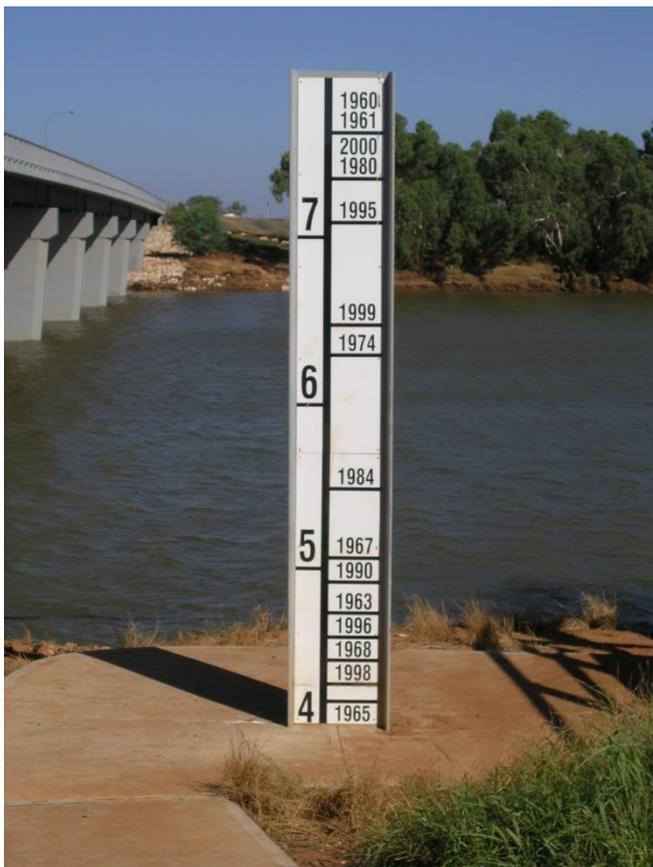
Figure 33 Staff gauge installed downstream of the Nine Mile Bridge

Developing consistent communication about peak flood levels to enable comparison between events is important to help emergency personnel and the community to take appropriate actions to reduce the risks and impacts of flooding. Future work on the appropriateness and mechanisms for this communication could provide greater clarity around these matters.
