Assessment of low-flow thresholds
in maintaining ecological health
of the Gingin Brook
2010–2011 dry season

Water Science
technical series

Report no. WST 41
July 2012

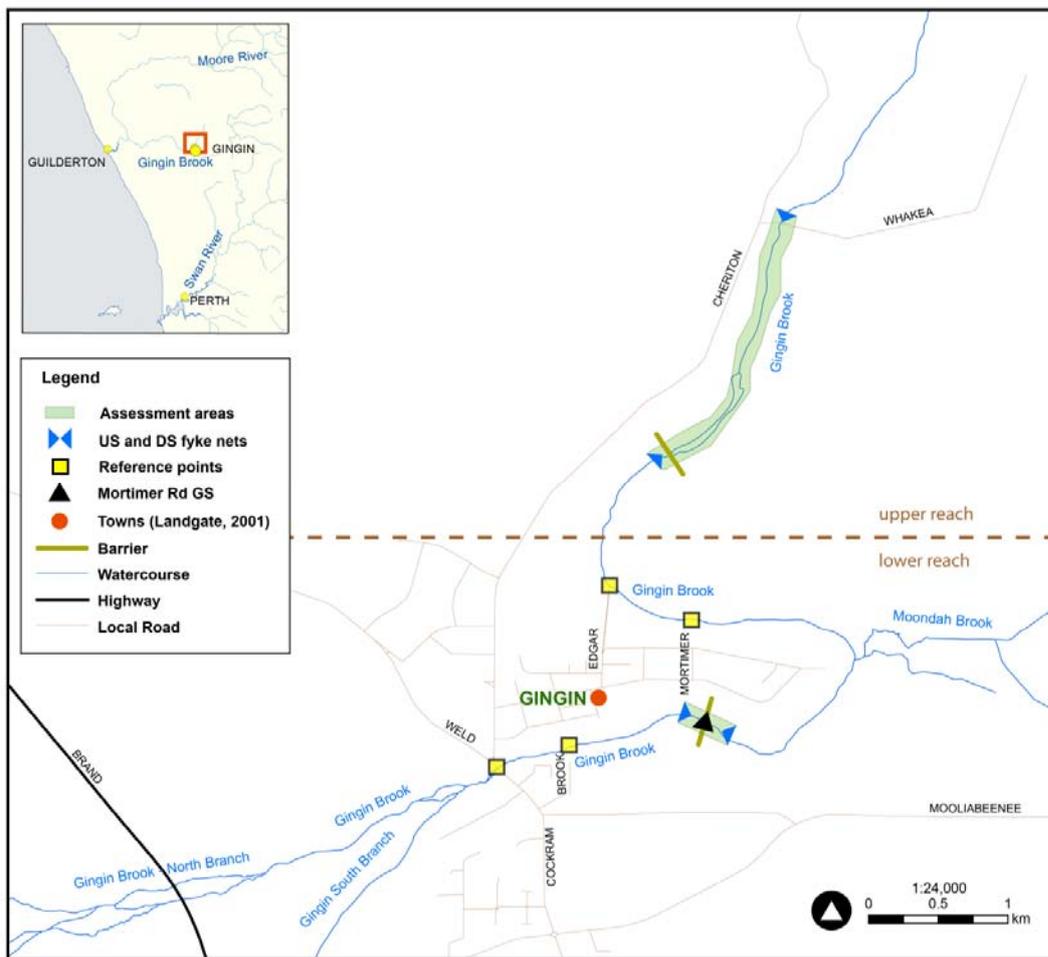
Figure 1 Study sites, in-stream barriers and gauging stations located on the upper Gingin Brook (US – upstream, DS – downstream, GS – gauging station).

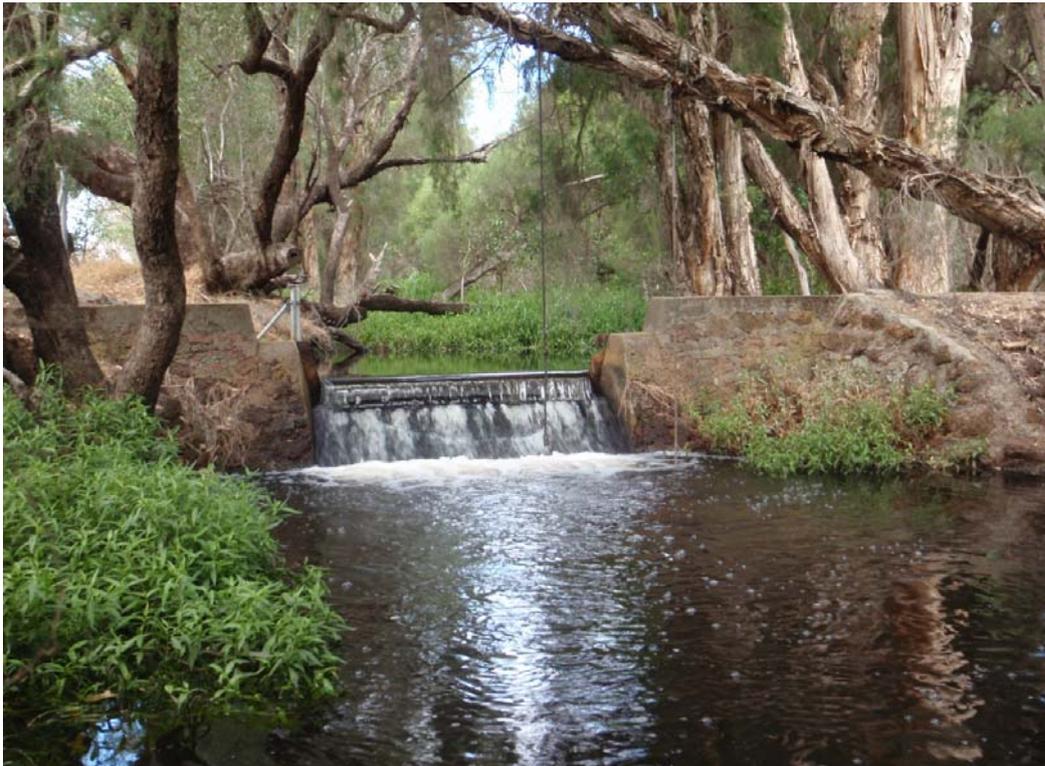
Plate 1 Gingin Brook weir on Mortimer Road

Fish fauna were also sampled in the deep pool directly below the Gingin Brook gauging station at Mortimer Road in February and April to assess if fish were congregating below the weir and using the pool as a refuge. The pool was not sampled in March because high water levels and fallen tree trunks prevented access (conditions were caused by a storm on February 28). A single fyke net with one central wing was placed in the centre of the pool with the wing extended perpendicular to the stream bank. The fyke was deployed for a 24-hour period.

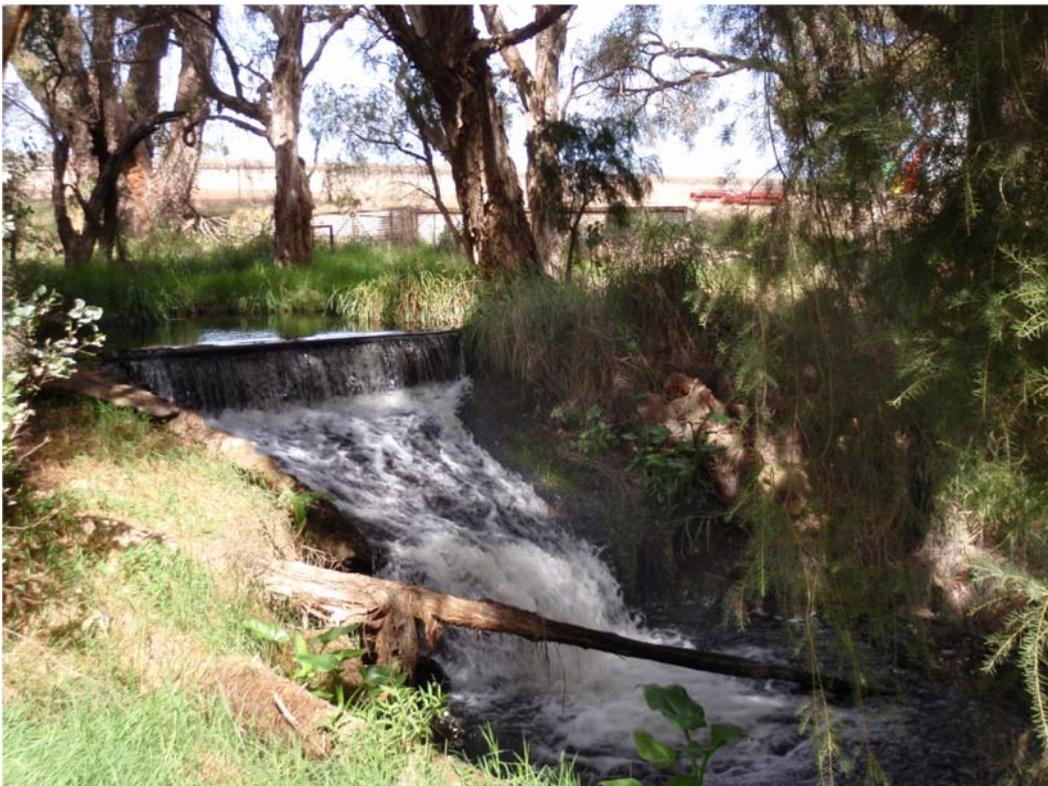
Plate 2 Cheriton Estate weir

Dissolved oxygen levels within the pool upstream of the Cheriton Estate weir (measured in February) were below the environmental threshold of 5 mg/L during the night, which is known to cause stress to aquatic fauna (ANZECC & ARMCANZ 2000; Hunt & Christiansen 2000; Koehn & O'Connor 1990). The night time minima was around 4 mg/L (Figure 4). The pool also displayed the largest diurnal range of 4.35 mg/L, which is relatively high and demonstrates that algal production and respiration are dominating the oxygen dynamics in the pool. Dissolved oxygen levels at the Whakea Road site in March were below the environmental threshold of 5 mg/L for most of the day, with levels stabilising around 4 mg/L (Figure 4). In April the dissolved oxygen at Whakea Road increased, with a night time minima of approximately 6.3 mg/L and daytime maxima of 9.8 mg/L. The brook below the Cheriton Estate weir remained well oxygenated, with concentrations being maintained between 6.5 and 7.9 mg/L during March and between 8.1 and 9.1 mg/L in April (Figure 4).

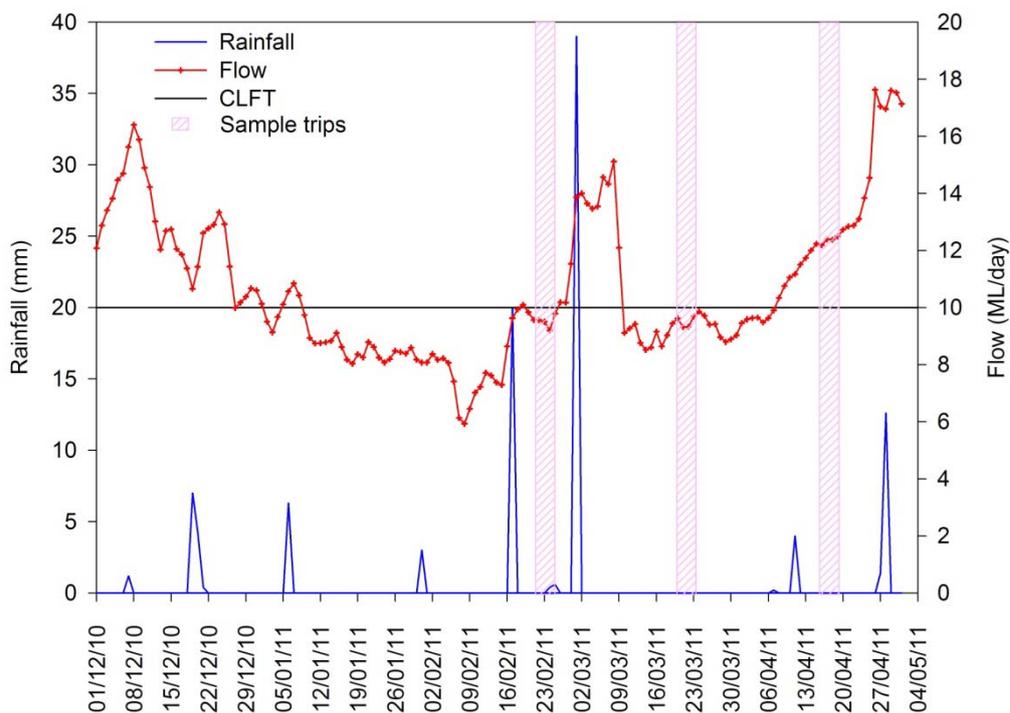
Figure 2 *Gingin Brook – daily flow from Gingin Brook gauging station (617058) and daily rainfall from the Gingin meteorological station (009018) between December and April 2011. Pink shading indicates field sampling occasions.*

Streamflow in the Gingin Brook during the 2011 dry season was below the CLFT of 10 ML/day for a large proportion of January and February 2011 (leading into the sampling period for the project). Rainfall events in late February subsequently increased the streamflow above 10 ML/day for a period of approximately 10 days, however flows returned to levels below the CLFT between March 10 and April 7 (Figure 2). During the sampling period for the project (February 21 to April 21) flow in the brook ranged from 9.20 to 12.84 ML/day. The lowest flows were recorded in January to early February – with flows ranging between 5.9 and 11.5 ML/day.

The number of days where streamflow was recorded below the CLFT in 2011 (80 days, 53% of the time) has almost doubled since 2010, more than tripled since 2008 (Table 2) and before this (1975–2007) had reached the 10 ML/day threshold 1 to 2% of the time (DoW 2011c). Accordingly, the period where flows have been below the CLFT has also increased significantly in 2011: before 2011 low-flow breaches were typically confined to January and February, compared with breaches recorded from January through to April in 2011. The number of consecutive days where flow was

In situ spot measurements of dissolved oxygen showed levels being generally maintained at around 6 mg/L during the study period. In April, however, dissolved oxygen levels in the pool upstream of the Gingin Brook weir were between 5.55 mg/L at the surface and 4.65 mg/L at the bottom. Flows at this time were at their highest – approximately 12 ML/day (Figure 2).

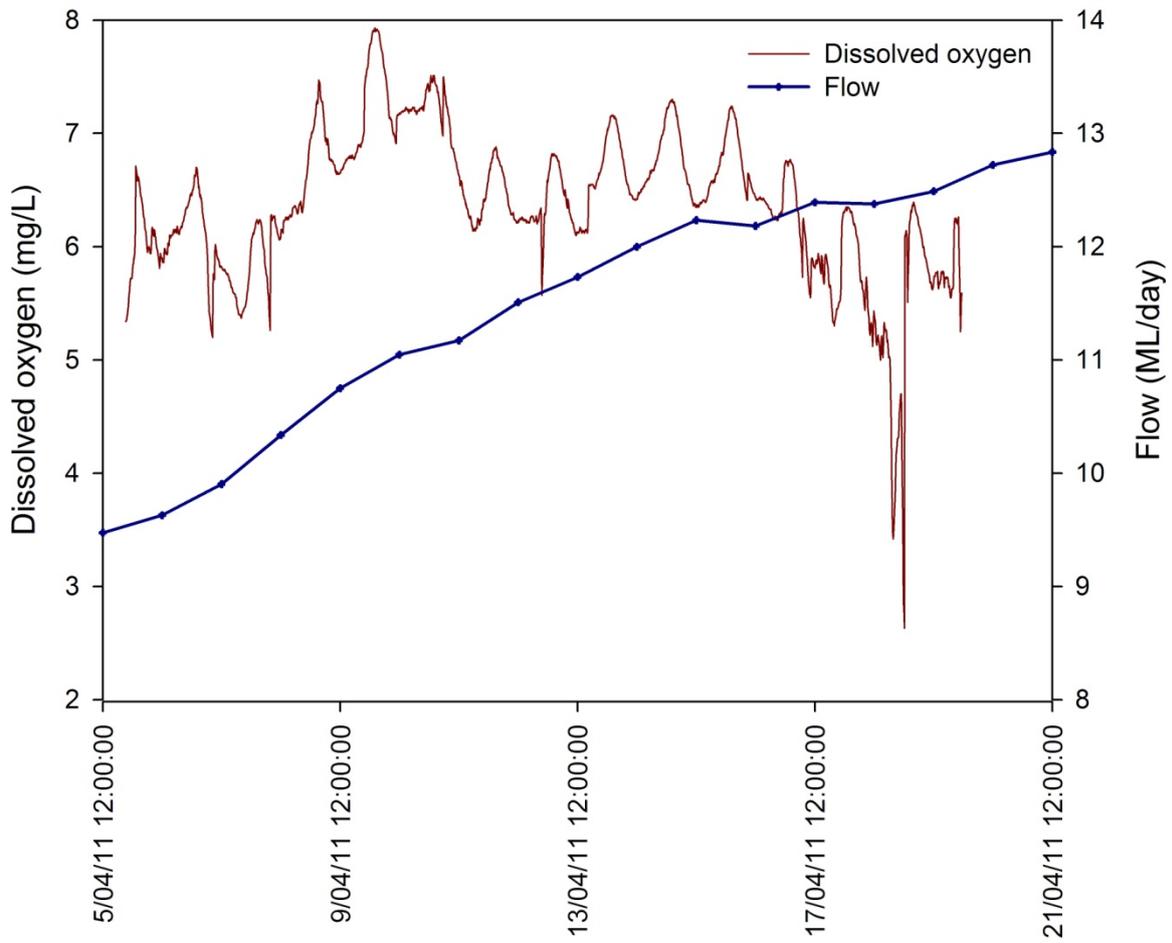
Figure 3 Dissolved oxygen in the lower reach of the Gingin Brook relative to gauged flow at Gingin Brook gauging station. The decline in dissolved oxygen seen on 18 April is likely due to equipment failure.

Dissolved oxygen data recorded during April at the lower site (Figure 3) ranged between 6 and 7 mg/L, with the exception of a short-term rapid decrease in dissolved oxygen to below 3 mg/L observed at midday on April 18. This could be attributed to suspended materials in the system temporarily affecting the sensor as a result of cattle crossing the brook upstream (cattle access to the brook was observed immediately upstream of the loggers).

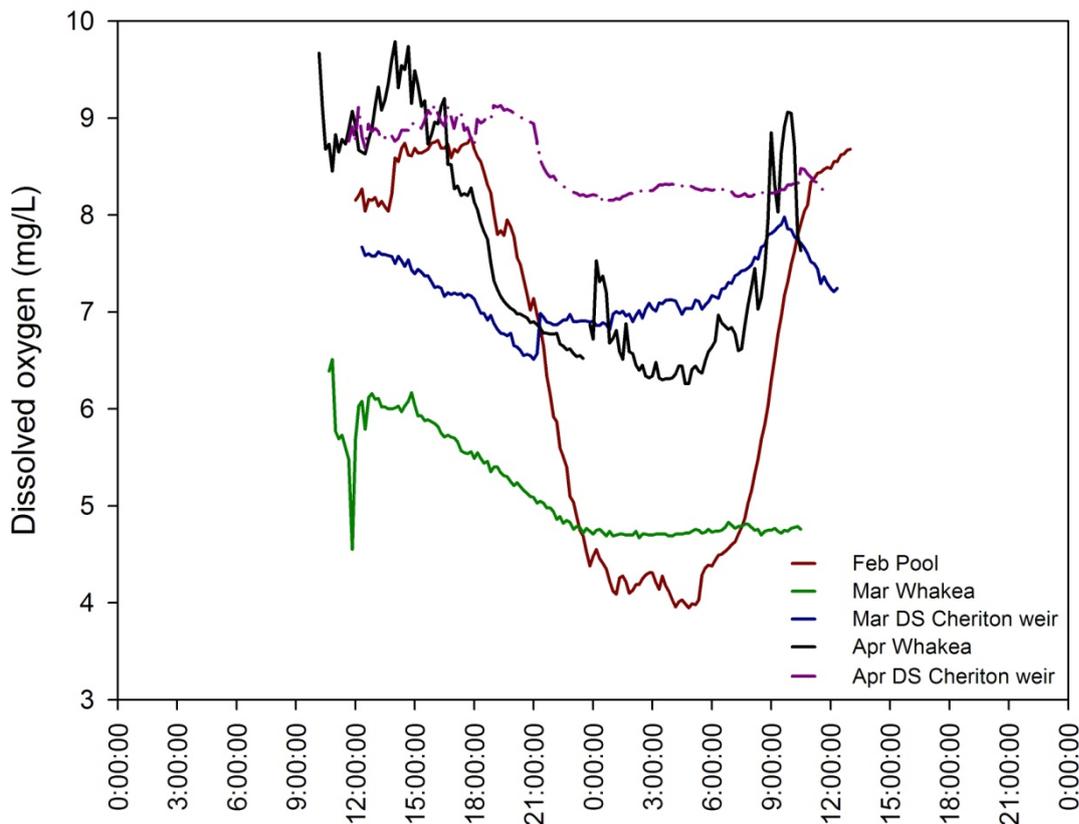
Figure 4 Diel dissolved oxygen in the upper reach on the Gingin Brook.

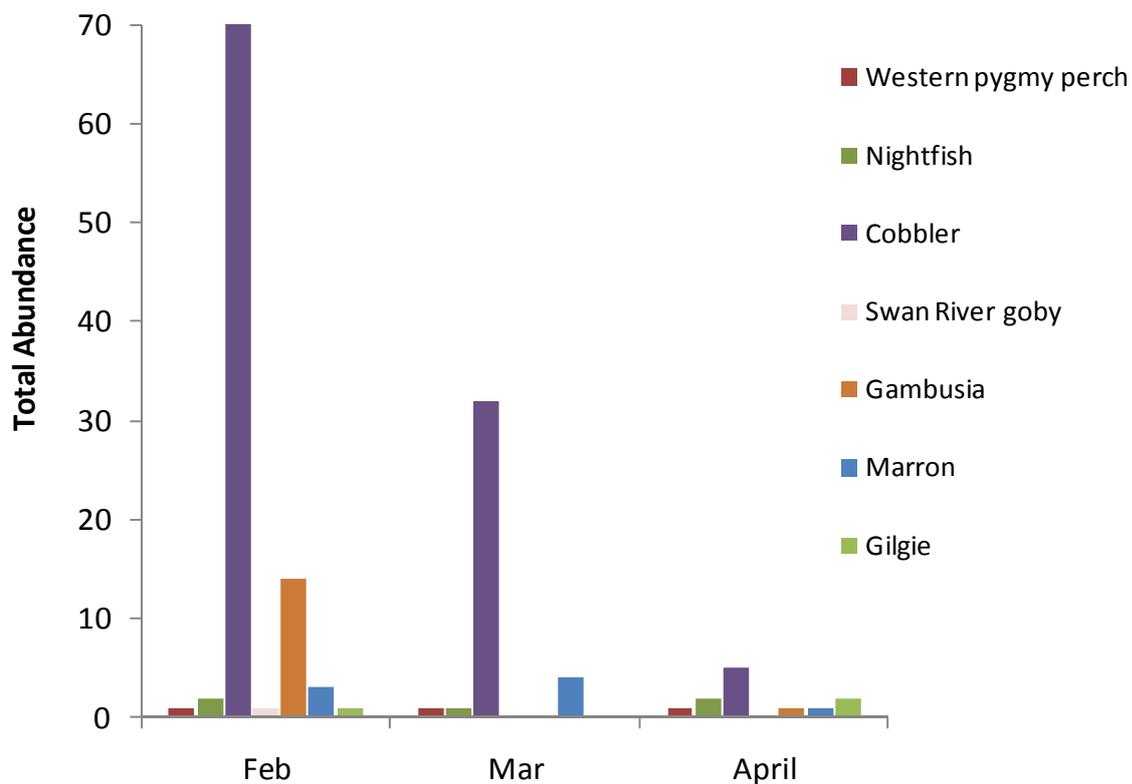
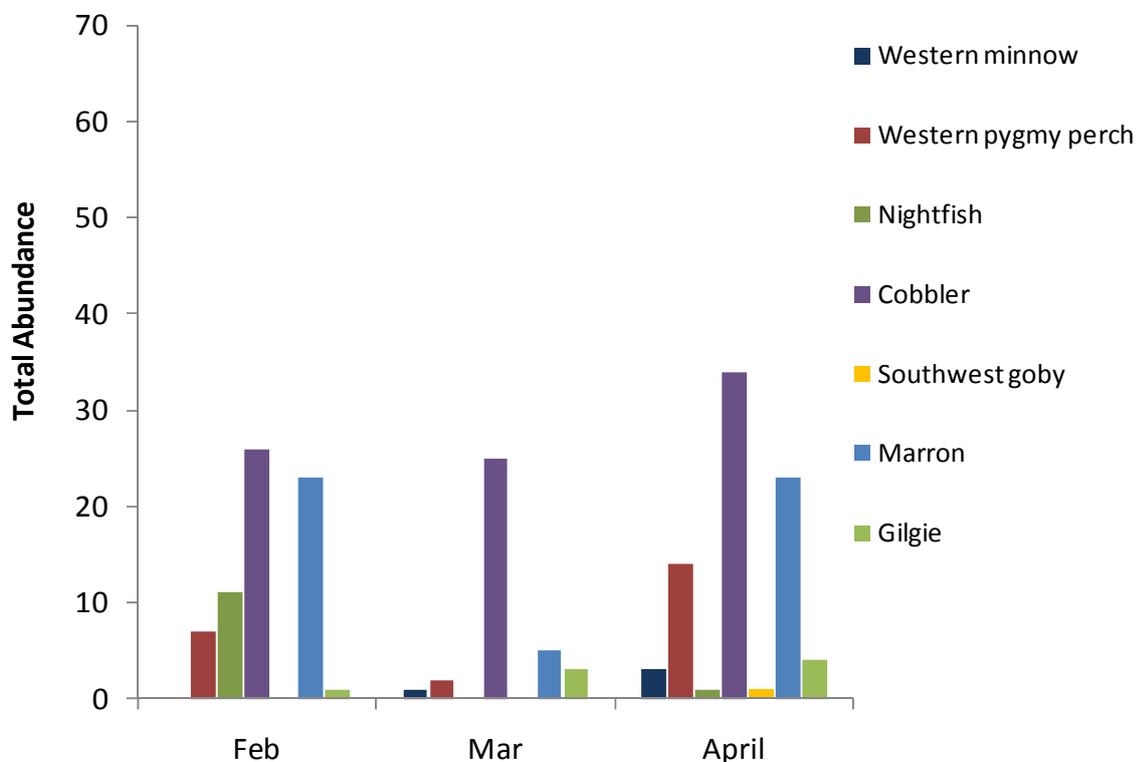
Figure 5 Fish fauna assemblage at the upper and lower reaches on the Gingin Brook.

Western pygmy perch, western minnow and nightfish were found at both sites, being typically more abundant in the lower reach (figures 5 and 6). Numbers and size class distribution (Figure 7) of these three species support the existence of viable, sustaining populations.

During this study freshwater cobbler were abundant and the data supports a viable population, including successful recruitment indicated by many individuals <100 mm TL (juveniles) (figures 5, 6 and 7). Based on numbers caught in fyke nets, small groups of freshwater cobbler appear to be migrating upstream predominantly during February and March, with only a few individuals in April. Given that reproductive condition was not advanced it is likely that migrations are due to food and/or habitat selection. This trend is consistent with observations from the adjacent Lennard Brook, with a peak in migration around February (Galvin & Storer 2011). Note: a previous assessment of the Gingin Brook during spring detected what is believed to be the peak upstream migration period for spawning in this system, with approximately 300 adult freshwater cobbler (in advanced reproductive condition) captured in fykes over 24 hours (data collected through Storer et al. 2011a). This is almost 1000% more individuals caught than in this present study. The presence of in-stream barriers in the Gingin Brook does appear to be an impediment to freshwater cobbler (and other native fish) due to most of the catch being below the barriers. Yet under the current flow regime this does not seem to be affecting population dynamics. Therefore it appears that freshwater cobbler have adapted to the impediments to migration and that current flow conditions are sufficient to sustain populations – at least in the short term.

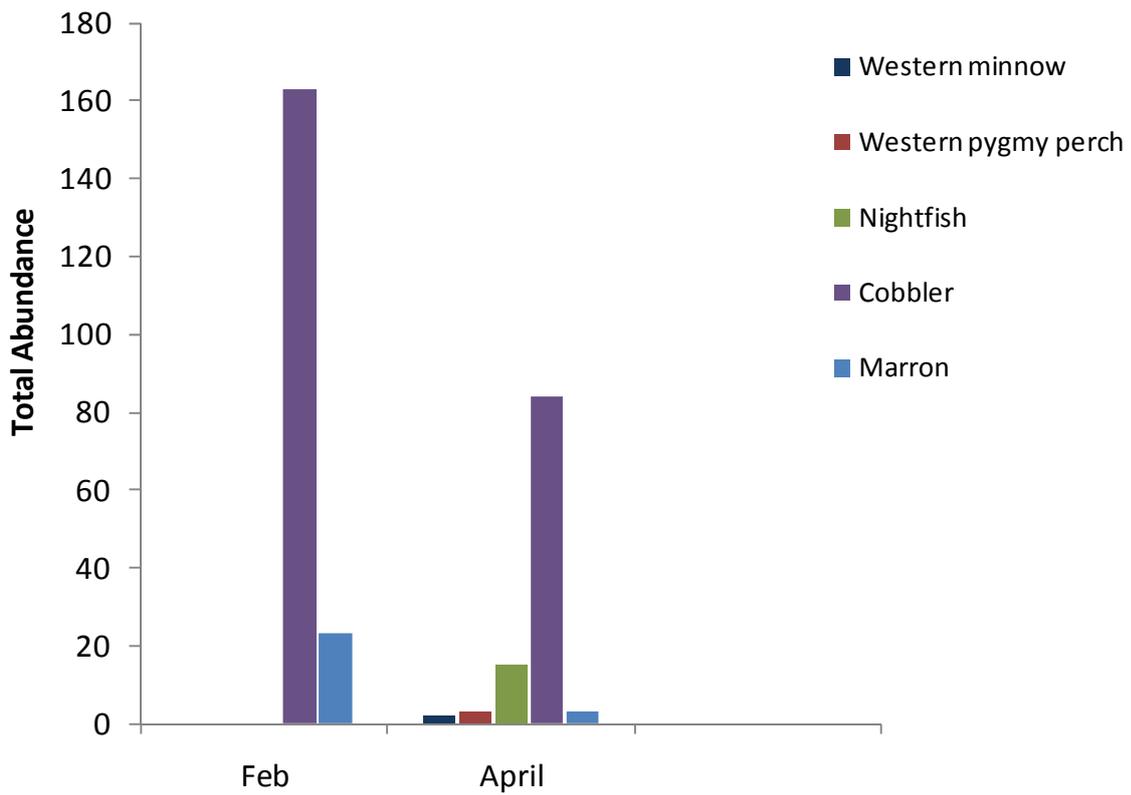
Figure 6 *Fish fauna assemblage in the pool below Gingin Brook gauging station weir at Mortimer Road (lower reach).*

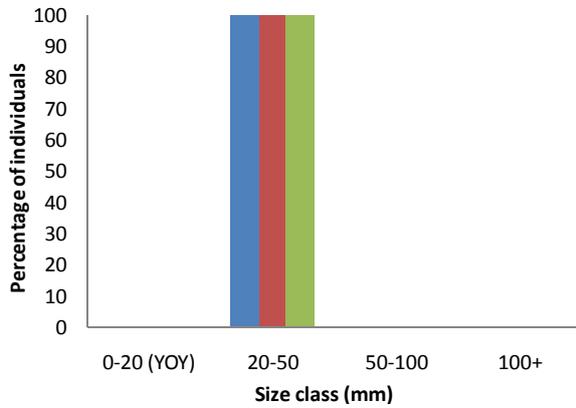
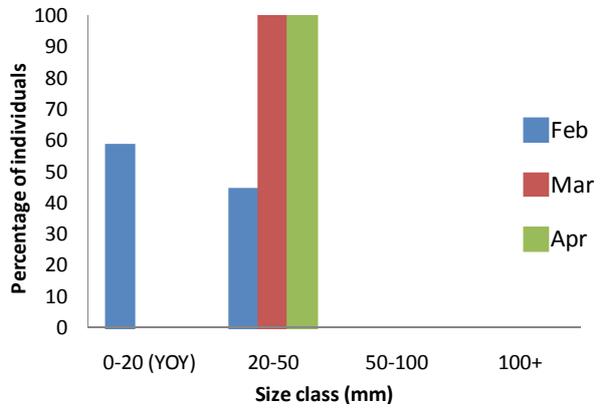
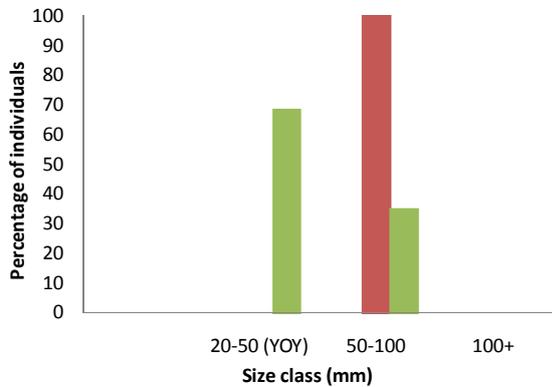
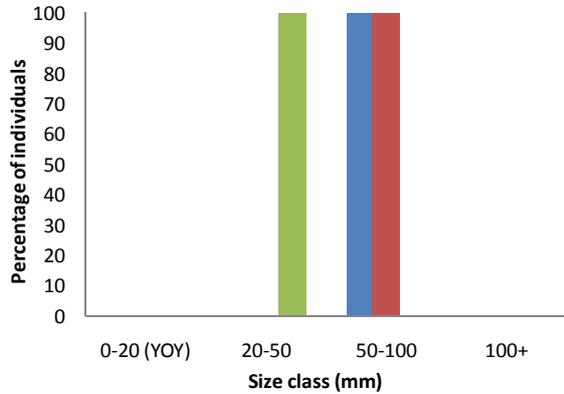
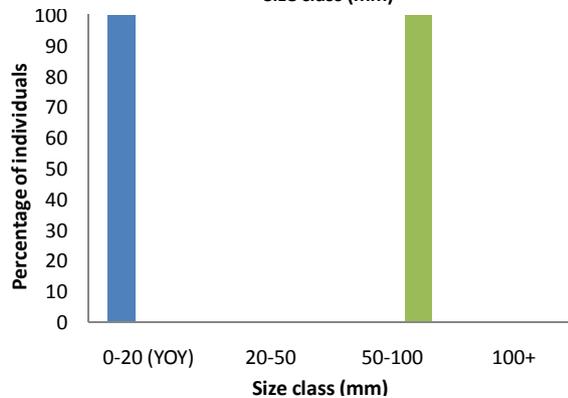
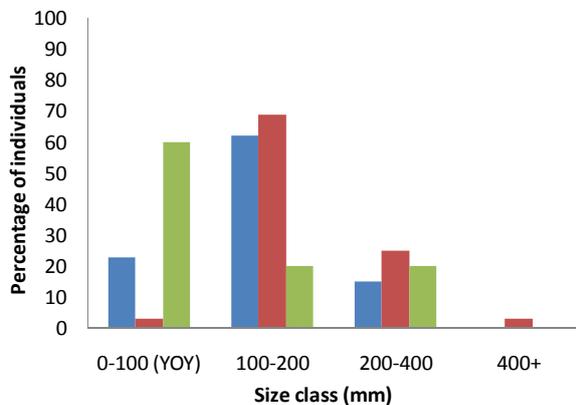
Figure 7 Size class frequency distributions for the freshwater fish in Gingin Brook (YOY – young of year).

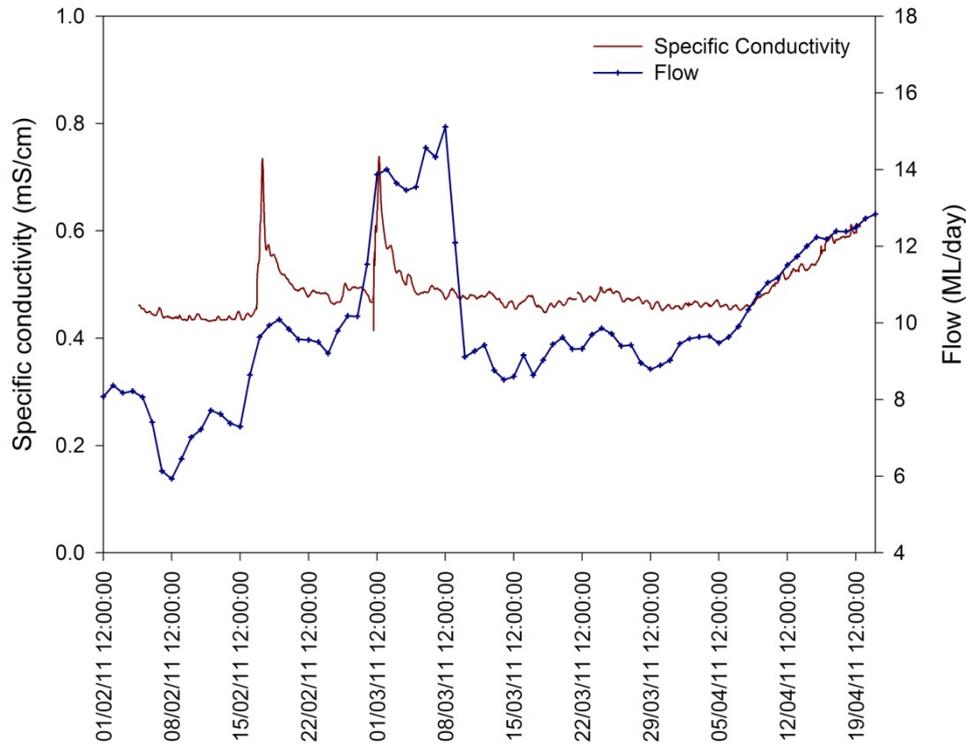
Figure 8 Specific conductivity monitored over the study period at the lower reach on the Gingin Brook.

Electrical conductivity within the Gingin Brook remained relatively fresh with the exception of small increases after large rainfall events. This indicates the potential for inputs of salt via runoff from the surrounding cleared catchment. However, given the levels recorded this is not a major concern for the brook at this time. Towards the end of the study period (April) there was an increasing trend in electrical conductivity observed, which coincided with rising streamflow and a decrease in pH from 6.4 to 6.0. Given no rainfall was observed during this period it is unlikely this trend relates to the input of salt from runoff. It is more likely that the increase is associated with groundwater discharge contributing to the surface water flow (e.g. through reduced evaporation and atmospheric pressure changes). Anecdotal evidence supports this, with landholders observing increases in the streamflow independent of rainfall during March and April (E. Wedge and L. Carvell pers. comm.).

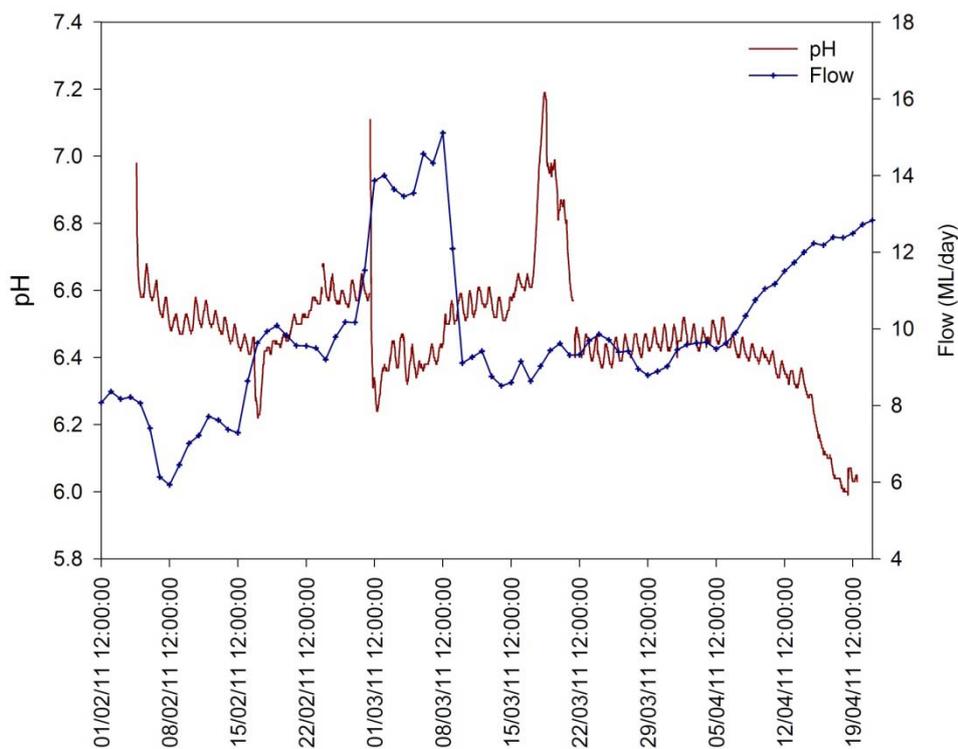
Figure 9 pH monitored over the study period at the lower reach on the Gingin Brook.

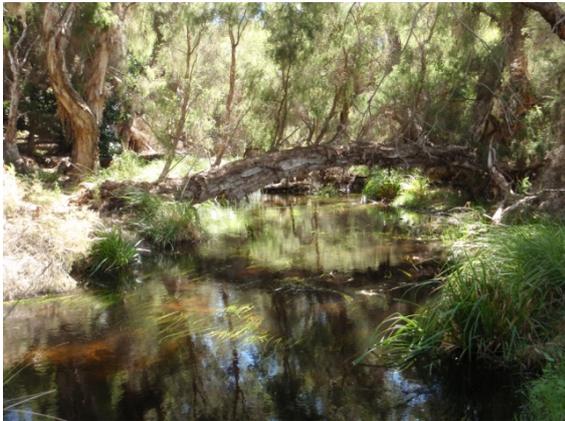
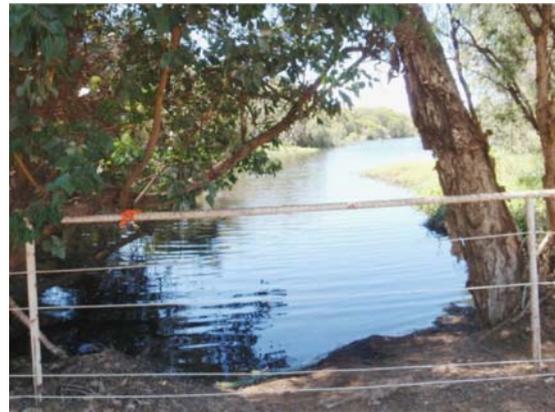
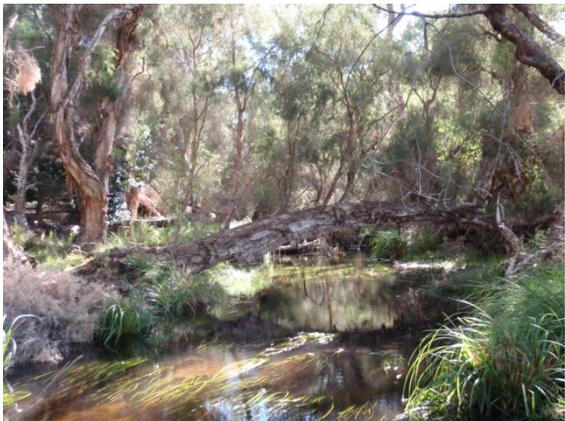
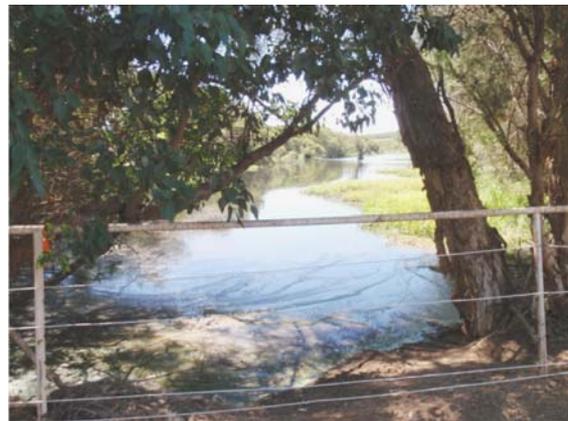
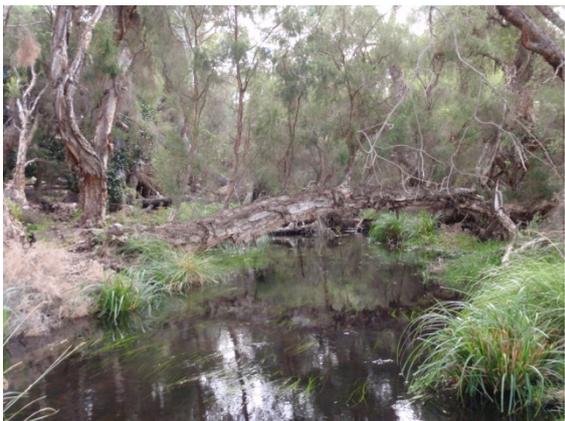
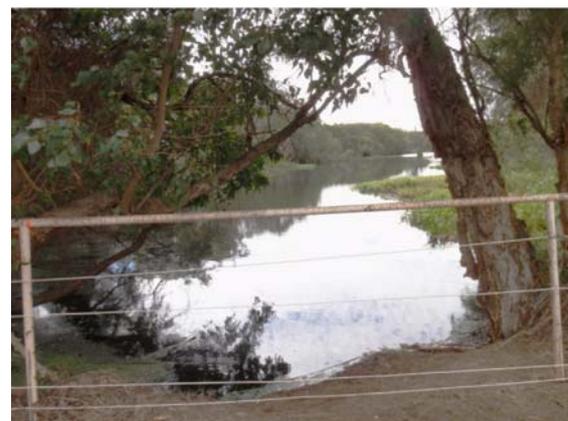
Figure 10 Photo points 1 and 2 taken at Whakea Road and the pool upstream of Cheriton Estate weir in the upper reach of the Gingin Brook.

No obvious diminished lateral connectivity was observed during this period based on water level and flow data collected at reference points or through observations of aquatic habitat at the study sites (see site photos in Appendix D).

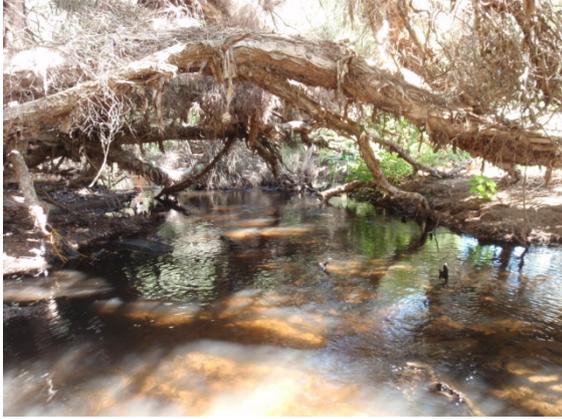
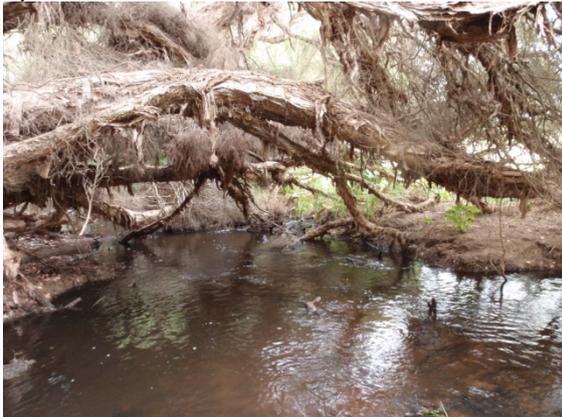
Figure 11 Photo point 3 taken at the run downstream of Cheriton Estate weir in the upper reach of the Gingin Brook.

The habitat downstream of the Cheriton Estate weir is more degraded compared with Whakea Road: the in-stream vegetation is virtually absent with only small clumps of emergent macrophytes present and no submerged macrophytes. Large woody debris and detrital material is also sparse in the system. Above the Cheriton Estate weir, the pool is filled in with large amounts of silt and organic matter. In places the silt/organic matter was more than 1 m deep. Surface water above the silt/organic layer was shallow at approximately 30 cm deep. Emergent vegetation was present around the edges of the pool, providing some habitat for biota.

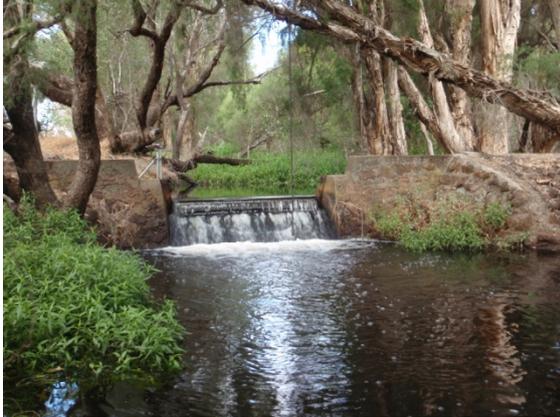
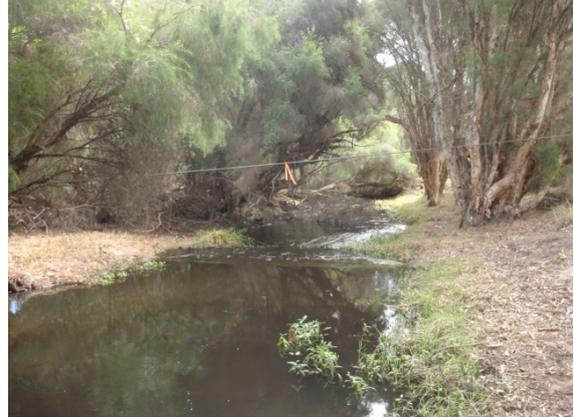
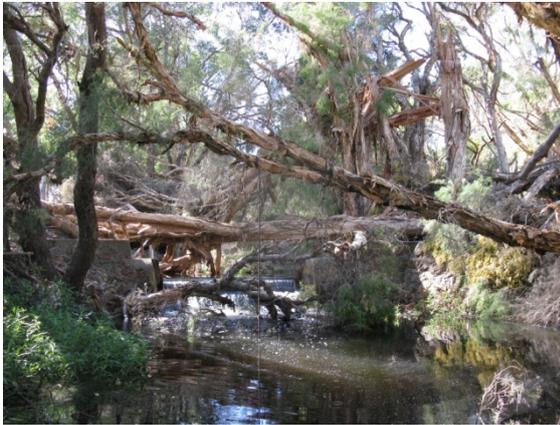
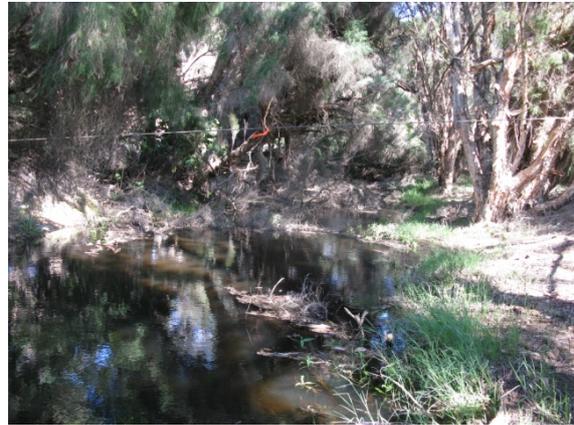
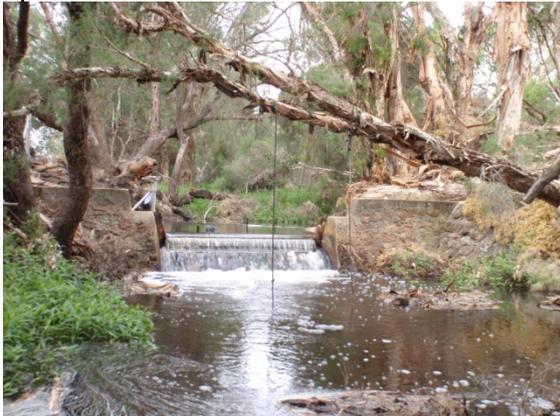
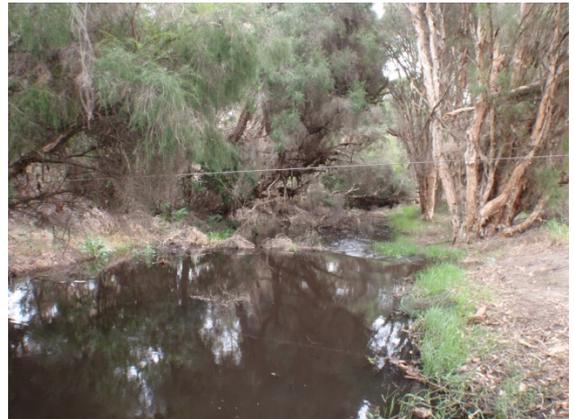
Figure 12 Photo points 1 and 2 taken at the Gingin Brook gauging station and upstream of the concrete spillway (downstream of Gingin Brook gauging station weir) in the lower reach of the Gingin Brook.

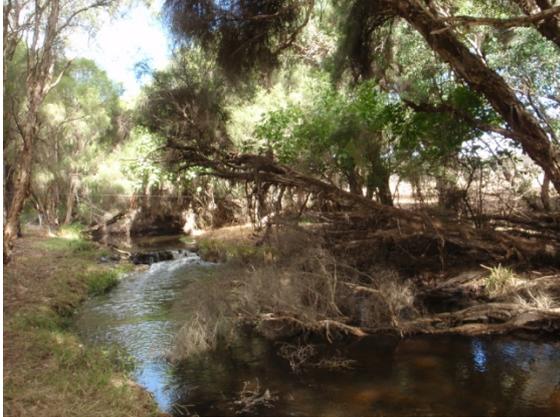
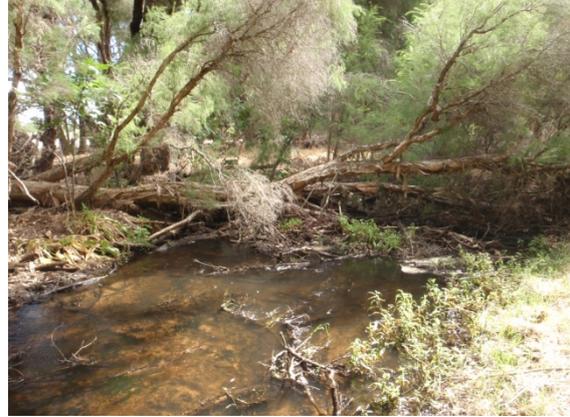
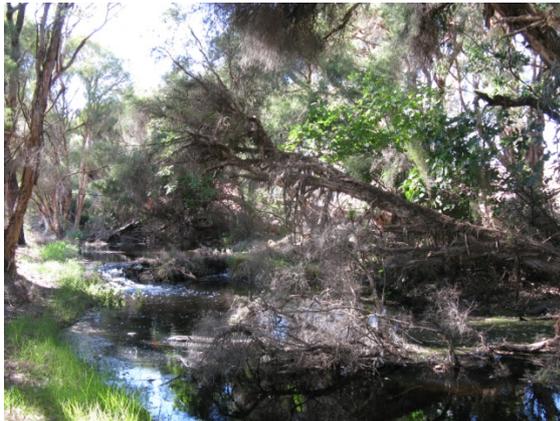
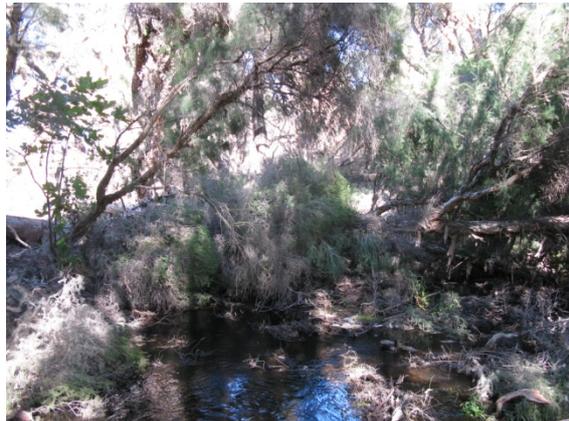
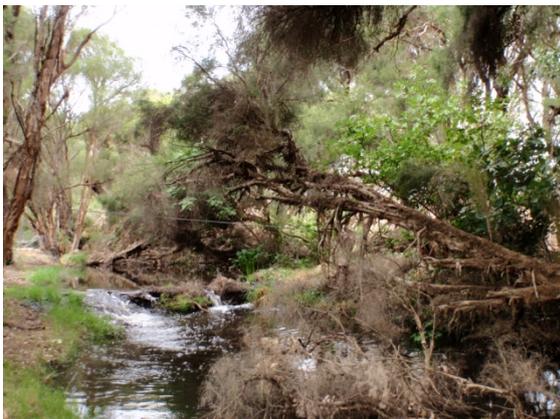
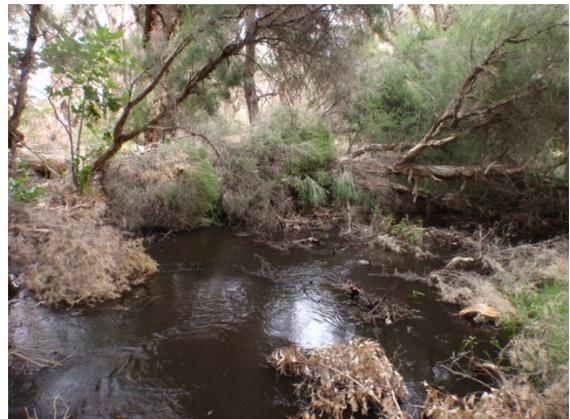
Figure 13 Photo points 3a and 3b taken at approximately 20 m downstream of concrete spillway (downstream of Gingin Brook gauging station weir) on the lower reach of Gingin Brook.
