Assessment of low-flow thresholds  
in maintaining the ecological health  
of the Lennard Brook  
2010–2011 dry season

Report no. WST 42  
August 2012

# Assessment of low-flow thresholds in maintaining the ecological health of the Lennard Brook

2010–2011 dry season

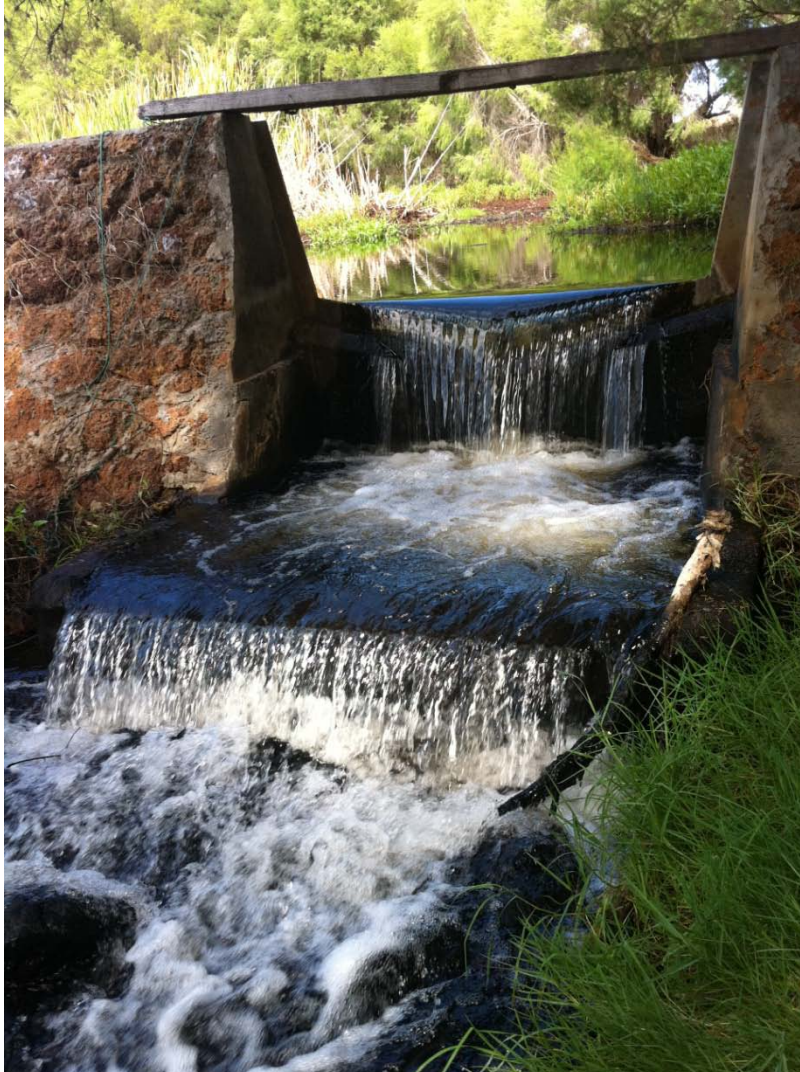
*Plate 1 Molecap Hill weir*

Fish movement was unaffected by the low-flow conditions experienced throughout the study period with the exception of the Molecap Hill weir. Under summer low-flow conditions it is likely this weir impedes all fish movement. However, during high flows

In-stream barriers on the brook also alter the connectivity of the surface water. Based on the barrier assessment undertaken in this study, the weir structure at Molecap Hill gauging station poses an obstruction to fish migration during summer low flows, but is likely to be drowned out in higher flows. As no obvious impacts on recruitment of native fish species were observed within this study, it appears that fish populations are self-sustaining. This implies that system connectivity is sufficient under the current flow conditions. However, if low-flow conditions further reduce (particularly below the 6.6 ML/day minimum recorded in this study) it may increase the level of disconnection, particularly in the shallower lower section. This may impact fish populations either directly through impediments to migration or due to decline in environmental health caused by reduced flushing (discussed below in water quality) or through changes in community interactions (e.g. increased competition/predation as a result of reduced habitat availability).

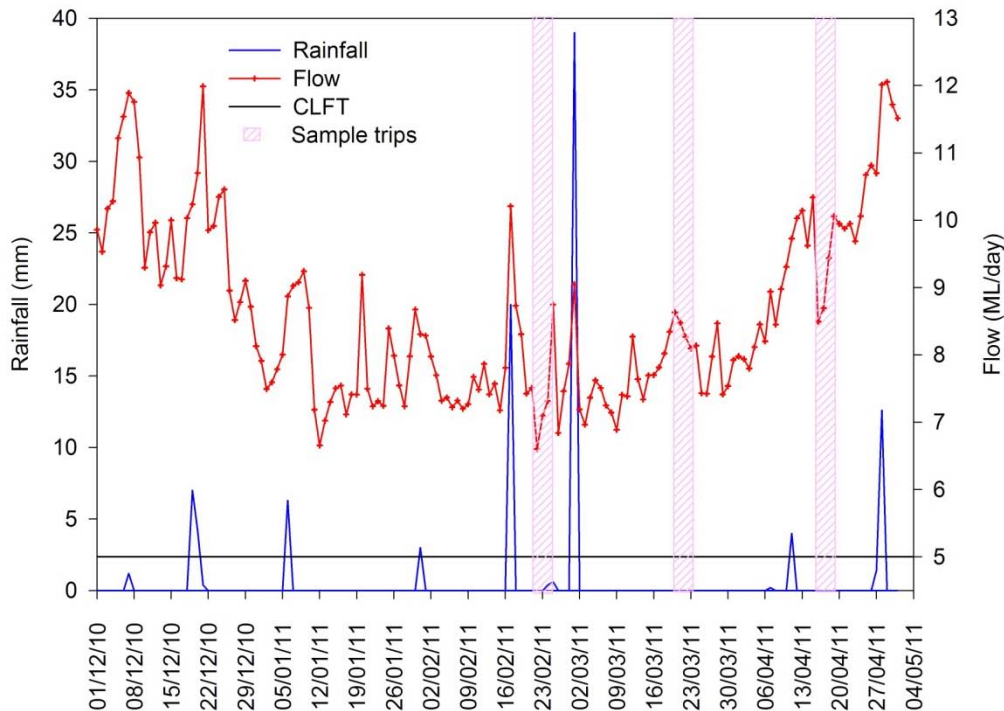
*Figure 2 Lennard Brook – daily flow from Molecap Hill gauging station (617165) and daily rainfall from the Gingin meteorological station (9018) during December to April 2011. Pink shading indicates sampling occasions.*

Streamflow in the Lennard Brook remained above the CLFT of 5 ML/day for the entire duration of the study: flows ranged from 6.6 to 12.1 ML/day. There was an evident decline in flow during January to late March, with the lowest flow (6.6 ML/day) recorded on 22 February (Figure 2).

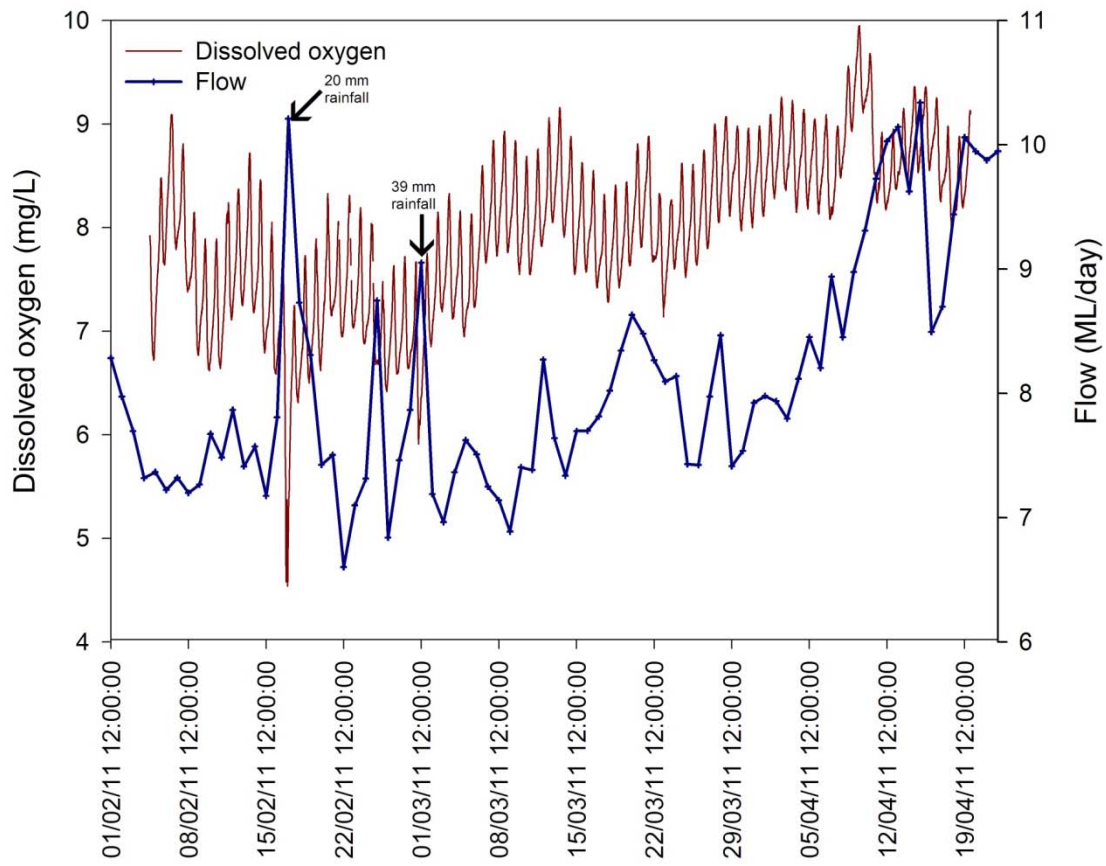
Figure 3 Dissolved oxygen at the lower site on the Lennard Brook relative to gauged flow at Molecap Hill gauging station. Major rainfall events are indicated on the plot.

Dissolved oxygen levels in March were variable, with concentrations varying between approximately 5.6 and 7.2 mg/L through the 24-hour period (Figure 4Figure ). Diel oxygen concentrations in April show a distinctive diurnal curve. Dissolved oxygen was maintained at adequate concentrations with levels staying above 6.5 mg/L. Flows recorded at this time were 9.9 ML/day (Figure 3).

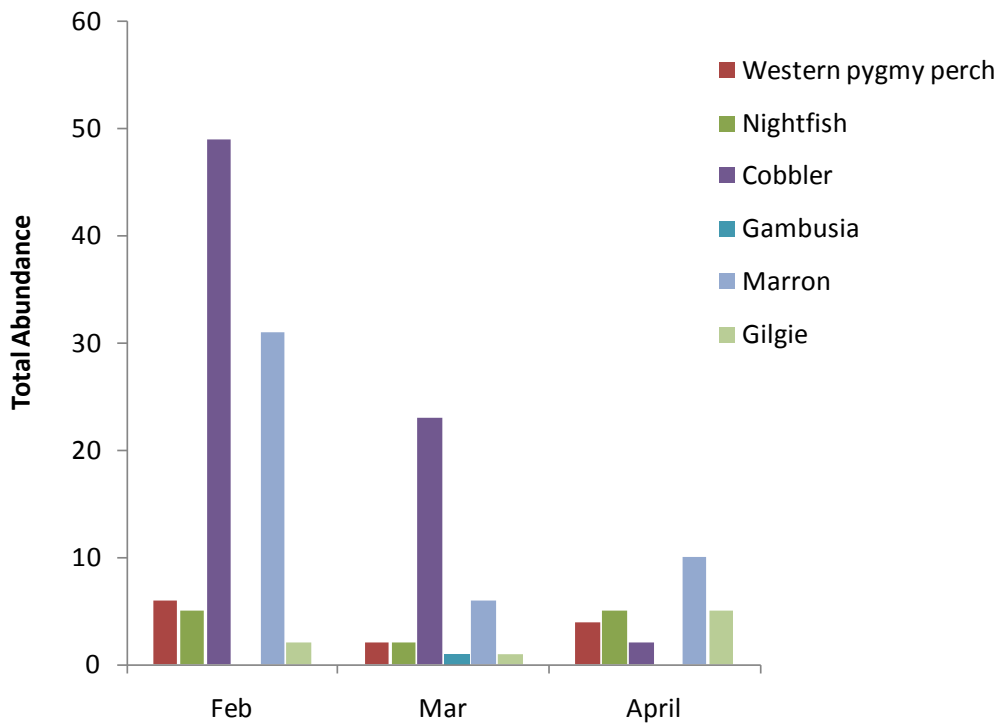
**Figure 5** Fish fauna assemblage at the upper and lower sites on the Lennard Brook.

Freshwater cobbler was only recorded at the brook's upper site (Figure 5). Large numbers were observed migrating upstream in February and March: 98% and 71% of the catch respectively. No downstream movement was recorded, which suggests that freshwater cobbler remained in the brook's upper reaches.

The native fish assemblage at the lower site consisted of western pygmy perch, western minnow, nightfish and western hardyhead (Figure 5). The western pygmy perch was the most abundant fish species in February with 58 individuals collected. Western pygmy perch were observed schooling in large numbers (10–12 individuals) during February. Western minnow abundance increased over the study period but nightfish abundance remained fairly consistent between seven and eight individuals. An estuarine species, the western hardyhead (*Leptatherina wallacei*), was recorded in low abundance in February at the lower site.

Both the freshwater crayfish species – gilgie and marron – were collected at the lower site (Figure 5). Gilgies were consistently observed in similar numbers throughout the study period. Marron were only recorded in February.

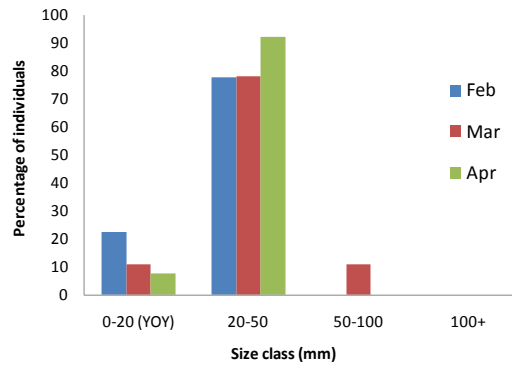
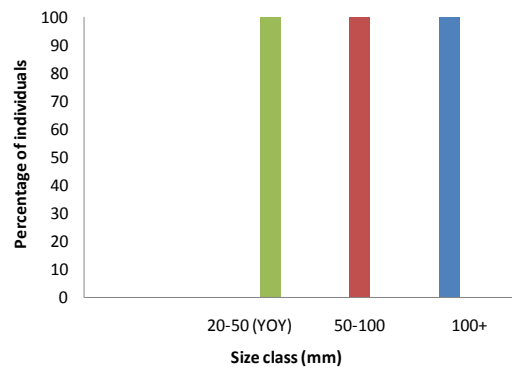
Figure 6 Size class frequency distributions for the freshwater fish in Lennard Brook (YOY – young of year).

Freshwater cobbler were abundant at the brook’s upper site but none were recorded at the lower site. The population at the upper site appeared viable, with successful recruitment indicated by many individuals < 100 mm TL (juveniles) (Figure 5 and Figure 6). Based on numbers of freshwater cobbler caught in fyke nets, small groups appear to be migrating upstream predominantly during February and March. Given that reproductive condition was not advanced it is likely that migrations are due to food and/or habitat selection. This trend is consistent with observations from the

The data collected during this study indicate the populations of western pygmy perch, nightfish and western minnow are reproducing, since both adults and juveniles (young of the year) were captured. Hence, these populations appear sustainable under the current flow conditions. Western minnows were only captured at the lower site, which may be due to either natural variation (e.g. seasonal migration patterns) or an in-stream barrier affecting access to the upper reach. The upper site assessed in this study is the furthest upstream that monitoring has taken place compared with previous studies in the area (Beatty et al. 2010; Morgan et al. 2000). As such, there is no relevant baseline to compare distribution of the western minnow. A similar study by Beatty et al. (2010) in the previous dry season recorded western minnows approximately 2 km downstream of the upper site monitored in this study. As such, if the absence of western minnows from the upper site is due to an in-stream barrier it would occur within this 2 km section (anecdotal evidence supports the presence of a barrier in this section). This observation is consistent with studies on the adjacent Gingin Brook where western minnows were only captured below the Gingin Brook gauging station weir at Mortimer Road (Galvin & Storer 2012; Beatty & Morgan 2004; Morgan et al. 2000). Further work is required to determine if western minnow movement is being obstructed by the presence of in-stream barriers in the Lennard Brook.

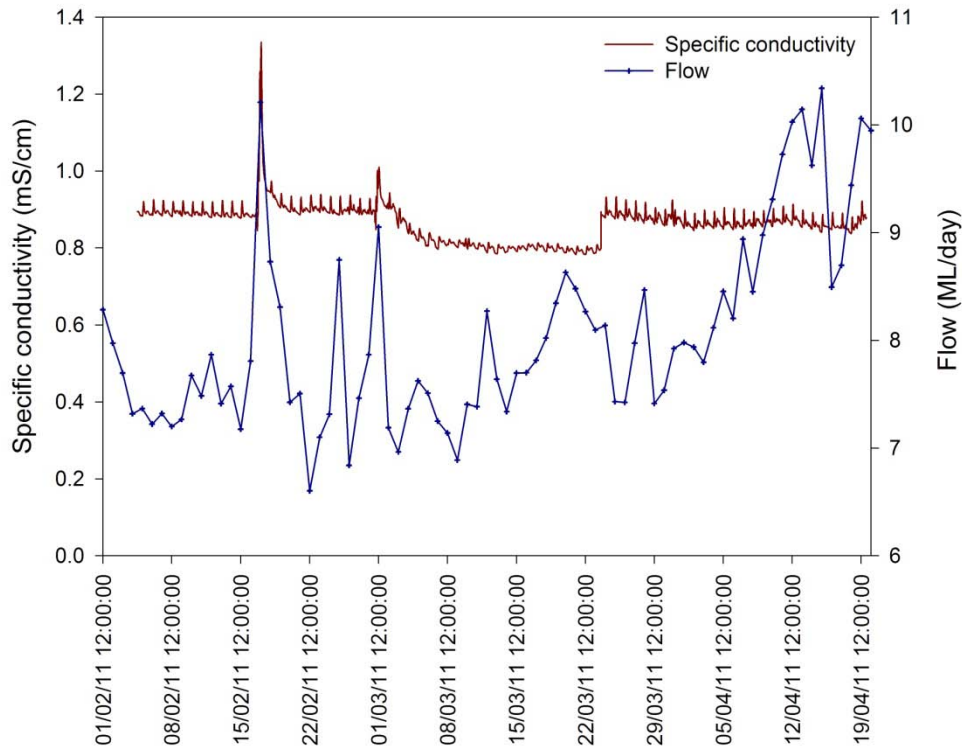
Figure 7 Specific conductivity monitored over the study period at the lower site on Lennard Brook.

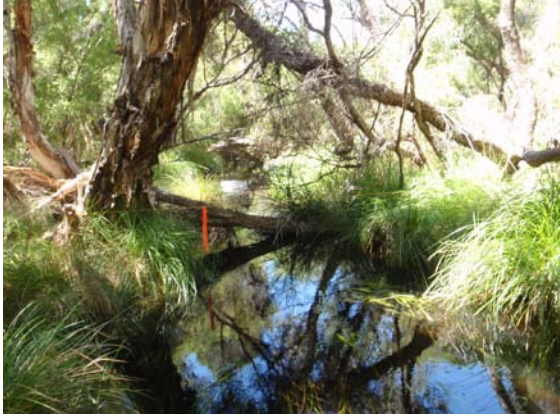
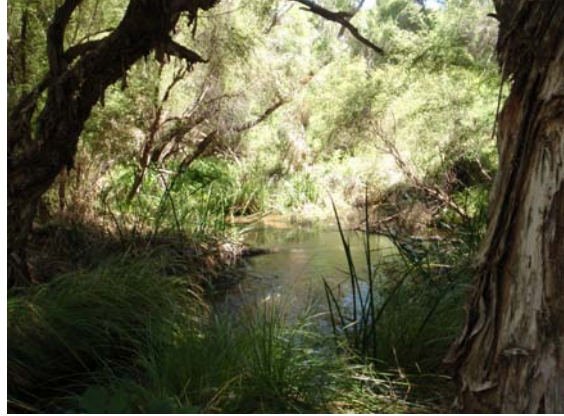
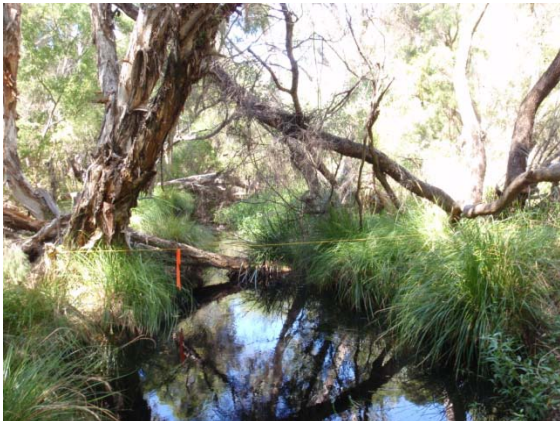
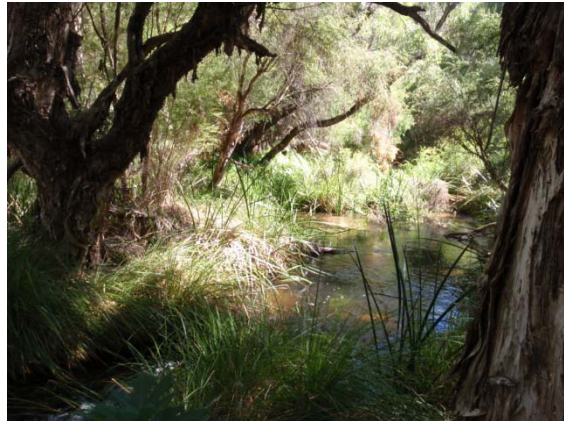
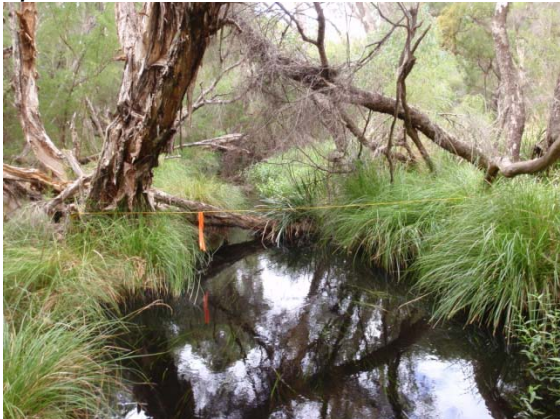
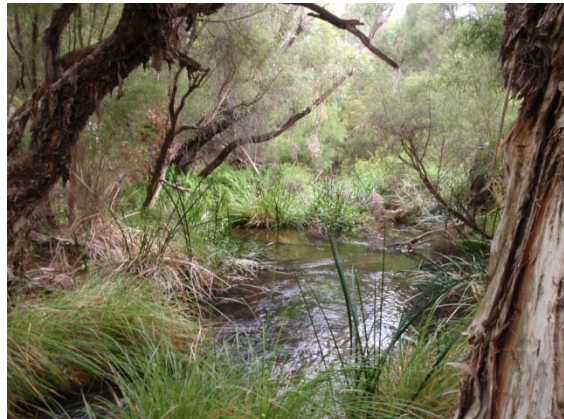
*Figure 9 Photo points 1 and 2 taken at the upper assessment site located on the upper reach of Lennard Brook, taken near the bridge.*

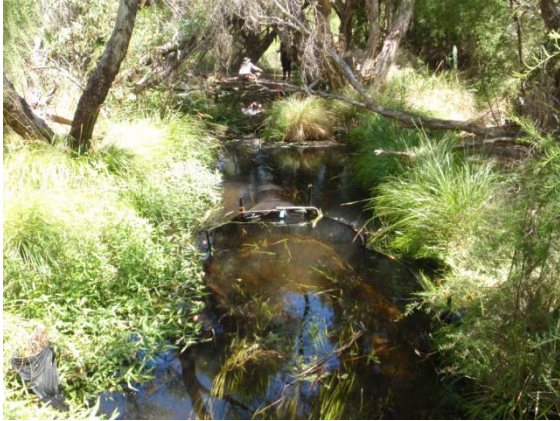
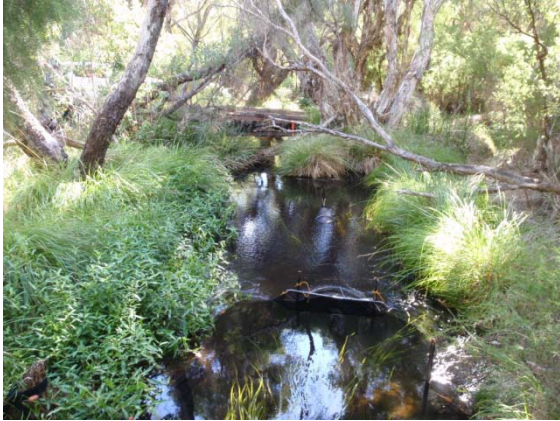
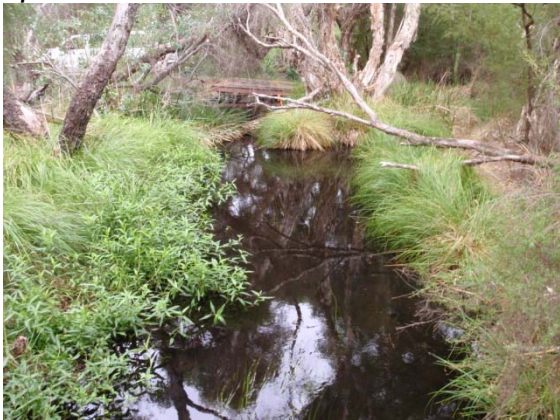
*Figure 10 Photo point 3 taken at the upper assessment site located on the upper reach of Lennard Brook, taken at the top of the site.*

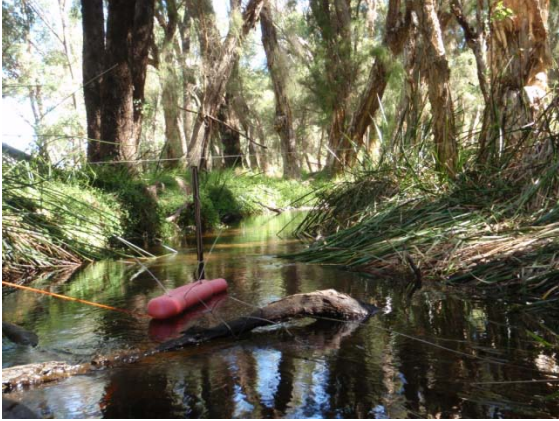
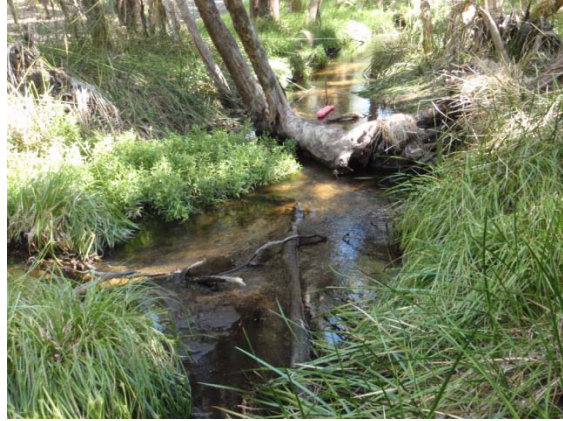
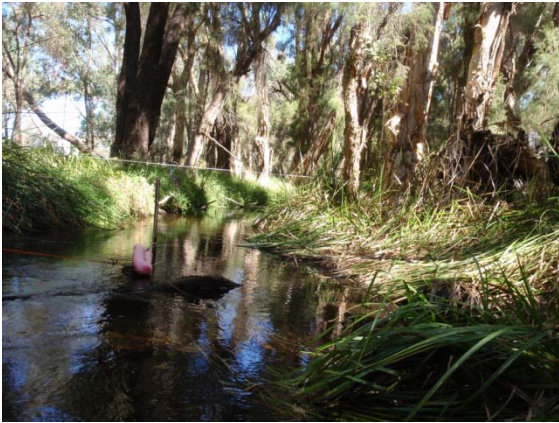
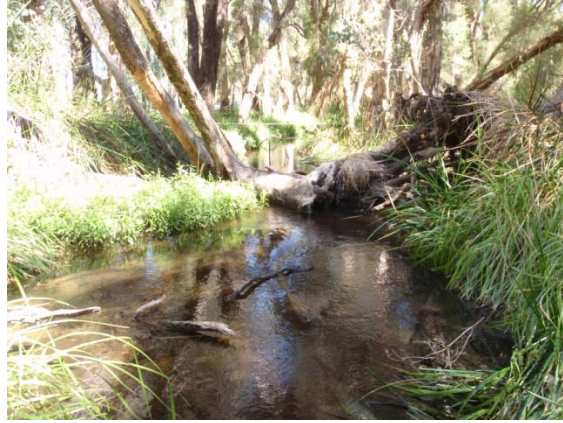
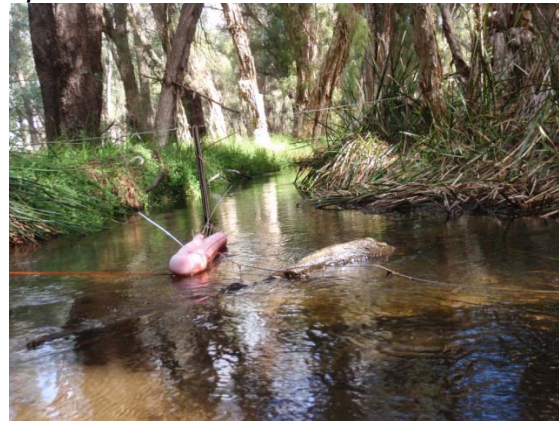
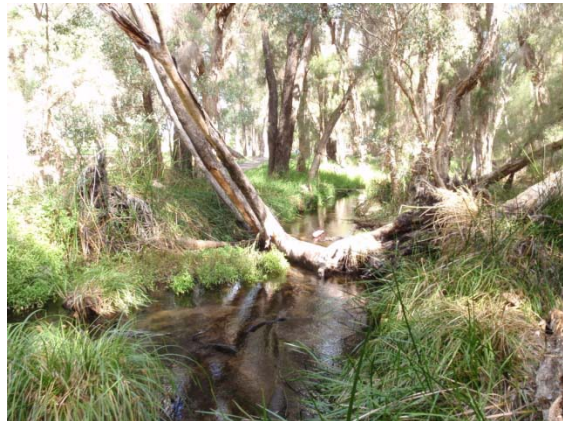
*Figure 11 Photo points 1 and 2 taken at the lower assessment site located on the lower reach of Lennard Brook, taken at the top of the site.*

Flows in Lennard Brook were generally adequate to maintain both longitudinal connectivity and water depth for maintaining aquatic habitat (e.g. woody debris, submerged macrophytes and draping vegetation). In February a drop (5 cm) in water levels was observed over the two-day sampling period at the lower site. At the time flows were at their lowest – 6.6 ML/day. This drop in flow resulted in a decrease in the lateral inundation of the stream habitat, disconnecting draping vegetation and exposing some areas of large woody debris. Exposed habitat is clearly shown in photographs (see Appendix D and Figure 11 and Figure 12).

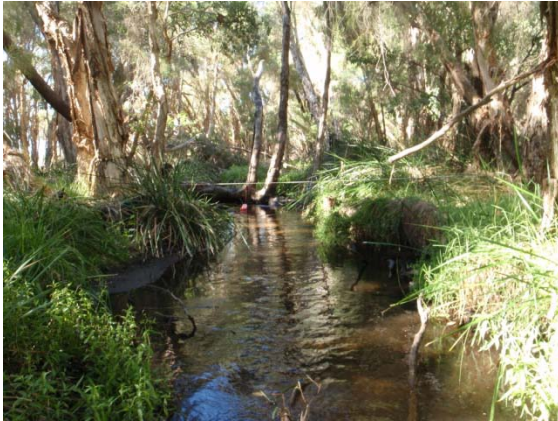
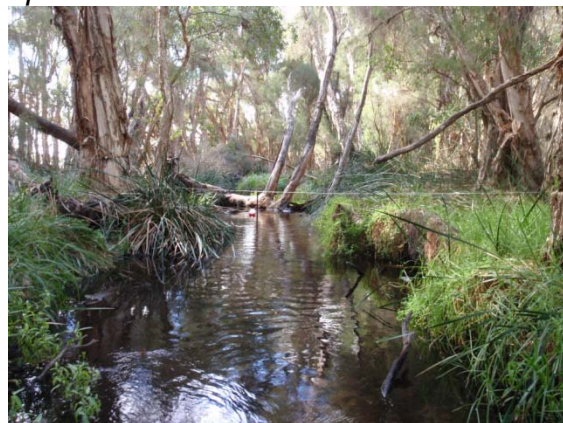
*Figure 12 Photo point 3 taken at the lower assessment site located on the lower reach of Lennard Brook, taken at the top of the site.*
