Claisebrook in the Swan Estuary, Western Australia

A synthesis of environmental information and historical retrospective

Department of Water Technical Report prepared for the Swan River Trust
November 2013

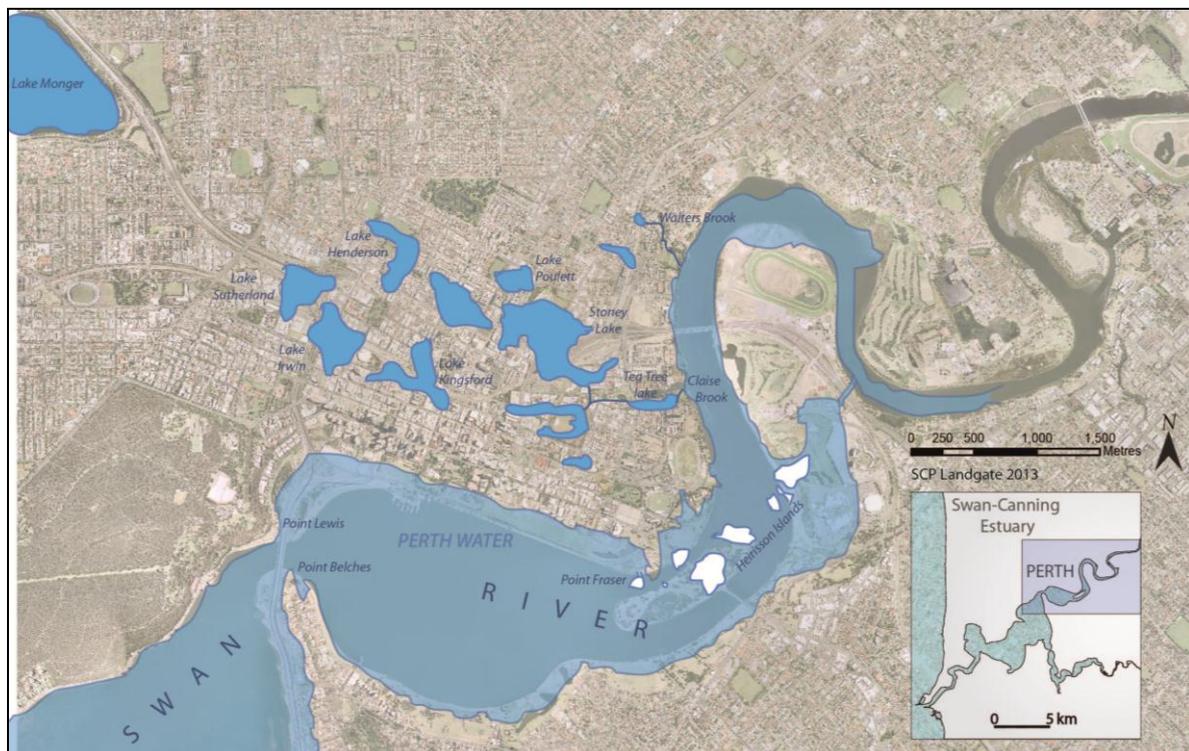
Figure 4 Freshwater lake system (1800s) superimposed on a present-day map (2013) draining to the Swan Estuary via Clause's Brook, later known as Claise Brook (position of lakes sourced from Seddon 2004).

During the 1800s, Clause's Brook was a seasonal waterway, which was typically dry in summer and flowing in winter. Numerous interconnected freshwater lakes drained into the Swan River via Clause's Brook (Seddon 2004) (Figure 4).

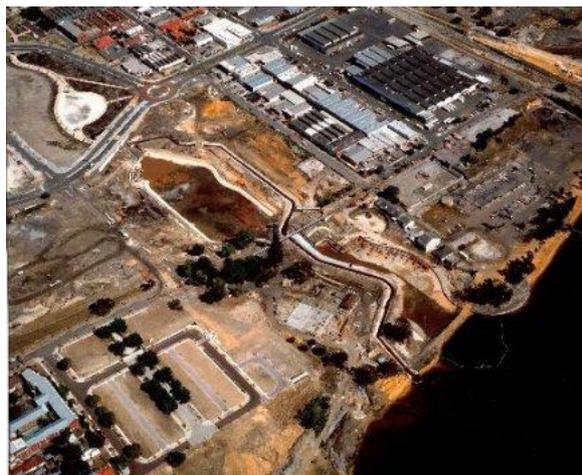
Figure 11 East Perth Gasworks site under development prior to the excavation of the Claisebrook Cove - mid 1990s (Metropolitan Redevelopment Authority 2013b).

The site was subsequently redeveloped (Figure 11) to create an artificial canal-type waterway (Claisebrook Cove) at the outlet of the Claisebrook Drain (Figure 12 and Figure 13). The resulting waterway is surrounded by Claisebrook Village (present time) comprising both domestic (1 450 homes) and retail properties (East Perth Redevelopment Authority 2009) (Figure 13).

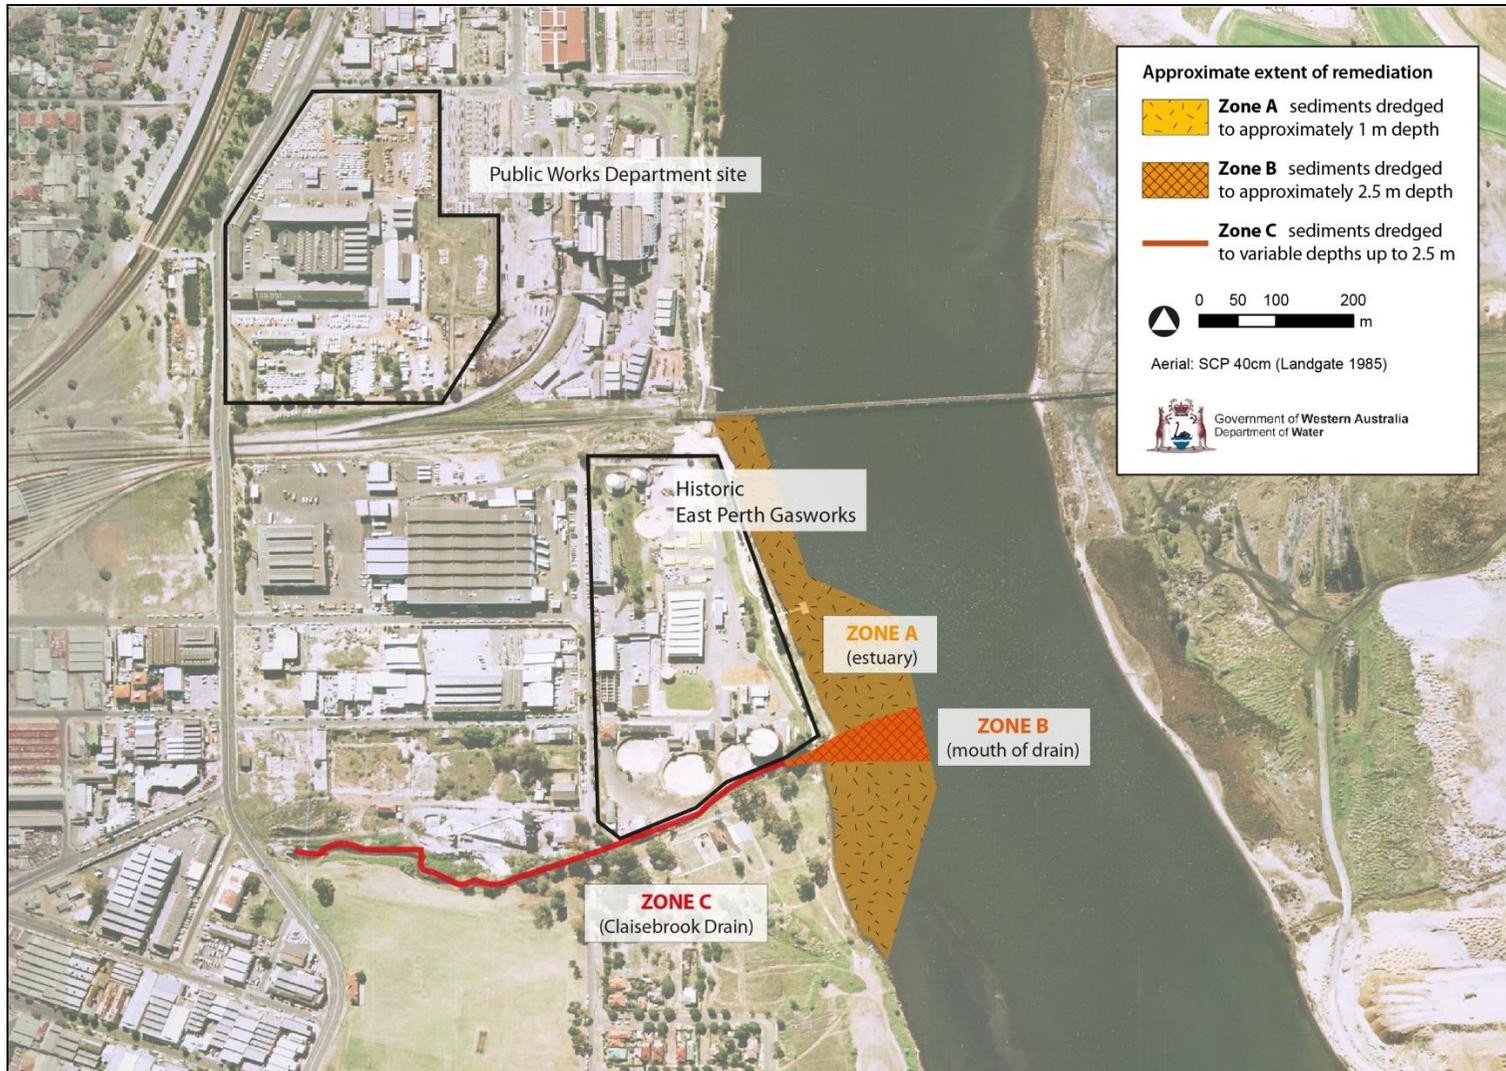
Figure 16 Swan Estuary Remediation: extent of remediation zone. Recreated from information sourced in the Remedial Strategy for the East Perth Gasworks and Swan River (East Perth Redevelopment Authority 1993).

Contaminated sediments were also removed from the foreshore and bed of the Claisebrook Drain by excavator as part of the construction of Claisebrook Cove (Figure 17 and Figure 18). Due to the presence of high levels of contamination, a minor part of the inlet near the mouth was excavated to 1 m below its original design depth and backfilled with clean quartz sand from a Gnangara quarry to the required finished level. Clean quartz sand from Gnangara was also used to backfill the dredged area of the estuary, generally to a depth of 1 m (Camp Scott Furphy 1996a). Figure 19 shows the change in form of Claisebrook Drain before and after excavation.

- III. Despite extensive remediation (Section 2), surficial sediments collected from several sites in the remediated zone of the estuary (Figure 16) exhibited comparatively high levels of PAHs (also observed in Nice 2009).

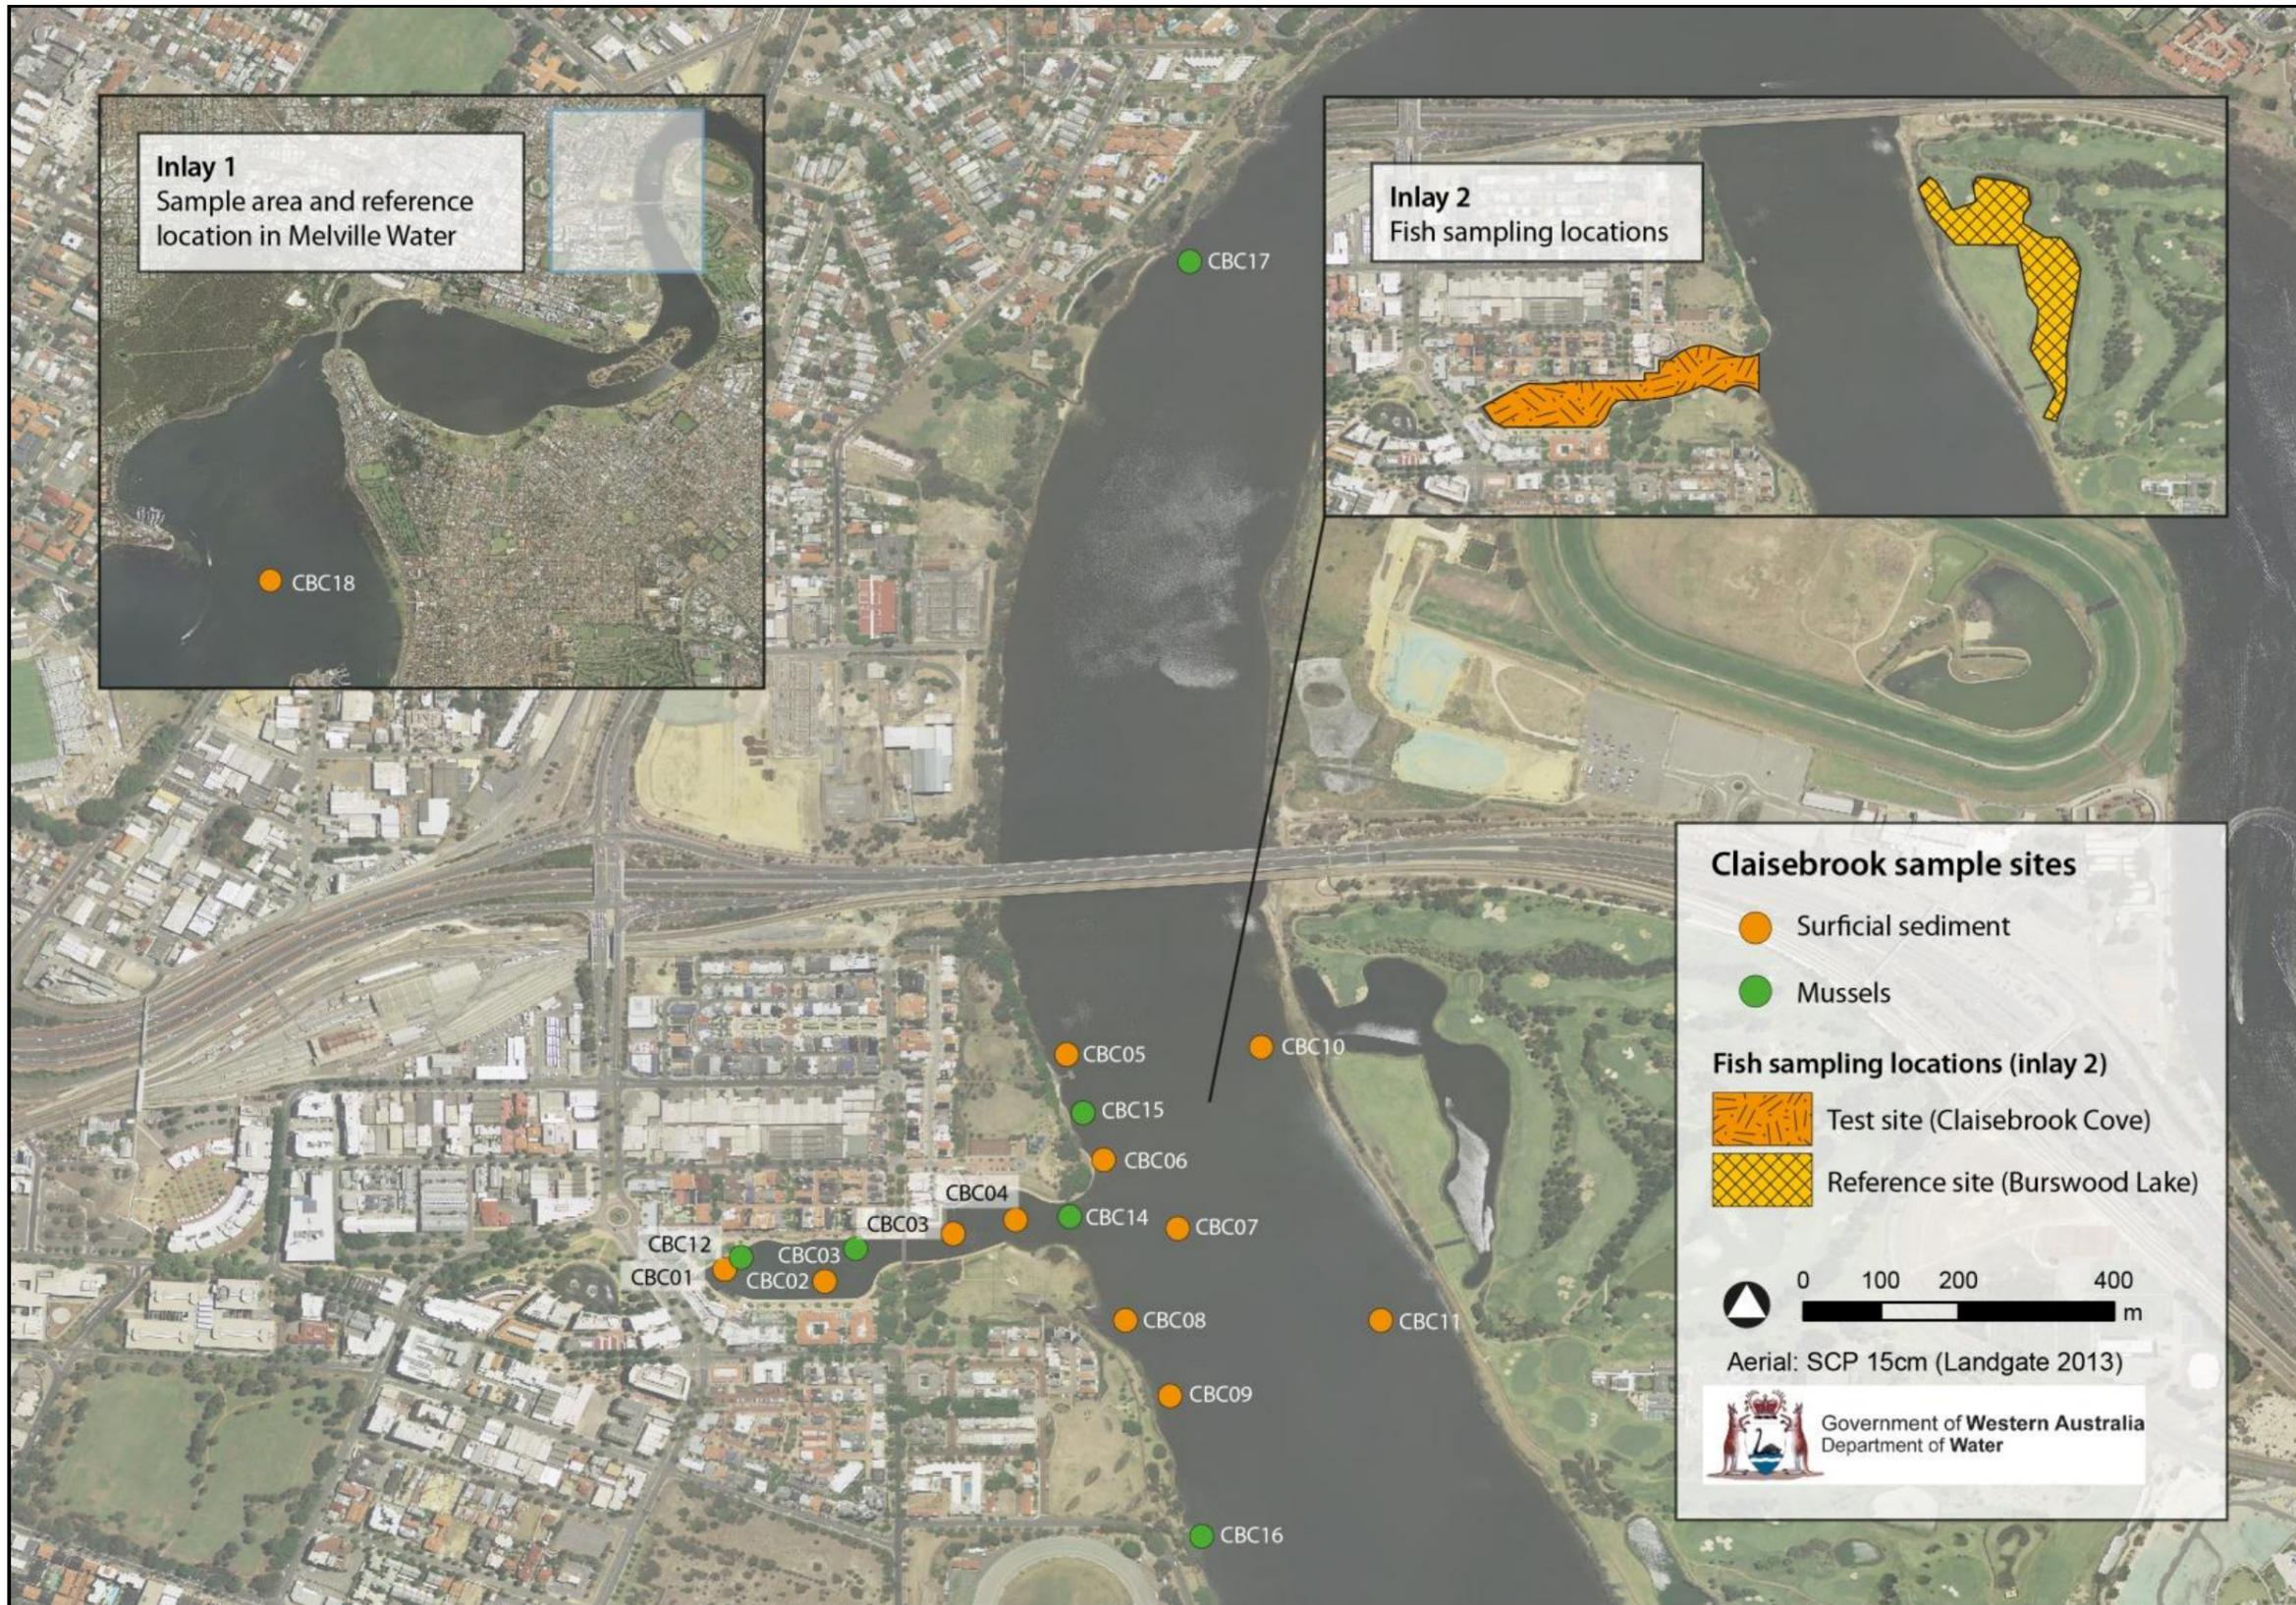
Figure 26 Site locations of Stage 1 investigations: *Ecotoxicological and bioaccumulation investigations of the Swan Estuary in the vicinity of Claisebrook* (Nice and Fisher 2011) and *Fish Health in Claisebrook Cove* (Rawson et al.2011).

To determine:	Line of evidence	Study
toxic potential of sediment collected from the estuary based on laboratory exposures of field collected sediments to laboratory animals representative of those found in the estuary	Sediment toxicity	Nice and Fisher 2011
types and concentrations of contaminants present that may be responsible for any toxicity observed	Sediment chemistry	Nice and Fisher 2011
whether contaminants known to be present are bioaccumulating in naturally occurring biota (mussels)	Bioaccumulation in biota	Nice and Fisher 2011
whether wild-caught fish from Claisebrook Cove displayed evidence of toxicity (through biomarkers of physiological stress)	Fish health	Rawson et al. 2011

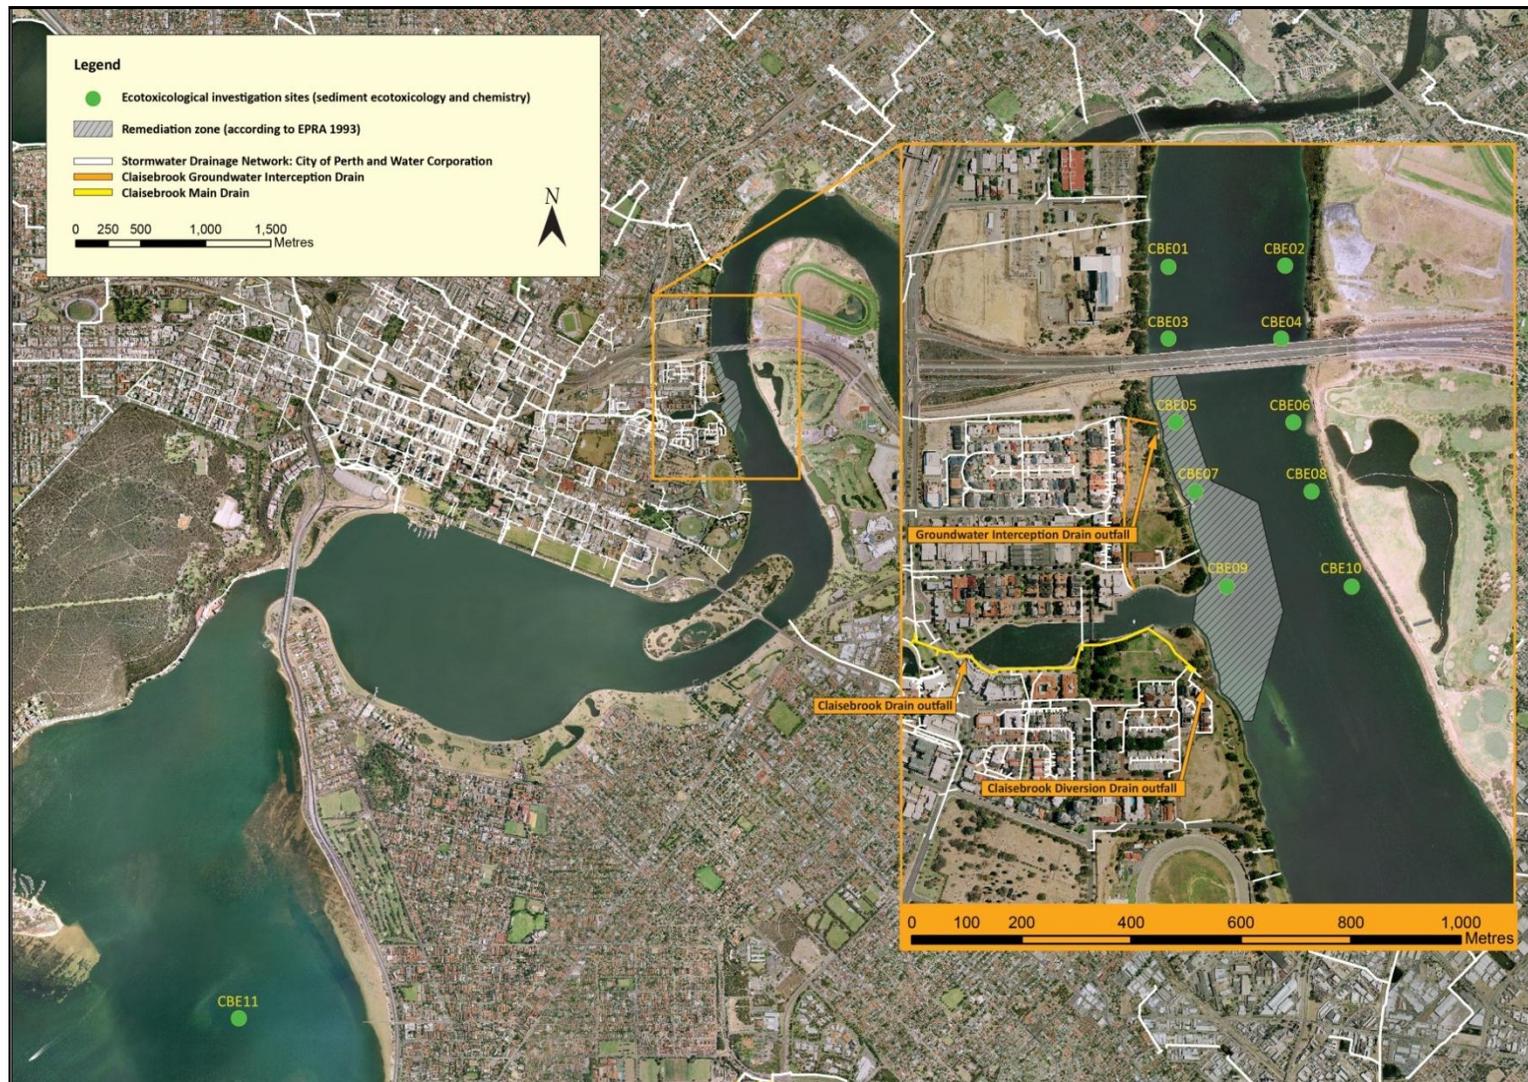
Figure 28 Site locations from Stage 2 investigation: *Ecotoxicological investigation of the groundwater interception drain (GID) outfall at Claisebrook in the Swan Estuary* (Nice 2013a).

The sediment toxicity assessment (Nice 2013a) comprised a targeted sample design focussing on the GID outfall in the main channel of the estuary adjacent to the historic gasworks site with sites upstream and downstream from the GID outfall (Figure 28). The spatial design enabled determination of whether the GID outfall was a likely source of the PAH contamination and toxicity previously observed (Nice and Fisher 2011) or whether the source was likely to be upstream, downstream or across the estuary from the GID outfall. It also allowed determination of the extent of the contamination.

Red border indicates site within the zone of interest. ISQG = Interim Sediment Quality Guideline (ANZECC & ARMCANZ 2000); single black border indicates concentration higher than ATA Acceptance Criteria, double black border indicates concentration higher than 10xATA Acceptance Criteria; blue indicates concentration higher than low ISQG; orange indicates concentration higher than high ISQG; n.a. = no ANZECC & ARMCANZ guideline available; * alternative guidelines for benzo[b+k]fluoranthene of 240 and 1340000 µg/kg (Ontario Sediment Quality Guidelines 1993 lowest effect level and severe effect level respectively). ** is the ATA Criteria for each of benzo[b]fluoranthene and benzo[k]fluoranthene separately. N.d. = not detected; limit of reporting: 10 µg/kg. Samples comprised the top 2 cm of sediment. Data not normalised to 1% OC. Site locations are shown in Figure 28.

Red border indicates site within the zone of interest. ISQG = Interim Sediment Quality Guideline (ANZECC & ARM CANZ 2000); single black border indicates concentration higher than ATA Acceptance Criteria, double black border indicates concentration higher than 10xATA Acceptance Criteria; blue indicates concentration higher than low ISQG; orange indicates concentration higher than high ISQG; n.a. = no ANZECC & ARM CANZ guideline available; * alternative guidelines for benzo[b+k]fluoranthene of 240 and 1340000 µg/kg (Ontario Sediment Quality Guidelines 1993 lowest effect level and severe effect level respectively). ** is the ATA Criteria for each of benzo[b]fluoranthene and benzo[k]fluoranthene separately. N.d. = not detected; limit of reporting: 10 µg/kg. Samples comprised the top 2 cm of sediment. Data normalised to 1% OC. Site locations are shown in Figure 28.

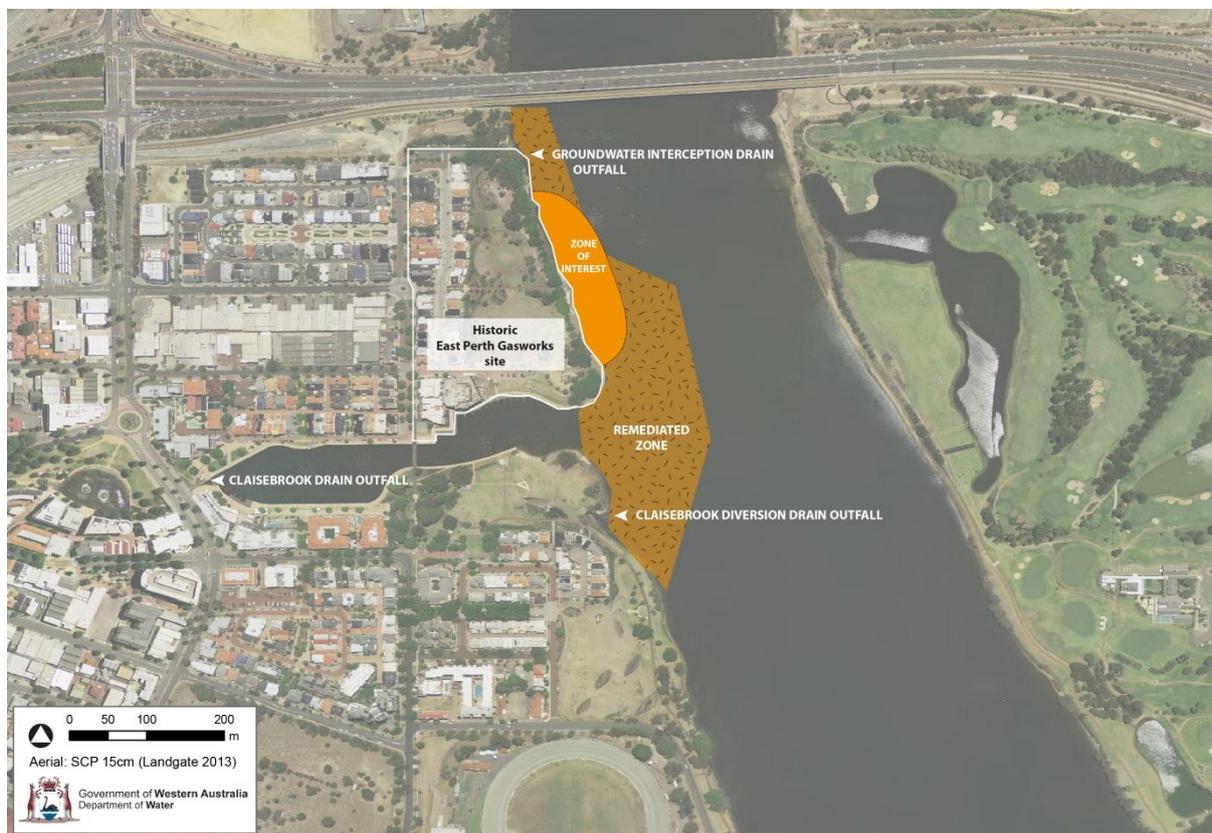
Figure 31 Contaminant hotspot – *zone of interest* identified from DoW studies (Nice 2013a, Nice 2011).

For all further discussion in this paper, this localised contaminated area shall be described as the *zone of interest* (Figure 31).

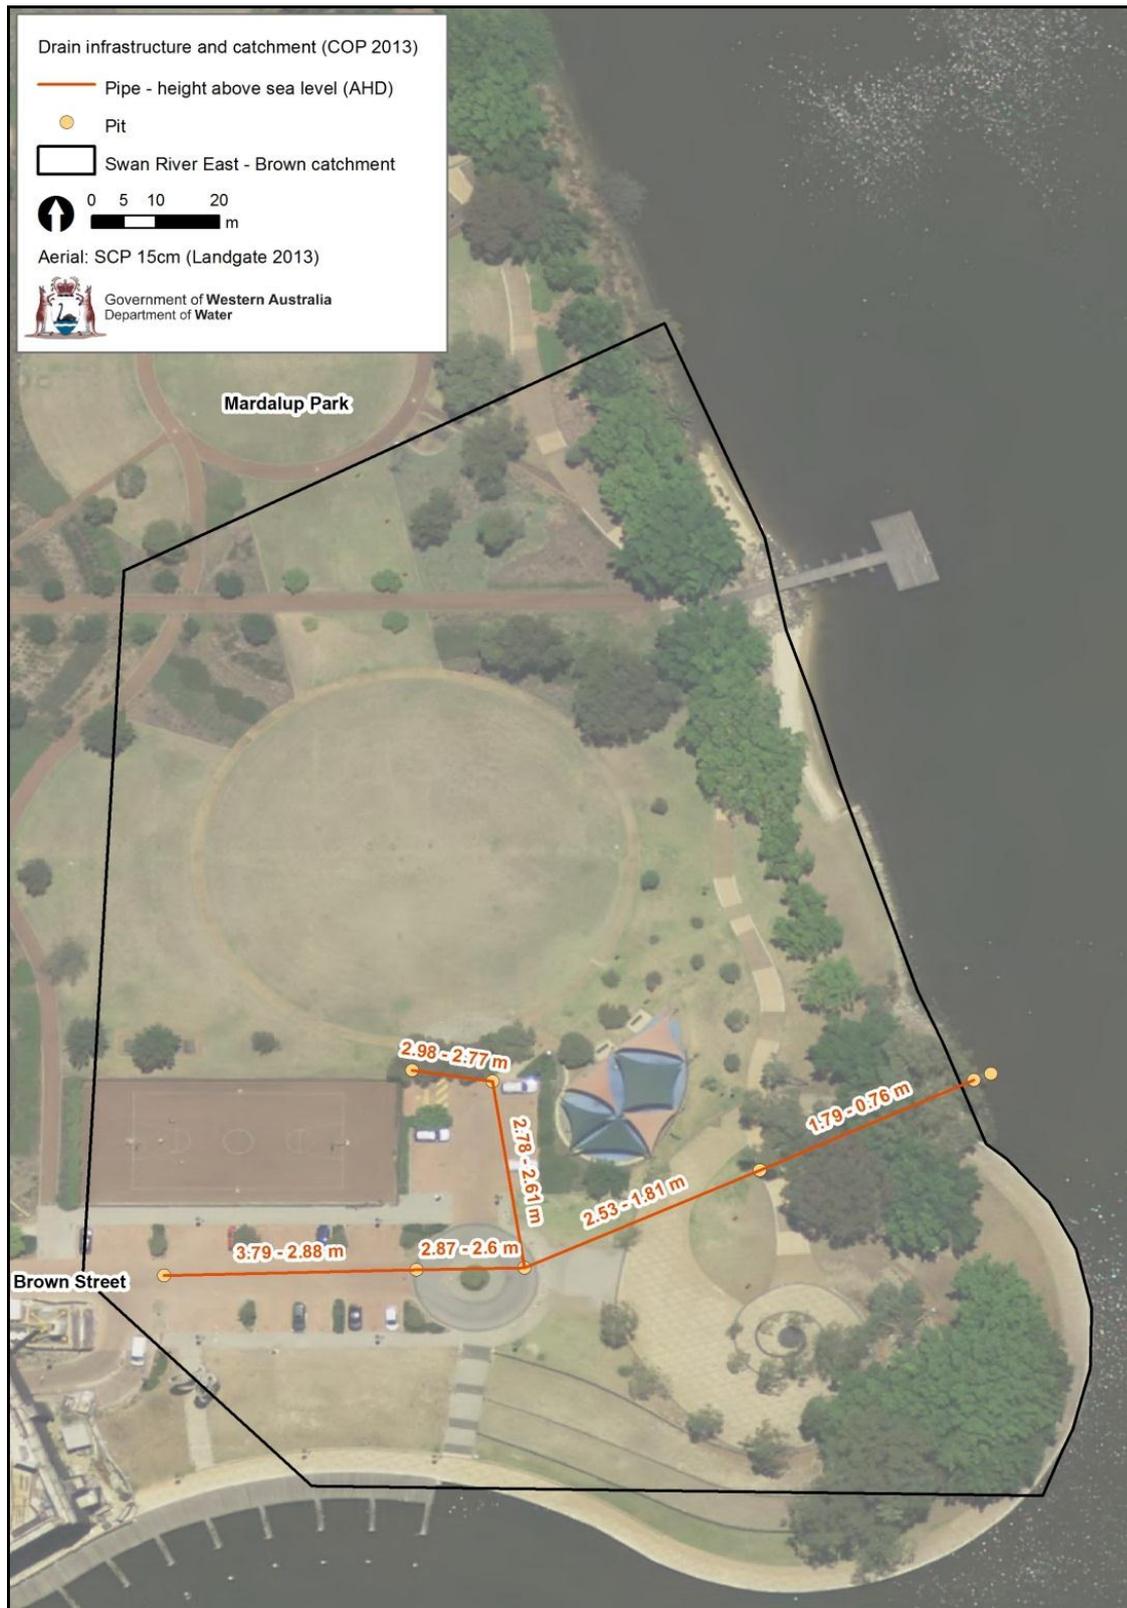
Figure 41 Catchment and discharge point of Brown Street Drain.

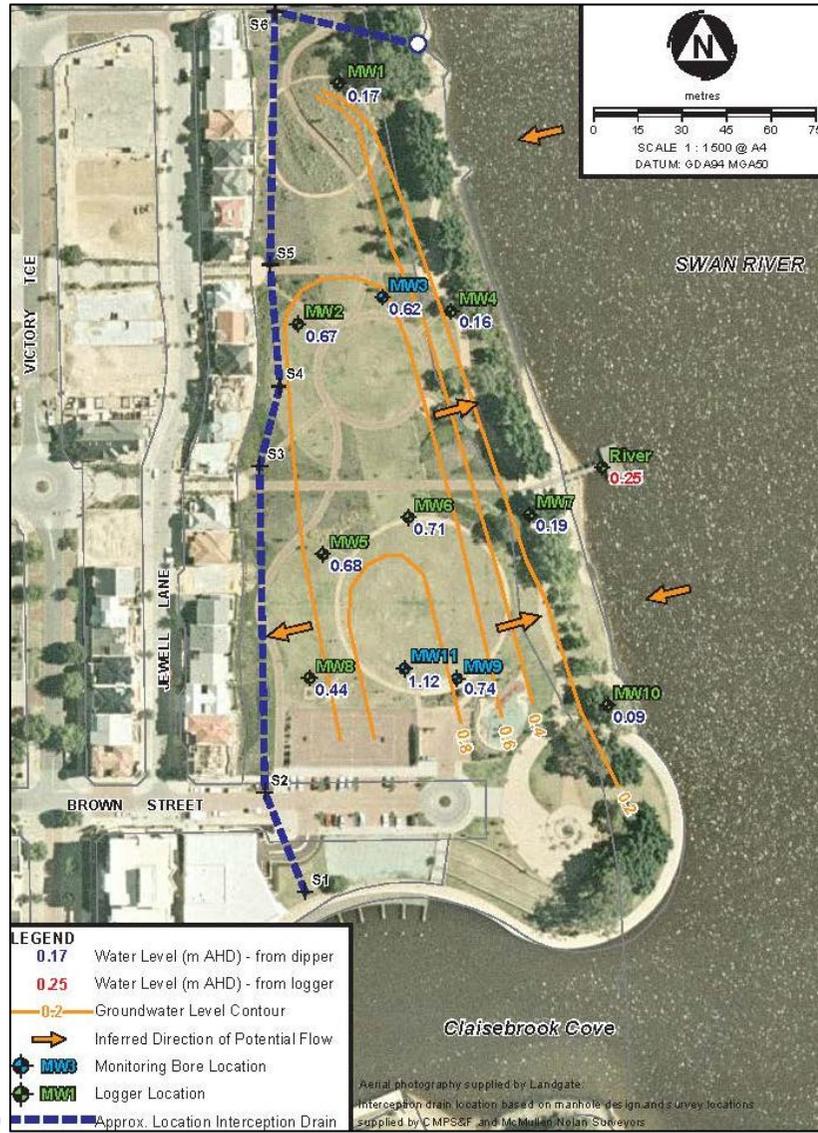
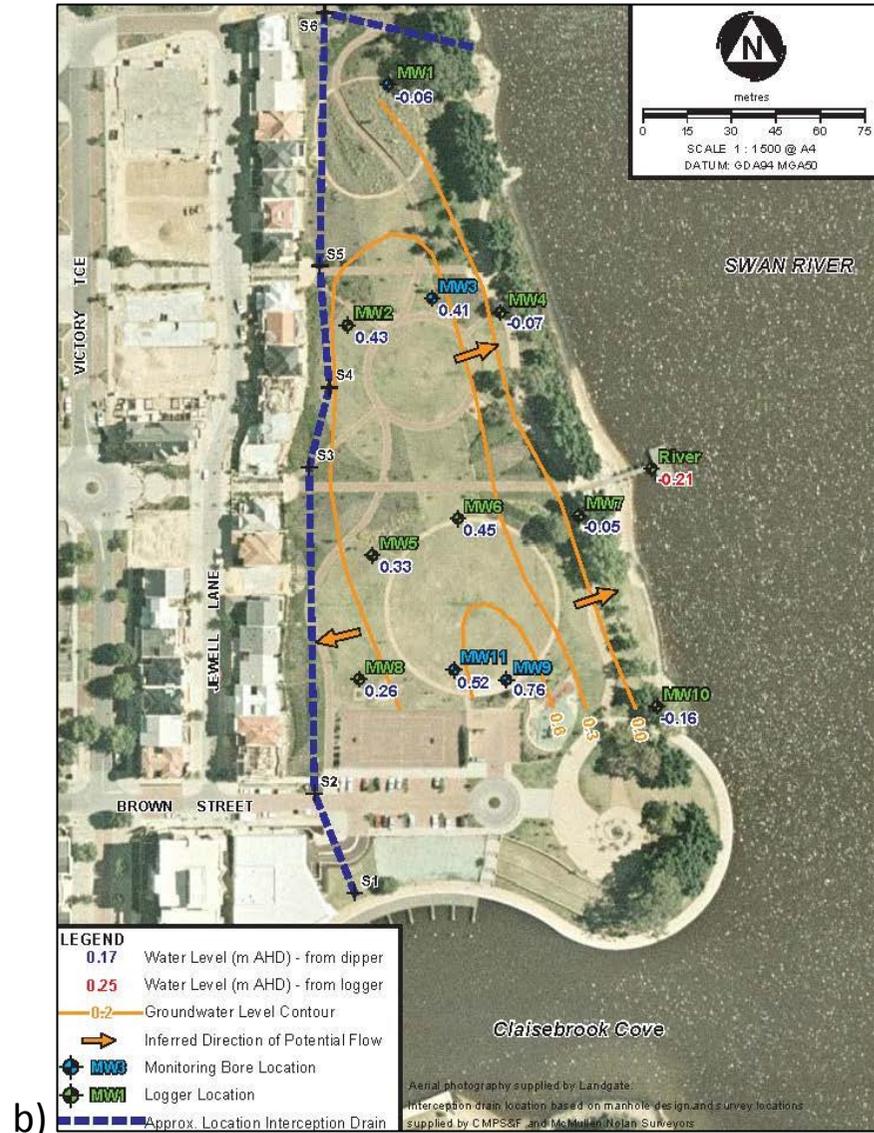
Figure 42 Groundwater level contours and flow direction at Mardalup Park, a) 25/11/2008; b) 06/02/2009 (Source: ENV 2009).

Similarly, the most recent compliance monitoring (available at the time of writing this report) of the containment management strategy (ENV 2011a) demonstrated that groundwater levels in the containment area were again mostly above or equal to the estuary level in July, September and December 2010 (Figure 43). The report notes that the levels observed within the containment area indicate that the flow of groundwater is away from the containment area, including to the interception drain on the western and northern boundaries of Mardalup Park (discussed previously) and to the Swan Estuary on the eastern and southern boundaries (ENV 2011a). This report does not indicate a specific point of entry for the groundwater to the estuary. However, the integrity of the 1 mm thick plastic cut-off curtain on the eastern boundary and the 10.5 mm sheet pile wall on the southern boundary (Figure 20) is currently unknown and may warrant investigation.
