Department of  
Environment and Conservation

# ACID SULFATE SOIL SURVEY

## SUPERFICIAL GEOLOGICAL SEDIMENTS ADJACENT TO THE PEEL-HARVEY ESTUARY

SEPTEMBER 2009

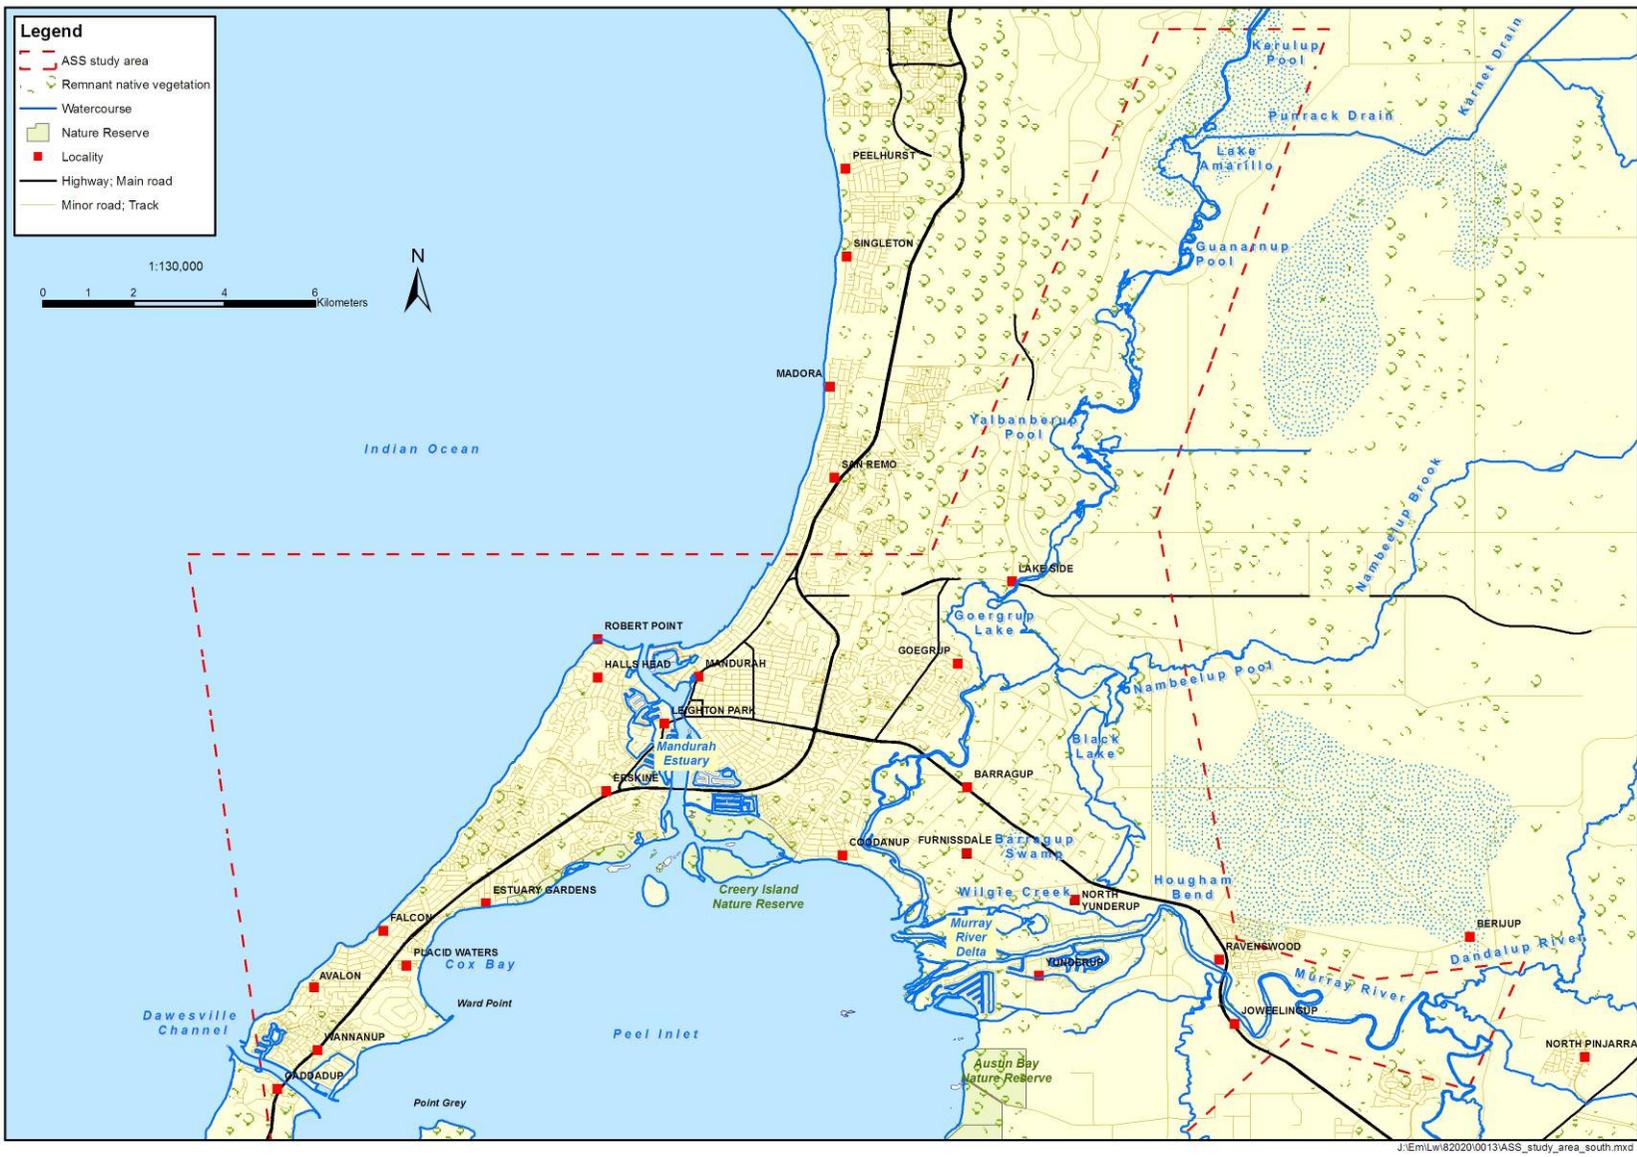
Figure 1: Northern extent of the Peel-Harvey study area with main geographic features (rivers, points, lakes, wetlands).

Several rivers feed into the Peel-Harvey estuary, which are flanked to varying extents by local clay and silt rich floodplain deposits (McArthur, 1991). The Serpentine River flows into the Peel Inlet from the north, entering between Spearwood and Bassendean dunes and forming a delta that merges with that of the Murray River. The Murray River flows into the Peel Inlet from the east, mainly transecting the Pinjarra Plain (and upper Guildford formation). The Murray-Serpentine delta consists of a few main channels flanked by levees, lakes, abandoned channels, lakes and flats with a complex series of interlayered muds and sands (Semeniuk and Semeniuk, 1990). The only major natural flow into the Harvey estuary is the Harvey River, which enters from the south-east after transecting Bassendean dunes and the Pinjarra Plain. The Harvey River delta consists of multiple channels, levees, abandoned channels and flats with a similar series of complex soils to that in the Serpentine-Murray delta (Semeniuk and Semeniuk, 1990). The Peel-Harvey estuary is also flanked by numerous peripheral wetlands being more extensive on the eastern side of the estuary (Semeniuk and Semeniuk, 1990). Depending on proximity to the estuary, the soils in these wetlands have been described as being predominantly muds and sandy muds (Semeniuk and Semeniuk, 1990).

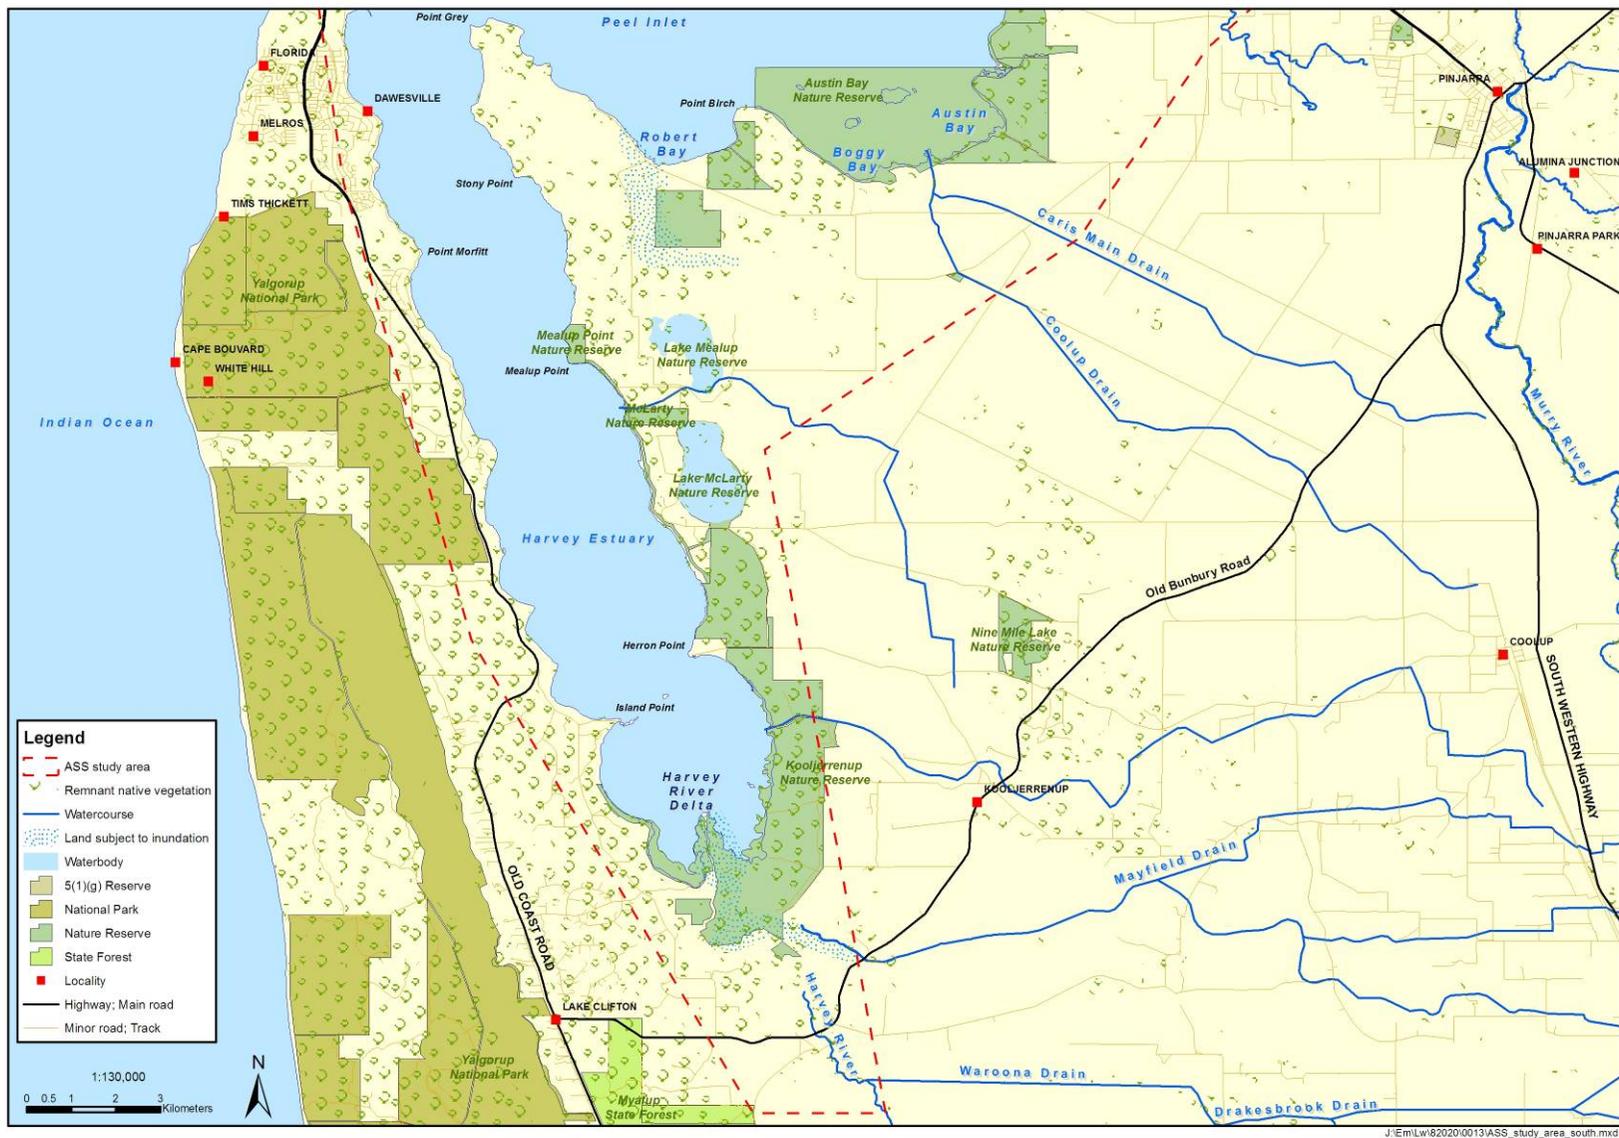
Figure 2: Southern extent of the Peel-Harvey study area with main geographic features (rivers, points, lakes, wetlands).

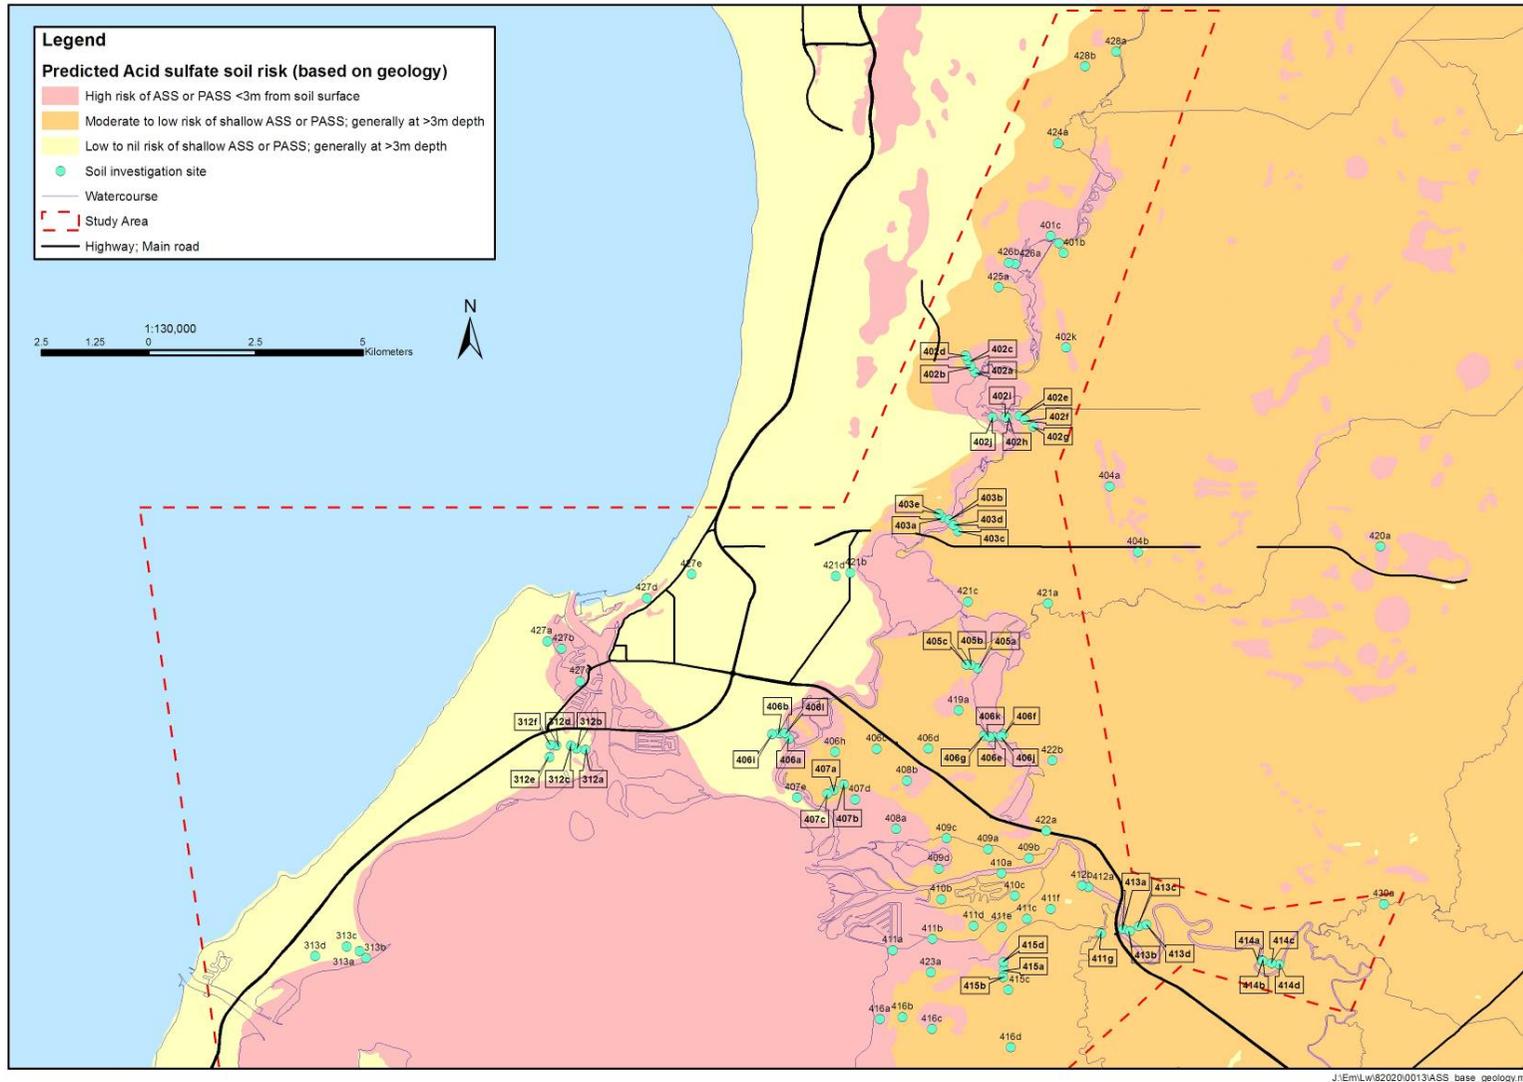
Figure 3: Initial ASS risk map (based on 1:50 000 scale environmental and urban geology mapping) and superficial formation investigation sites (Peel inlet, Serpentine and Murray Rivers). Note: map not printed to scale.

Target sites for on-ground characterisation and investigations of ASS were identified using the base map of expected ASS risk (Figure 3, Figure 4) and local interpretation of where PASS materials might be expected during on-site reconnaissance. Sites were broadly located as transects across dominant, mainly east-west, landscape patterns ( ), though individual site placement was determined by local landscape conditions that would determine highest likelihood of ASS occurring (i.e. predominance of wetland vegetation, surface organic accumulations, evidence of shallow and/or at least a semi-permanent water table; see Department of Environment 2004b). Details of site locations are listed in Appendix 2.

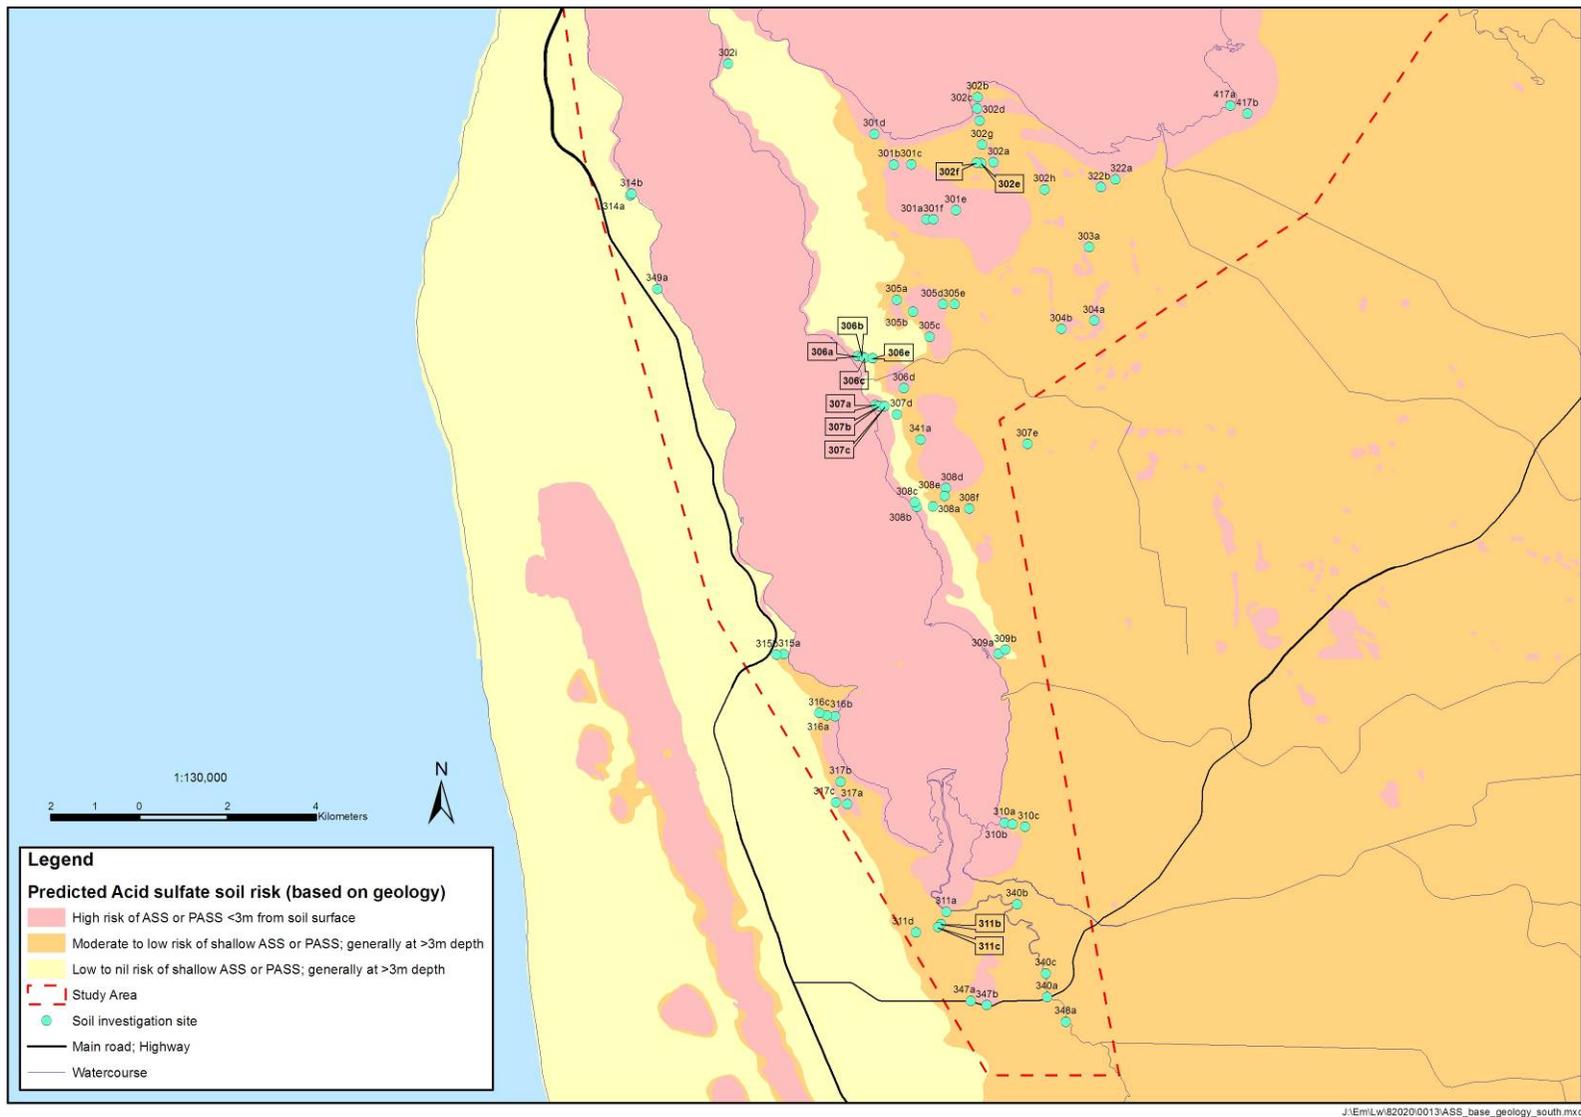
Figure 4: Initial ASS risk map (based on 1:50 000 scale environmental and urban geology mapping) and superficial formation investigation sites (SE Peel inlet, Harvey Inlet and Harvey River). Note: map not printed to scale.

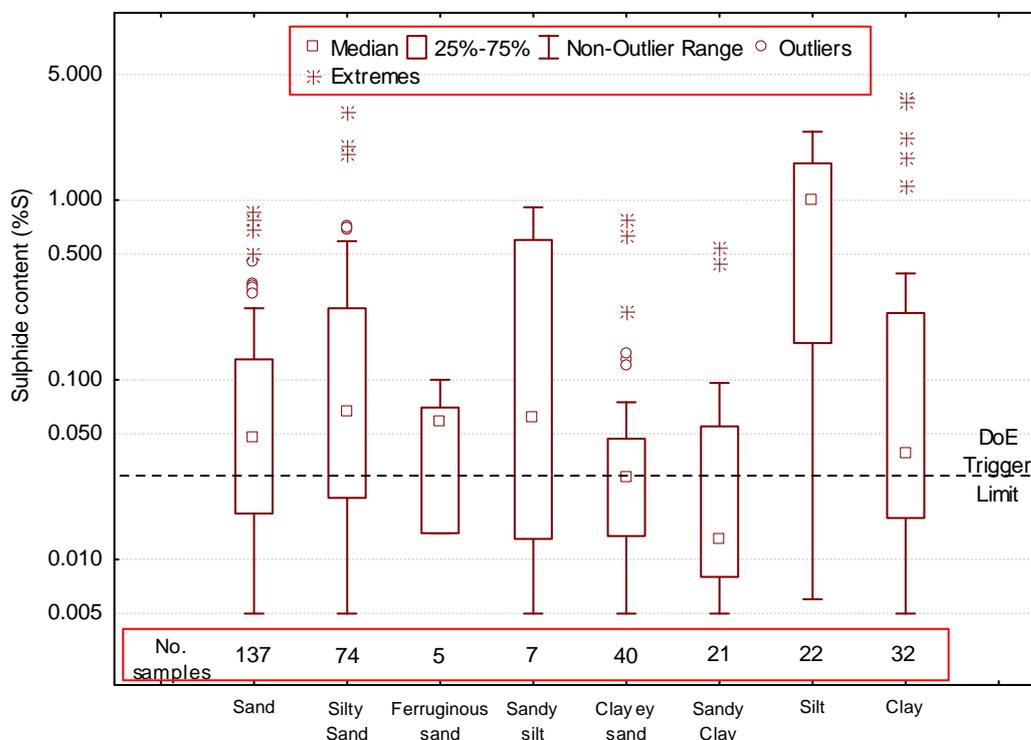
Figure 5: Concentrations of PASS materials (as indicated by % sulfide-S on a logarithmic scale) for representative samples of horizons (grouped by dominant soil texture).

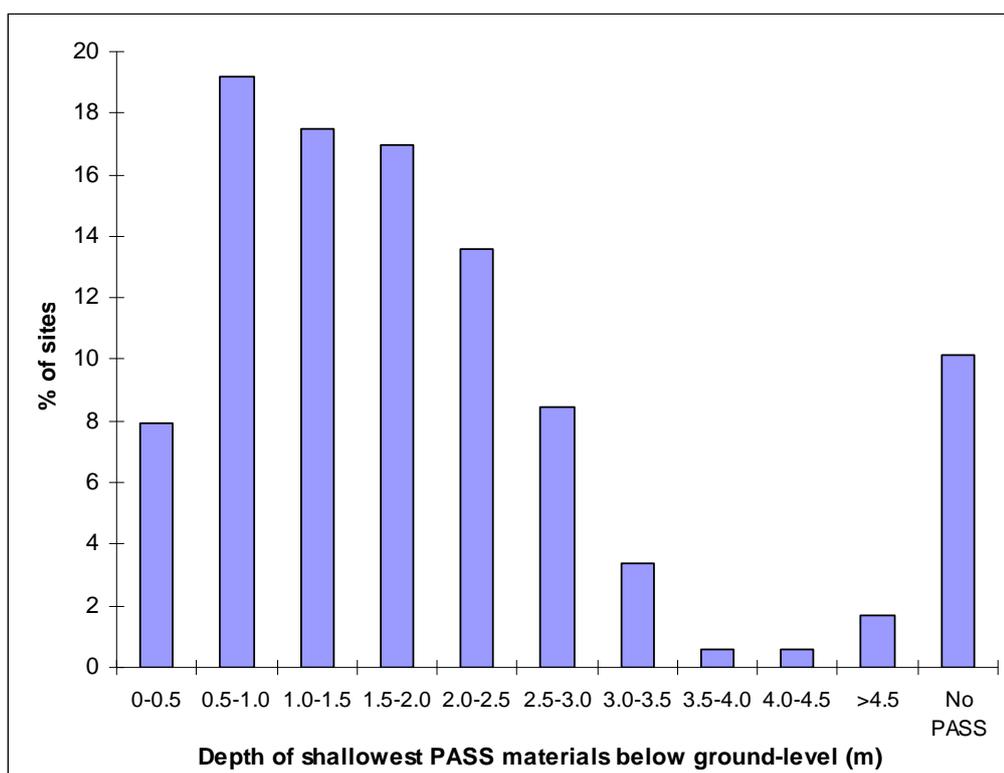
Figure 6: Distribution of sites classified by depth of shallowest PASS materials below ground-level.

There were few profiles investigated where PASS materials occurred within 0.5m of the ground-surface (Figure 6), but this does not indicate that there were no areas with very shallow PASS materials. Few shallow PASS materials were found because most investigations were carried out where drill rig access was possible, thereby largely excluding tidal flats and wetland basins. Significant concentrations of PASS materials were frequently found within 0.5m of the ground-surface where hand-auger investigations were carried out in wetland basins and tidal flats (particularly supra-tidal flats).

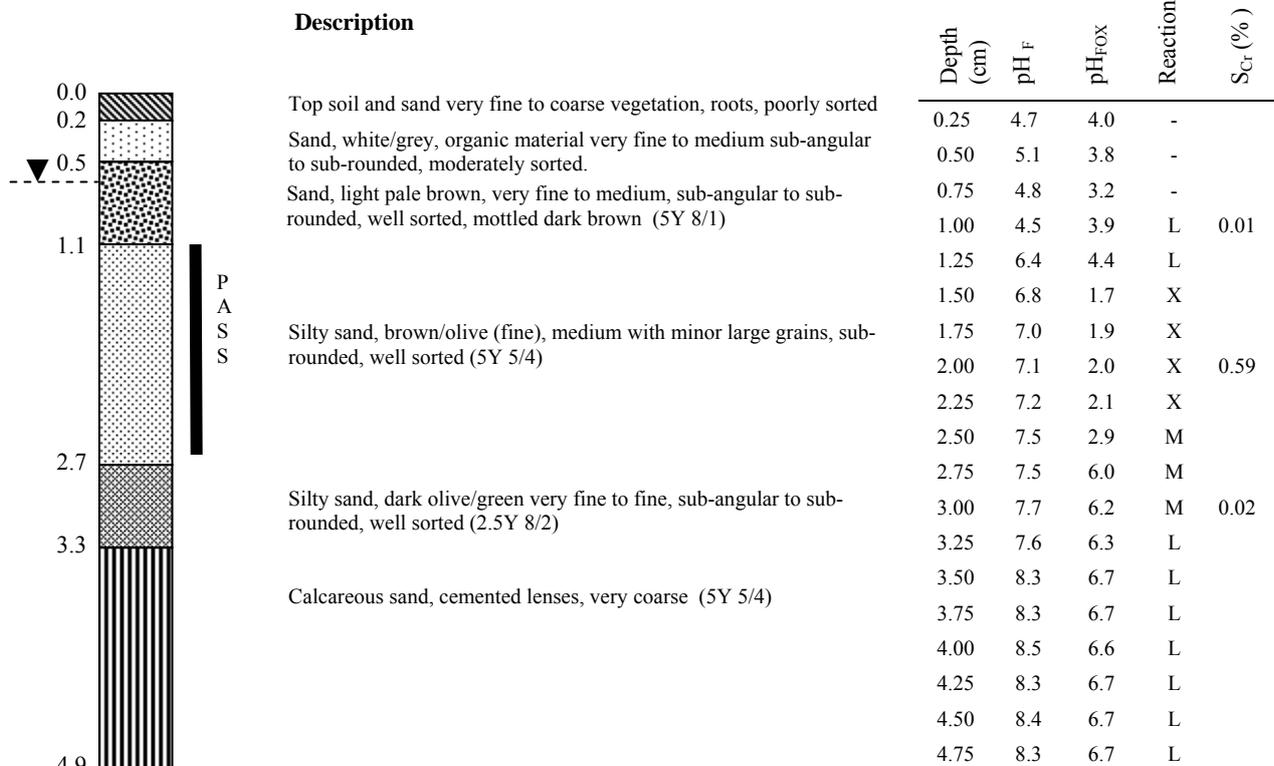
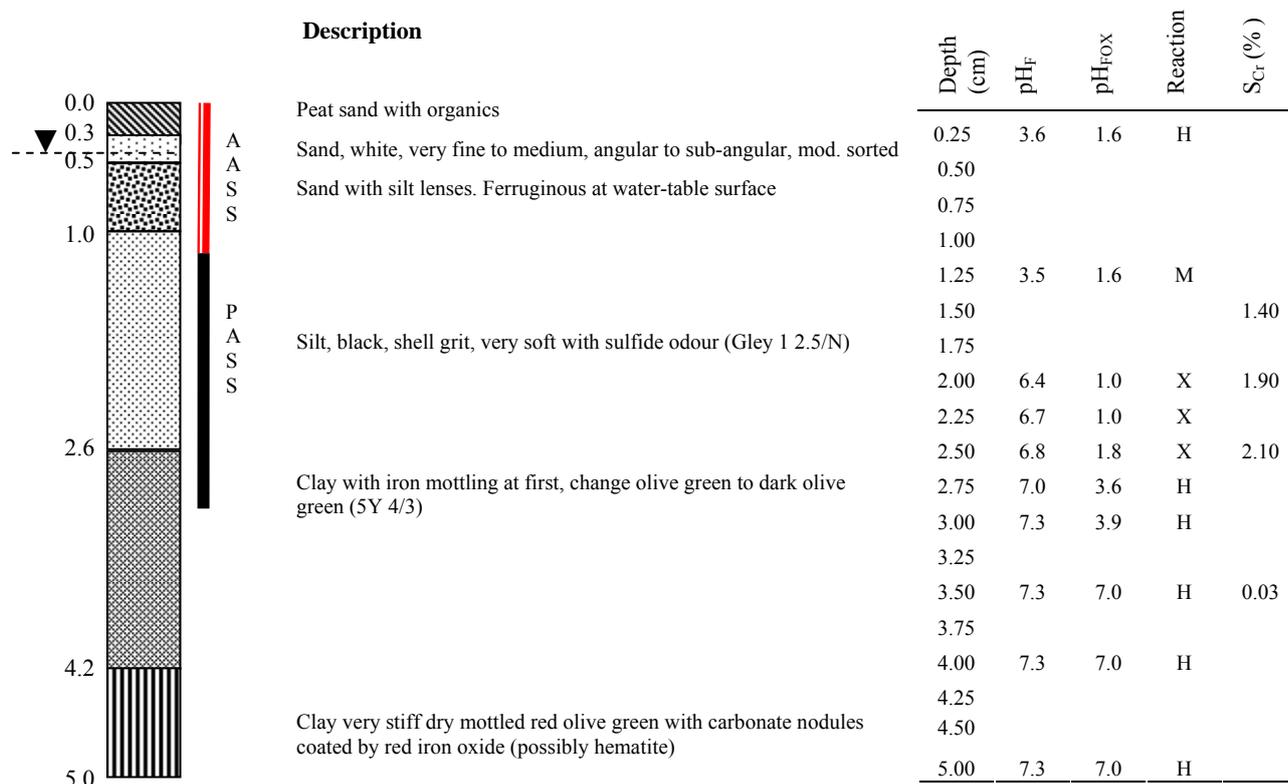
**(a) Site: 302b**

**Location: East Robert Bay, Austin Bay Conservation Reserve**

**(b) Site: 409d**

**Location: Murray River Backswamp, North Yunderup**

Figure 8: Examples of common profiles in low-lying land adjoining the Peel-Harvey Estuary with PASS materials throughout profiles dominated by silty sands (a) or sands (b) (pH<sub>F</sub>, pH<sub>FOX</sub> and reaction as per Appendix 3; S<sub>Cr</sub>=laboratory analysis of Chromium reducible S).

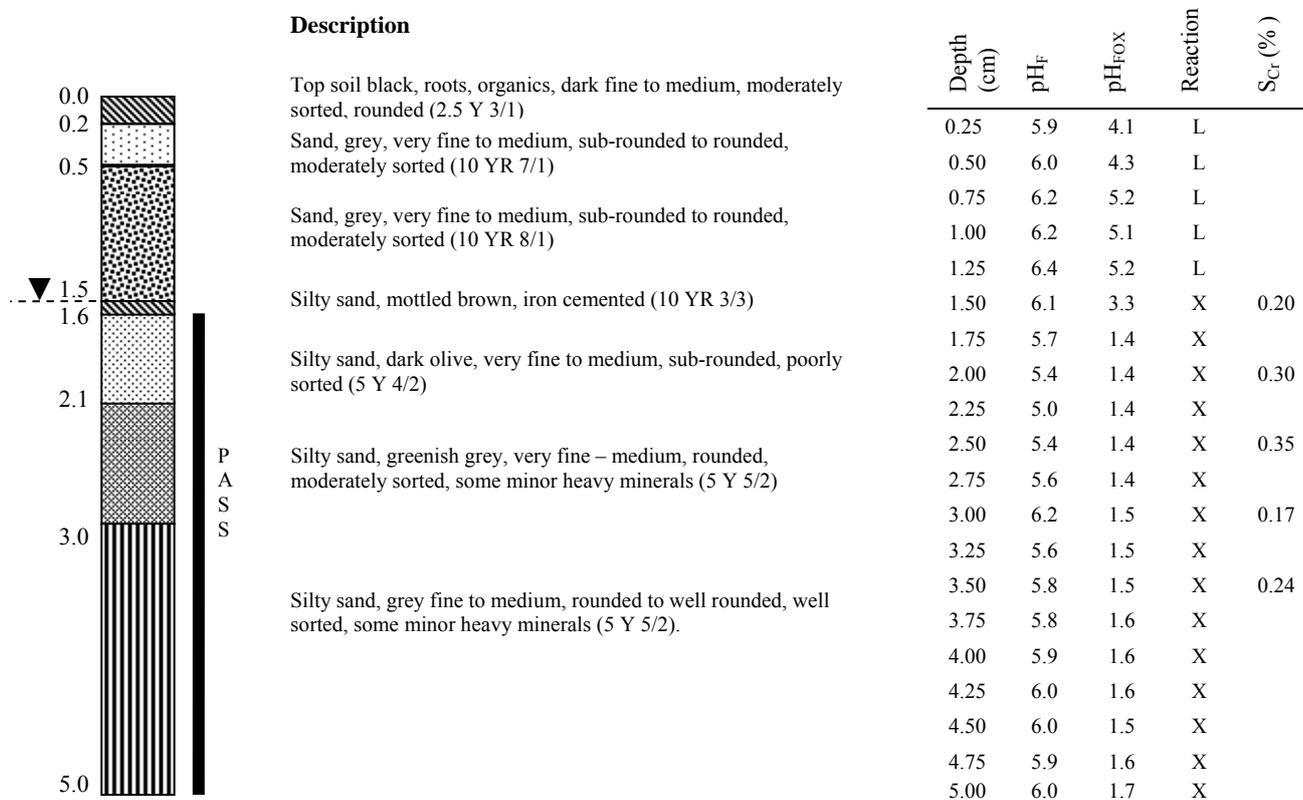
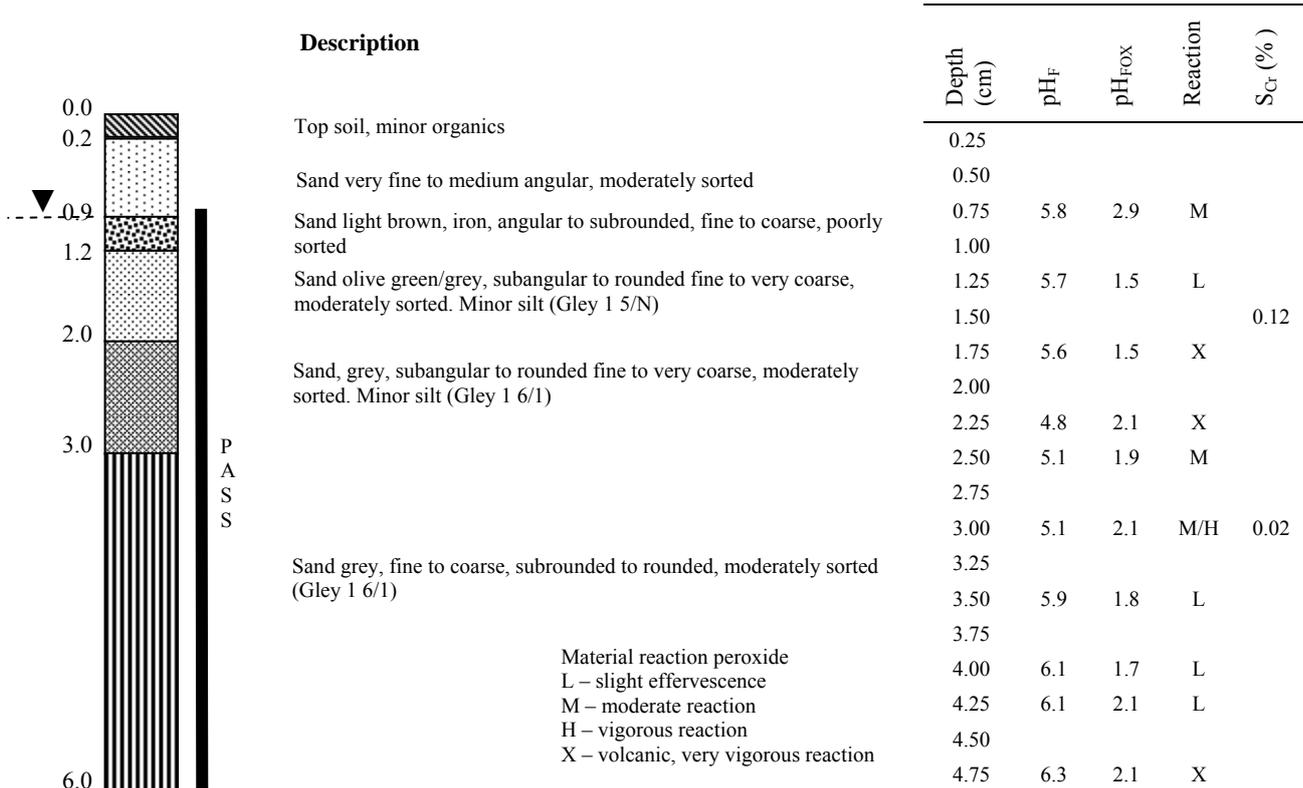
(a) Site: 317b

Location: North Harvey Delta, Off Sthrn Estuary Drive

(b) Site: 407b

Location: Off Ronlyn Road, Furnissdale

Figure 9: Examples of common profiles in low-lying land adjoining the Peel-Harvey Estuary with PASS materials only in shallow silty sand (a) or sand and silt horizons (b) but not underlying deeper horizons (pH<sub>F</sub>, pH<sub>FOX</sub> and reaction as per Appendix 3; S<sub>Cr</sub>=laboratory analysis of Chromium reducible S).

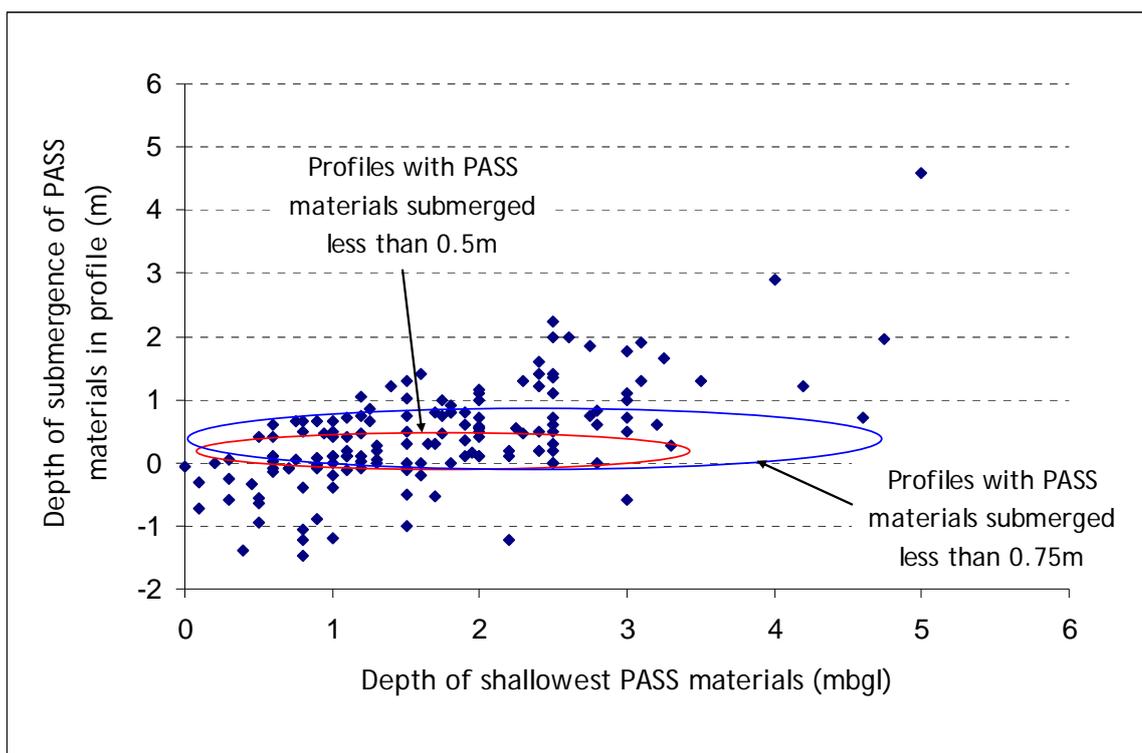
Figure 10: Plot of the depth at which shallowest PASS materials occurred in superficial sediment profiles (mbgl) in relation to the depth that the materials were submerged below the water-table (measured at the time of coring), for profiles where both PASS materials occurred and a water-table measurement was available (145 sites).

A number of profiles (23 per cent) contained PASS materials above the watertable, as indicated by negative submergence values in Figure 10 (e.g. south Mandurah bridge site 312d). Where this occurred PASS materials occurred in horizons with organic rich horizons, clay, actual ASS materials or extensive iron mottling in the horizon above the water-table.

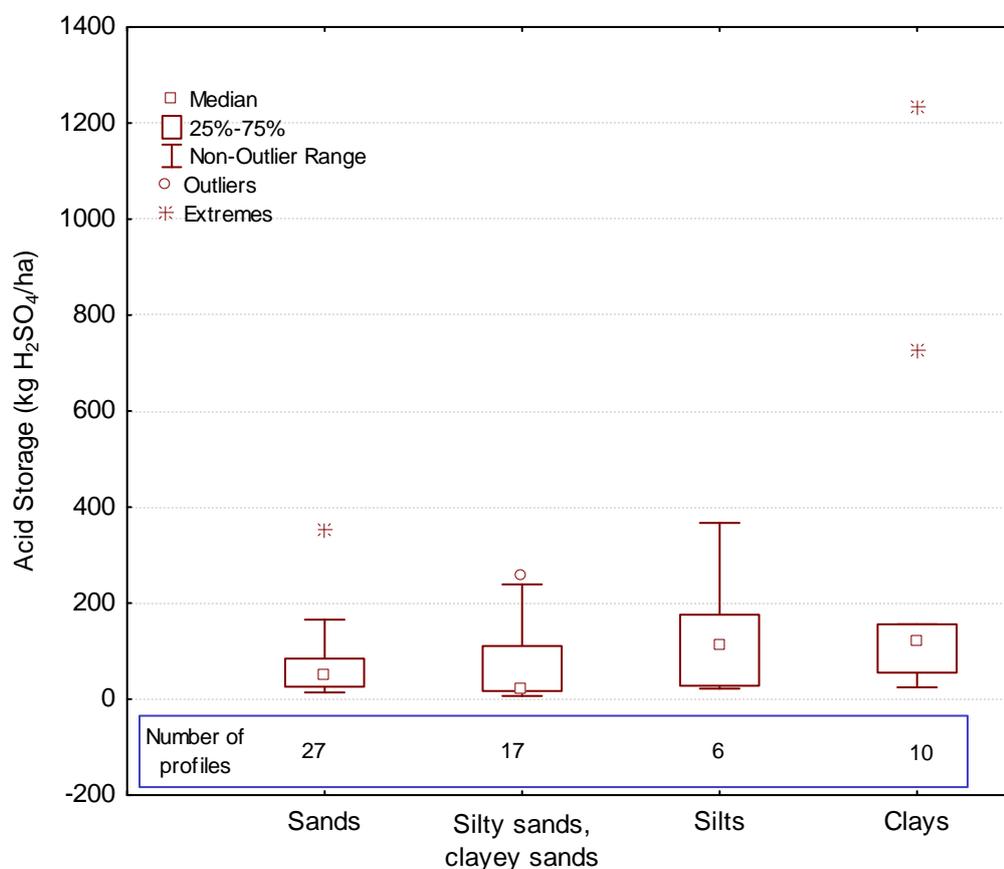
Figure 11: Estimation of acid storage within the shallowest PASS materials (up to 1 m thickness) categorised by the dominant textures in which the PASS materials occurred.

Acid storage ranged over three orders of magnitude from less than 10 tonnes H<sub>2</sub>SO<sub>4</sub>/ha to more than 1,000 tonnes H<sub>2</sub>SO<sub>4</sub>/ha (Figure 11). Superficial sediments with PASS materials occurring in mainly coarse textured materials (sands and silty sands) could contain as much acid storage as those with PASS materials in mainly finer textured materials such as silts and clays, though there were fewer of the latter (Figure 11). This result broadly reflected the patterns of sulfide contents for soil materials (Figure 5), and confirms that a similar pattern also occurs for whole profiles (where acid storage is considered across horizons). There was only one profile where peat was the dominant soil material containing PASS materials (Mandurah town site, 427d) and the acid storage from the 0.2m layer of this was estimated to be equivalent to 56 tonnes H<sub>2</sub>SO<sub>4</sub>/ha (not shown in Figure 11).

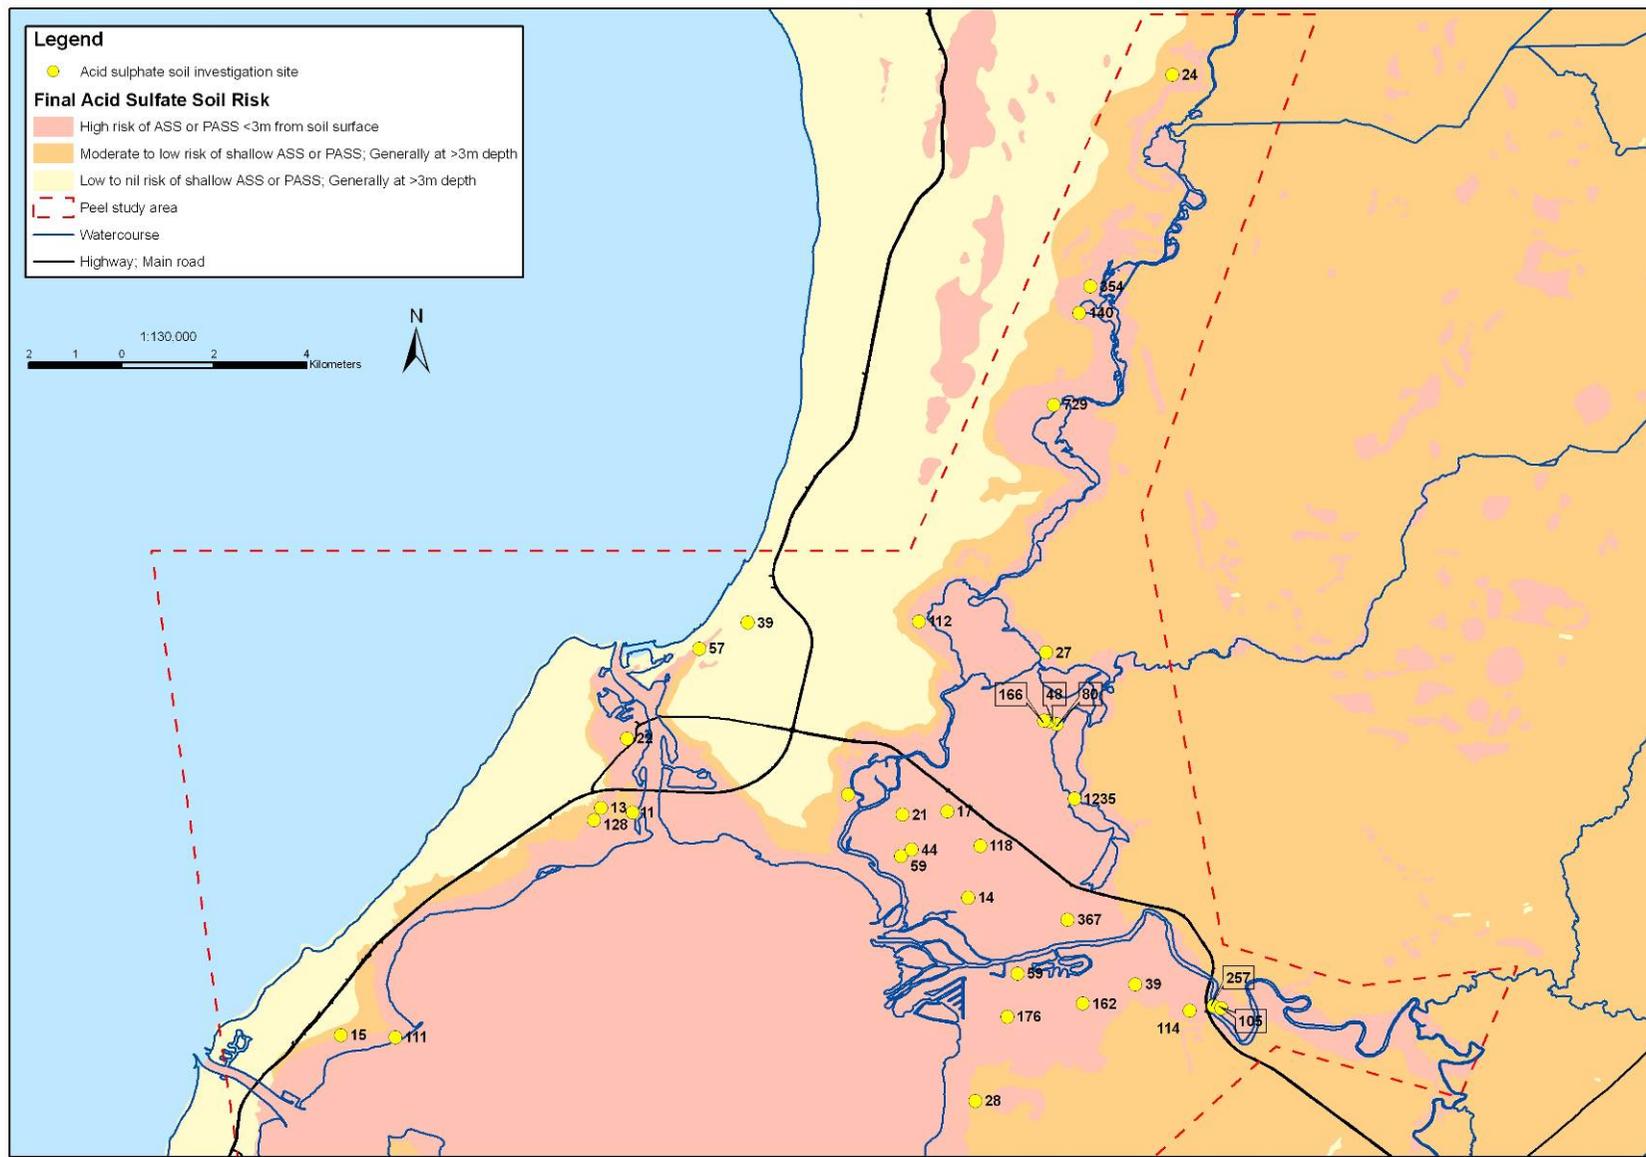
Figure 12: Estimated storage of potential acidity (tonnes  $H_2SO_4/ha$ ) within the surface 1m of shallow PASS materials encountered at Acid Sulphate Soil investigation sites in

superficial sediments around the Peel Inlet, Serpentine River and Murray River. Note: map not displayed to scale.

Greatest concentrations of acid storage generally occurred in superficial sediments closest to the estuary or rivers draining to the estuary (Figure 12, Figure 13), however were not limited to these landscapes. Significant shallow storage of potential acidity occurred in the floodplains of the Serpentine River (between 354 up to 1235 tonnes  $\text{H}_2\text{SO}_4/\text{ha}$ ), floodplain terraces of the Murray River (257 – 367 tonnes  $\text{H}_2\text{SO}_4/\text{ha}$ ) and low lying wetlands and dunes immediately adjoining the Peel-Harvey estuary (e.g. Robert Bay, Falcon Point and north of Island Point). Storage of more than 100 tonnes  $\text{H}_2\text{SO}_4/\text{ha}$  also could occur in superficial sediments adjoining wetlands some distance from the estuary, including Lake Mealup (at least 156 tonnes  $\text{H}_2\text{SO}_4/\text{ha}$ ), Lake McLarty (at least 128 tonnes  $\text{H}_2\text{SO}_4/\text{ha}$ ) and the Barragup Swamp (at least 118 tonnes  $\text{H}_2\text{SO}_4/\text{ha}$ ). Given that these assessments are based on cores not taken within the sediments of the wetlands it was likely that much greater acid storage occurred in these environments. Acid storage in many low-lying areas without obvious wetland features and not adjoining the estuary was generally between 10 and 100 tonnes  $\text{H}_2\text{SO}_4/\text{ha}$  (Figure 12 and Figure 13).

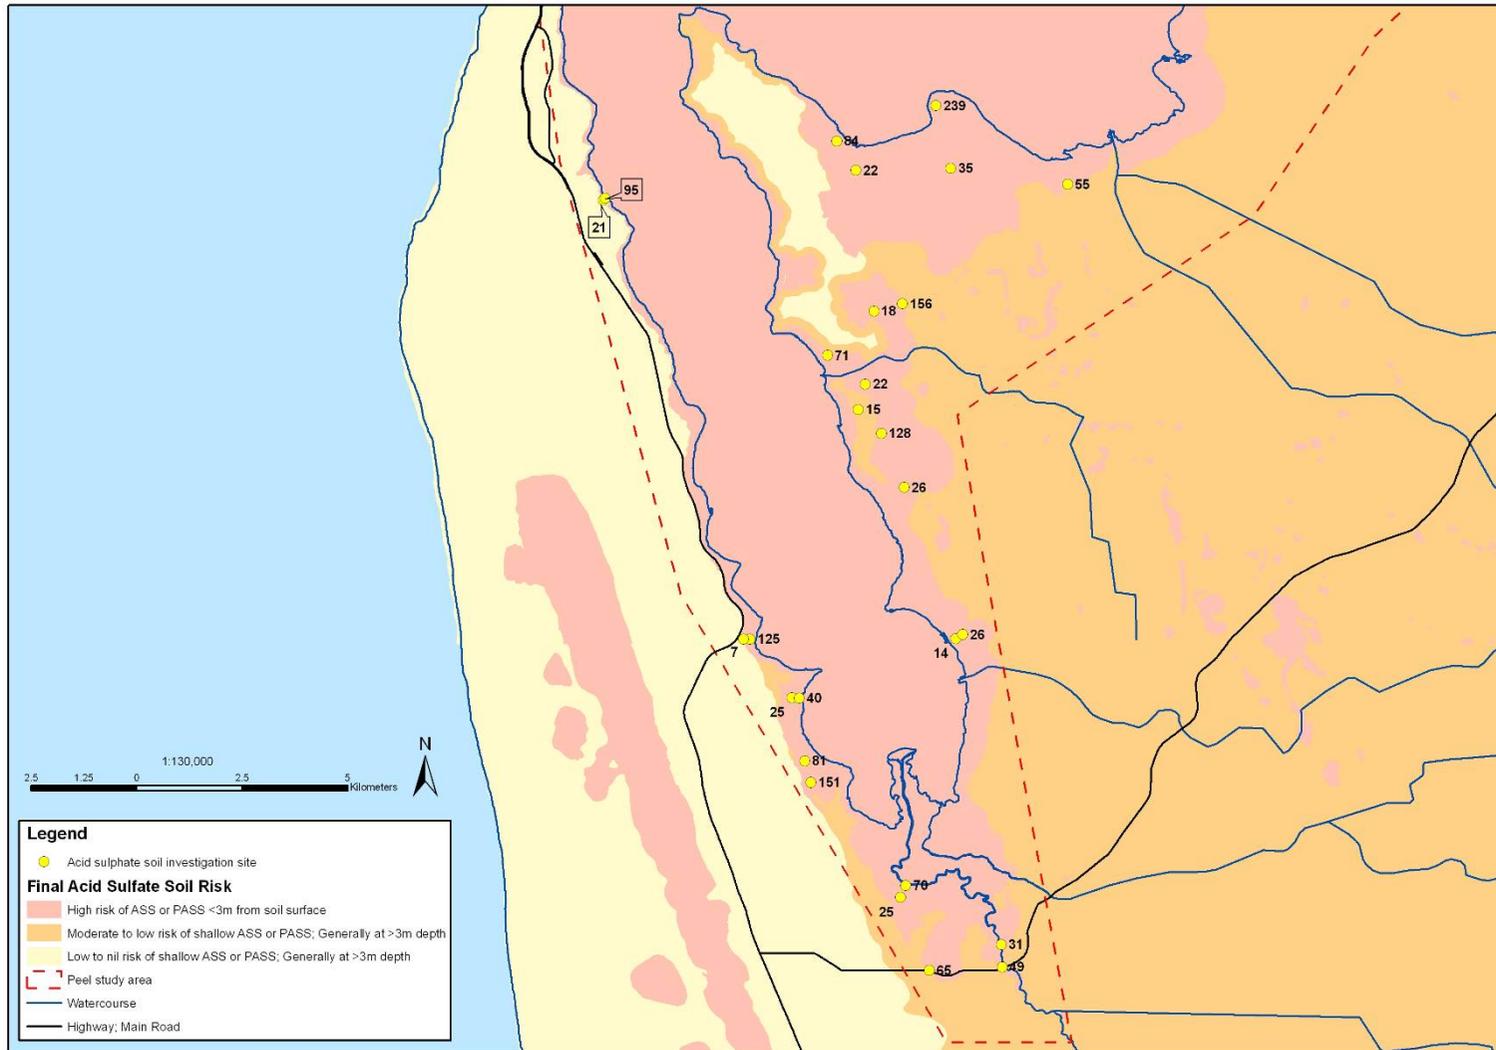
Figure 13: Estimated storage of potential acidity (tonnes  $H_2SO_4/ha$ ) within the surface 1 m of shallow PASS materials encountered at Acid Sulfate Soil investigation sites in superficial sediments around the SE Peel Inlet, Harvey Inlet and Harvey River. Note: map not displayed to scale.

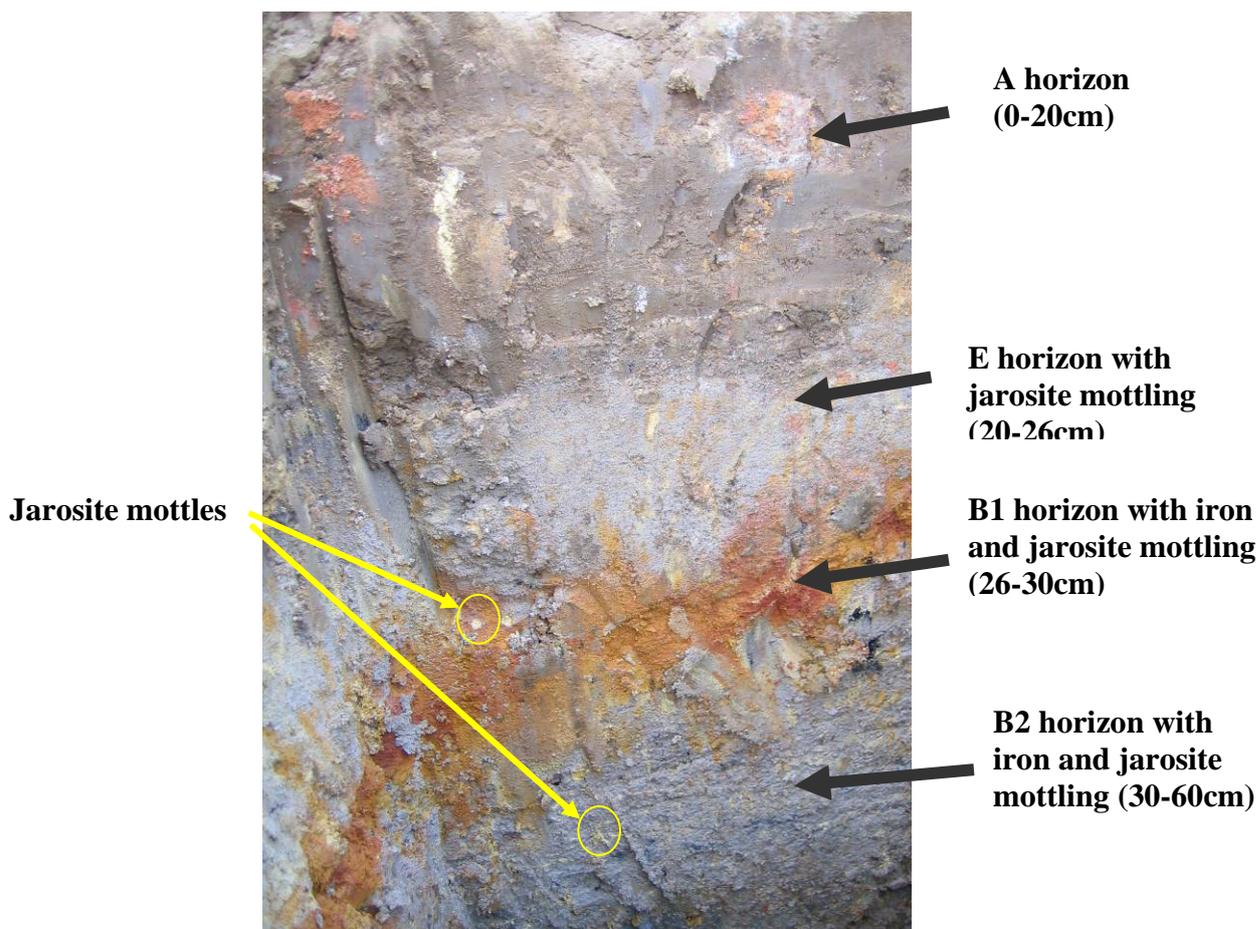
Figure 14: Jarosite evident as pale yellow mottling (Munsell Colour 2.5Y 8/3) within an actual ASS profile in South Yunderup site 411f

Visible pale yellow mottling (Munsell Colour 2.5Y-5Y 8/3-8/6) indicative of jarosite formation (Figure 14) and field pH less than 4 indicated the presence of actual ASS materials in five profiles. These profiles were Lake Amarillo site 426a, Black Lake site 406j, South Yunderup profiles 411f and 410c and Austin Bay profile 322a (Table 1). Except for sites 406j and 410c (where no laboratory data was available), this was corroborated  $\text{pH}_{\text{KCl}}$  being less than 4.5, significant actual acidity (determined by TAA) and acid soluble sulfate minerals (indicated by  $\%S_{\text{nas}}$ ; Table 1). Actual acidity in these horizons exceeded
