Department of  
Environment and Conservation

# ACID SULFATE SOIL SURVEY

## SUPERFICIAL GEOLOGICAL SEDIMENTS ADJACENT TO THE PEEL-HARVEY ESTUARY

SEPTEMBER 2009

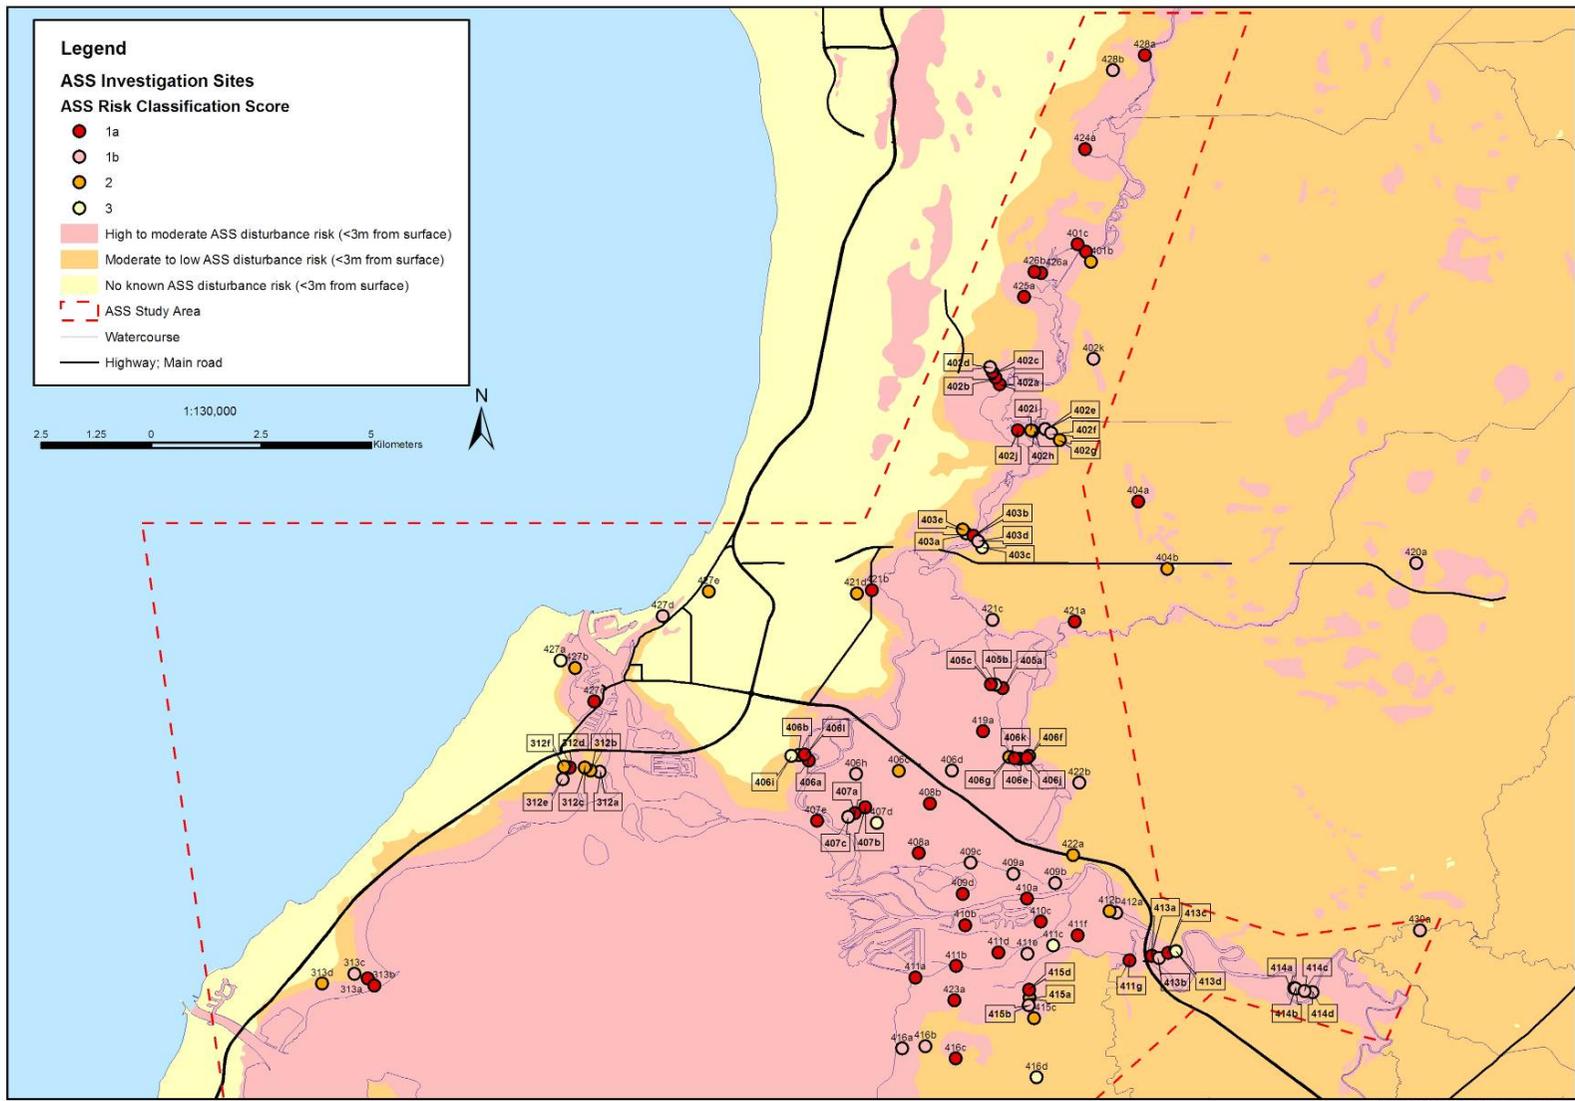
Figure 15: Mapping of high risk of potential Acid Sulfate Soil materials occurring within the superficial sediments (<3 mbgl) surrounding the Peel Inlet, Serpentine River and Murray River and classification of ASS disturbance risk for the superficial formations at various sites (see Appendix 2 for details on risk classification).

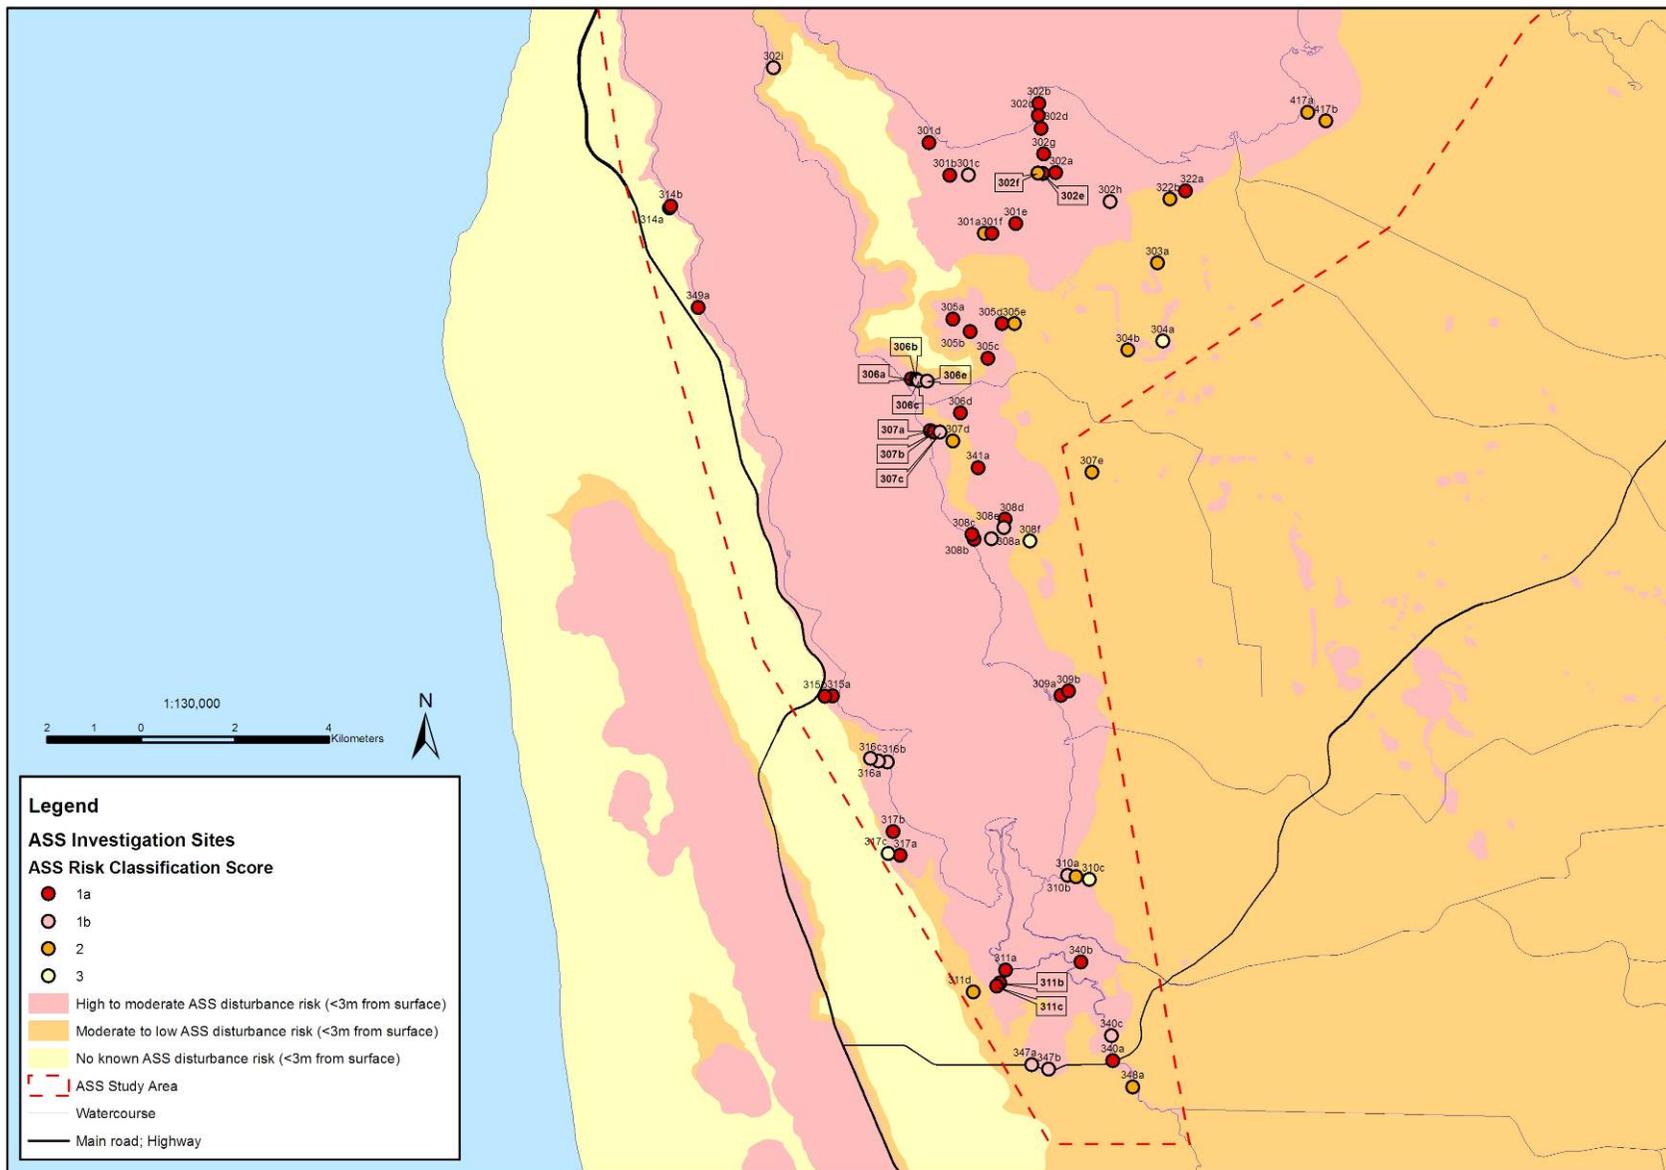
Figure 16: Mapping of high risk of potential Acid Sulfate Soil materials occurring within the superficial sediments (<3mbgl) surrounding the SE Peel Inlet, Harvey Inlet and Harvey Rive and classification of ASS disturbance risk for the superficial formations at various sites (see Appendix 2 for details on risk classification).

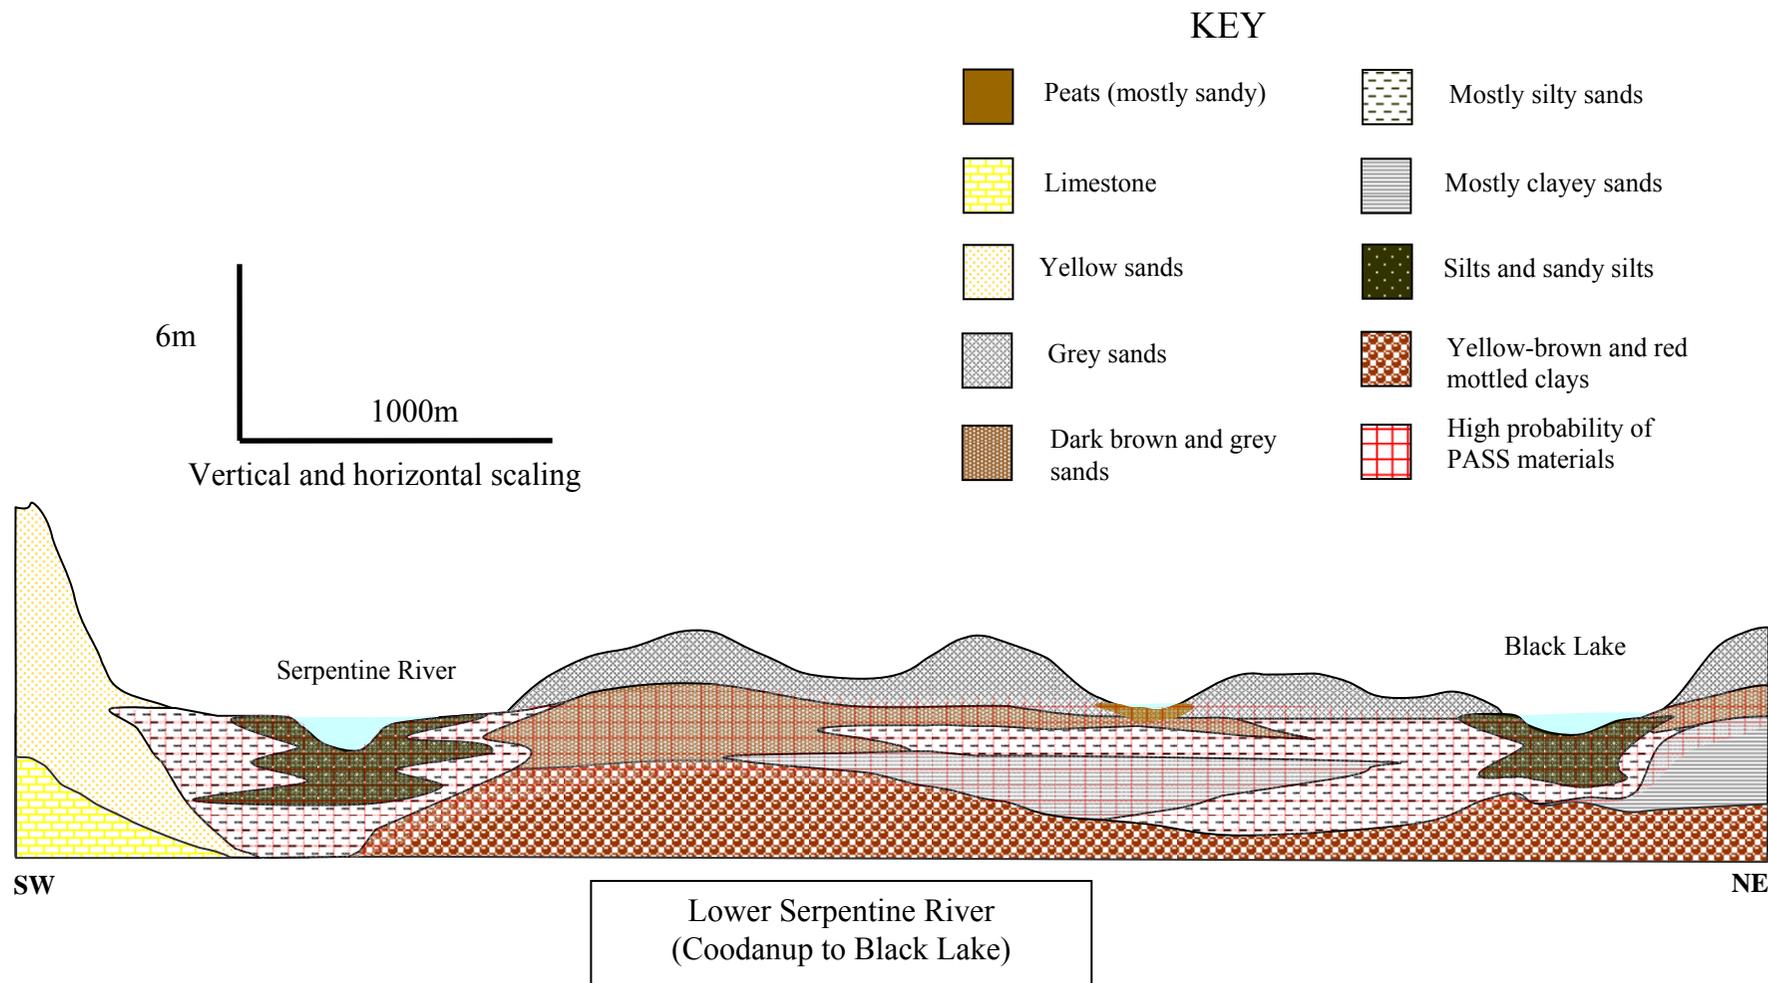
Figure 17: Schematic landscape cross-section illustrating occurrence of PASS materials in relation to landscape position and dominant lithology in the lower Serpentine River area (representing the landscape from Coodanup to Black Lake).

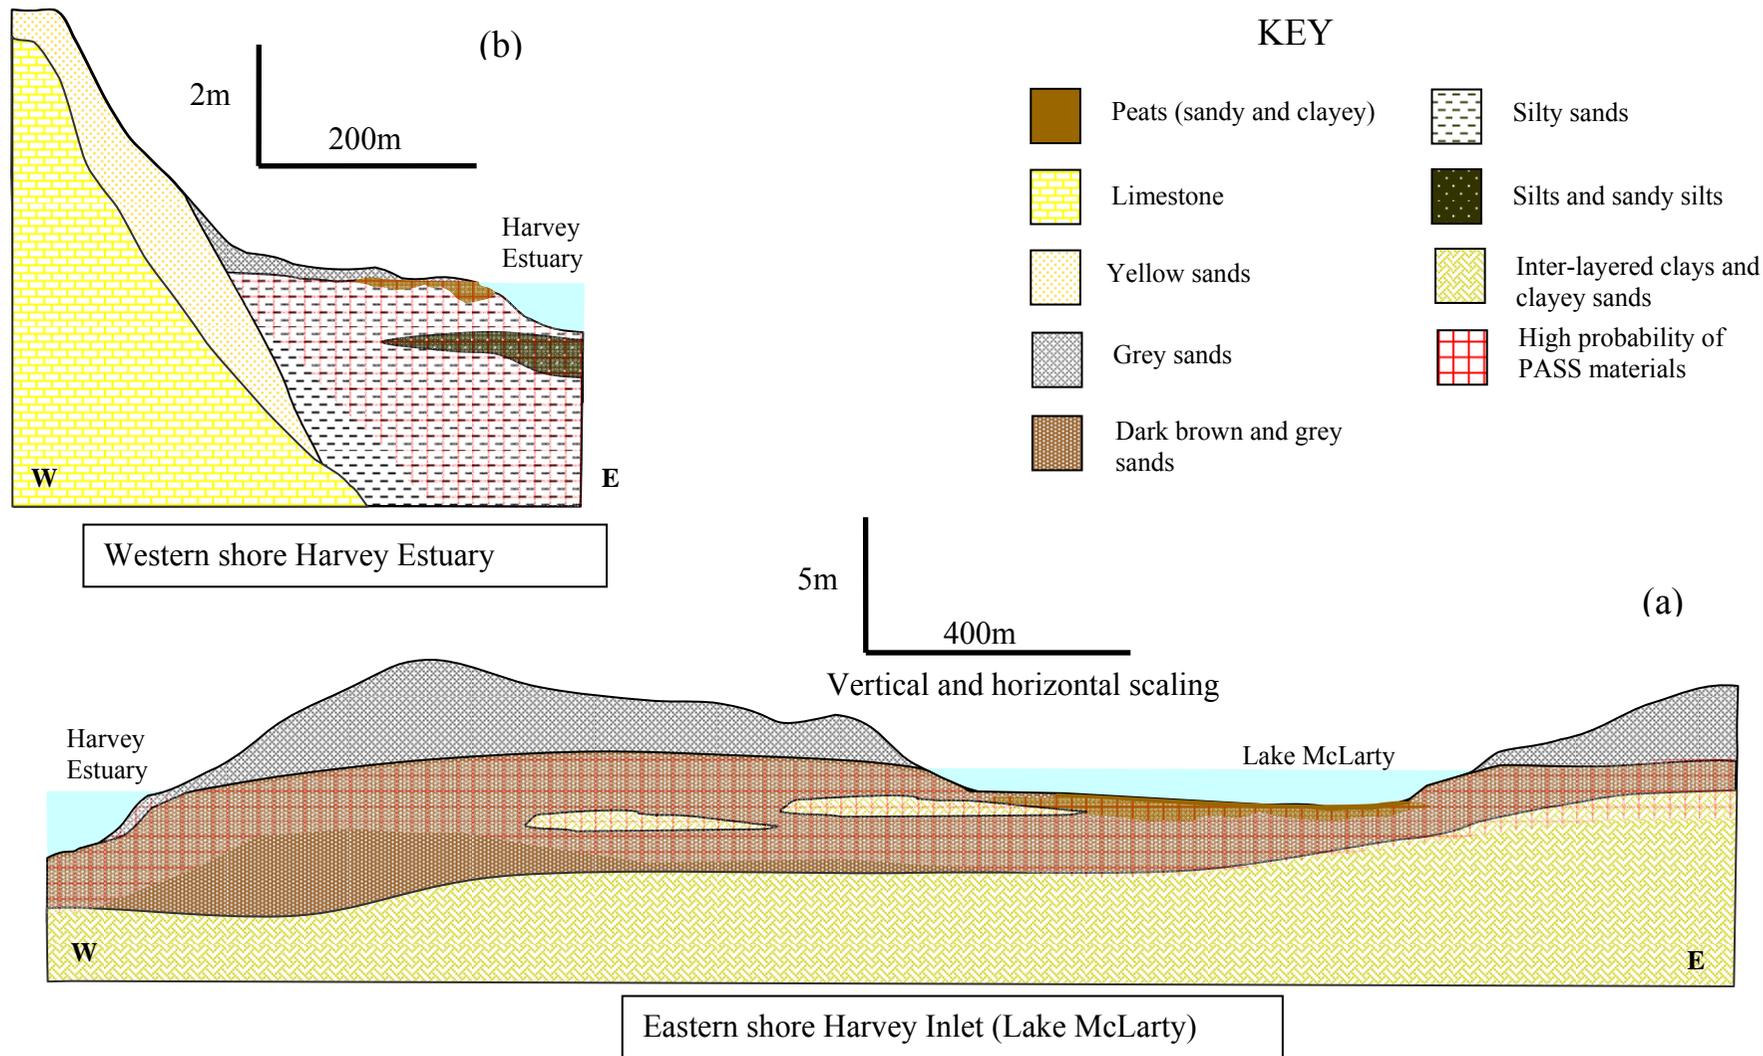
Figure 18: Schematic landscape cross-sections illustrating occurrence of PASS materials in relation to landscape position and dominant lithology for the (a) the eastern margin of the Harvey Estuary and (b) western margin of the Harvey Inlet near Lake McLarty.
