Assessment of ecological health and environmental water provisions in the Logue Brook

February to May 2011

Water Science
technical series

Report no. WST 43
May 2012

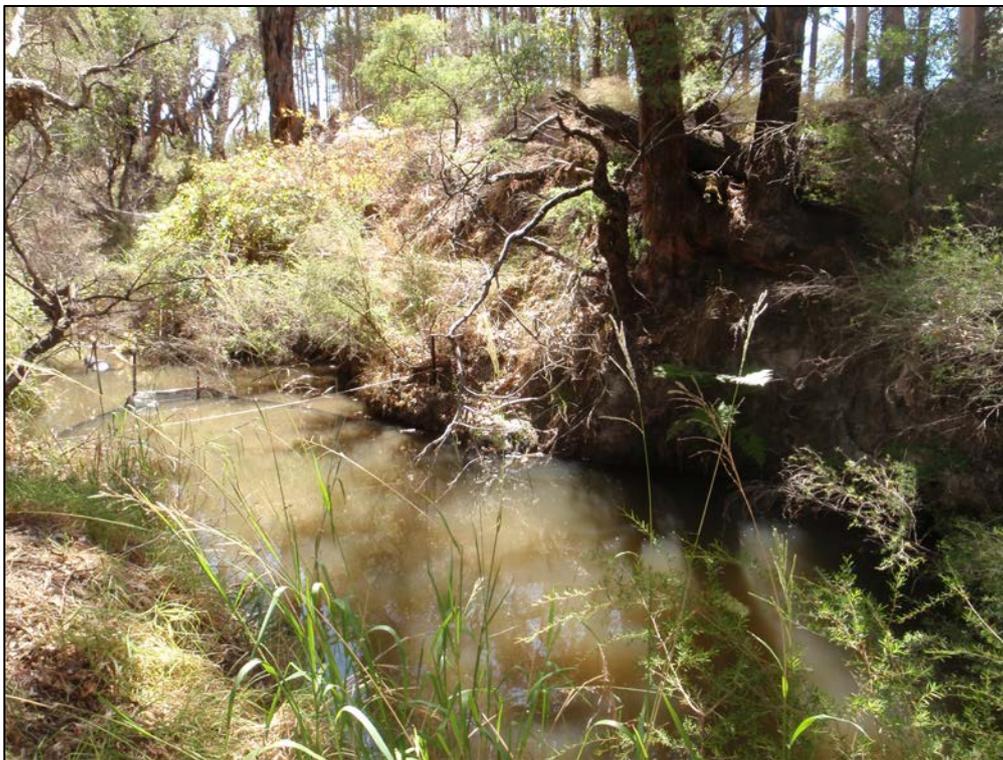
Figure 6 Lowland site (pool) (with fyke net visible)

The lowland pool site was located approximately 7 km downstream from the dam wall on privately owned land. The adjacent land use is agriculture, including a dairy farm immediately upstream. The site comprised a sequence of riffles, a deep pool (approximately 2 m deep) and a run. The site was located on a flat plain with a deeply incised watercourse forming steep banks. The channel was sparsely vegetated with river red gum and other eucalyptus trees, and a limited understorey of tea tree bushes, swamp paperbark and exotic weeds (including blackberry and grass) (Figure 6). Adjacent to the riparian zone (at the top of the banks) the vegetation comprised a blue gum plantation on the right bank and a stand of sheoaks on the left bank.

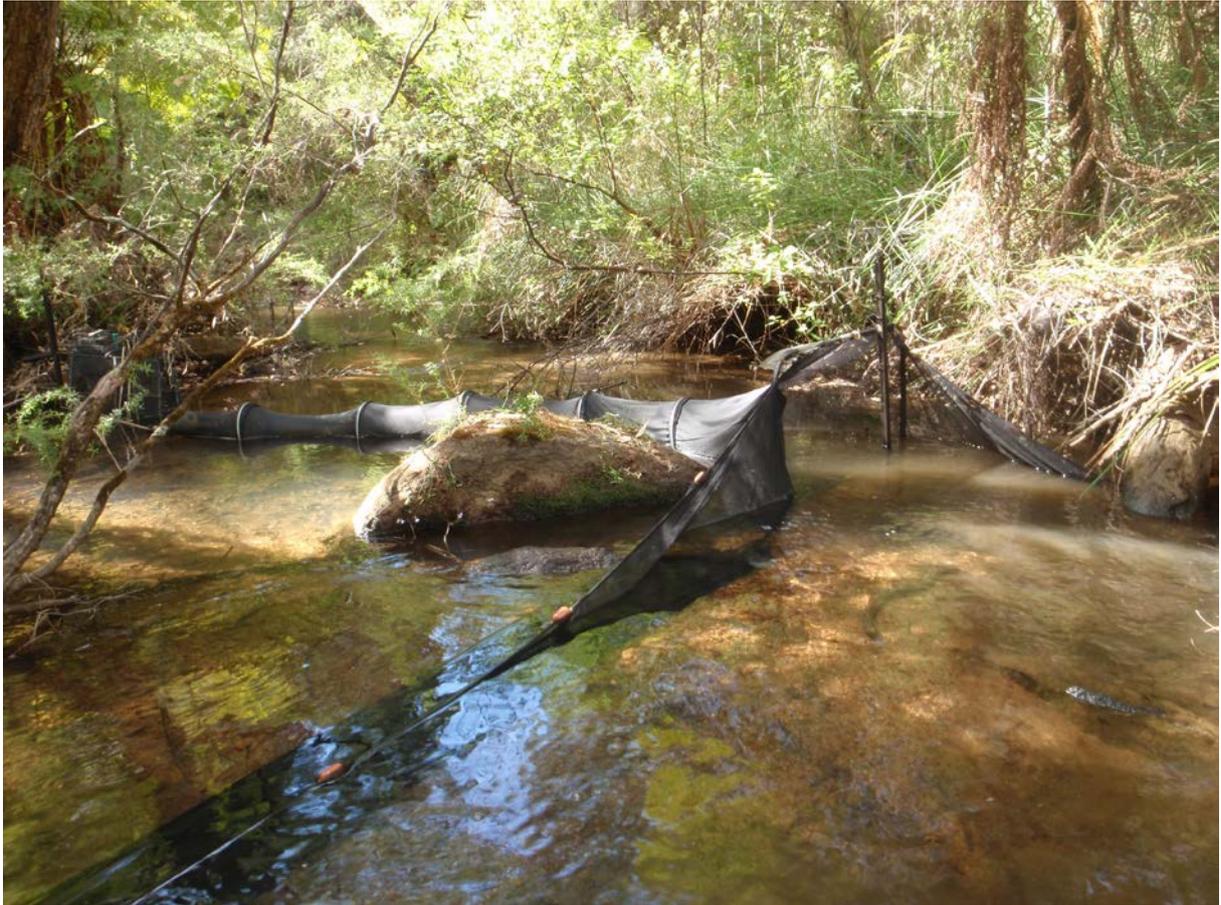
Figure 7 *Fyke net (deployed at the upland pool site)*

Sampling was conducted once per month between February and May 2011 (on 14–15 February, 14–15 March, 11–12 April and 9–10 May 2011). On each sampling occasion fyke nets and box traps (Figure 7 and Figure 8) were deployed for a 24-hour period under the conditions outlined in Table 4.
