Drain batter erosion trial at Wubin

Report No. SLUI 50

May 2009

NM Cox & SF Tetlow

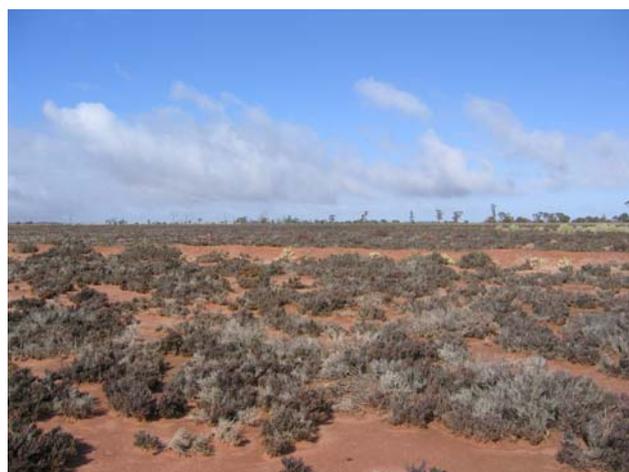
Figure 2 The Wubin drain batter trial site

The site is very flat, with gradients less than 0.1% (1:1000) and severely affected by dryland salinity. All evidence of the previous agricultural land use has disappeared and the land is colonised by halophytes (Fig. 2).

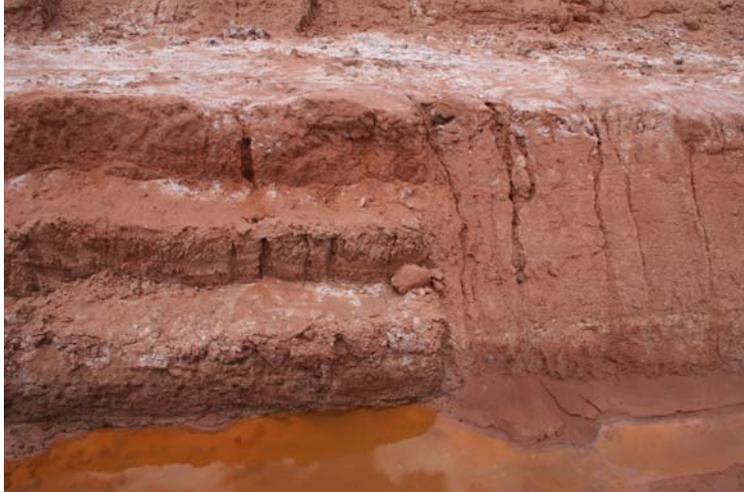
Figure 4 Sheet, rill and tunnel erosion were visible on all of the drain batters

The soils at the trial site are saline, sodic and subject to high rates of slaking and dispersion. In some parts of the drain this led to rapid erosion, largely with raindrop impact and runoff from the adjacent drain structures. Raindrop impact caused sheet erosion over the entire drain structure and runoff from the berms resulted in rill and tunnel erosion of the batters (Fig. 4).

Subsoils consist of uniformly distributed medium textured grey clay, mottled from 20–60% with red-brown sandy clay loam and cemented nodules. The groundwater that seeped through this clay profile was acidic and appeared rich in dissolved metals such as iron (Fig. 4).

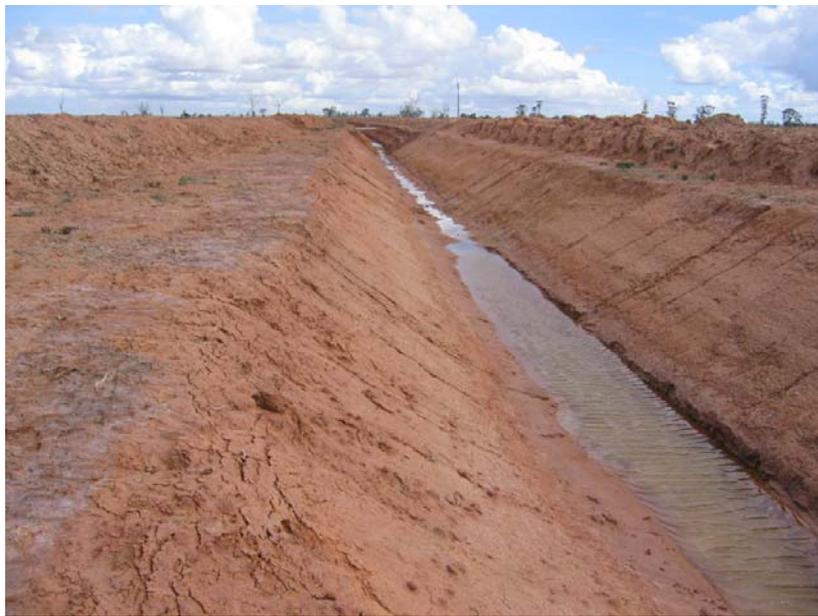
Figure 7 Treatment 3 (foreground) changing to treatment 2 (background) with the 4-m wide berm on the left side of the channel

Runoff within the drain structure, especially from the sides of the levees, can erode batters directly into the channel. To investigate ways of mitigating this runoff, treatments were designed with 1- and 4-m berm widths (Figs 6 & 7). For treatments in replicates 1 and 2, the 4-m wide berm is on the eastern side and in replicate 3 on the western side of the channel.

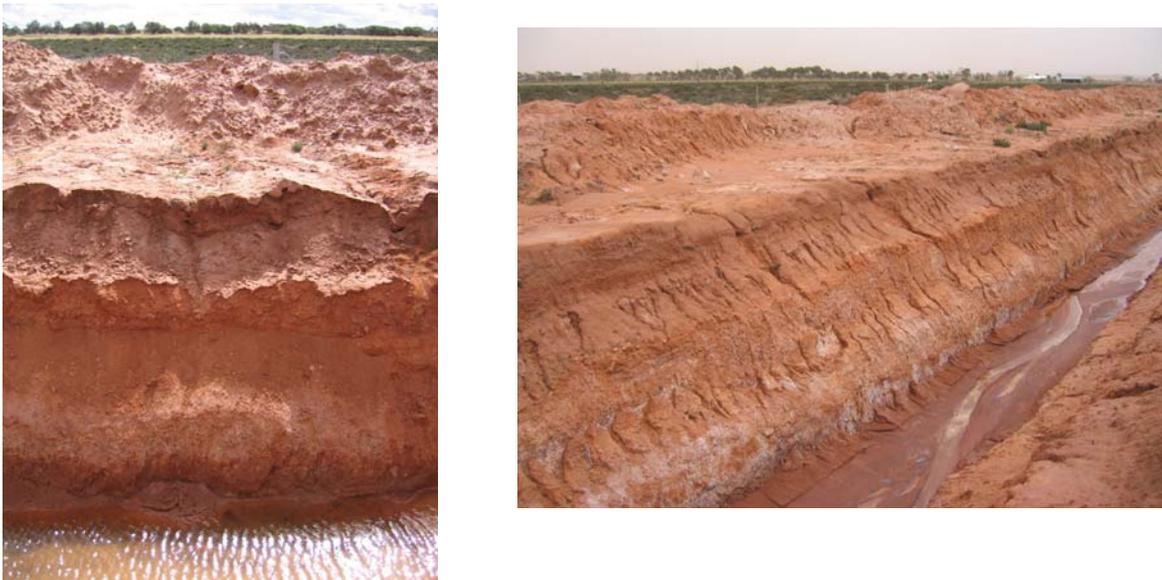
Figure 14 The step batter breaking down but holding the eroded material on the benches

The survey data showed that the step batter eroded least and accumulated the least soil within its channel floor, which suggests that it was the most stable design. Yet field observations and photographic monitoring contradict this. Generally, the step batter is the most unstable design and the reason this has not been captured by this evaluation is that most of the eroded soil has remained on the benches above the drain floor (Fig. 14) so the CSA of the batters has not decreased.

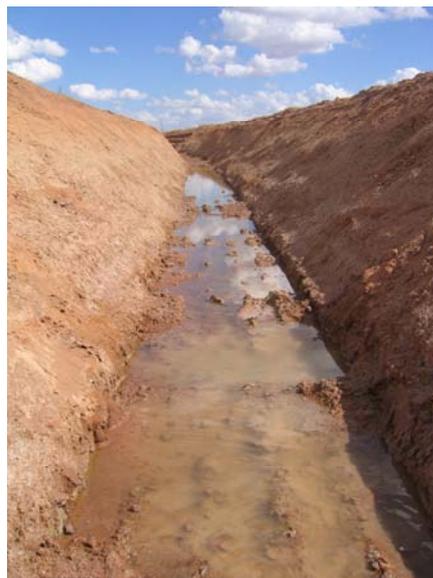
Figure 15 This section of treatment 3 channel has remained very stable throughout the trial

This being the case, both the survey results above and photographic record show that the 1:1 batter drain (treatment 3) is the most stable (Fig. 15). A close inspection of the surface of treatment 3 batters reveals that soil detached from the surface is less likely to be shed from this flatter batter to the drain floor.

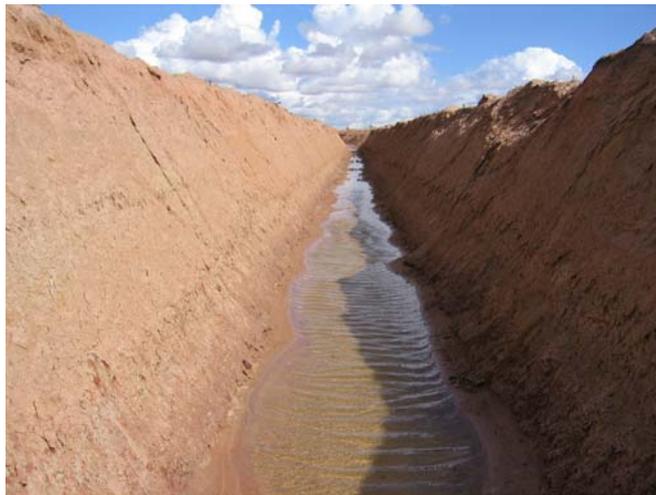
Figure 16 A section of treatment 1 channel with limited erosion at the 3rd survey

The steeper batters of treatment 1 also have less detached soil than the stepped batters of treatment 2 so treatment 1 is the second most stable design (Fig. 16). Treatment 1 batters do not have the sharp 90° protrusions at the edge of each bench that predispose the stepped batters to erosion. The overall length of the batter slope in treatment 1 is 2.2 m from top to bottom, compared with 3.3 m for treatment 2. These contributing factors tend to support the photographs that show the smooth short batters of treatment 1 are less likely to erode than step batters.

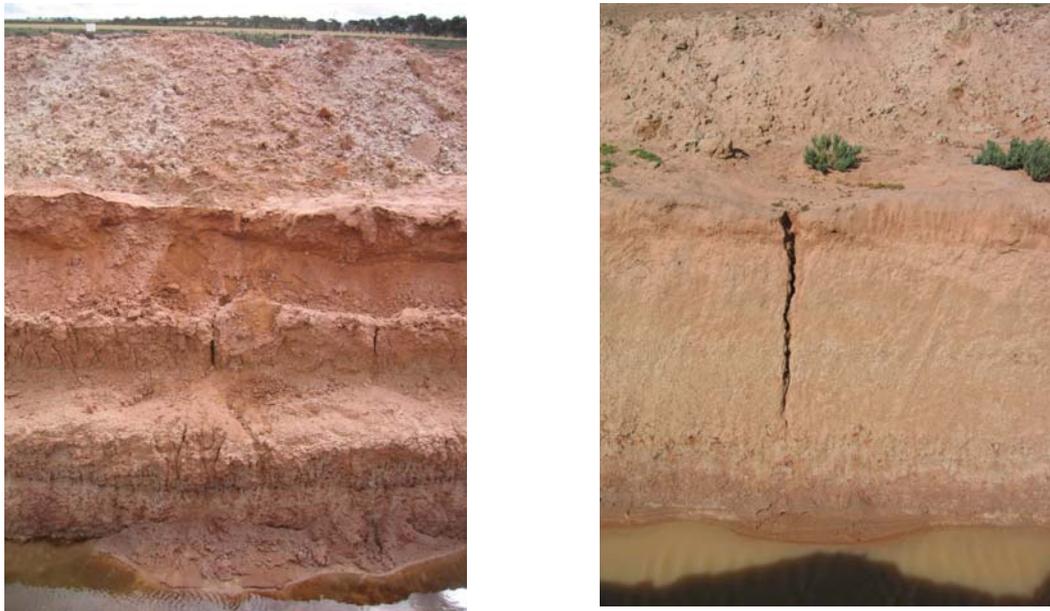
Figure 18 Eroded soil from the levee bank is easily transported across the narrow berm into the drain channel

The soil accumulated on the wide berms probably eroded from the levee banks (WBL). The eroded material from the levee banks at the narrow berms (NBL) did not accumulate on the berms, and was more easily transported directly into the drain channel. This is evident along some sections of the drains where small gullies have been formed, connecting the toe of the levee banks with the drain batters (Fig. 18).

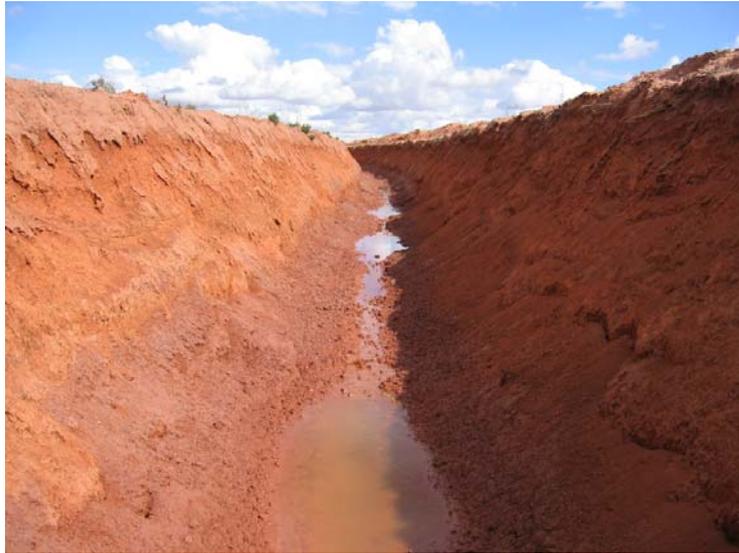
Figure 19 The crumbling batters of treatment 1 in replicate 2

Raindrop impact and runoff were not the sole contributors to batter erosion. Due to the high soil salinity, the process of wetting and drying caused the surface soil to break away (Fig. 19), and soil to readily fall onto the channel floor from the steeper batter slopes of treatments 1 and 2.
