## FORESHORE ASSESSMENT IN THE JANE BROOK CATCHMENT

Water and Rivers Commission Report No. WRM 18 2001

# Foreshore assessment in the Jane Brook Catchment

# Prepared by Nicole Siemon Ecosystem Management Services

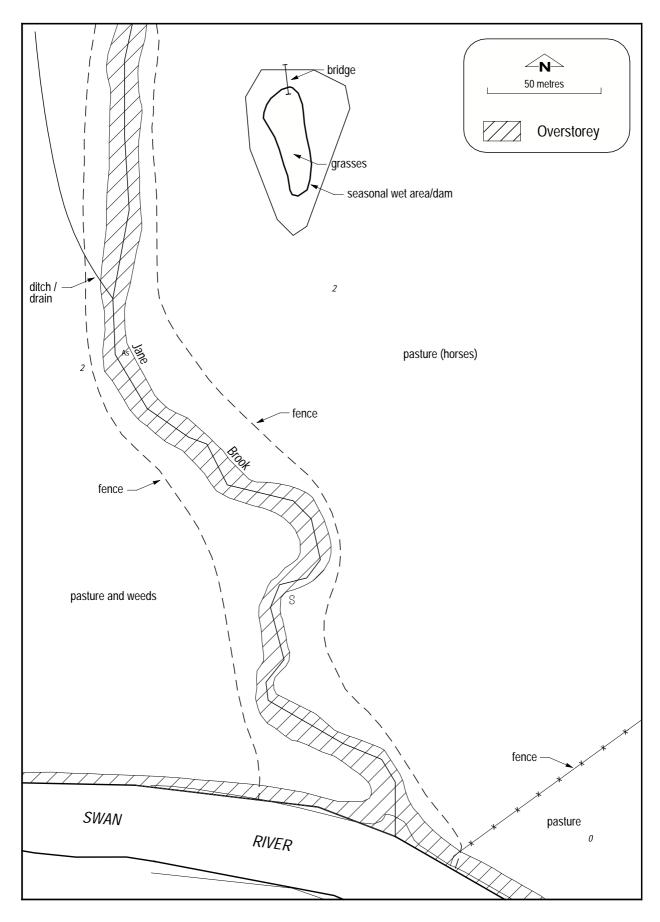
Jane Brook - Reid Highway Site 1 - Map 1

Vegetation: The riparian vegetation has been reduced to a very narrow strip, comprising only native overstorey and weed understorey species, with no significant middlestorey vegetation observed. The overstorey cover is continuous and dominated by frequent *Eucalyptus rudis* (Flooded Gum) and *Melaleuca rhaphiophylla* (Swamp Paperbark). *E. wandoo* (Wandoo) and *Acacia saligna* (Coojong) are present but are uncommon. There is little or no regeneration of any of these species. The understorey is continuous and is exclusively composed of weed species, in particular annual grasses and pasture

- Undertake soft engineering works on the most severe areas of erosion in accordance with suggested strategies provided in Appendix 4.
- Encourage the Water and Rivers Commission to investigate the hydrology of the brook, and develop strategies to protect the powerbends from increased degradation occurring during peak flow events.

- Increase the extent and diversity of fringing vegetation using appropriate species recommended in Appendix 3.
- Increase the extent of fringing vegetation, using plant species representative of all levels of the vegetative complex (Appendix 3) to protect the remaining remnants from dying out.

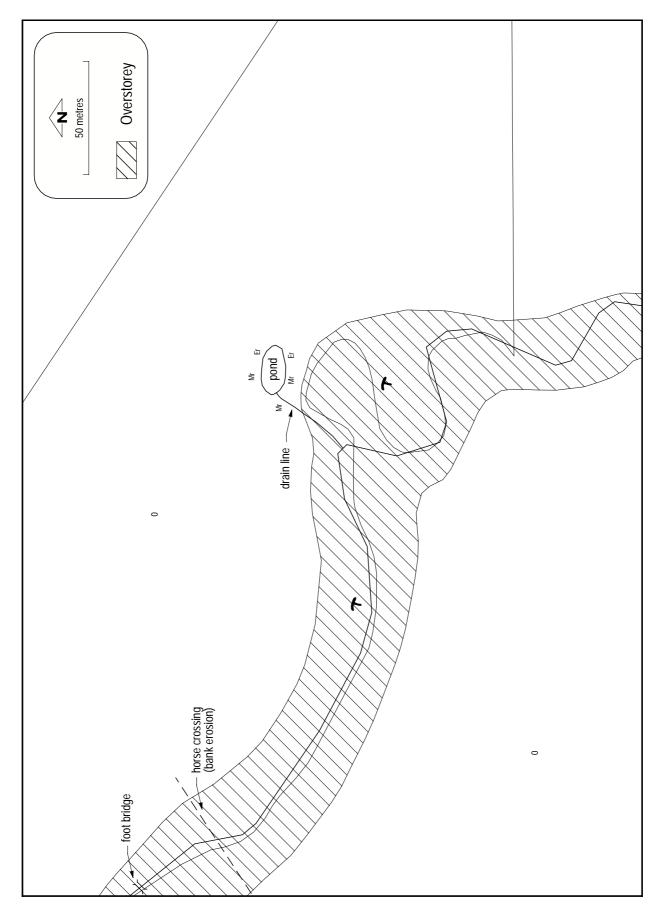
Jane Brook - West of Great Northern Highway Site 2 - Map 1

**Other issues:** Grazing, although helping control the spread of Watsonia, is preventing natural regeneration of native plants. There are a number of stock access and crossing points within the foreshore area. Small amounts of rubbish were also observed along the survey section.

- Repeatedly brushcut Watsonia, Phalaris, Paspalum and Soursob prior to flowering to enable a measure of control and reduce the fire hazard.
- Work to undertake revegetation within the main channel of the brook using native rushes and sedges, ensuring that any plantings are pegged into the substrate to protect them from being washed away in peak flows.

- Focus on controlling the Watsonia once stock grazing is minimised.
- Investigate the source of rubbish and control influx if possible.
- Encourage landholders to become more actively involved in foreshore management to achieve conservation purposes.

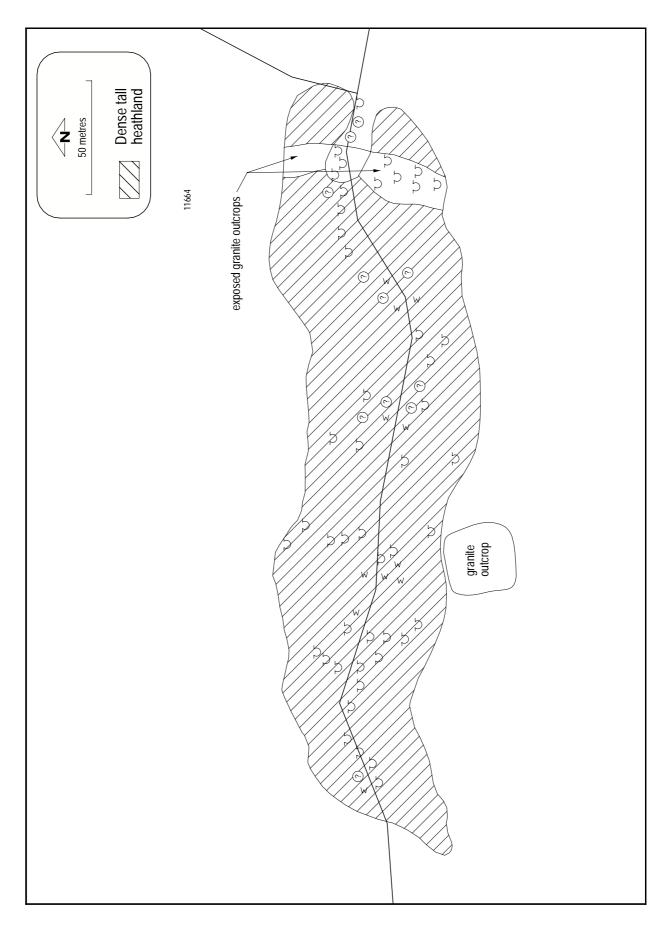
Strelley Brook - Toodyay Road Site 4 - Map 1

Honeypot) and *Darwinia citriodora* (Lemon-scented Darwinia). There are also occasional occurrences of *Acacia alata* (Winged Wattle). Understorey species present include *Alexgeorgea arenicola*, *Borya sphaerocephala* and *Corynotheca micrantha* (Net Bush). Four weed species were noted during the survey. These are African Feather Grass (*Pennisetum macrourum*), Watsonia (*Watsonia bulbillifera*), Medics (*Medicago* spp.) and a small herbaceous species with pink flowers. It is possible that there are other annuals present which were not apparent during the survey.

Other issues: Litter was present close to Toodyay Road and there are occasional tyres, drink cans and other debris instream along the length of the stream. There was evidence of a reasonably recent burn. There are a number of walk trails and fire access tracks that have not been aligned across the contours. These are eroding in some areas.

- Liaise with the landowner and local government authority to ensure that any prescribed burns (if used in this area) are undertaken in a mosaic pattern to provide sufficient cover and habitat for fauna while the vegetation is regenerating.

- Remove tyres and other rubbish dumped instream, being careful not to trample vegetation.

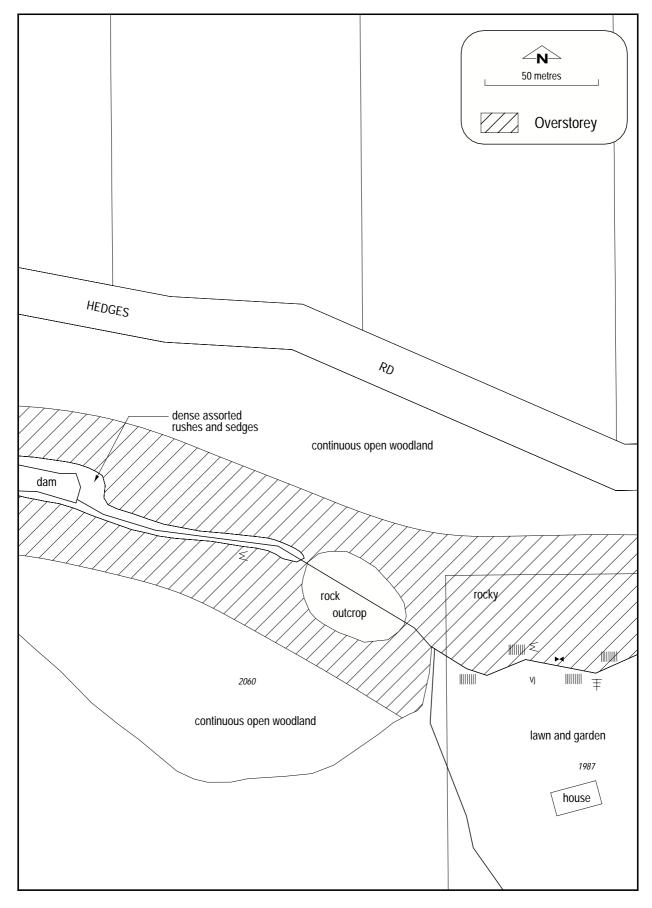
Mahogany Creek Site 5 - Map 1

Bank stability: The banks of Mahogany Creek in this section (Site 5) are in relatively good condition, with only localised areas of erosion and sedimentation observed. The extent of bank affected by slumping is minimal. The most severe area of erosion is within the road reserve, which crosses the creek in the central part of the site. This point appears to have been used as a crossing area but does not possess a culvert or similar device to limit potential erosion. The eastern end of the section has the facility for stocking, but contains no fencing to prevent stock access to the creek.

Common native species include Agonis linearifolia (Swamp Peppermint), Hakea undulata (Wavy Leaved Hakea), Trymalium ledifolium and Xanthorrhoea preissii (Grass Tree). The species list for the middlestorey is quite extensive. Native species are also well represented in the understorey, comprising up to 90% of species present. The most frequent understorey species noted during this survey included Andersonia lehmanniana, Cryptandra arbutiflora (Waxy Cryptandra), Dryandra nivea (Couch Honeypot), Grevillea bipinnatifida (Native Fuchsia), Baeckea camphorosmae (Camphor Myrtle), Hibbertia spicata (Yellow Buttercups), Hovea chorizemifolia (Holly-Leaved Hovea), Leucopogon sp. (Bearded Heath), Pimelea sp., Petrophile stricta and Dampiera alata. There are also a number of species of rushes and sedges within the creek, which also occur in the dam at the western end of the Weeds within the understorey include section. occasional occurrences of Watsonia (Watsonia bulbillifera), and a few occurrences of Bridal Creeper (Asparagus asparagoides), Soursob (Oxalis pescaprae), Shivery Grass (Briza minor) and Kikuyu (Pennisetum clandestinum). Although present throughout the section, the weeds become more frequent towards the eastern end.

- Work to increase the extent of fringing vegetation on the southern bank at the east end of the section and fence off from the grazing paddock using appropriate native species listed in Appendix 3.
- Encourage the neighbouring landholders to also manage their gardens so the integrity of the remaining riparian vegetation is not threatened particularly in relation to the non-native wattles.
- Inform the landholder of the benefits of improving and maintaining foreshore health. Controlling weeds reduces the fire hazard and minimises the potential future expense of controlling highly invasive weeds such as Watsonia.

- Encourage landowners to replace ornamental, exotic gardens with native species in particular along areas fringing the foreshore.
- Protect existing foreshore vegetation from stock, through the use of adequate fencing.
- Retain instream features either in situ, or arrange them so that they do not exacerbate erosion of the banks.
- Protect the foreshore vegetation fringe from degradation pressures, such as grazing.
- Investigate the sources of sediment within the waterways and catchment. Develop strategies to address erosion problems upstream to reduce the current sediment load.
- Develop a fire management plan in conjunction with the Department of Conservation and Land Management, the Shire and the local fire brigade to ensure adequate routes are maintained to protect the area in case of fire.

- Liaise with the local government authority to ensure future subdivisions and residential developments in the area have suitable management systems and infrastructure in place, to prevent degradation of the foreshore and stream environments.
- Approach the Department of Conservation and Land Management to undertake feral animal control to eradicate foxes.
- Liaise with the Department of Conservation and Land Management to determine whether or not they would consider including this area and adjoining bushland in the Western Shield program, if the community offers to advise local residents of the program to ensure protection of their pets.

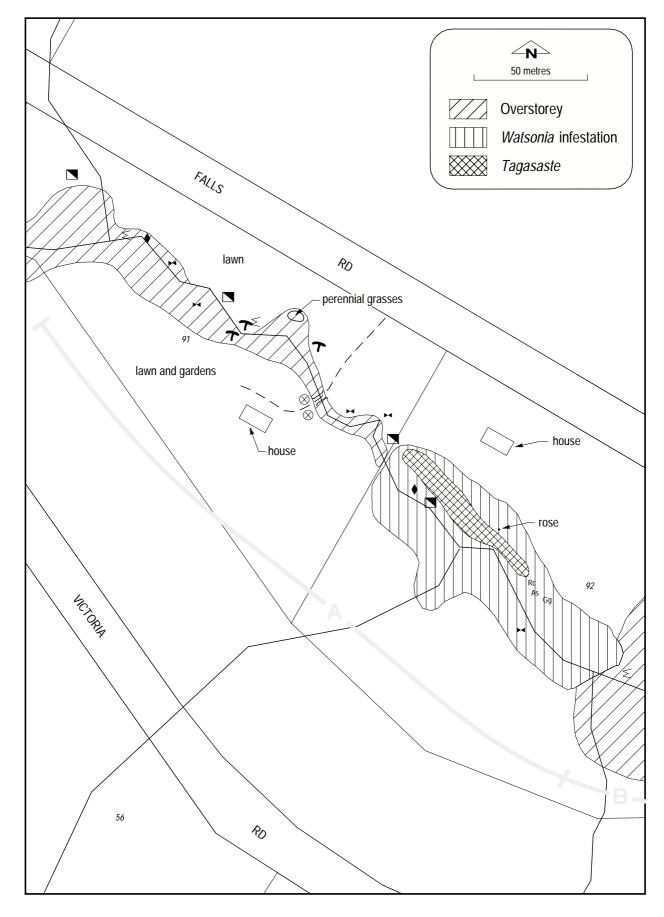
Falls Park Site 6 - Map 1

Other issues: The potential for garden escapes and permeation of fertilisers and grey water entering into the riparian zone is high due to the proximity of residential areas. The impacts of trampling due to recreational use can also be highly disruptive, increasing the possibility of weed encroachment and damage to germinating native seedlings, resulting in a further decline in foreshore vegetation health.

- Remove exotic vegetation, and monitor the level of natural replacement of this vegetation with native fringing or instream vegetation. Should the level of regeneration be minimal, reinforce with tubestock.

- Distribute an information leaflet to local residents encouraging them to become involved in the active management of the creek.
- Rationalise access tracks and commence revegetation works such as brush laying and direct seeding.

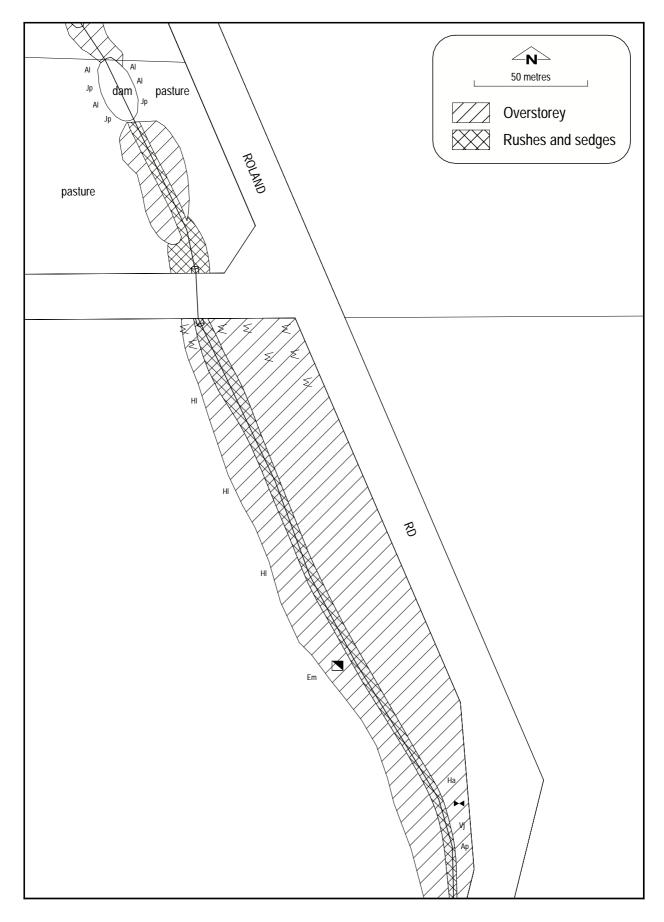
Clutterbuck Creek - Roland Road Site 9 - Map 1

Habitat diversity: The only permanent water within this section of the creek is in the dam. Along the main channel, the water is shallow and slow moving. The water is well filtered by the instream vegetation, and therefore does not show any signs of turbidity. Wildlife observed during the survey included kangaroos, frogs and bandicoots. Paddocks surrounding the area are stocked with sheep. The dense vegetation provides ample protection for fauna movement, reptile and invertebrate basking sites, and nesting and roosting sites for birds. The dense nature of the instream rushes and sedges gives good habitat for frogs.

- Ensure that infrastructures associated with residential developments do not result in degradation of the waterway.
- Maintain the health of the remnant vegetation through implementing stock management and weed control as outlined above.

- Provide new landowners with an information brochure outlining techniques for managing waterways and the benefits of retaining significant levels of native vegetation.
