JERDACUTTUP RIVER ACTION PLAN

WATER AND RIVERS COMMISSION
WATER RESOURCE MANAGEMENT SERIES
REPORT No WRM 43
JUNE 2004

The purpose of this Action Plan is to provide information on the condition of the Jerdacuttup River. The report describes the condition of the river, its vegetation, water quality, channel features, and then provides specific management advice for further works needed to protect the river. In summary, the River Action Plan provides:

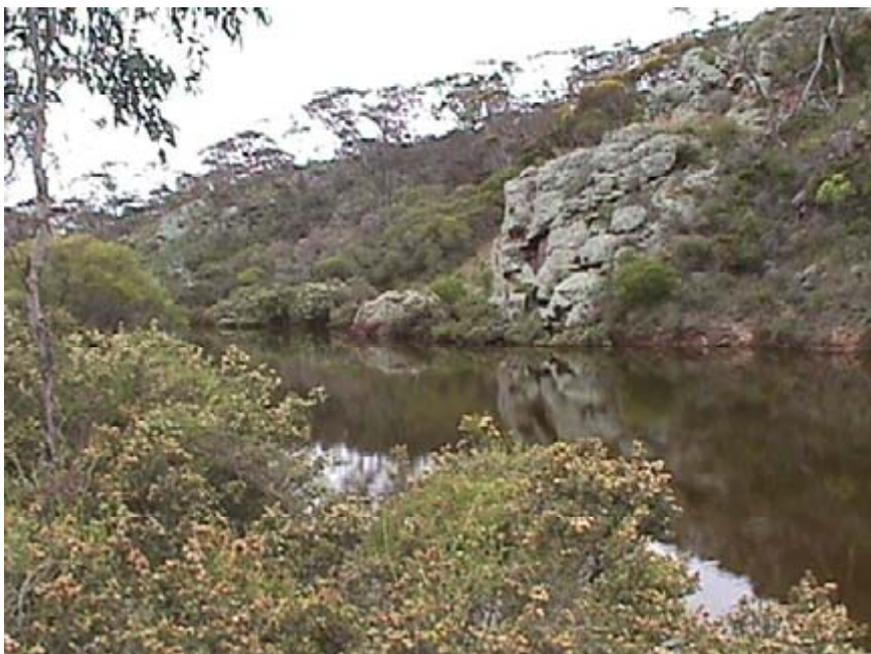
Jerdacuttup River, showing characteristic vegetation of the Ravensthorpe system (photograph Kaylene Parker)

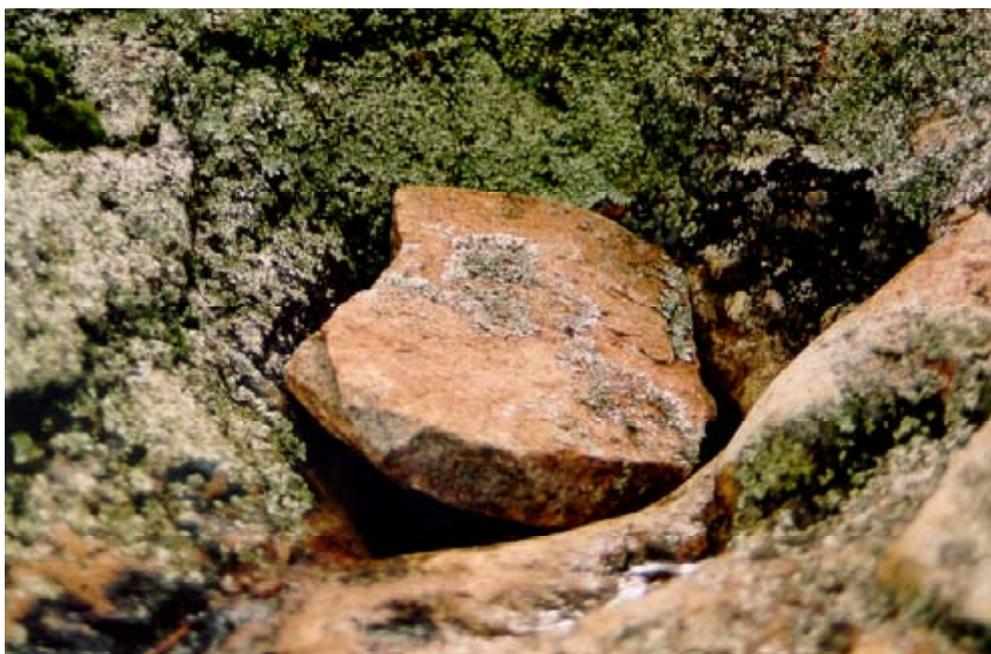
Gnamma hole on the river at the Carlingup Road crossing (photograph Kaylene Parker)

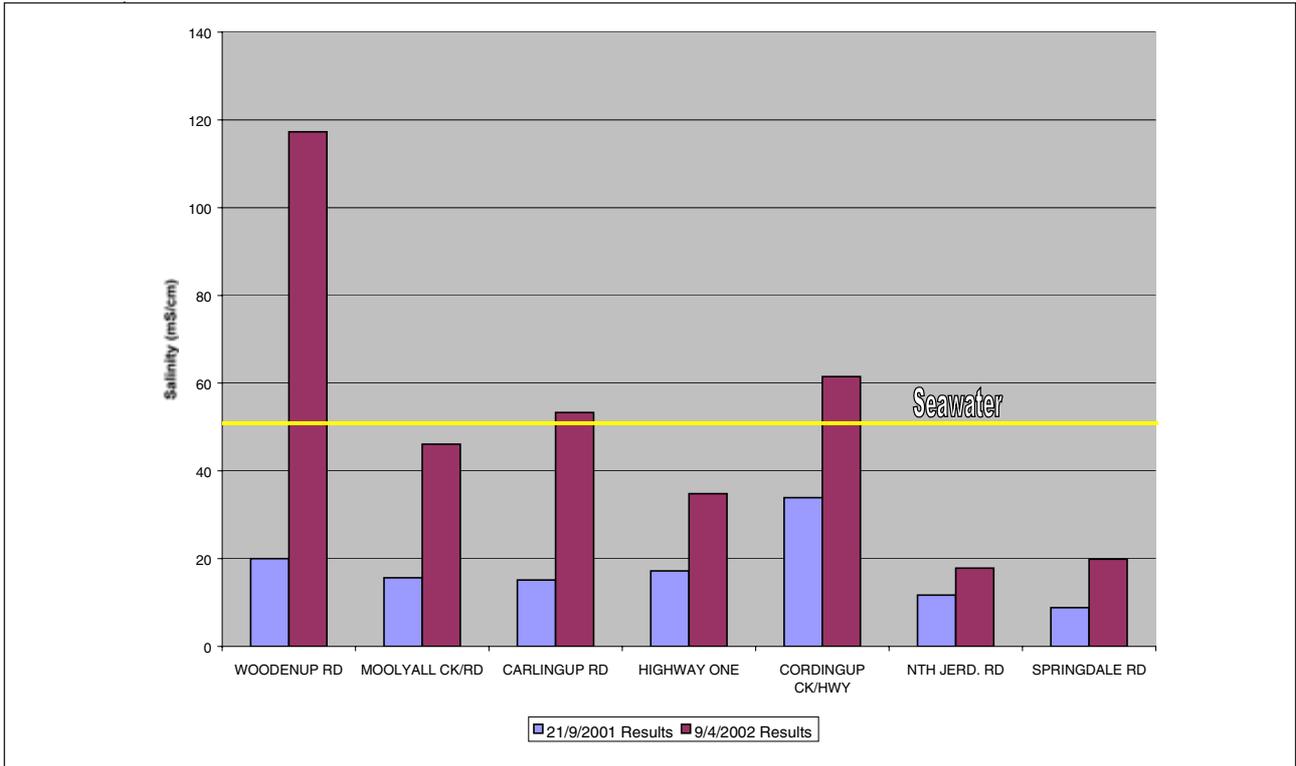
Figure 2. Conductivity levels of the (salinity) Jerdacuttup River and its major tributaries (mS/cm)

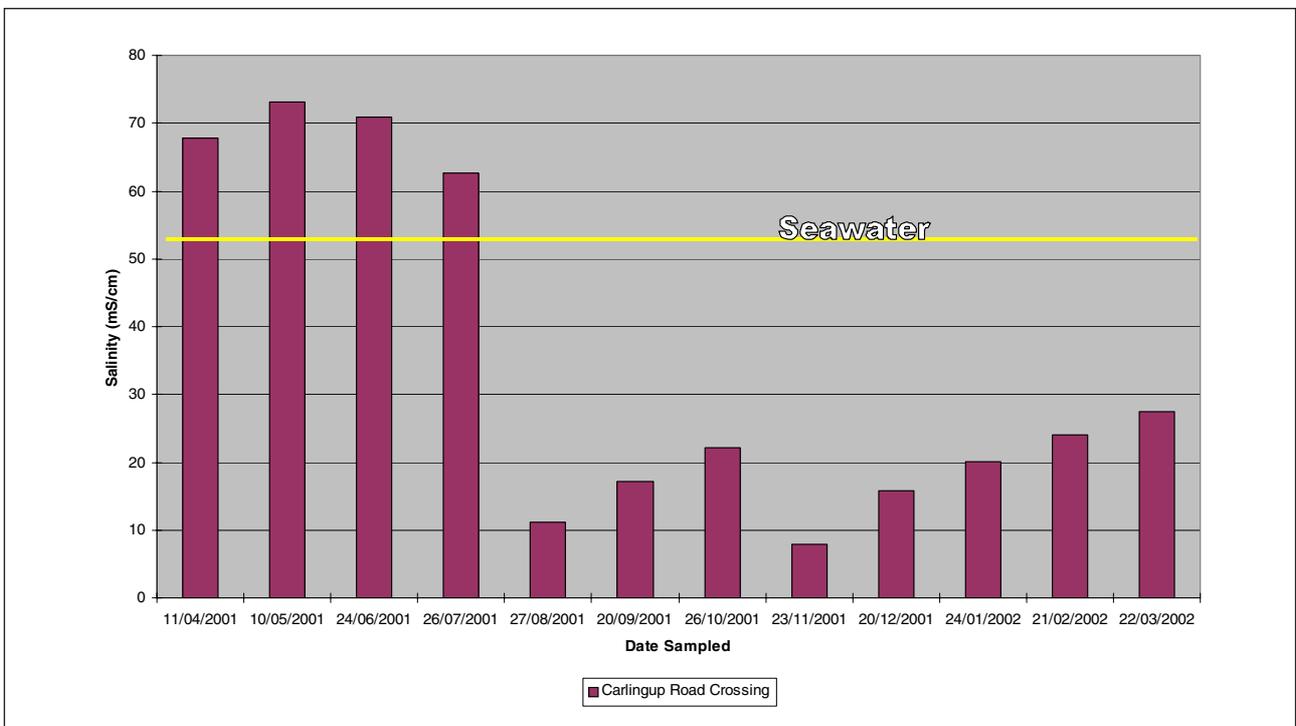
Figure 3. Conductivity levels (salinity) at the Carlingup Road Crossing on the Jerducuttup River over a one year-period (mS/cm)

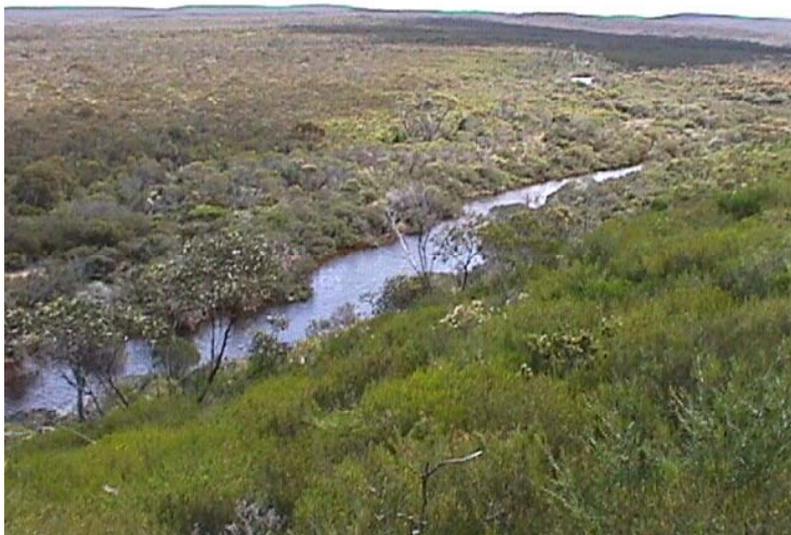
Section of river graded as A grade condition (photograph Kaylene Parker)

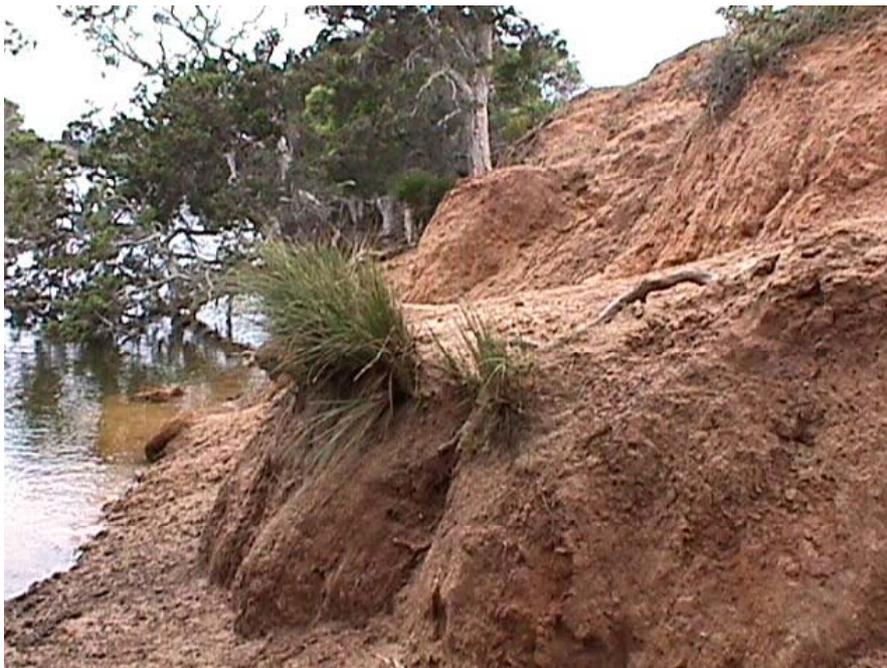
Section of the Jerdacuttup River showing erosion of the bank – caused by cattle access and the resultant loss of foreshore vegetation (photograph Kaylene Parker).

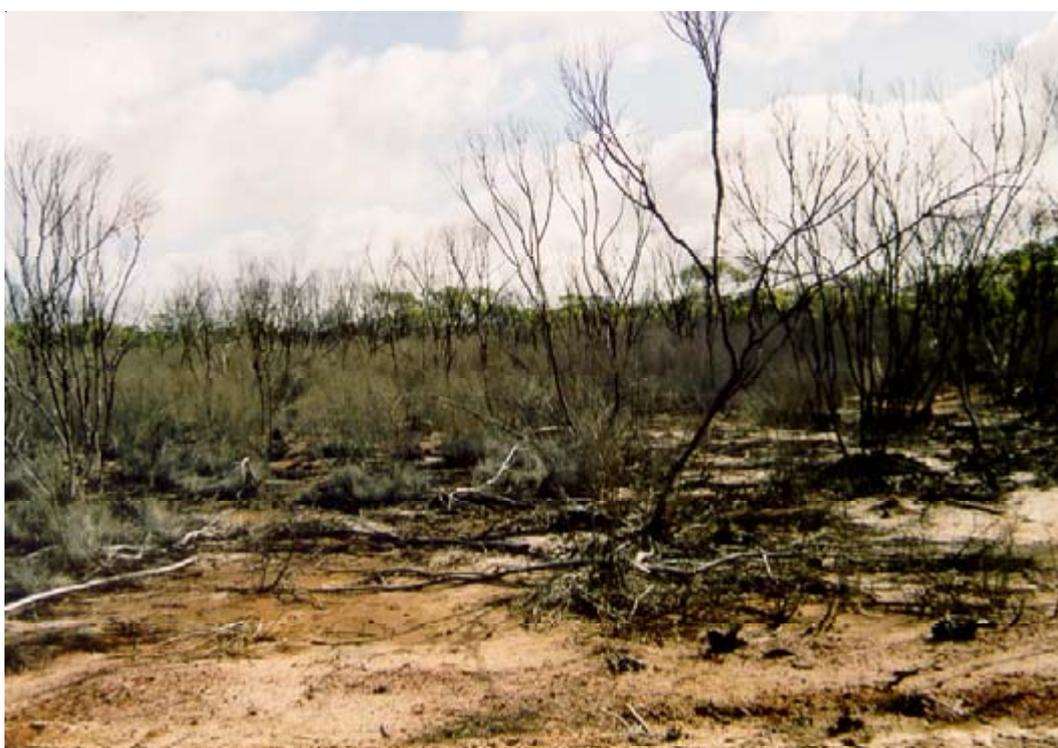
Dead vegetation on Woodenup Creek crossing/Woodenup Road due to waterlogging and possibly secondary salinisation (photograph Kaylene Parker)

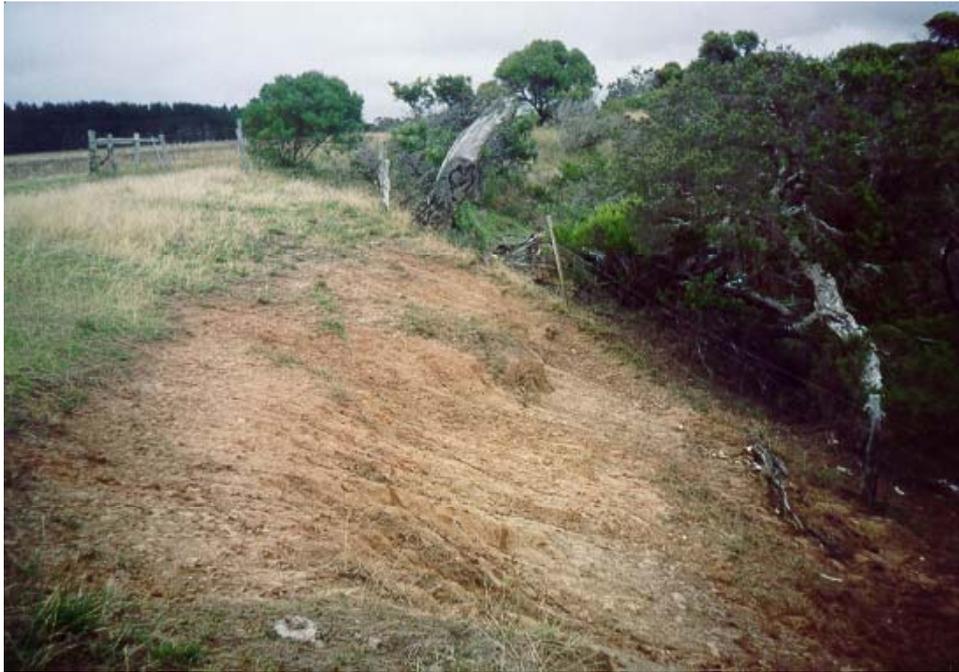
Fence line showing the difference between an unfenced and a fenced river corridor. Note the erosion and bank slumping in the unfenced section, in comparison to the well vegetated adjacent foreshore (photograph Andy Chapman)

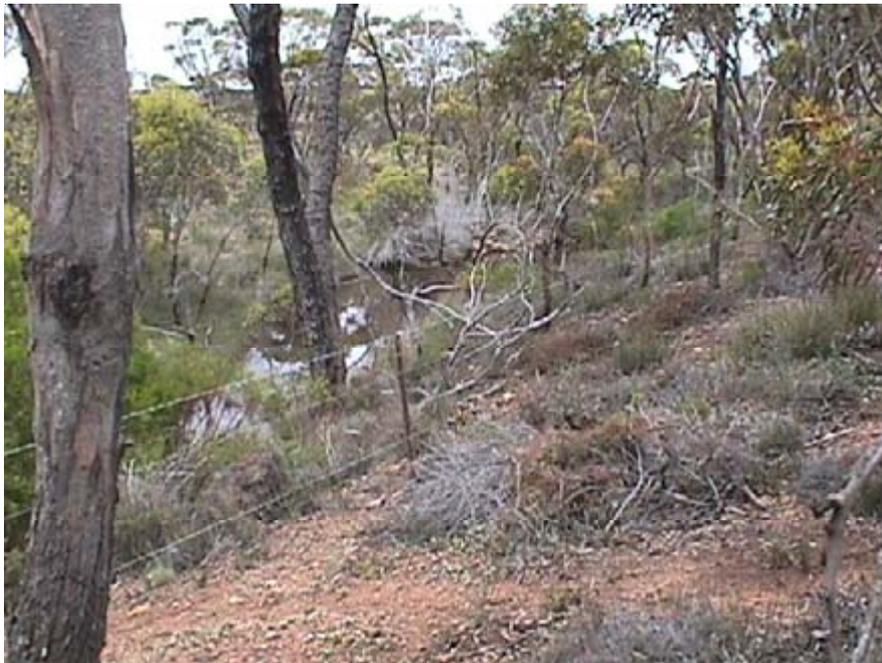
Inappropriate fence location due to inadequate foreshore reserve width (photograph Kaylene Parker)

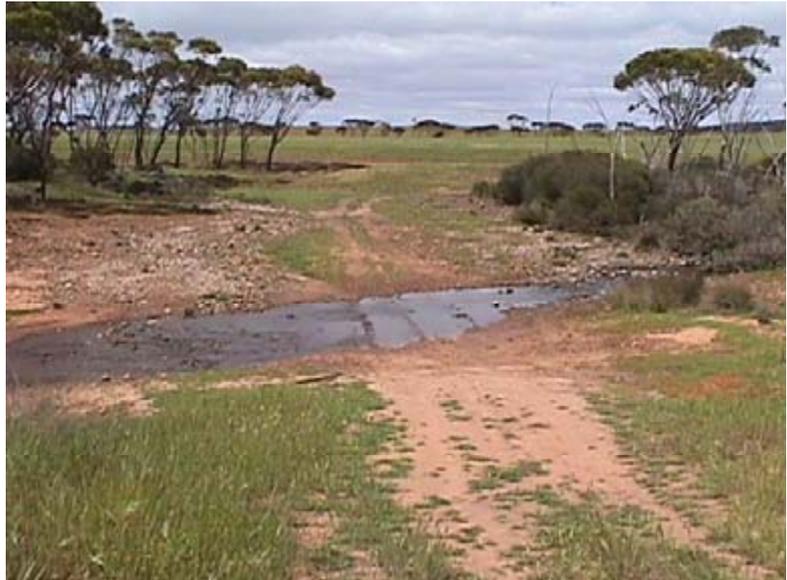
Crossing showing good design – following the contour. Small rocks could be placed to minimise the amount of water the vehicle drives through (photograph Kaylene Parker).

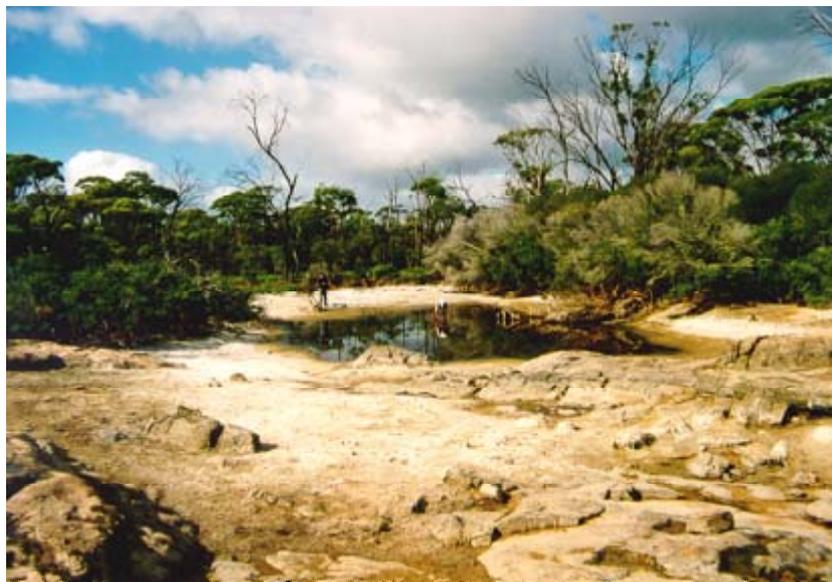
In section 12, the river is deepening. Past the crossing, a braided section is present followed by a V-sided valley. Some sedimentation is apparent prior to the river bends. There is a floodplain in this section of the river that needs to be fenced 75–100 m wide, or managed as a floodplain. Bank erosion is visible where the banks are not fenced and a large stabilised sediment plume is obvious.

Jerdacuttup River at Carlingup Road Crossing (Photograph Kaylene Parker)

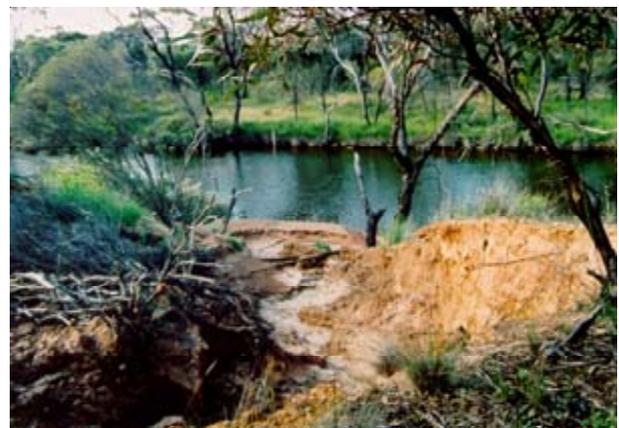
Headcut north of Highway #1 from an access track. This has deposited considerable amounts of sediment into the river pool (photograph Kaylene Parker)

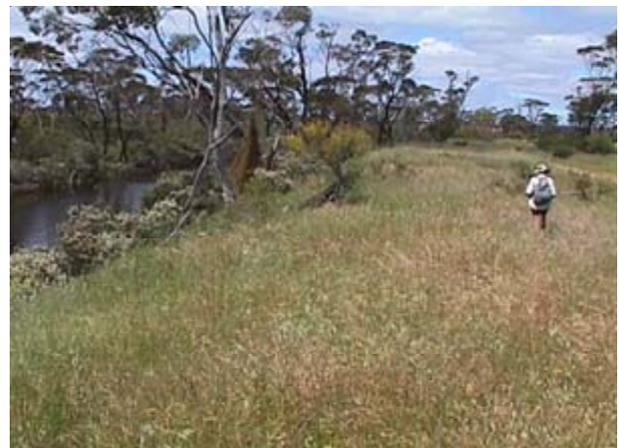
Weed invasion where the foreshore vegetation has been grazed. Revegetation is required in this section of the river (photograph Kaylene Parker)

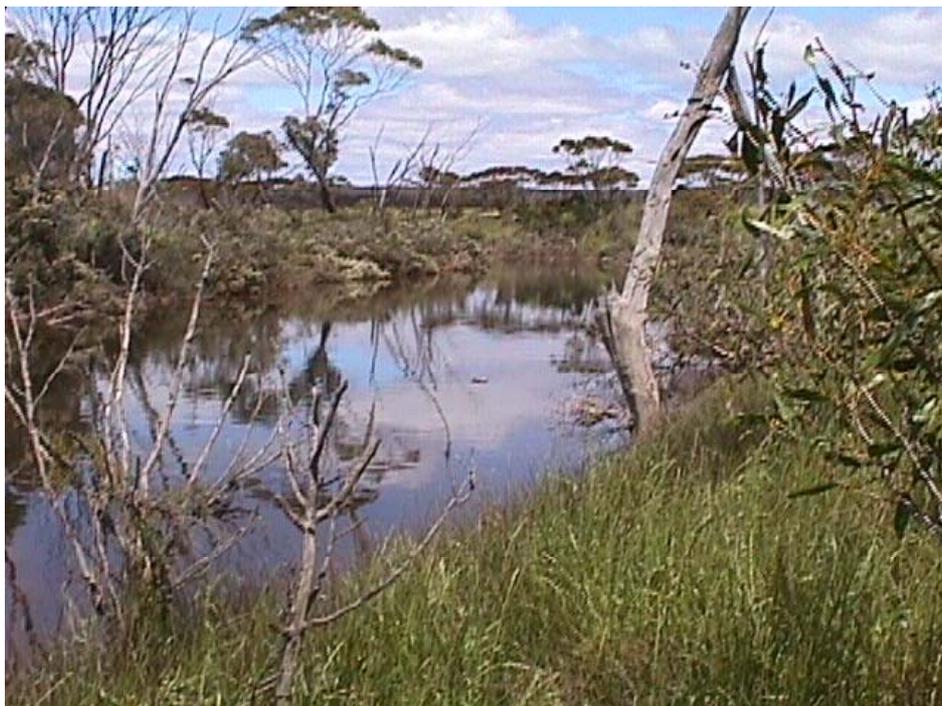
In this portion the river continues its well-developed, pool-vegetated river bed-pool sequence. The pools are particularly large, to 500 m in length, and they provide habitat for waterfowl, including breeding habitat, not seen elsewhere on the river. The river is under the influence of the greenstone landform and there are

Jerdacuttup River near Highway One (photograph Kaylene Parker)
