# Lower Warren River Action Plan

Prepared for Warren Catchments Council- Southern Forests Landcare  
and  
the Manjimup Land Conservation District Committee

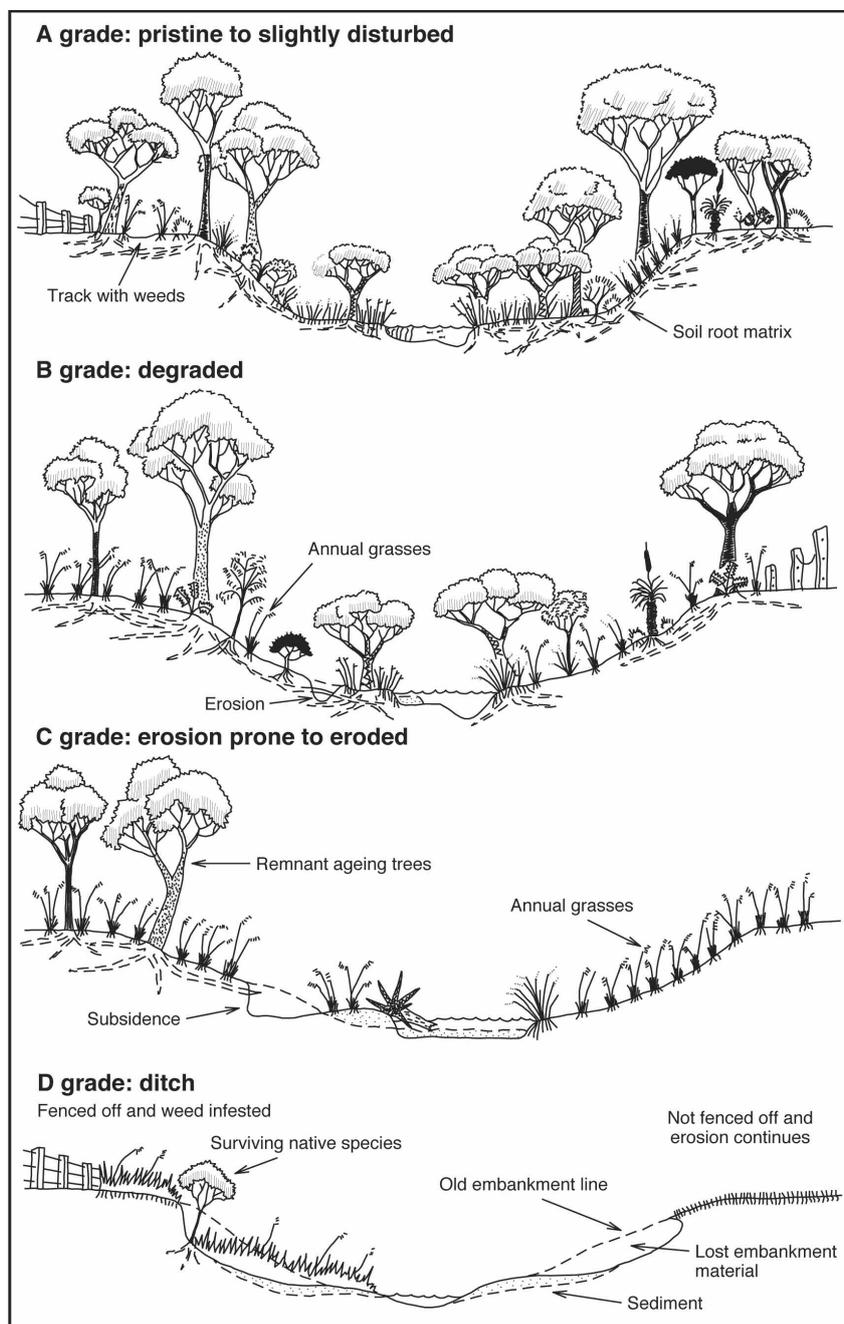
Figure 2: The four grades of river foreshore condition: A (pristine) to D (ditch) (after Pen & Scott, 1995)

The Pen-Scott method of riparian zone foreshore assessment was used to evaluate the condition of the lower Warren River foreshore. The Pen-Scott method is a standardised rating technique for classifying foreshore areas along a gradient from pristine (A grade) through to D grade, connoting a ditch. The four grades are further divided into three sub-categories per grade, i.e. A1, A2 and A3. A description of these grades follows and they are represented pictorially in Figure 2 (Pen & Scott, 1995). Indicative sites representing each grade along the Warren River are also included in the following pages (Figure 3).

The river embankments and/or channel are entirely vegetated with native species and there is no evidence of human presence, or livestock damage. This category, if it exists at all, would be found only in the middle of large conservation reserves where the impact of human activities has been negligible.

Native vegetation dominates but introduced weeds are occasionally present in the understorey, though not to the extent that they displace native species. Otherwise there is no human impact. A river valley in this condition is likely to be the highest quality river found today.

In this stage, weeds have become a significant component of the understorey vegetation. Although native species remain dominant, a few have probably been replaced or are being replaced by weeds.

Here, the annual grasses and weeds have been removed through heavy livestock damage and grazing, or as a result of recreational activities. Low level soil erosion has begun, by the action of either wind or water.

The highly eroded river valley has been fenced off enabling colonisation by perennial weeds. The river has become a simple drain, similar if not identical to the typical major urban drain.

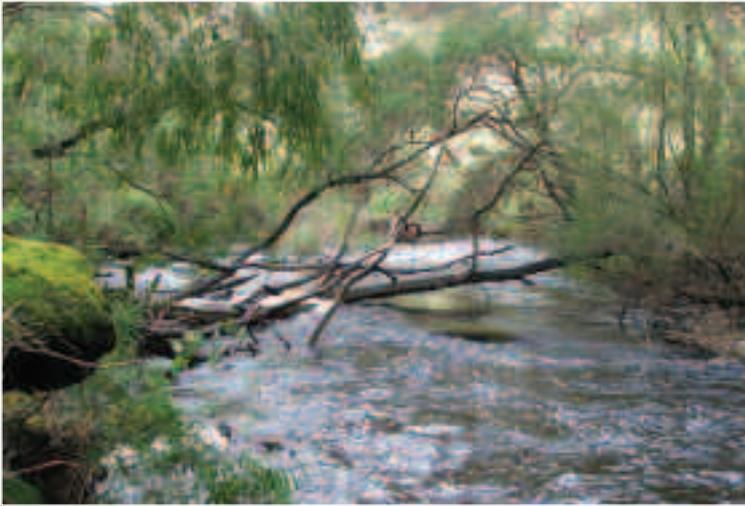
*A grade section*

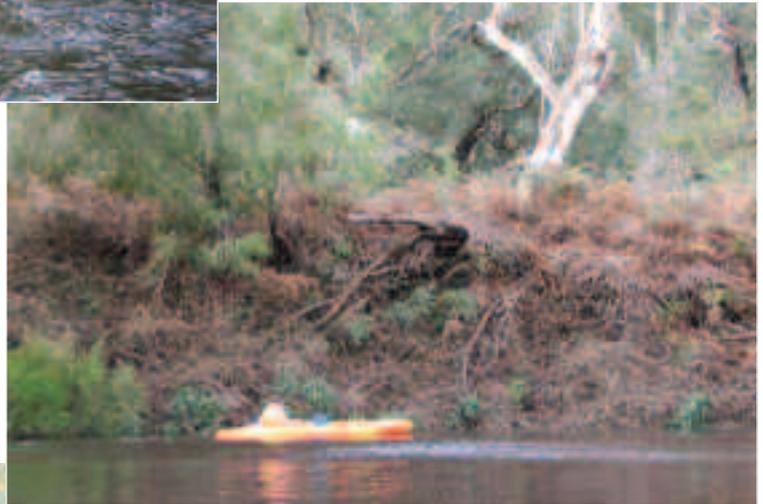
*B grade section*

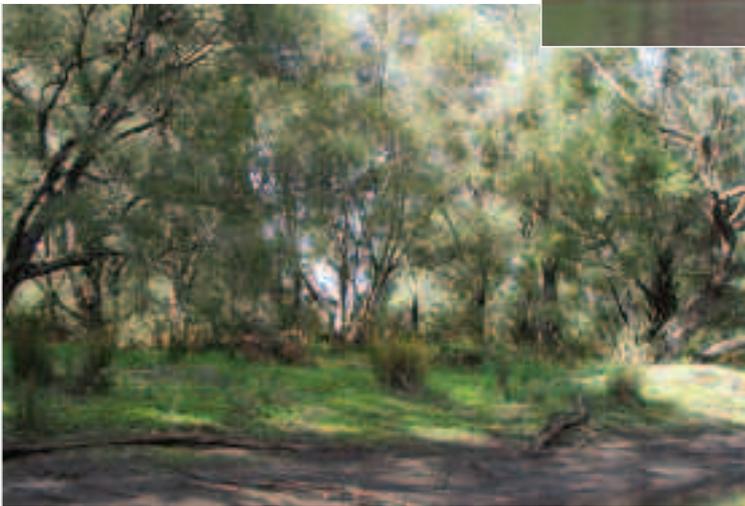
*C grade section*

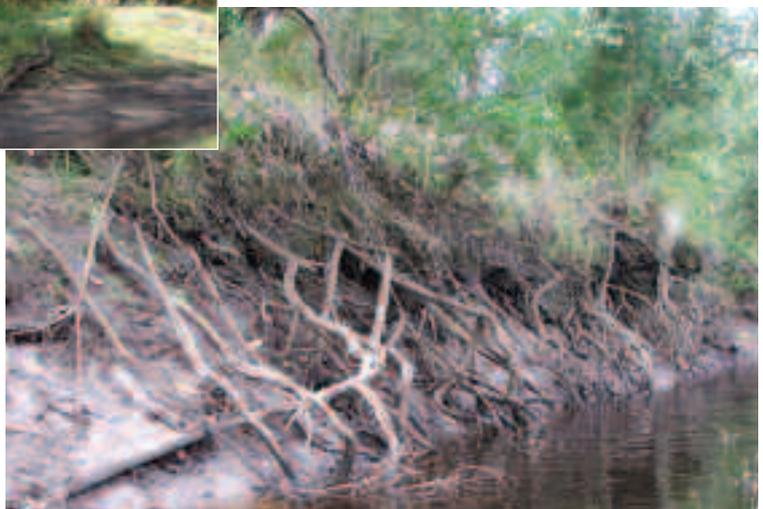
*Figure 3: Foreshore condition of the lower Warren River (photos- Jenni Munro)*

*Natural bank cutting exposing underlying root systems*

Natural, dynamic bank erosion processes occur freely on rivers and are evident along the length of the lower Warren River, where soils are sandy. The erosion process becomes exacerbated and cause for management

concern when supporting riparian vegetation is cleared and banks become further destabilised, leading to erosion and sedimentation downstream. As most of the erosion is a natural occurrence, bank cutting along the lower Warren River is not cause for significant concern, apart from areas where unrestricted stock access is compounding the erosion problem. Stock access to riparian zones also affects bank stability, vegetation cover and weed infestations and can enhance erosion concerns. For much of the section assessed, bank cutting is occurring on one side of the channel and deposition on the other, with the actual river channel being in a constant state of flux. Issues associated with erosion and subsequent siltation include loss of soil fertility, poor water quality, infilling of summer pools, increased channel width, further loss of native riparian vegetation, alteration of in-stream vegetation and flow dynamics, macroinvertebrate communities and the potential effects of reduced photosynthesis (WRC, 2000g).

There are areas of potential concern along the lower Warren River where natural and dynamic erosion processes have become exacerbated. The lower Warren has a sandy soil substrate, making the banks more prone to erosion and slumping than heavier soils. Although much of the river retains a dense and supportive riparian zone, bank erosion is still significant and intensified in areas of stock access. Revegetation of unstable banks is the easiest way to combat erosion; however engineering solutions involving modification of channel flow may be necessary if revegetation proves inadequate. If deemed necessary, site-specific advice and

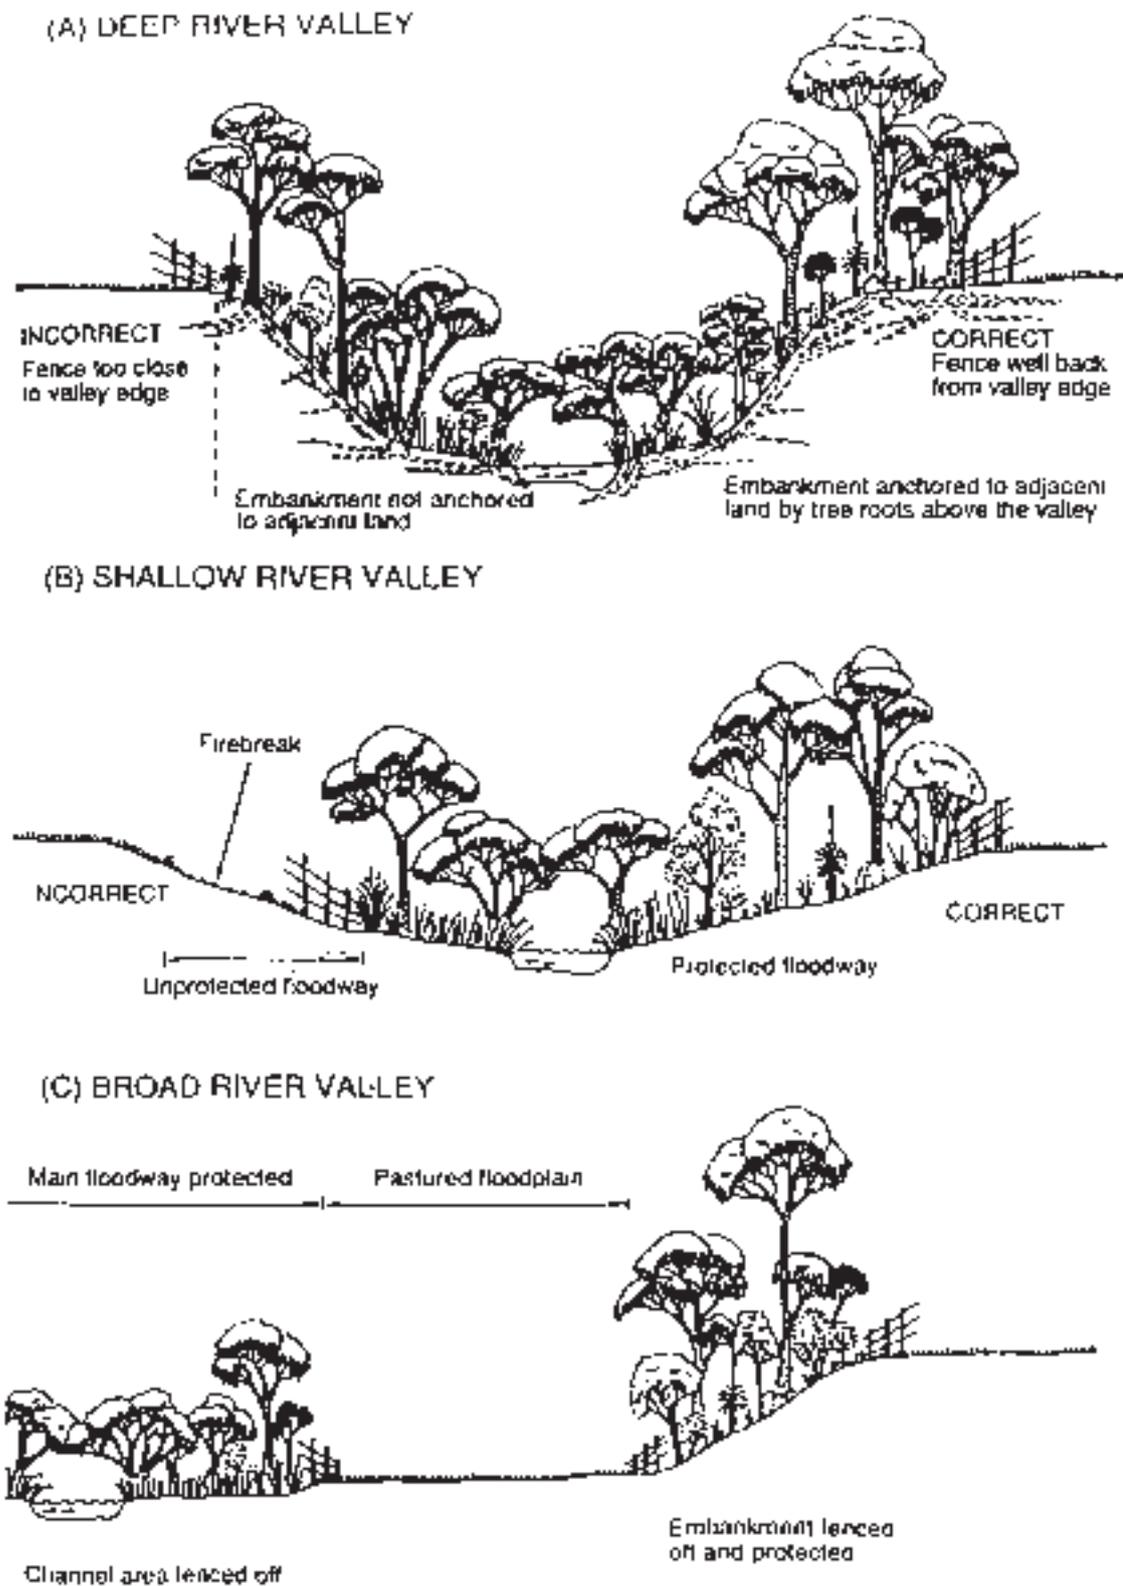
Figure 4: Placement of fences in relation to the river valley

Fencing off the riparian zone does not have to be absolute; the quantity of land from which stock are excluded will depend on management objectives. If the aim of fencing is to protect high quality riparian vegetation to maintain habitat, landscape and ecological corridors, all stock should be excluded. However, if the riparian zone has a history of grazing and stock exclusion could lead to the proliferation of weeds and a fire hazard, allowing access for seasonal grazing is beneficial. Fences in this instance are used to control the level of grazing so that the dominant native vegetation is able to regenerate. Considerations when planning fence location include the form of the river, presence of riparian vegetation and frequent flood levels, in addition to land tenure and cadastral boundaries. Correct fence placement in relation to river valleys is illustrated in Figure 4.

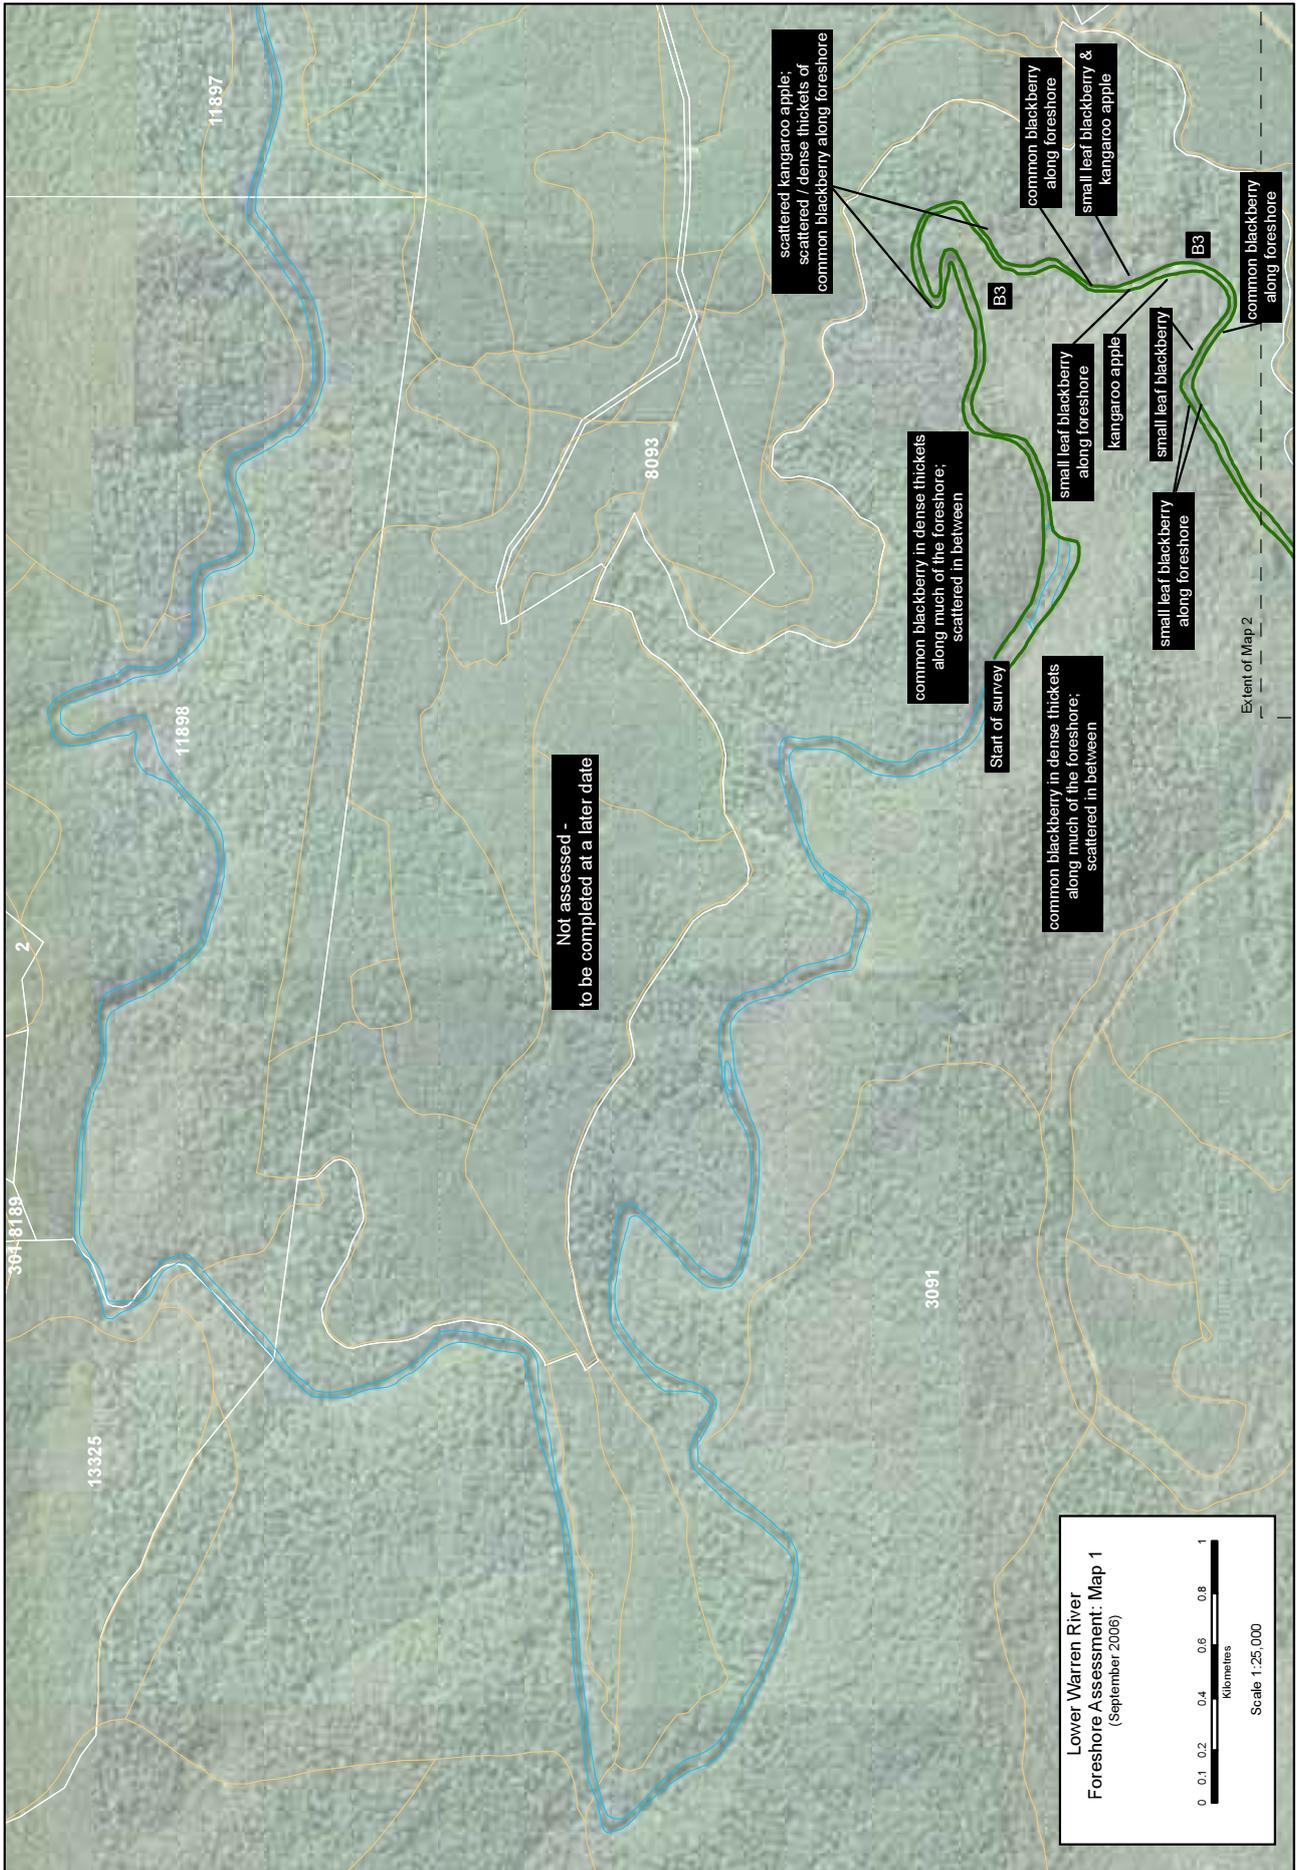
Lower Warren River Map 1

Common native flora species noted along the stretch include: flooded gum *Eucalyptus rudis*, Warren River cedar (wattie) *Taxandria juniperina*, swamp willow (wonnich) *Callistachys lanceolatum*, river banksia *Banksia semindua*, albizia *Paraserianthes lophantha*, Western Australian peppermint *Agonis flexuosa*, karri sheoak *Allocasuarina decussata*, karri hazel *Trymalium floribundum*, sword sedges *Lepidosperma* sp., rushes *Juncus* and *Baumea* sp., *Billardiera floribunda*, karri *Eucalyptus diversicolor*, tassleflower *Leucopogon verticillatus*, *Astartea fascicularis*, mohan *Melaleuca viminea*, bracken *Pteridium escalatum*, swamp peppermint *Taxandria linearifolia*, clematis *Clematis aristata*, blackbutt *Eucalyptus patens*, dungyn *Hakea oleifolia*, zamia *Macrozamia reidleyi* and weeping grass *Microlaenea stipoides*.

Summary Information	
Location/lot numbers of adjacent properties	National Park
Foreshore condition rating (as at Oct 2006)	B3 100%
Vegetation cover & health	Immediate foreshore area dominated by common and small leaf blackberry thickets. Beyond infestations, densely vegetated with native species, excellent vegetation health and diversity
Land use	Warren State Forest/ Greater Hawke National Park

1. Monitor effect of blackberry biocontrol rust and further spread of common and small leaf blackberry
2. Monitor spread of golden dodder
3. Monitor emergence and spread of other weed species
