PHILLIPS RIVER ACTION PLAN

DEPARTMENT OF ENVIRONMENT
WATER RESOURCE MANAGEMENT SERIES
REPORT NO WRM 40
MAY 2003

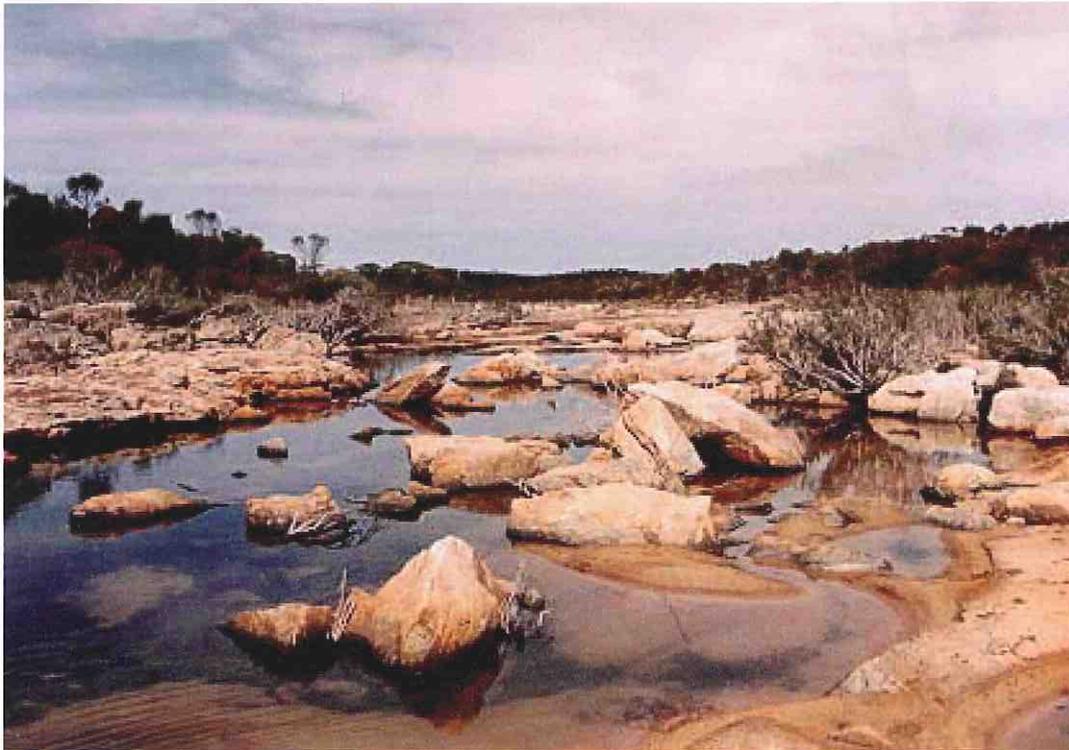
A Grade vegetation of the Phillips River – pristine to near pristine condition

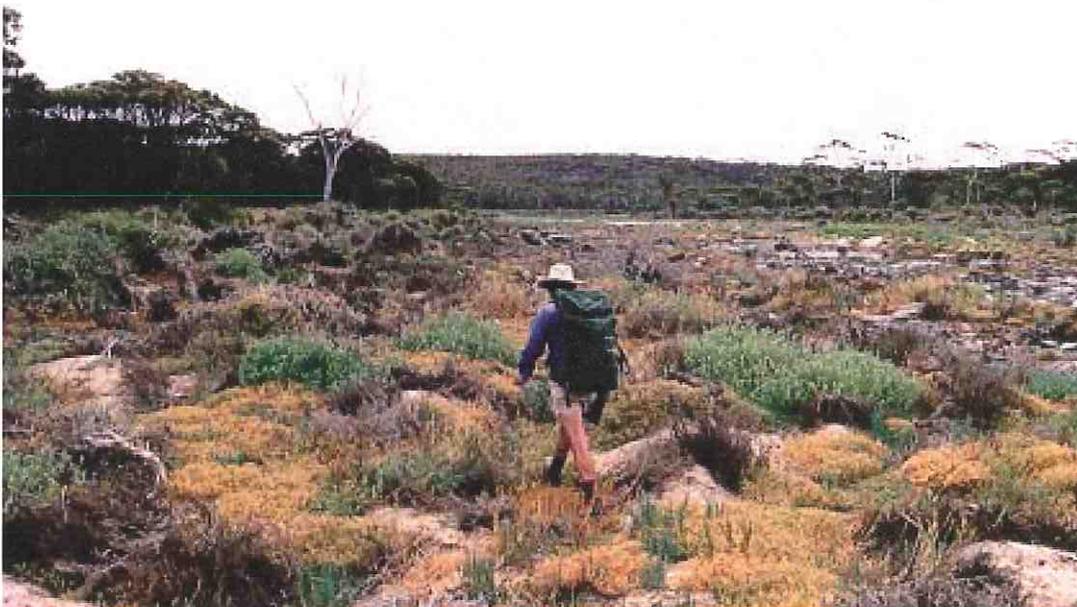
B Grade condition – note the weeds, although this is probably largely influenced by the 2000 flood event

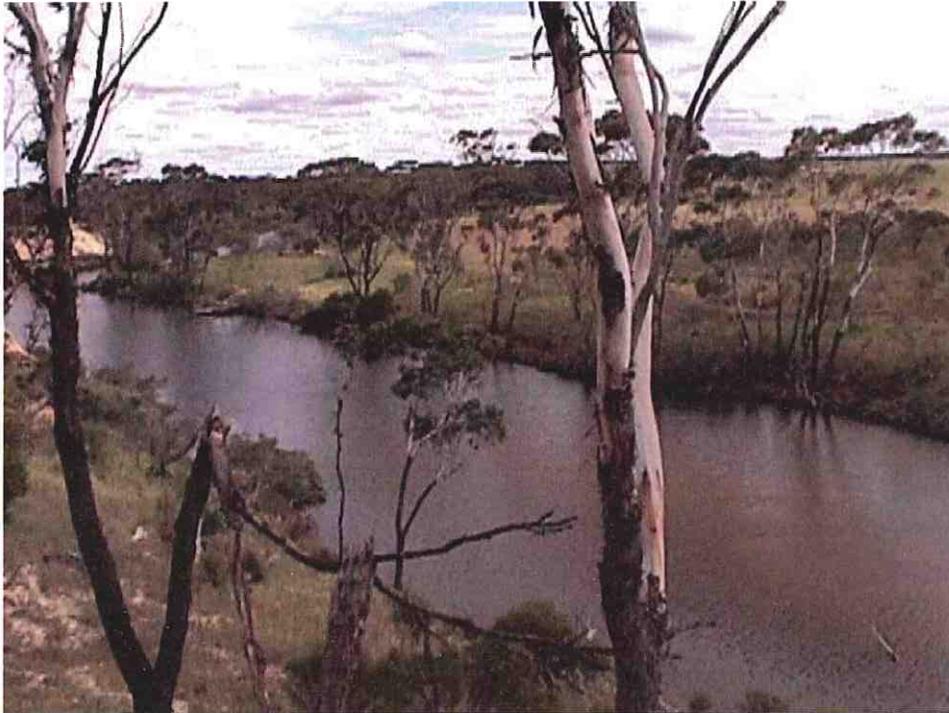
C Grade – note the overstorey remains however the understorey is sparse and weed dominated. This site has since been fenced

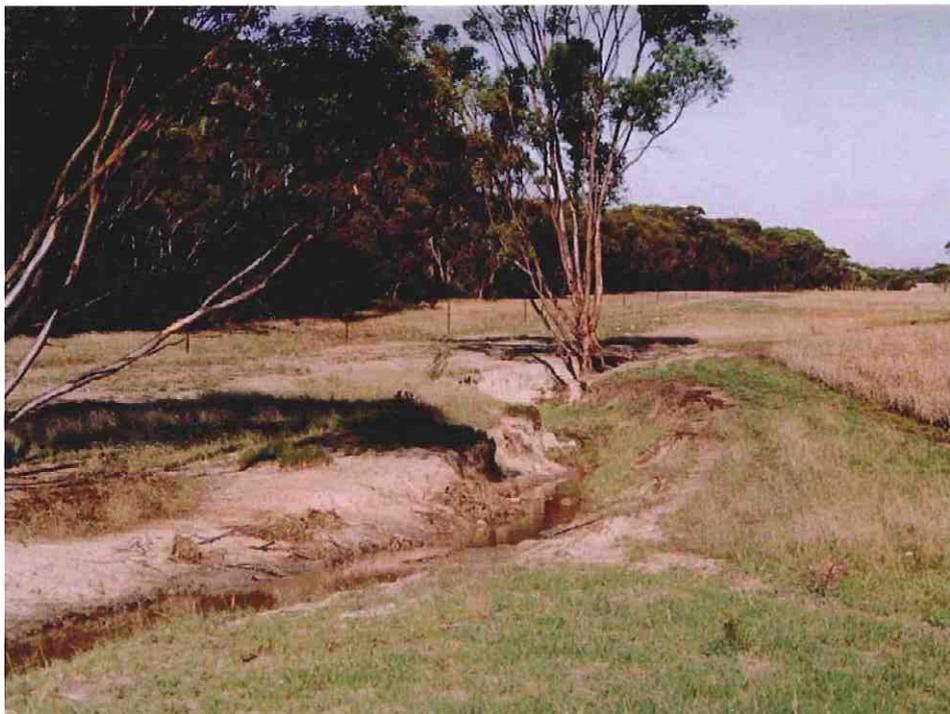
D Grade – note the erosion and lack of understorey species. This is a tributary of the Phillips as there were no sections on the Phillips that were D grade condition

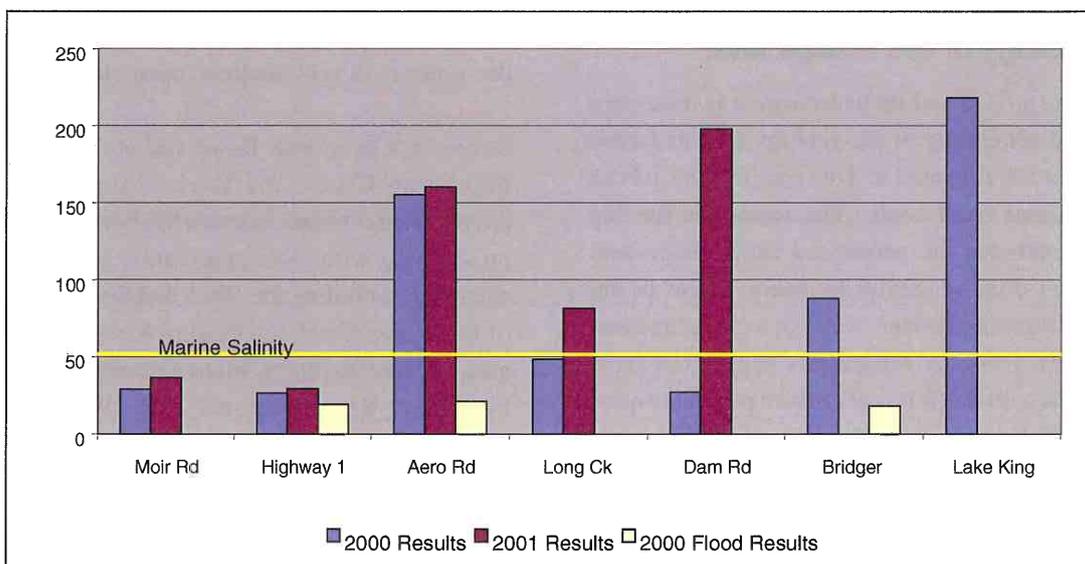
Figure 2. Conductivity levels (salinity) of various sites of the Phillips River (mS/cm)

The Water and Rivers Commission conducted a 'snapshot' of river water quality in 1999, 2000 and 2001 and recorded salinity measurements (figure 2, table 3). This data does not enable any trend analysis, however indicates differing salinity levels in the river at different sites, and for different times. This data showed that the Phillips River is considerably more saline towards the north of the catchment, and becomes fresher towards the coast.

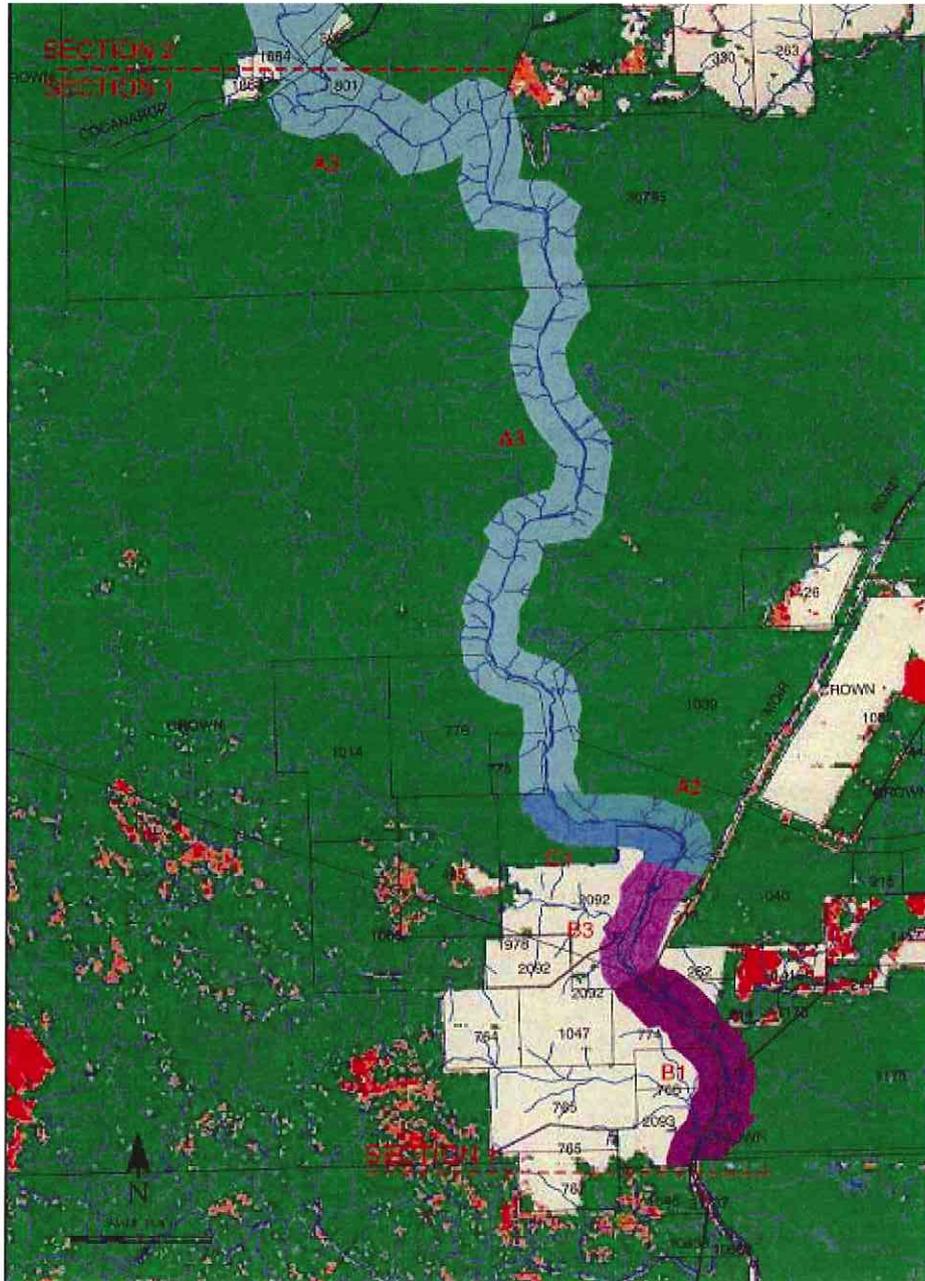
Figure 8. Foreshore survey results - Fitzgerald River National Park boundary to Cocanarup Road

Rabbits were abundant in section 2 where they were more frequently recorded than anywhere else on the River. Management requirements are; to gazette a river reserve over VCL between FRNP boundary and the north-west corner of MHL 180; to assess the African boxthorn threat over sections 5 – 11; invite the owners of Kaybalup farm, Cocanarup and CG 217 and MHL 280 as well as the Ravensthorpe LCDC and the Department of Conservation and Land Management to participate in remediation and management of these degraded sections of river (noting that the routing of the access to FRNP is an issue here).

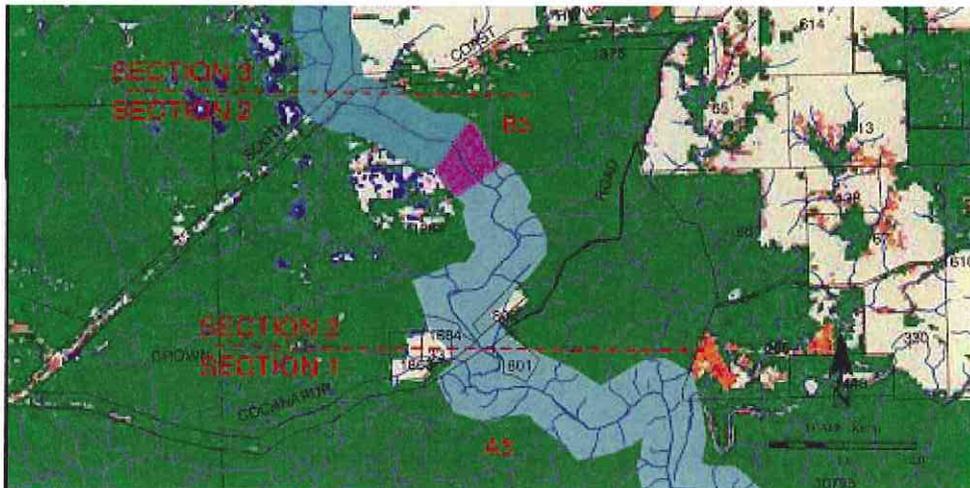
Figure 9. Foreshore survey results - Cocanarup Rd to Highway One

Management issues are to invite the owners of Cocanarup as well as the Ravensthorpe LCDC to participate in remediation and management of degraded parts section of section 12. This degradation is historical rather than current.

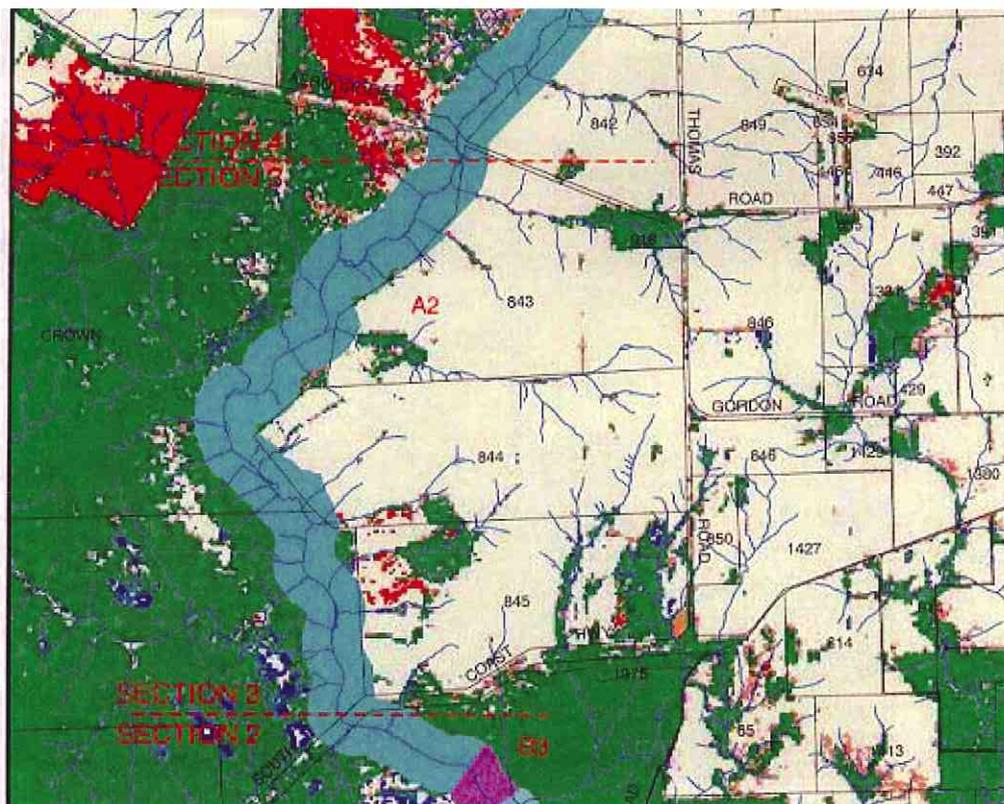
Figure 10. Foreshore survey results - Highway One to Aerodrome Road

A management issue is to gazette a river reserve between the northern boundary of Cocanarup timber reserve and Aerodrome Road.

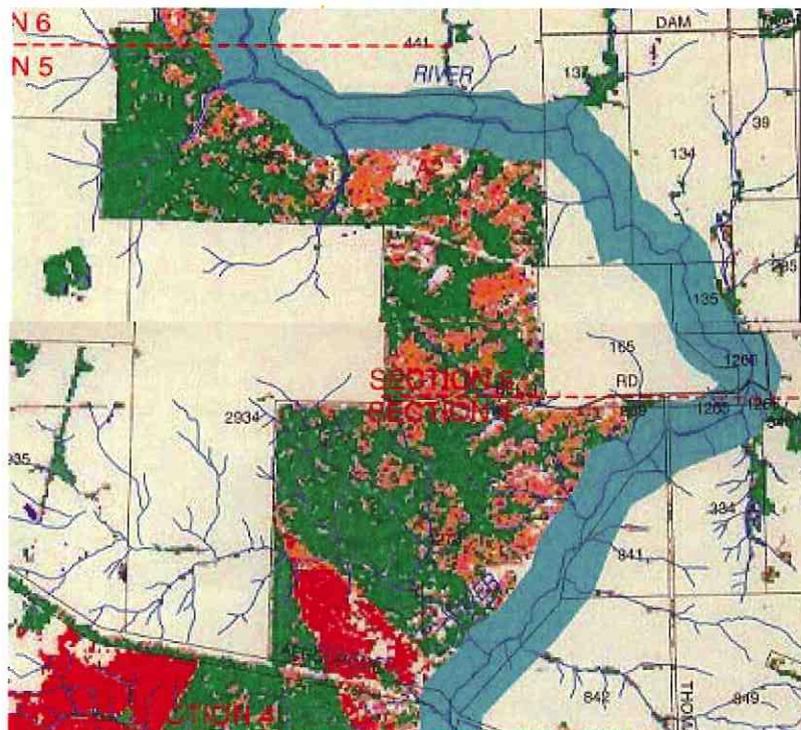
Figure 11. Foreshore survey results - Aerodrome Road to Dam Road

Management issues are in conjunction with the Shire of Ravensthorpe to re-design and re-construct the Belli Road crossing.

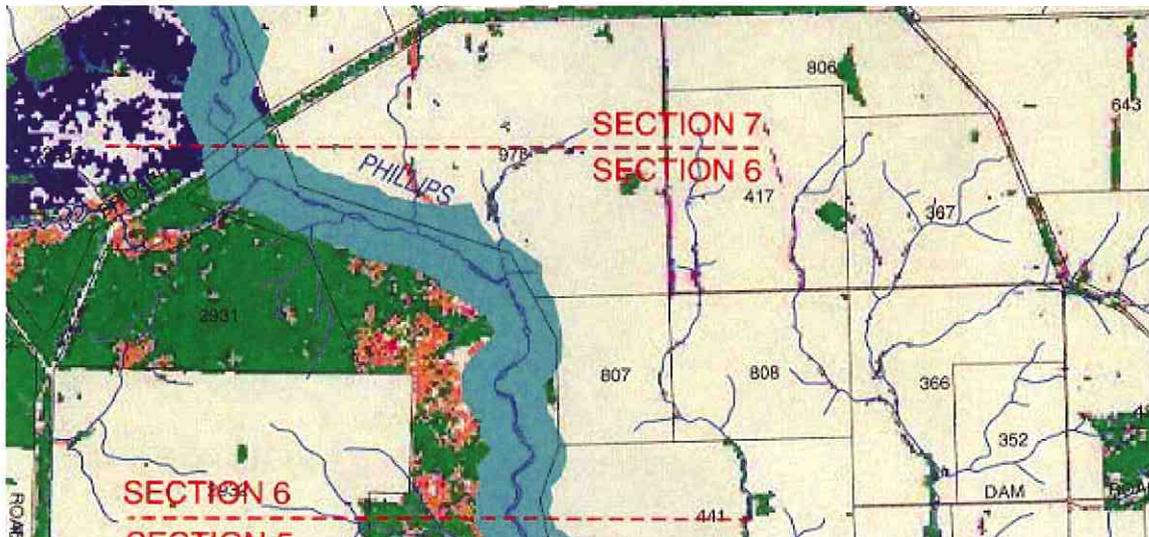
Figure 12. Foreshore survey results - Dam Road to Bridger Road

A distinctive feature of sections 22-23 is the presence of dolerite dykes in bare gneissic rocks of the riverbed. These dykes are the source of extensive hypersaline seepage. In places the combined effect of seepage is to produce a small but perceptible flow of highly saline water.

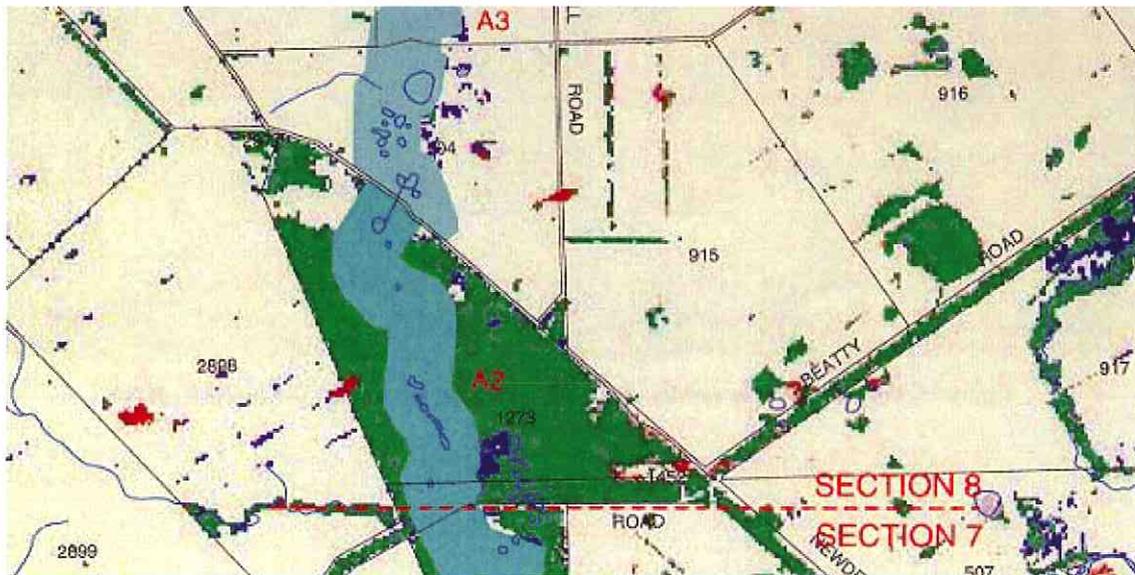
Figure 14. Foreshore survey results - Fitzgerald Road to Lake King-Ravensthorpe Road

A management issue is to monitor the extent of salinisation and/or waterlogging present.
