STATE OF THE WATERWAYS IN THE FITZGERALD RIVER CATCHMENT

WATER AND RIVERS COMMISSION
WATER RESOURCE MANAGEMENT SERIES
REPORT NO WRM 36
APRIL 2003

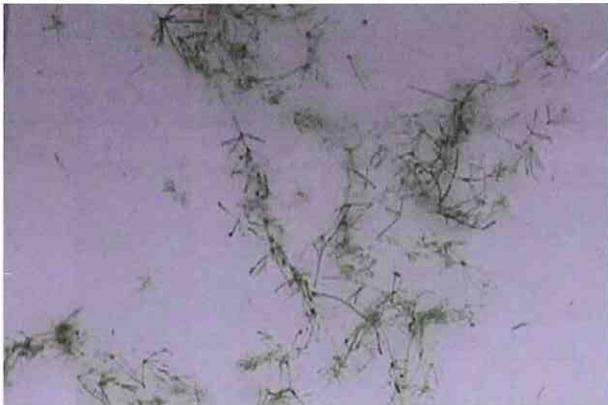
Chara spp. (photograph Kaylene Parker)

The two main species of macrophytes identified by the Water and Rivers Commission during the 'snapshot' were the angiosperm, *Ruppia megacarpa* and the Charophyte species - *Chara*. There may be other macrophyte species present in the river system however more intense surveys would need to be conducted to confirm this.

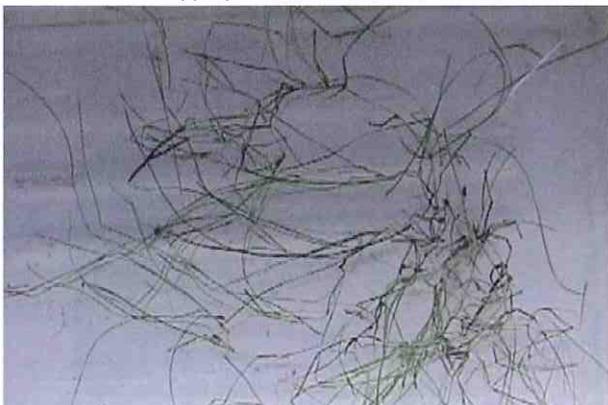
Ruppia spp. (photograph Kaylene Parker)

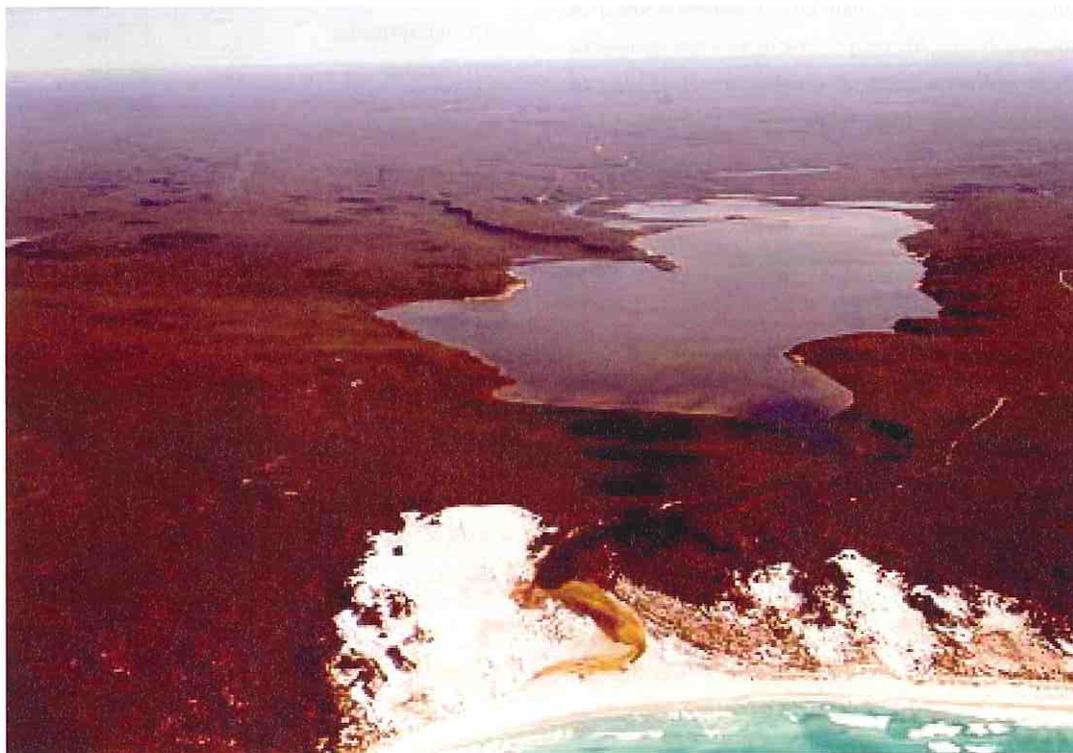
Fitzgerald Inlet (photograph Simon Neville)

The Inlet discharges onto the beach near Point Charles after high rainfall events. The bar breaks infrequently and generally only stays open for a few days. It is said once to have remained open for 18 months and to have had abundant fish and shellfish at the turn of the century. A flood broke the bar in about 1963 and again in 1971, 1978 and 1988. Runoff from the catchment is estimated to be 5 mm and the mean annual flow into the estuary $8 \times 10^6 \text{ m}^3$.

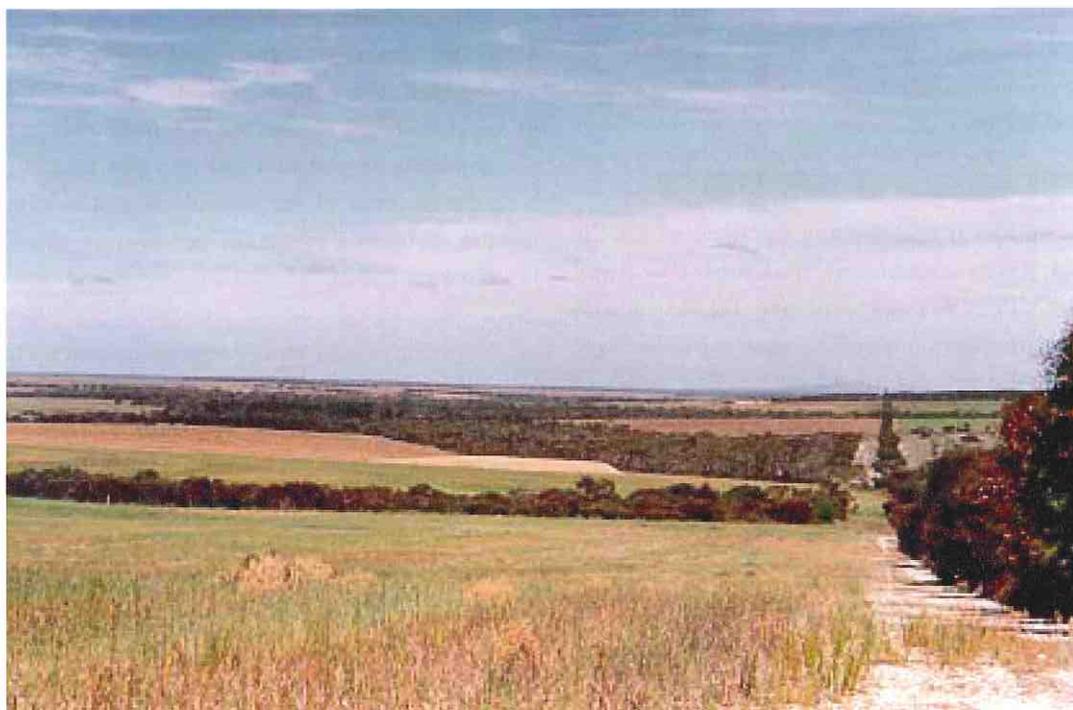
Tributaries of the Fitzgerald River – showing a good buffer of vegetation (photograph Kaylene Parker)

Landholders within the catchment are trying to address the lack of riparian vegetation by fencing off waterways to protect the riparian zone from livestock. Also, extensive revegetation efforts have been undertaken, either through planting of native seed or seedlings, to replace the riparian vegetation. This has proved very successful, but it takes time for the vegetation to re-establish.

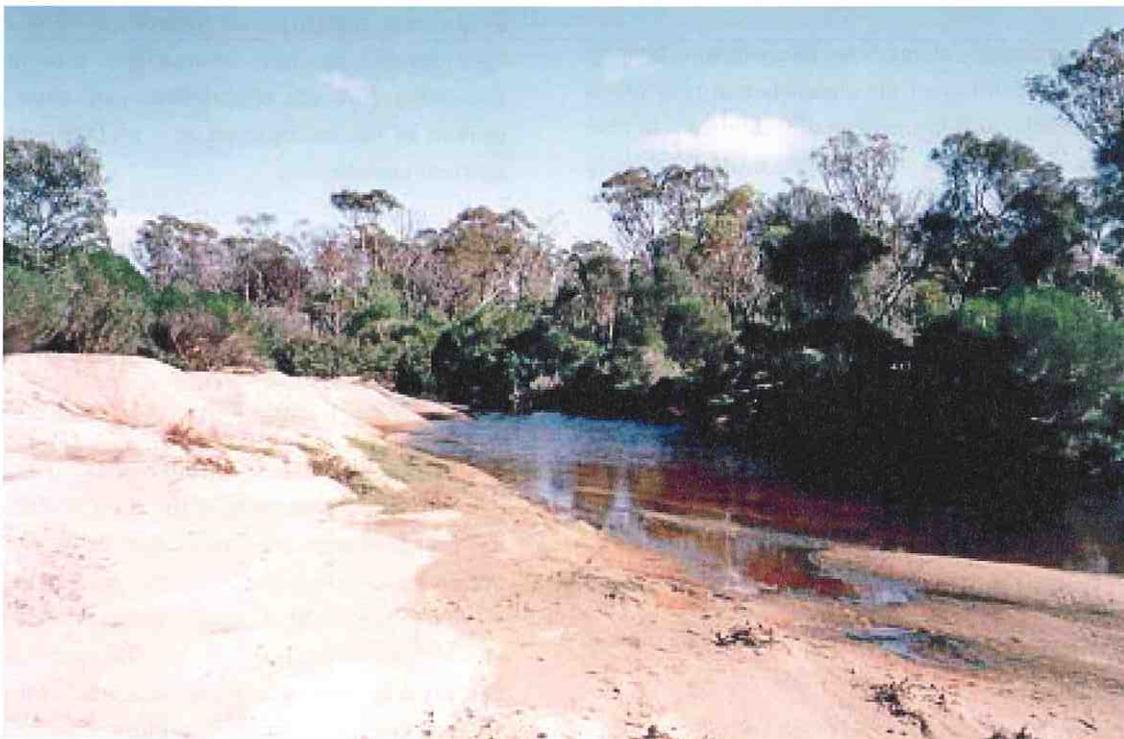
Sediment in the Fitzgerald River – south of South Coast Hwy (photograph Kaylene Parker)

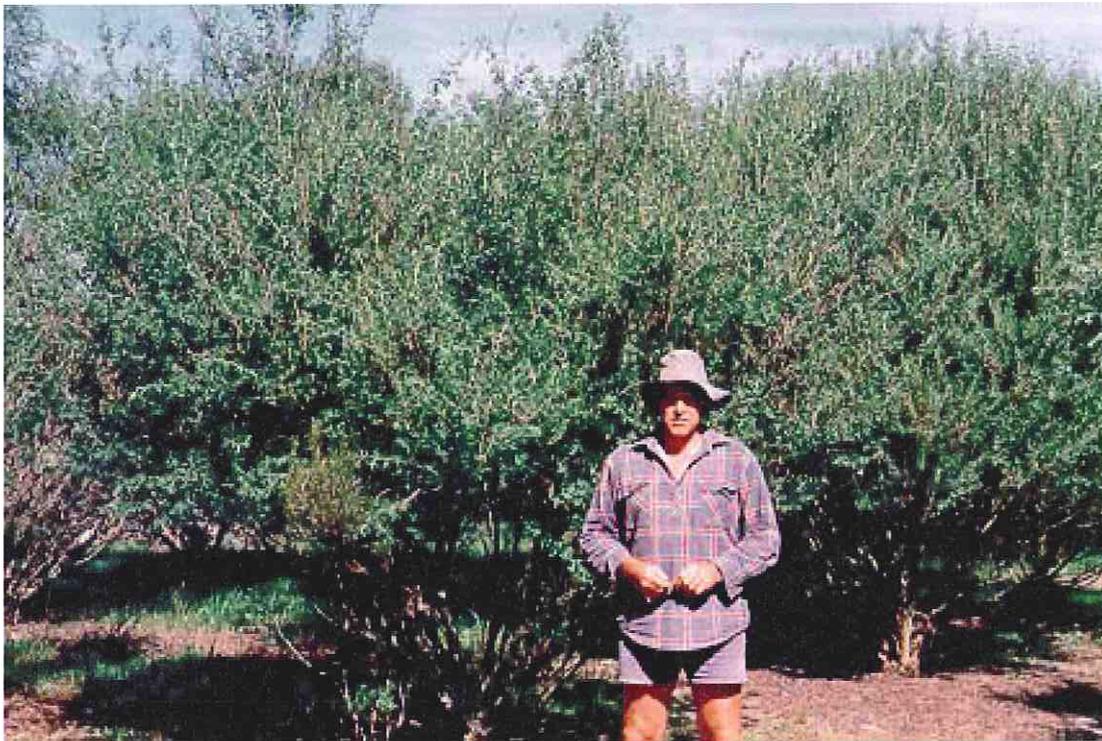
Figure 12. 'Pineplace' revegetation efforts

Twertup Creek is a southerly flowing tributary of the Fitzgerald River. The upper reaches originate in 'Pineplace' and flows through three other properties before entering the Fitzgerald River National Park. Twertup Creek is a brackish-saline waterway. The vegetation in the channel supports this with the presence of salt tolerant species such as samphires. Salinisation has caused a small area of vegetation to die and this secondary salinity is encroaching a small area of farmland adjacent to the creek.
