Prepared for **Department of Water**
Yarra Yarra Regional Drainage Program
Evaluation of Xantippe, Jibberding and Mongers 16 drains

January 2017

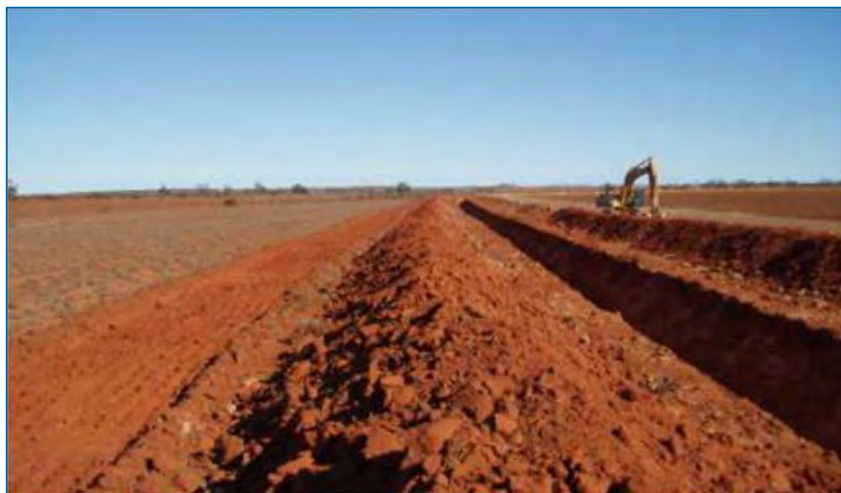
Plate 1: Construction of arterial drain showing central channel, levee banks and surface channel (YYCMG 2010)

The basic design of the drain incorporates a central deep drain, with the spoil used to form continuous 1.5 m high levee banks on both sides of the channel to prevent surface water inflow and silt accumulation in the drain (Plate 1). Drains were constructed just upslope of the lowest alignment along the valley floor to maintain floodway capacity in the valley for significant events. The levee banks are set back 1.5 metre either side of the channel with shallow surface water channels formed on the outer edge of the levee banks to convey surface water out of the catchment. The arterial drains were generally 2.5 m depth, with 1.25 m width bottom and 1(V):0.5(H) batter slopes, forming a channel with cross-section of approximately 5.6 m².

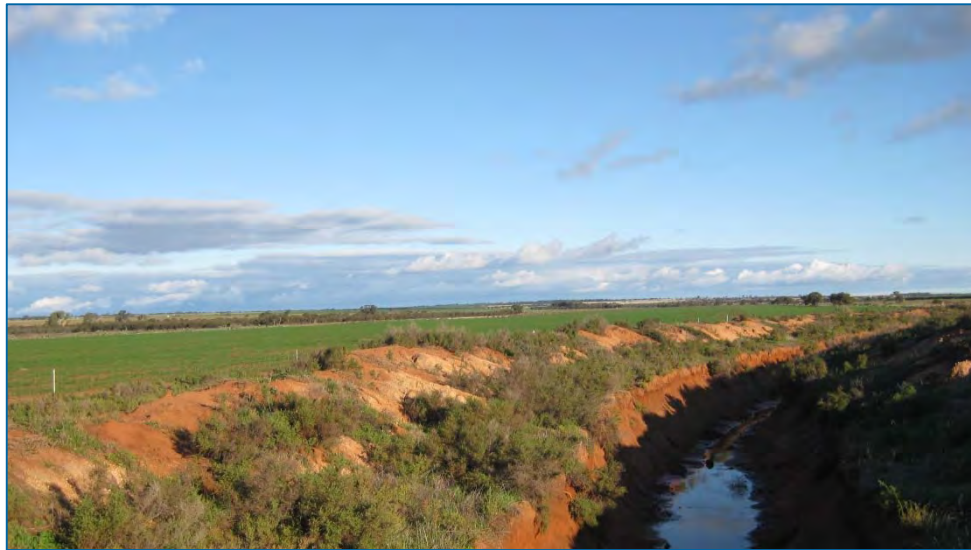
Plate 2: View north-west from Campbell Road drain crossing looking across Hathaway front paddock towards Dalwallinu-Kalannie Road. Paddock planted to barley.

Discussions with the landholder and leaseholder of the property adjacent to the Campbell Road transect during the site visit suggested improvement in surface condition and crop productivity in the paddocks immediately north-east and south-west of the intersection of the Dalwallinu-Kalannie Road and Campbell Road. The paddocks were previously reported as having visible salt crusts, with Fordyce (2015) noting that the paddock to the north-east of the intersection previously had been patchily cropped, with numerous bare areas and waterlogged patches that supported sparse *Nyssa* grass, samphire and bluebush. After drain construction the landholder and leaseholder both observed improvements in crop condition within both paddocks, which are now cropped to barley and have no visible salt scalds or observed patchiness (Plate 2).

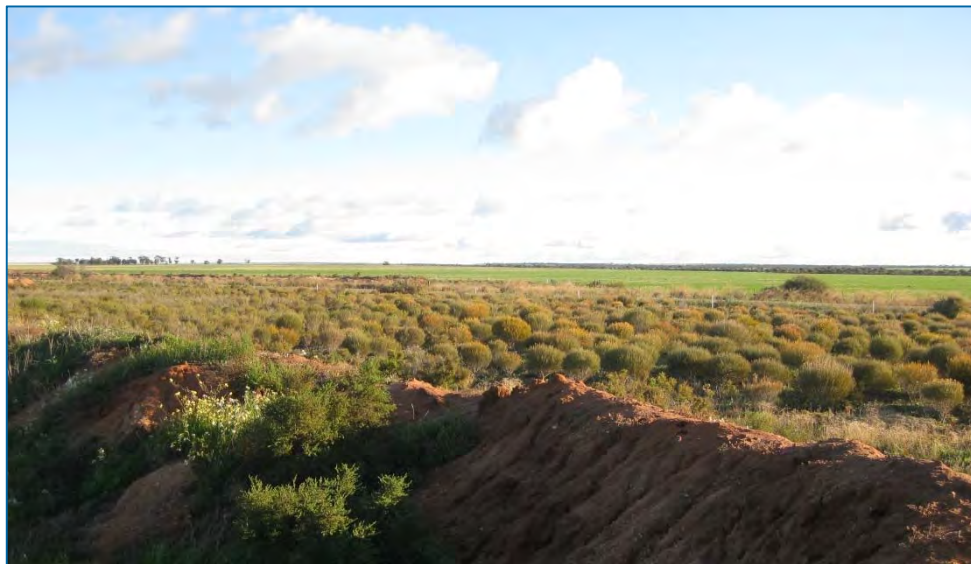
Plate 3: View north-east from Campbell Road drain crossing showing established broombush plantation within drainage corridor.

In June 2016, the broombush plantation adjacent to the Campbell Road transect (KL1-KL6) appeared to be well established (Plate 3), and volunteer shrubs had established on the drain banks (Plate 2). Similarly, the vegetation within the wide drainage corridor adjacent to the Angel transect (KL10-KL15) appeared to be in good condition and showing no signs of stress associated with salinity (Plate 4).

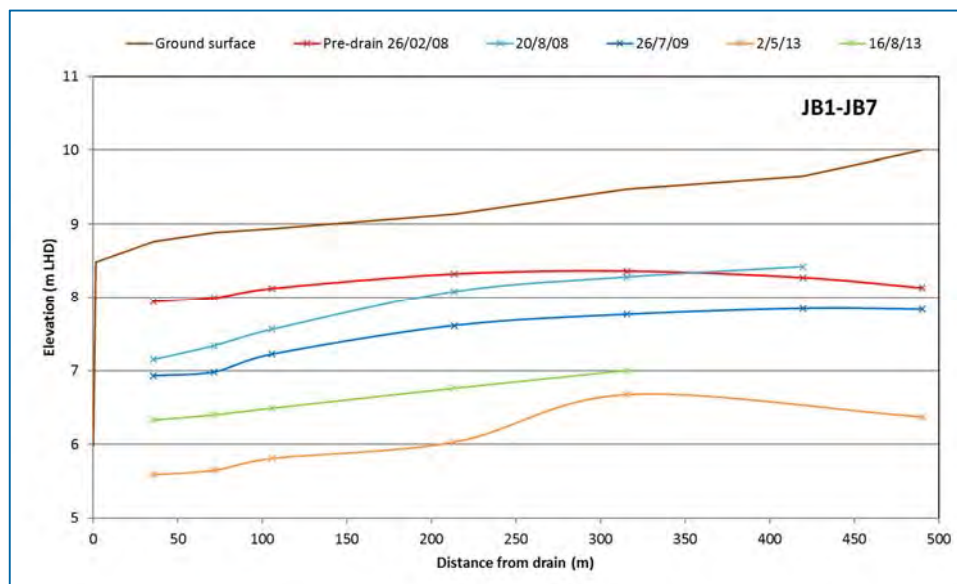
Figure 19 Woolf Road transect watertable profiles

The persistent increased watertable slope towards the arterial drain along the bore transect after the construction of the arterial and additional private spur drain (Figure 19) indicates the drainage density in proximity to the transect (drainage on three sides) has an influence on the watertable, extending over several hundred metres.

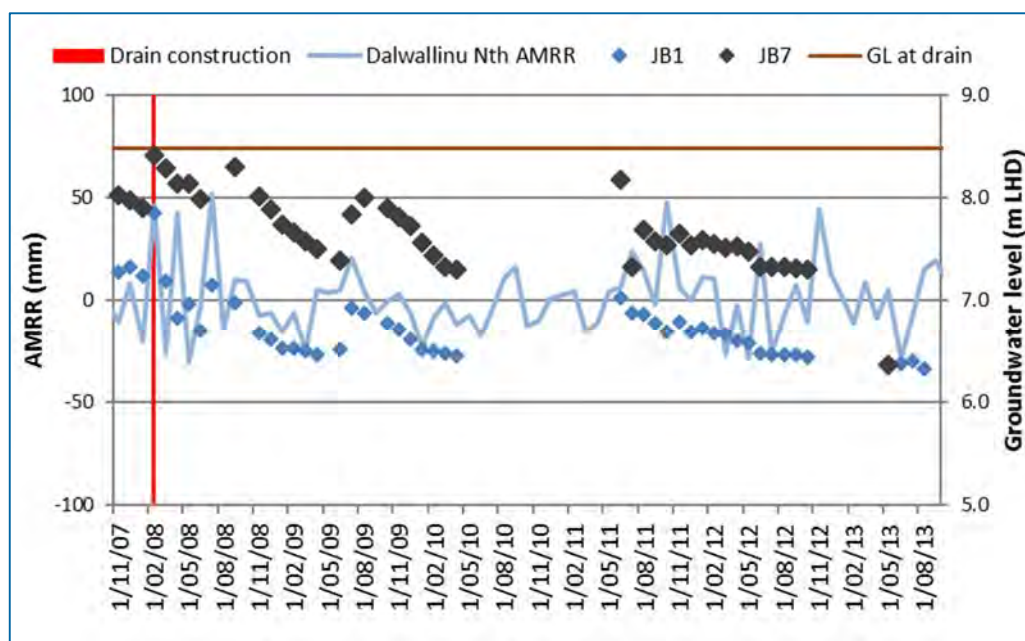
Figure 20 Woolf Road transect AMRR comparison

Comparison of the watertable response of bores JB1 and JB7 to AMRR trend for the Dalwallinu North BoM station shows that the drain construction (29 February 2008) occurred during an upward trend in AMRR indicating a period of predominantly above-average rainfall (Figure 20). Subsequent watertable peaks across all bores also coincide with upward trend in AMRR (August 2009), however later periods of above average rainfall (September 2011 onwards) do not produce similar peaks in watertable response, particularly in bore JB1.

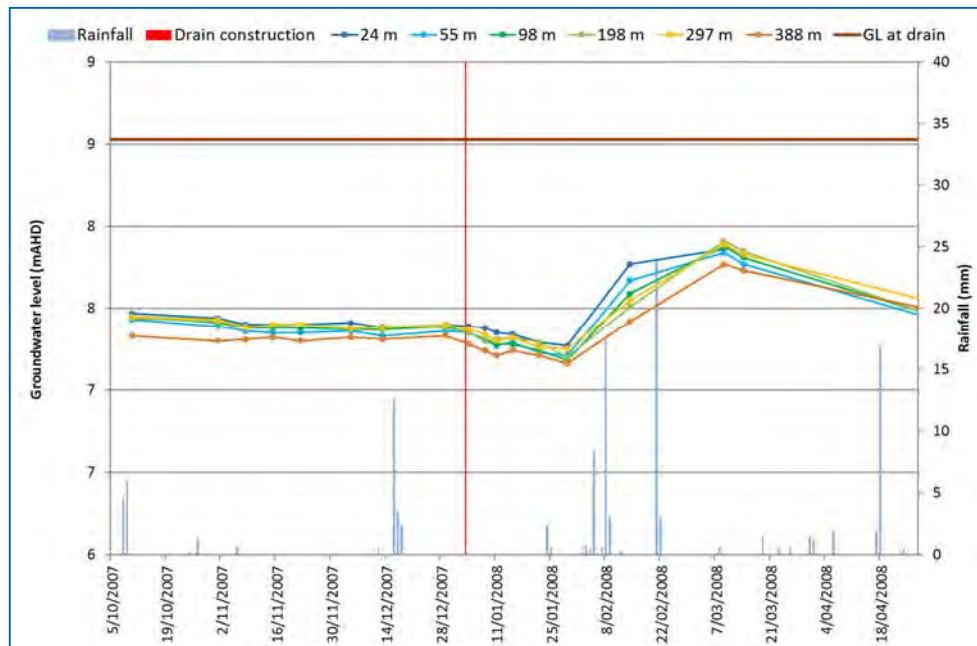
Figure 21 Wasley Road transect initial groundwater response

Rainfall amounts of 10.5 mm in late January, 35.5 mm in early February and 42.5 mm in late February 2008 were reported at the local farmer rain gauge in Jibberding (Lee Farm), with above average rain also reported for the Dalwallinu North BoM station in February. This unseasonal rainfall caused water levels in the valley floor to rise above monitored pre-drain levels across the bore transect in March 2008, with the largest observed increases in the bores located 98 m (JB12) and 198 m (JB13) from the drain.

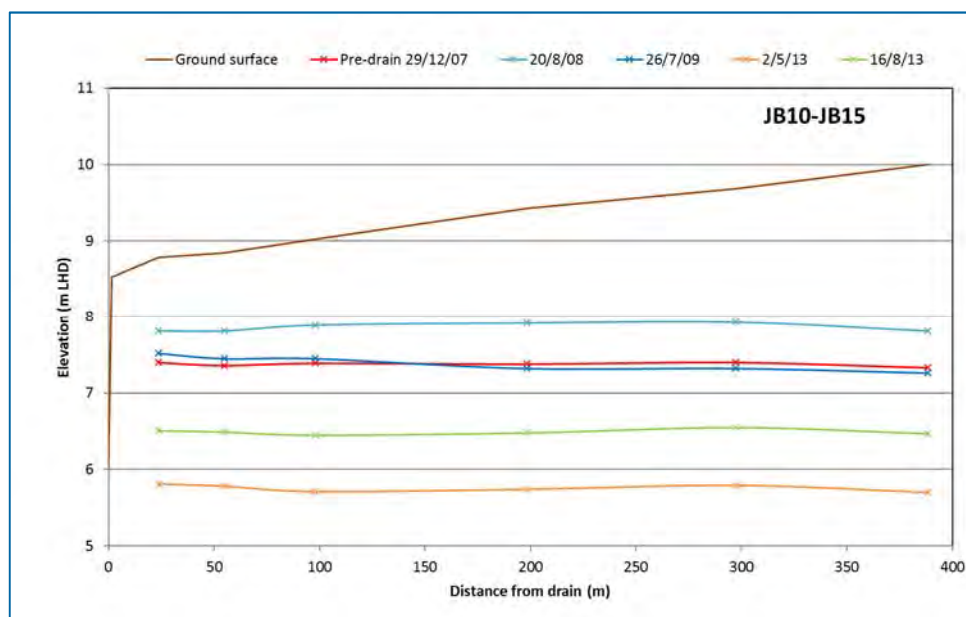
Figure 23 Wasley Road transect watertable profiles

During both peak and baseflow groundwater periods the hydraulic gradient across the transect is generally flat (Figure 23). Between June and December 2011 there is an extended period of reversal of the hydraulic gradient away from the drain (Figure 22). During this period the observed rainfall record at both the Sunnydale and Dalwallinu North BoM stations returned to average winter rainfall, with above average rainfall observed for the September to December period.

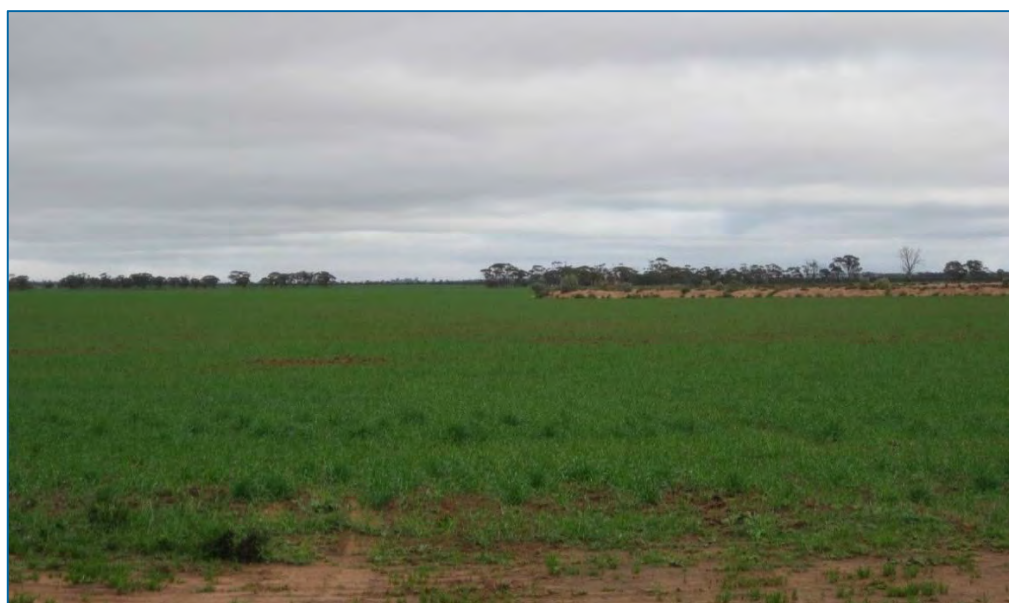
Plate 5: View south-west from Woolf Road transect towards corner of southern spur drain. Area further in distance now planted to wheat

Crop productivity improvements were reported by the landholder at the Woolf Road transect who observed that isolated areas of paddocks impacted by salinity had been reclaimed through construction of privately funded spur drains. The landholder had constructed a spur drain to a southern paddock (west of the bore transect) at the same time as construction of the arterial drain to connect a 20 ha area that was previously unable to be cropped, with the area now cropped as wheat (Plate 5). Additional private spur drains constructed by the landholder included a previously constructed drain to the south of the arterial drain (located east of the bore transect), and a more recently constructed spur drain to the north.

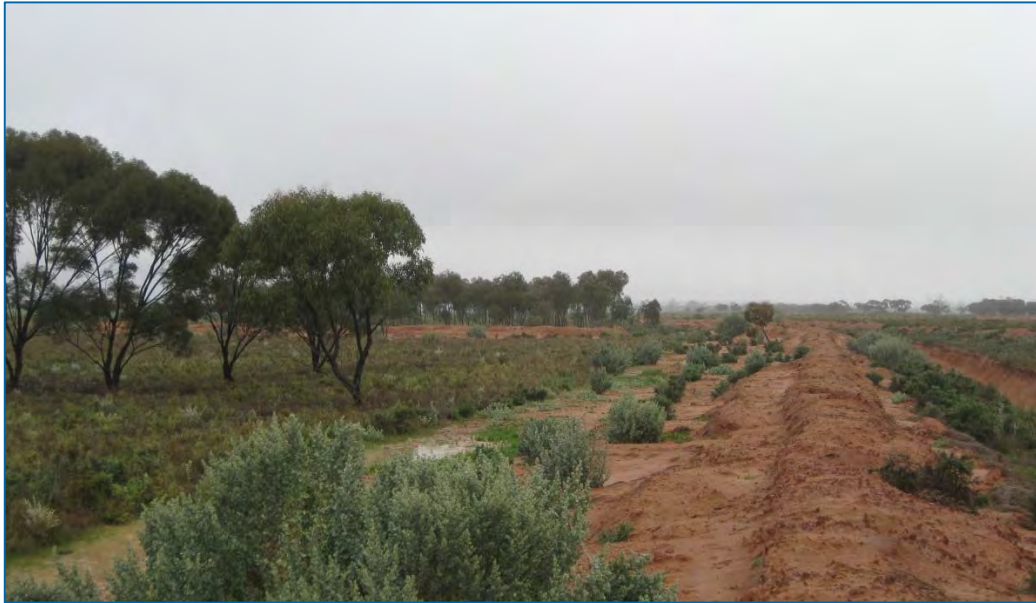
Plate 6: View west-south-west from Woolf Road transect looking upstream towards southern spur drain, showing adjacent vegetation.

During the site visit in June 2016 rye grass and cape weed were observed to be growing in the valley floor area of the Woolf Road transect suggesting that the area is less saline than previously. The landholder intends to clear some of the privately planted oil mallee, York gum and saltbush for the purpose of preparing the soils for barley cropping following ripping and application of gypsum.
