Seagrass snapshot: Leschenault Estuary 2022–23

Through the Healthy Estuaries WA program, the condition and area of seagrass is being monitored in five South West estuaries, including the Leschenault Estuary. This snapshot provides an update on the distribution of seagrass in the Leschenault Estuary in February 2023.

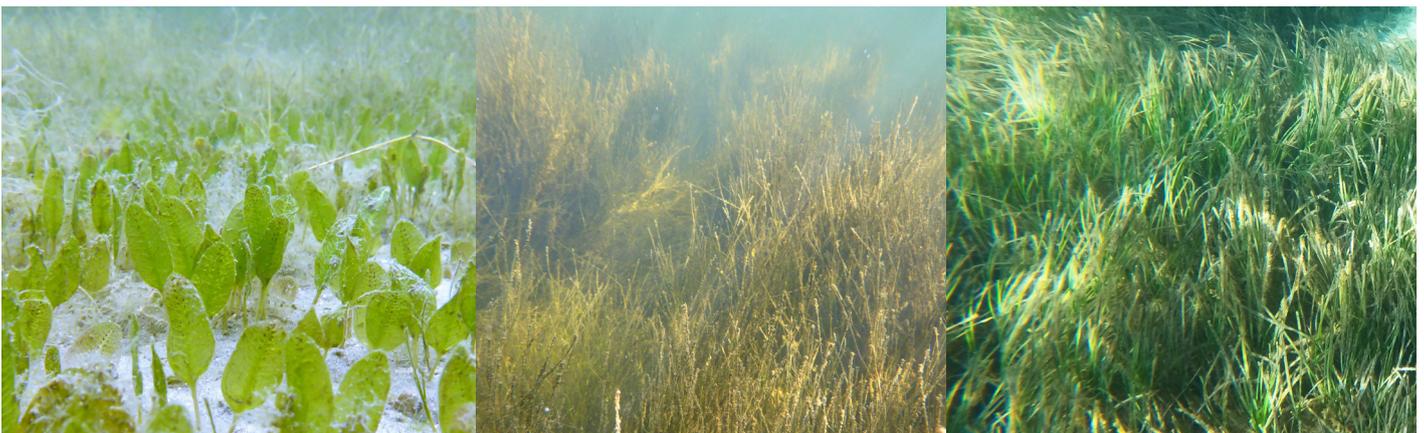
Three species of seagrass occur in the Leschenault Estuary. *Halophila ovalis* (left image) is dominant and is generally found throughout the estuary basin. *Ruppia megacarpa* (centre image) is often observed along the eastern shoreline. *Zostera muelleri* (right image) is found near The Cut, where the waters are more marine.

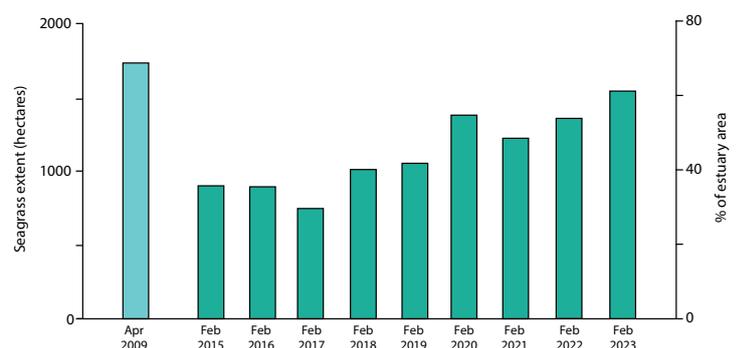
Seagrass over time

- Historically, seagrass was distributed throughout the estuary, except in a small area of deep water in the central basin.
- In April 2009, seagrass covered 1,741 hectares of the estuary – about 69 per cent of the estuary area.
- By 2014, there was a substantial loss of seagrass, particularly in the northern basin. This prompted regular monitoring to start in 2015.
- Seagrass is slowly recovering but is yet to return to the extent reached in 2009.

The Department of Water and Environmental Regulation monitored seagrass annually from 2015 to 2023. Seagrass distribution was lowest in 2017, increasing to more than 60 per cent in recent years. Seagrass started recolonising the northern estuary in 2020, which had not been observed since 2009.

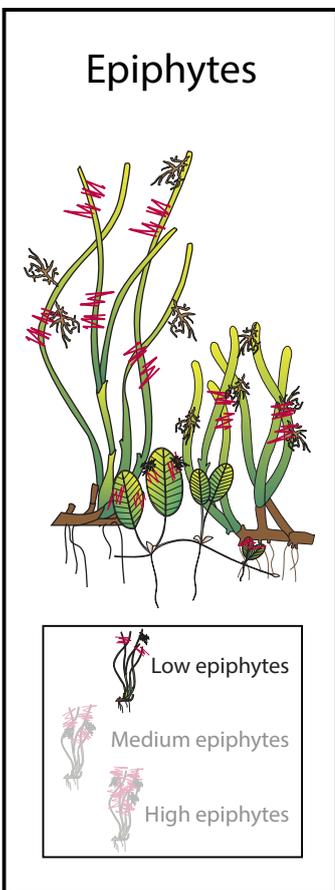
Seagrass distribution in February 2023

Seagrass was estimated to cover 1,549 hectares in February 2023, which is just over 60 per cent of the estuary area. Areas close to The Cut and along the eastern shoreline north of Australind continue to have the densest seagrass cover. Compared with 2022, there was a considerable increase in seagrass extent in the northern basin, and an increase in the density of cover observed north of Australind on the eastern shoreline.

The seagrass meadows are continuing to recover, particularly in the northern basin. *Halophila* was present across most areas of the estuary. *Ruppia* was dominant along the eastern shoreline and continues to expand its range in the north of the estuary. *Zostera* has maintained localised distribution close to The Cut, often in mixed meadows with *Halophila*.

While the abundance of small organisms growing on the seagrass leaves (epiphytes)¹ was low on average, there was medium to high abundance on the recovered meadows in the northern basin in February 2023.

Overall, seagrass in the Leschenault Estuary was in a stable and good condition in February 2023. The recovery of seagrass in the northern basin is ongoing and highlights the importance of continuing work to improve water quality.
