Seagrass snapshot: Wilson Inlet 2022–23

Through the Healthy Estuaries WA program, the condition and area of seagrass is being monitored in five South West estuaries, including Wilson Inlet. This snapshot provides an update on the distribution of seagrass in Wilson Inlet in December 2022.

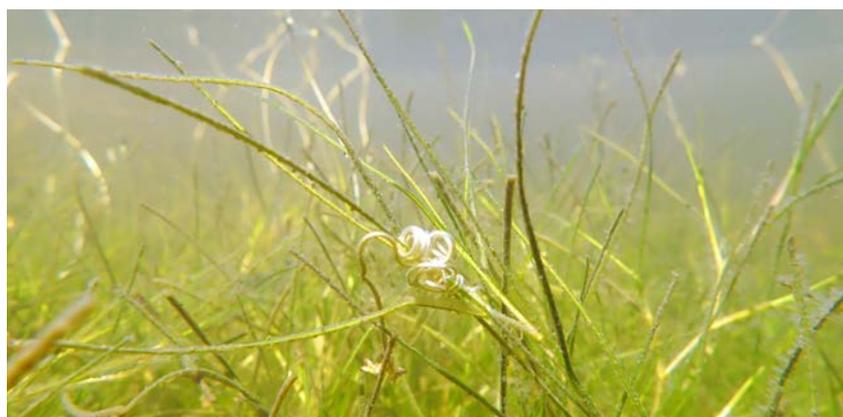
Once pollinated, the long white flower stalks coil tightly close to where it emerges from the leaves. Seagrass was seen flowering in many areas across the estuary in December 2022. This indicates the plants are reproducing, which can support a viable seedbank.

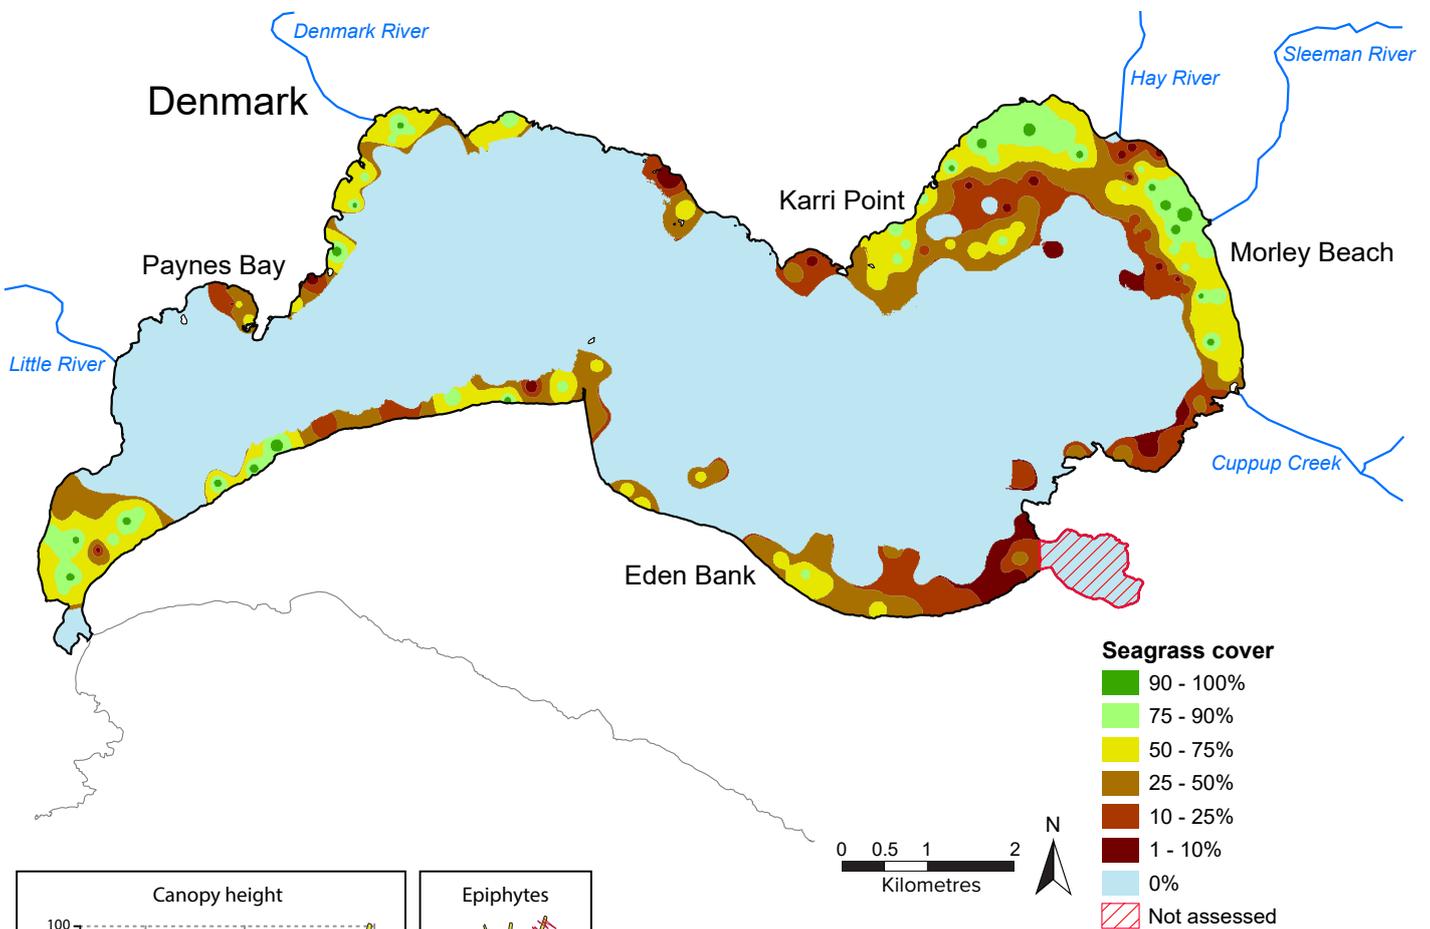
Seagrass distribution in December 2022

Seagrass was estimated to cover 1,293 hectares in December 2022, which is about 27 per cent of the estuary area. The seagrass appears to be recovering in some parts of the estuary, particularly in Paynes Bay where seagrass was not recorded in December 2021. Dense meadows were found in several areas of the estuary, including near the mouth of the estuary and at Denmark River, Karri Point and Morley Beach. While the meadows have been dense along Eden Bank in previous years, these were mostly absent in December 2022. Seagrass was found in shallow areas of the estuary, with more than 95 per cent growing in water less than 2 metres deep at the time of the survey.
