Erosion at Millstream Chichester National Park

April 2011

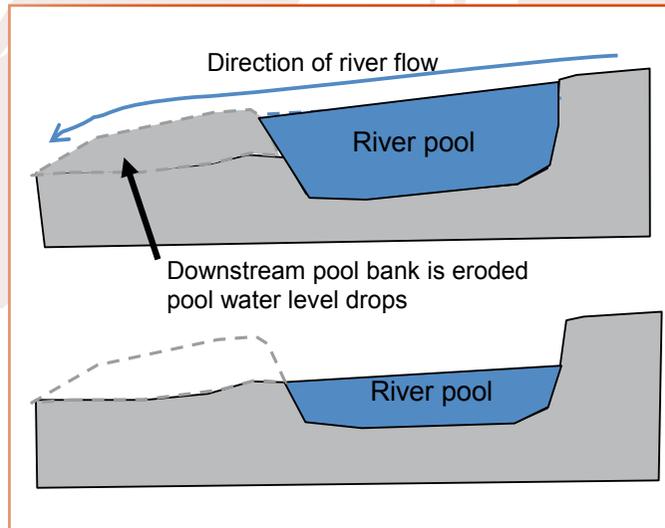
The major impacts includes loss of riparian vegetation, scouring of river channels and bank erosion at permanent pools. Bank erosion occurred at Crossing Pool in 1988 and more recently in 2009. As a consequence the water level of Crossing Pool is now about 2m lower with obvious impacts to this popular recreation site. Local groundwater levels have also dropped and surrounding vegetation is showing signs of water stress.
