FORESHORE AND CHANNEL ASSESSMENT OF TALBOT BROOK

WATER AND RIVERS COMMISSION
REPORT NO. WRM 29
2002

The Talbot Brook catchment drains portions of the Shires of York and Beverley into the Dale River which feeds the Avon River. Foreshore and channel assessments along Talbot Brook were undertaken between June and August 2001.

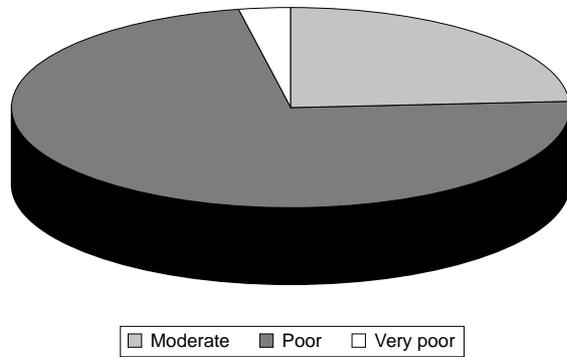
Figure 1. Bank stability and sedimentation ratings for Talbot Brook

Figure 1 shows that 24% of surveyed sections were rated as having moderate bank stability and erosion. The majority of sections (73%) were classified as poor and 3% as very poor. 9% of the surveyed sections were utilising artificial stabilisation techniques along the banks, meaning that techniques, such as log and rock walling, have been employed along the banks to protect degraded areas from further erosion and undercutting. There were also some locations (ie. road bridges) where channel stabilisation had been undertaken as part of engineering structures for safety reasons and to support the construction of such features.

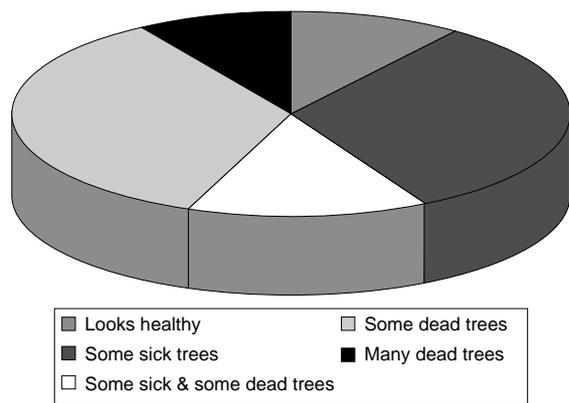
Figure 3. Vegetation health

Figure 3 shows that 32% of surveyed sections recorded some sick trees among the foreshore vegetation, while 35% of sites had some dead trees. Only 10% of sites were recorded as having healthy looking vegetation (ie. lots of leaves, natural regeneration of native species, lack of weeds, diversity of native species and a low level of disease and insects).

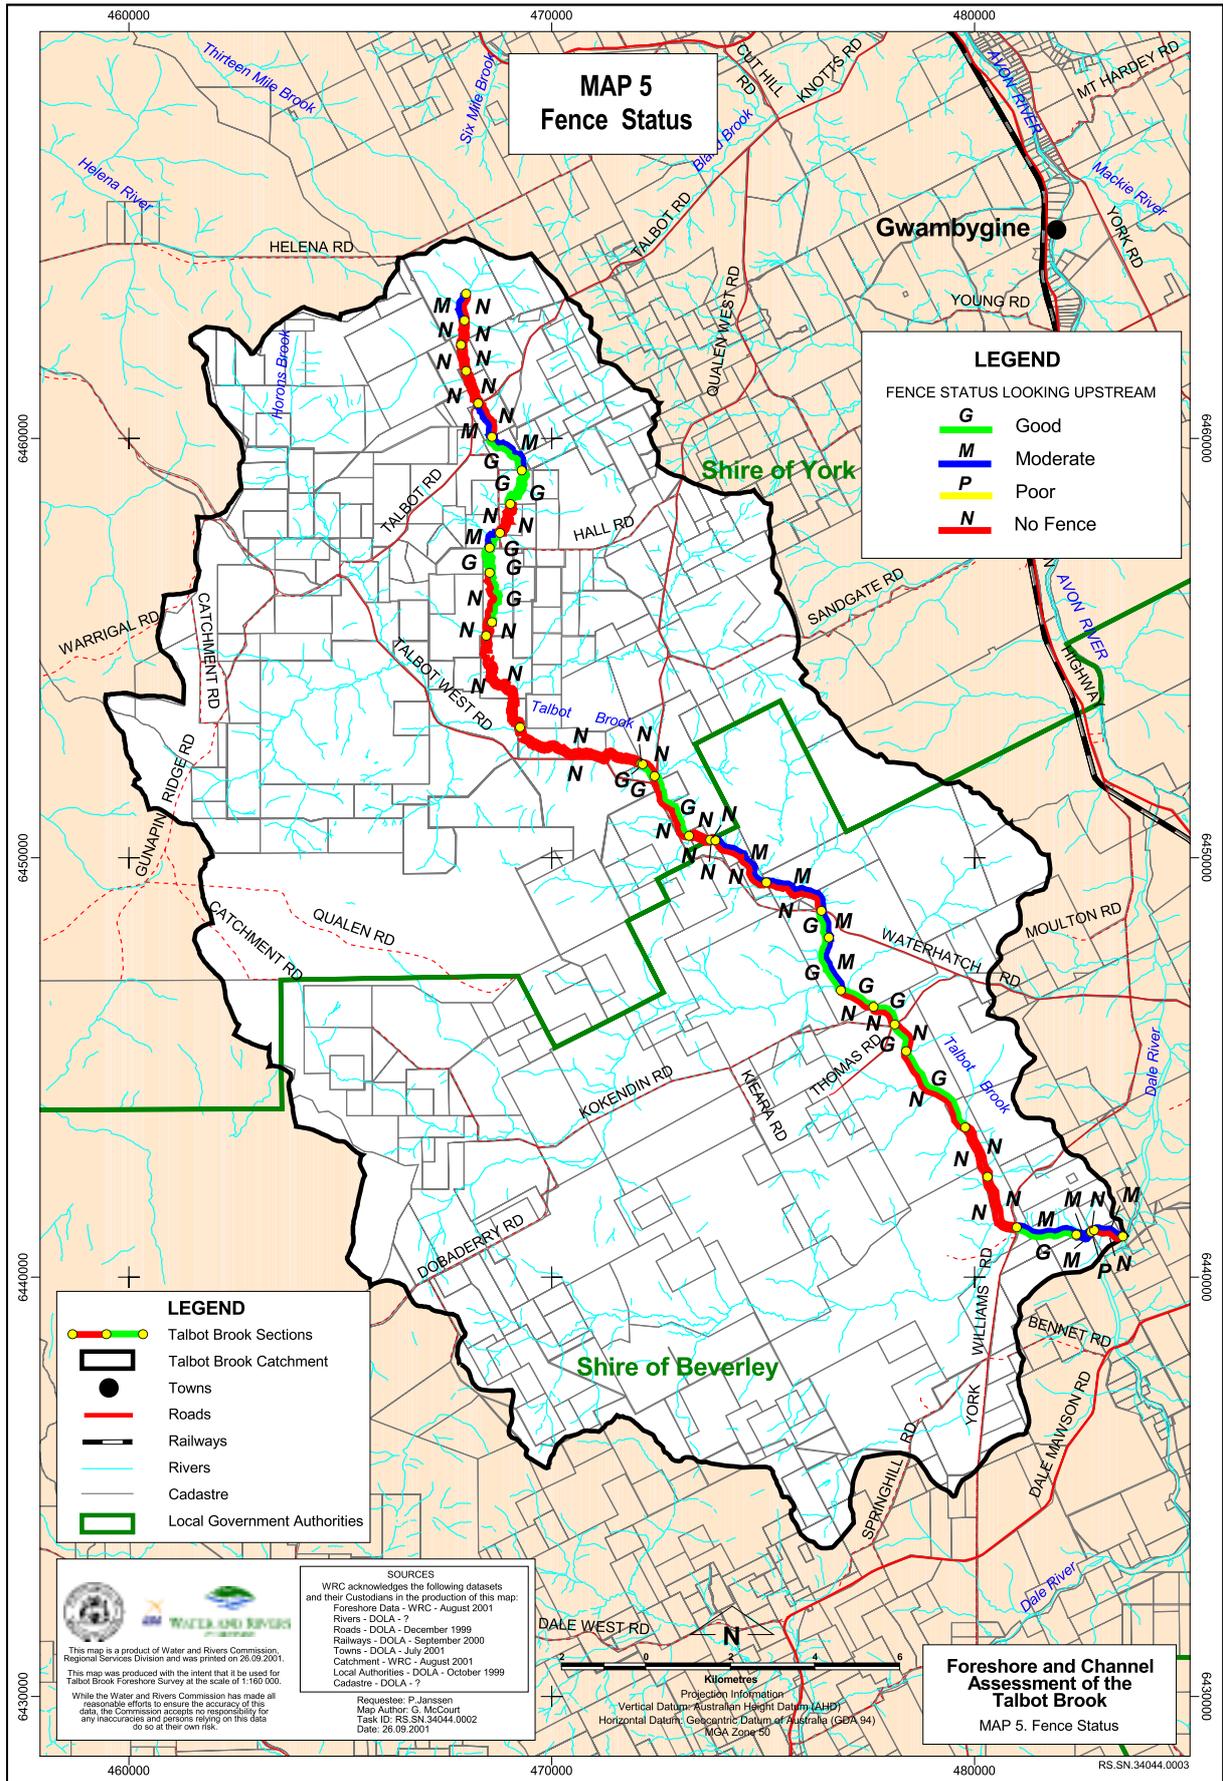
Map 5. Fence status

Distance of fence from riverbank (metres)	Proportion of sections in each category (%)	
	Left bank	Right bank
< 10	0	0
11 – 20	11	3
21 – 30	11	15
>30	23	29
Not fenced	55	53

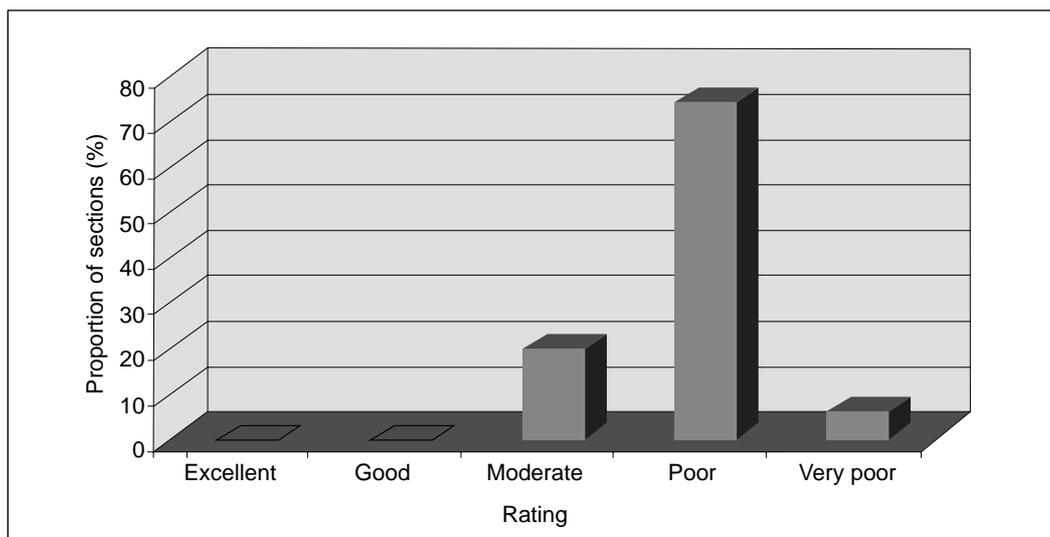
Figure 5. Overall stream environmental health ratings

The results in Figure 5 show that only 20% of the surveyed sections were classified as having a moderate stream health, 74% as poor and 6% as having very poor stream health. The dominantly poor health rating of the brook was mainly due to poor ratings in all categories with the exception of stream cover and habitat diversity of which 65% and 88% of sites respectively were rated as moderate, as shown in Table 7. Appendix 4 provides a description of each factor at each level of health.

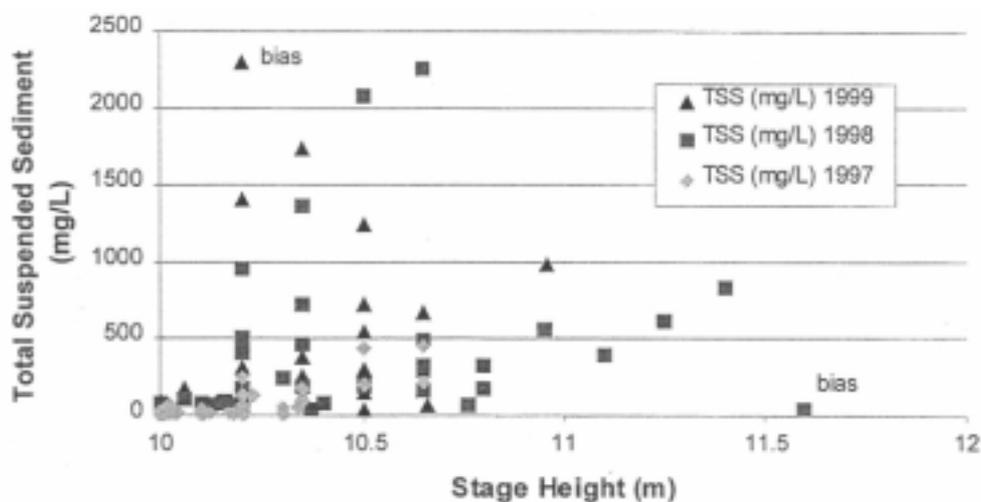
Figure 3: Total suspended sediment versus stage 1997 – 1999

Figure 3 clearly depicts that our measurements of TSS in 1997 were significantly correlated to stream flow - with a correlation coefficient value of 0.757 . This means that there was a good trend for an increase in flow to be associated with an increase in TSS, as we might expect. The clear relationship that we can see is likely to be influenced by the comprehensive data set of both fixed grab and IHS samples taken over the year. This provides us with adequate variation in flows not only during storm events, but also during 'normal' flow conditions.

Looking at Figure 3, there were two samples clearly acting as a bias to the trend. One sample was taken where a high flow of 11.6 m had very low suspended sediment levels (42 mg/L). This sample was a fixed grab taken at the peak flow of the major event sampled on the 31st August 1998, once the brook had exceeded its bankful capacity and flooded onto the surrounding floodplain. The low suspended sediment content reinforces the role of the floodplain in the dissipation of the stream energy, and therefore its ability to carry sediment. That is, once the brook exceeded bankful, the suspended sediment load was deposited onto the floodplain.

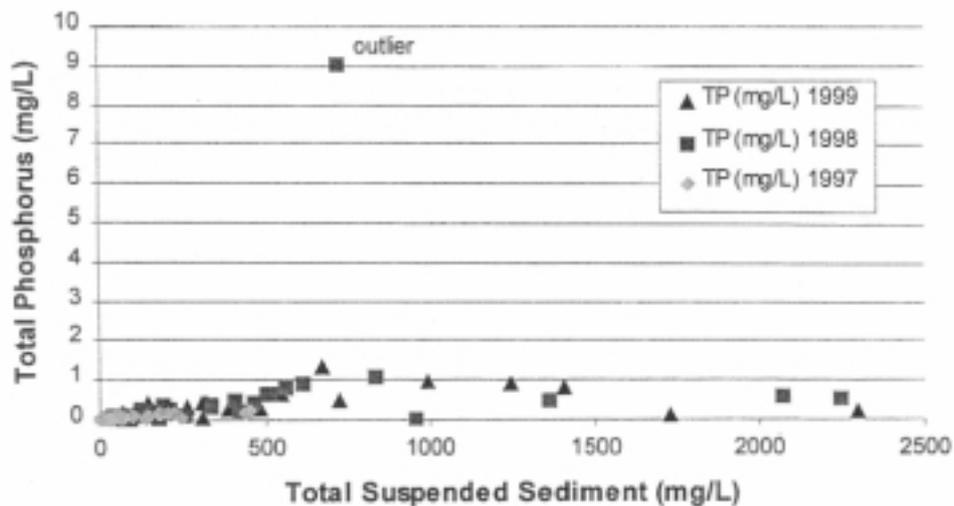
Figure 4: Total Phosphorus versus Total Suspended Sediment 1997 – 1999

In 1998, there was one sample that recorded an extremely high TP result compared to remaining samples – marked on Figure 4 as an ‘outlier’ because of its extreme value. This sample was taken from the IHS B (second from the base at 10.35 m) during the storm event on the 31st August 1998. In Natarsha’s lab notes she had commented that this sample was "very, very muddy", indicative of the high suspended sediment load. This outlier has been removed to look only at the TSS and phosphorus relationship with the remaining samples (Figure 5).

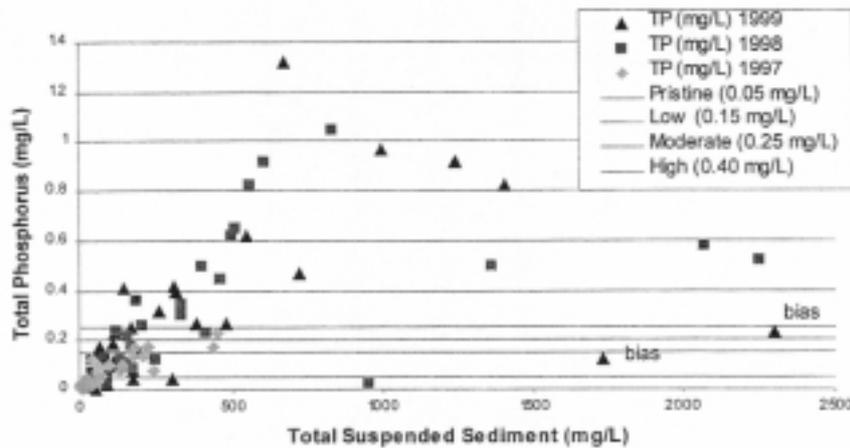
Figure 5: Total Phosphorus versus Total Suspended Sediment 1997 – 1999 (outlier removed)

Figure 5 depicts samples taken in both 1997 and 1998 showing a positive correlation between TP and TSS. This is as we would expect – an increase in sediment was associated with an increase in TP (correlation coefficients of 0.886 in 1997 and 0.558 in 1998).

In 1999, however, the correlation coefficient was significantly lower at 0.418. Looking at Figure 5, there are two samples that are acting as a bias to the 1999 trend we would expect – where high sediment levels had comparatively low TP levels. These samples were taken during very different circumstances.

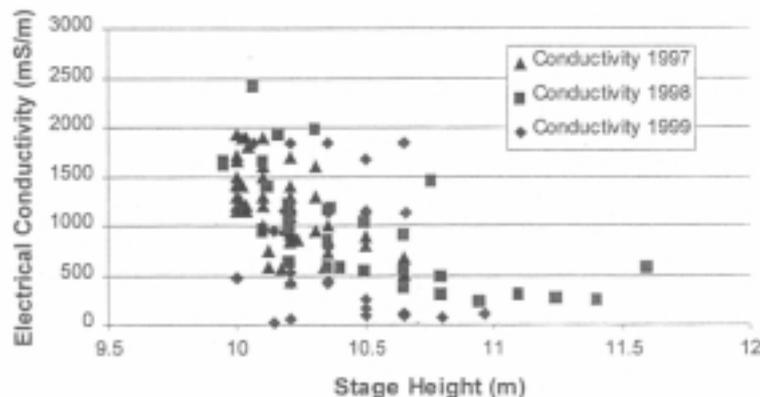
Figure 7: Electrical conductivity versus stage, 1997 – 1999

Figure 7 depicts that in 1997 and 1998, EC was related the stage - with correlation coefficients of -0.581 and -0.674 respectively. That is, an increase in flow decreases the salt content.

Figure 7 depicts no clear relationship between EC and stage height in 1999, with a coefficient value of -0.198 . This lack of a direct relationship may indicate that there were insufficient fixed samples taken to establish a trend. In 1999, the samples were taken from different stage levels during the same three events – when EC may be effected by both dilution and incoming salt from surface runoff.

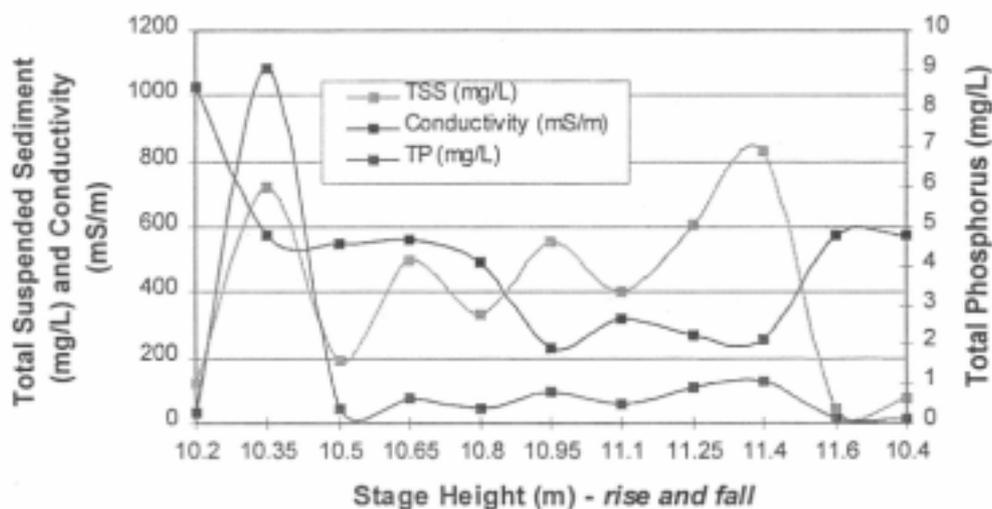
Figure 8: Major flow event at Talbot Brook 31st August 1998

We can see the clear relationship between flow and conductivity. As the level of water in the brook increased, the conductivity levels decreased with the effect of dilution. This clear trend suggests that the overall salt load in the creek did not alter much over the event.

We have already established that there is a strong relationship between TP and TSS, and we would therefore expect the two parameters to follow one another closely. The initial peak in both TP and TSS is following high rainfall on saturated soils - massive overland runoff causing phosphorus-rich topsoil to be washed into the brook. After the initial peak, both TSS and TP values decline sharply - as rainfall soaks into the land its power to erode decrease. As the water in the brook rises, its gains energy to erode sediment from within the channel. We can see a gradual increase in both TSS and TP levels until the water level exceeds bankful capacity at 11.6 metres flooding the surrounding floodplain and depositing its bedload.
