River Recovery Plan for the Dale River

Incorporating foreshore and channel assessment

REPORT NO. RRP 10
APRIL 2006

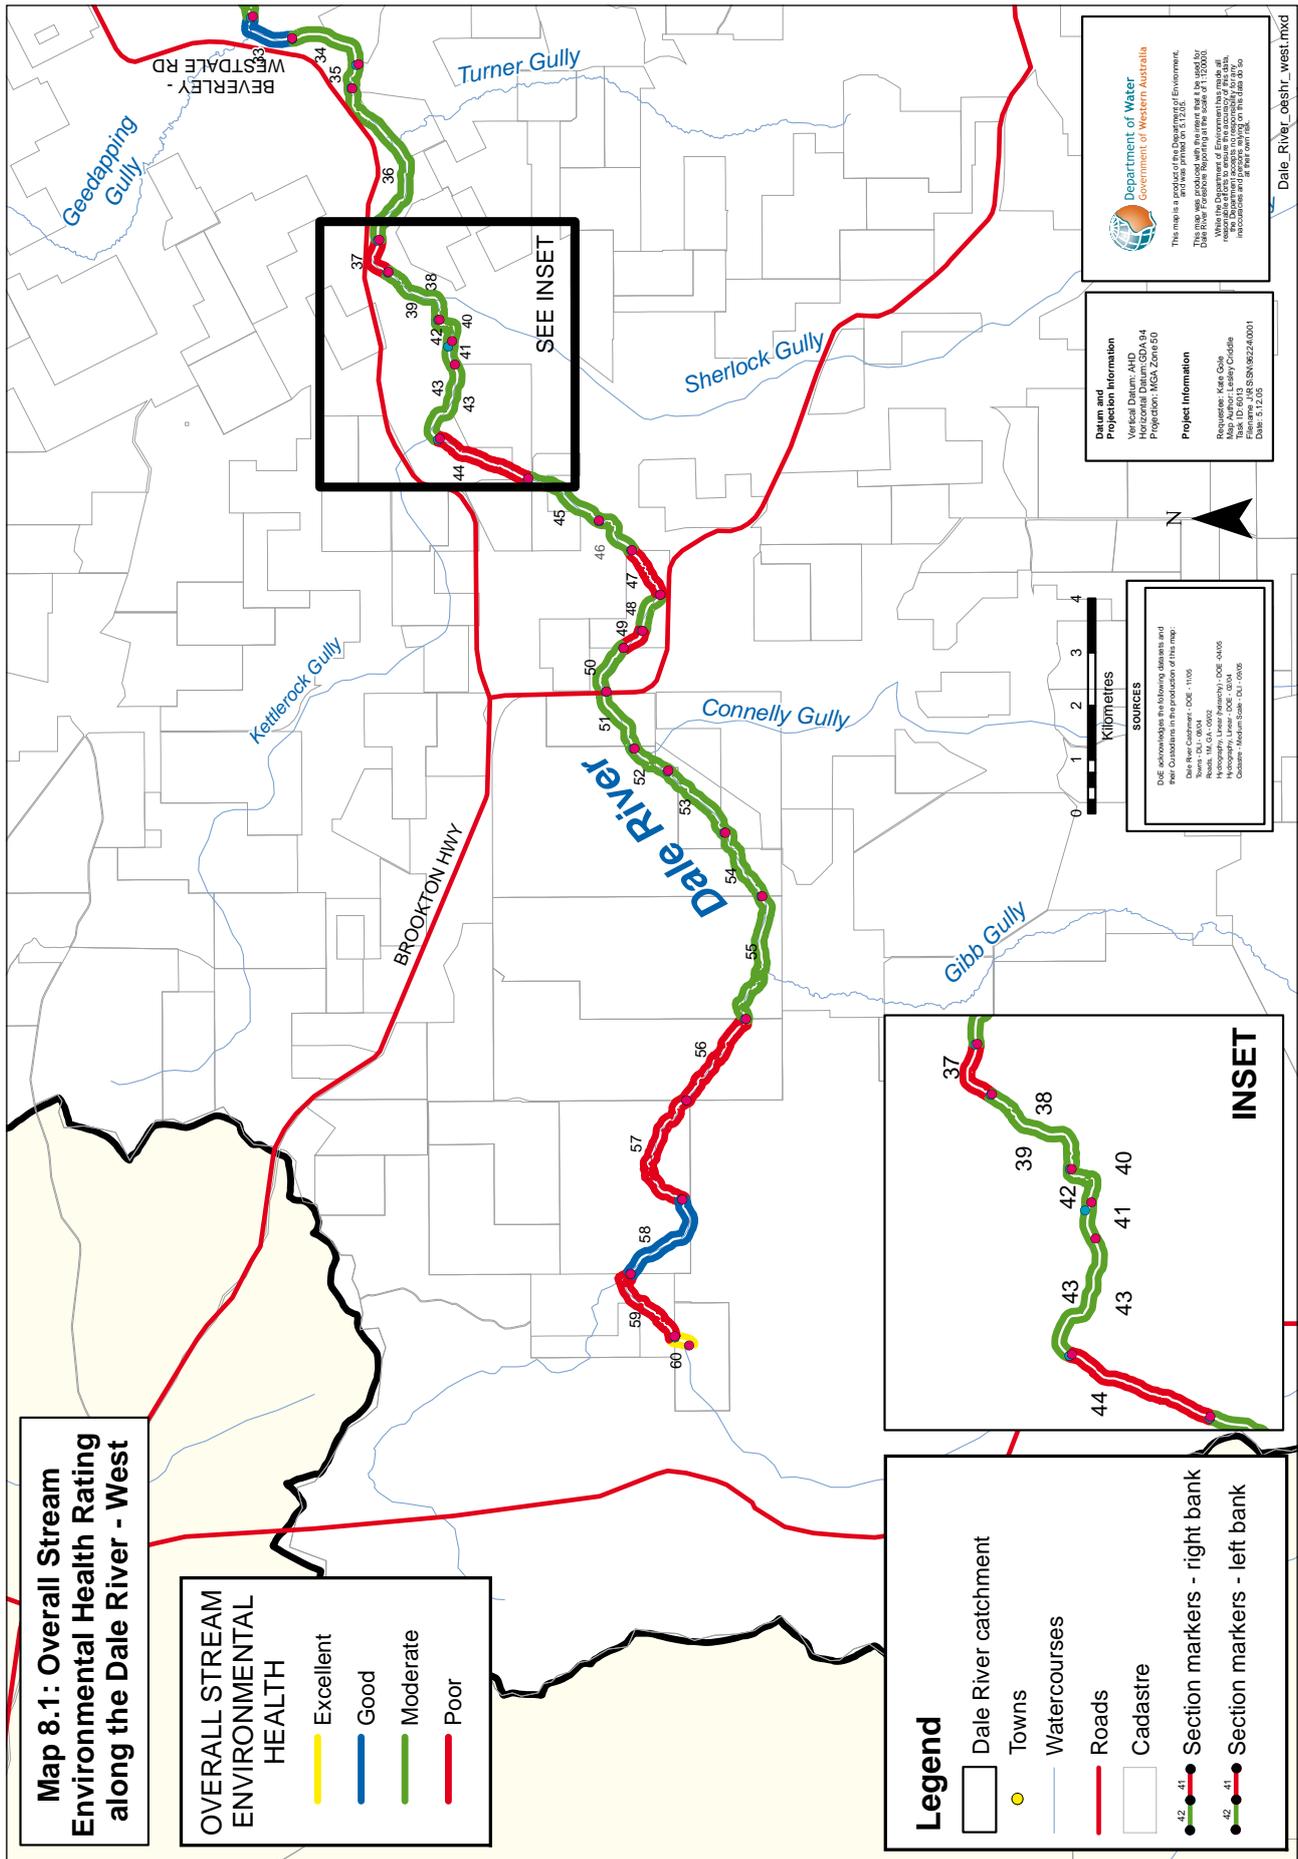
Map 8.1. Overall stream environmental health rating along the Dale River – West

Seventy-seven percent of sections have a moderate overall stream environmental health rating (OESHR) with 18% of sections rating as poor, 3% as good and 2% as excellent (Maps 8.1 and 8.2). Most of the individual categories are scored as moderate (Table 8) however the stream

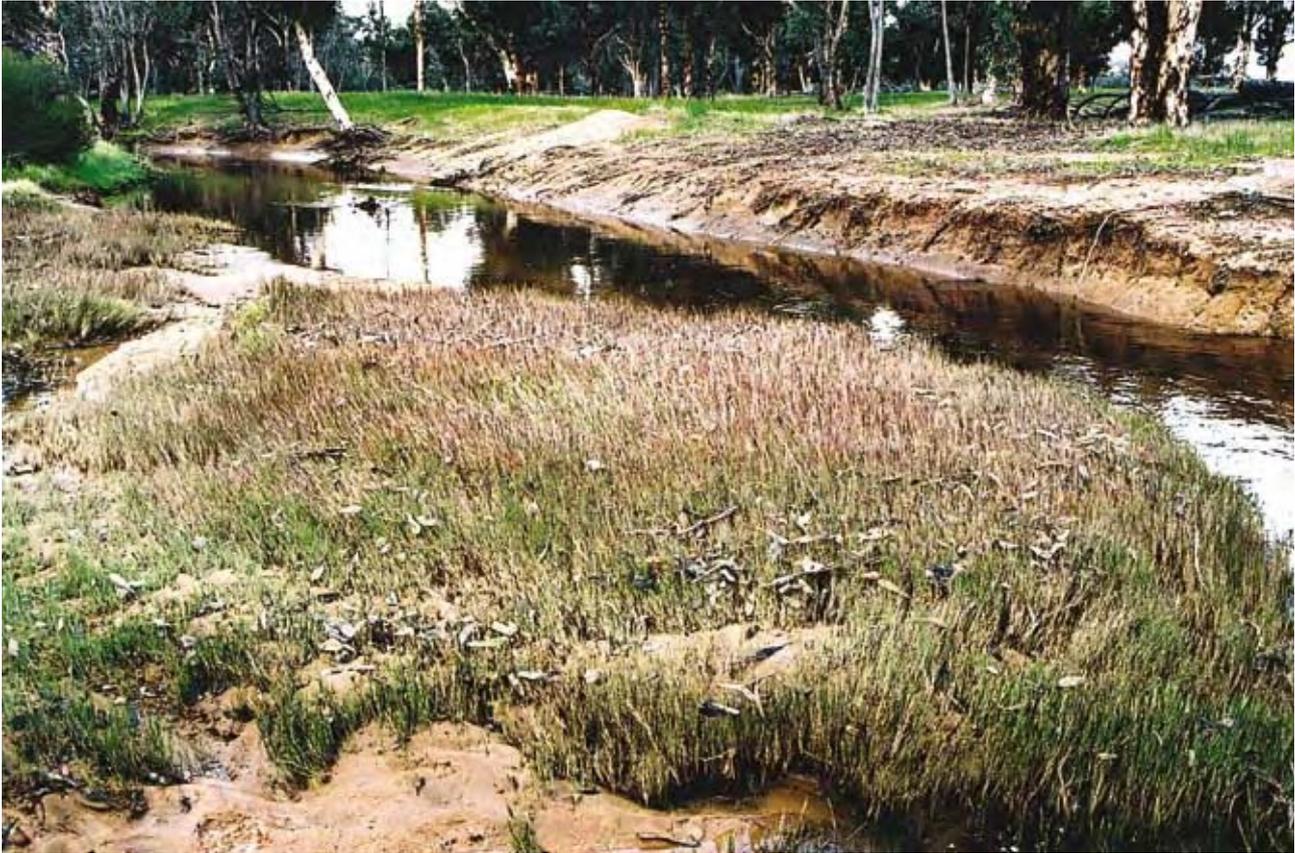
Image 7. Native marine couch colonising sediment

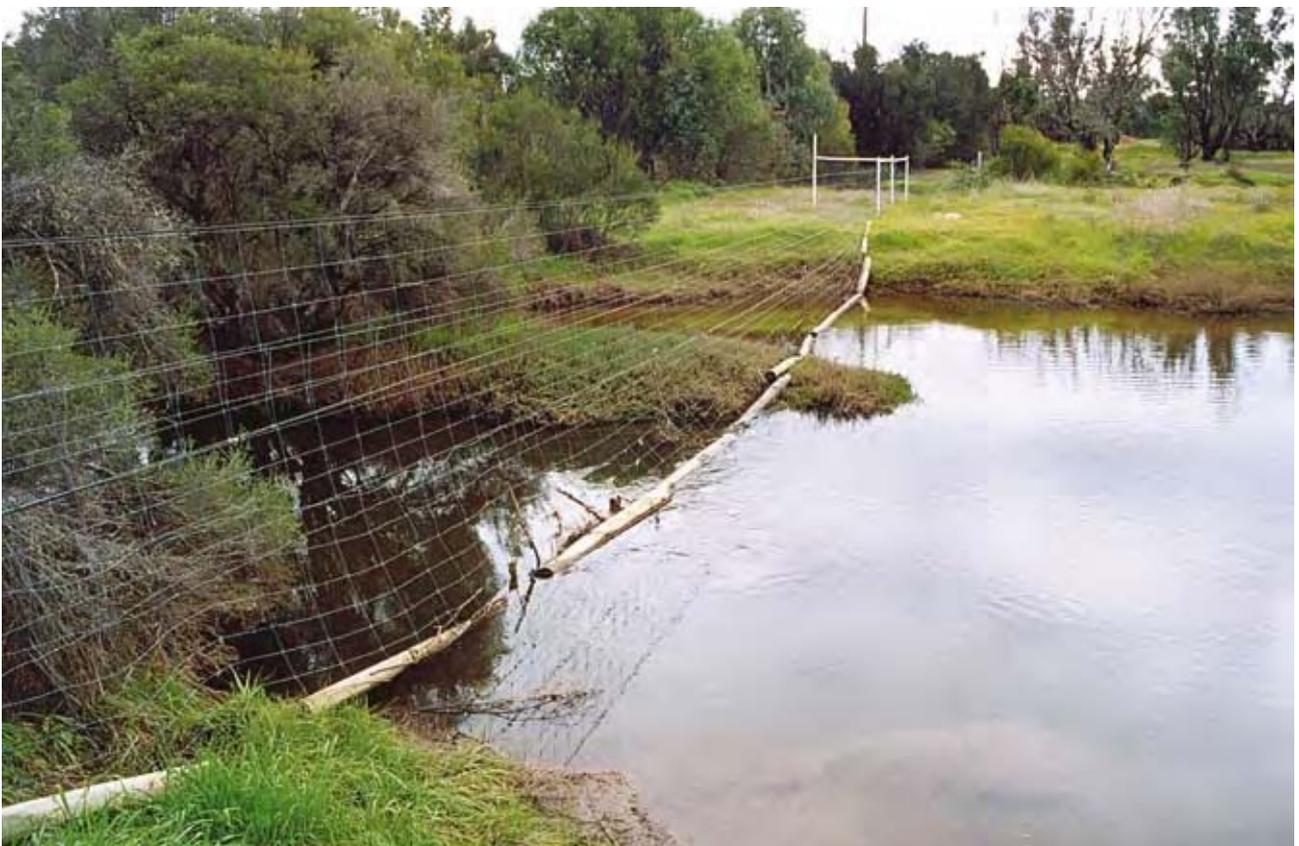
Image 9. A well-constructed, well-maintained cross-channel fence

Fences can be constructed to resist flood damage by constructing them with the least vertical height that gives adequate stock control, locating posts as close together as possible and in as firm soil as possible, that is in clay as opposed to sandy soils. Fences crossing waterways also need regular maintenance to prevent damage from accumulating flood debris (Images 8 and 9).

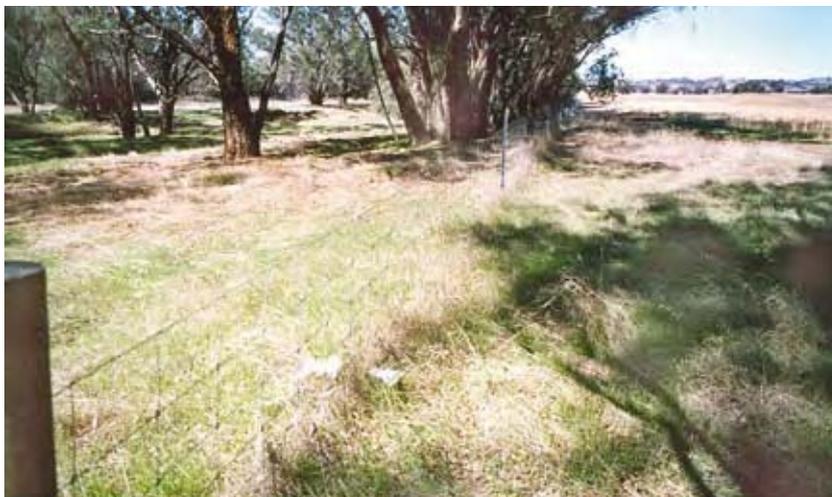
Fence condition:
GOOD.
