Bulong Tailings Storage Facility

Likelihood of Failure Assessment & Dam Break Study

121085.01 R01 (Rev 0) SEPTEMBER 2021

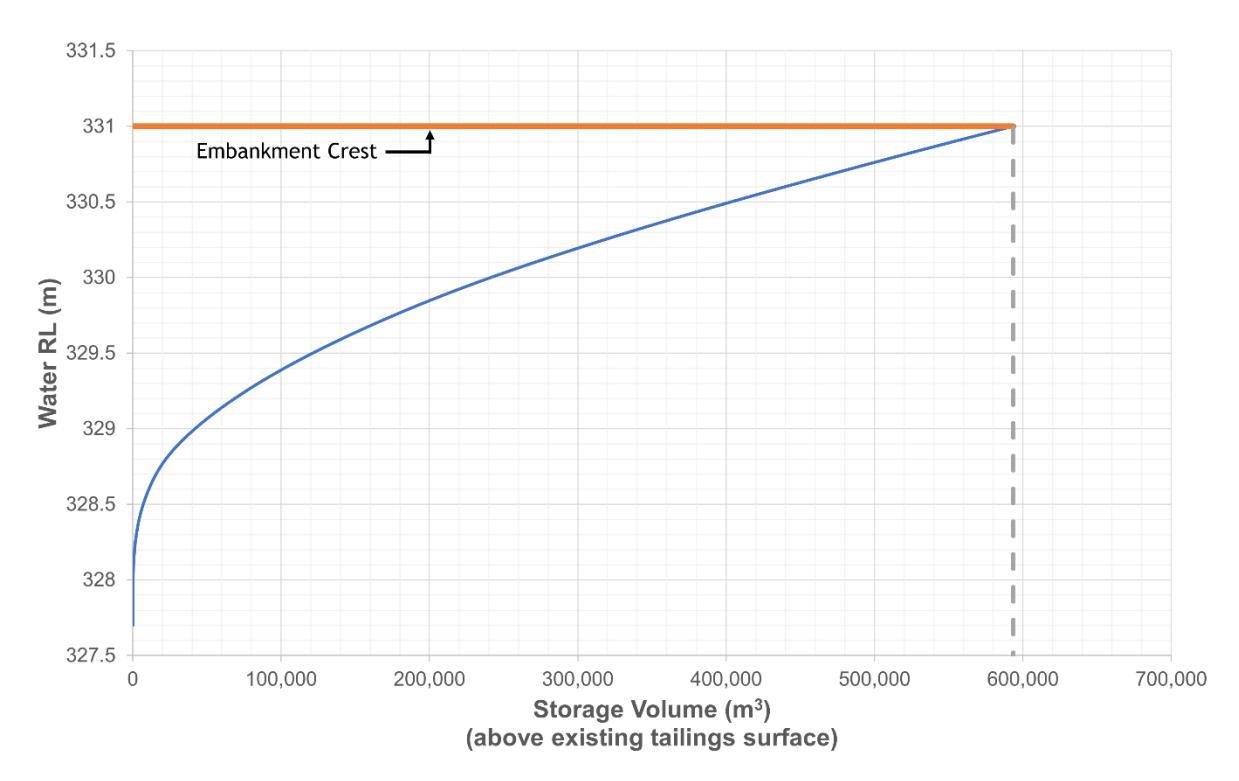
CHART 2 : BULONG TSF POND STORAGE CURVE

Based on the pond storage curve presented in **Chart 2**, the total maximum storm storage within the TSF is approximately 594,000 m³.

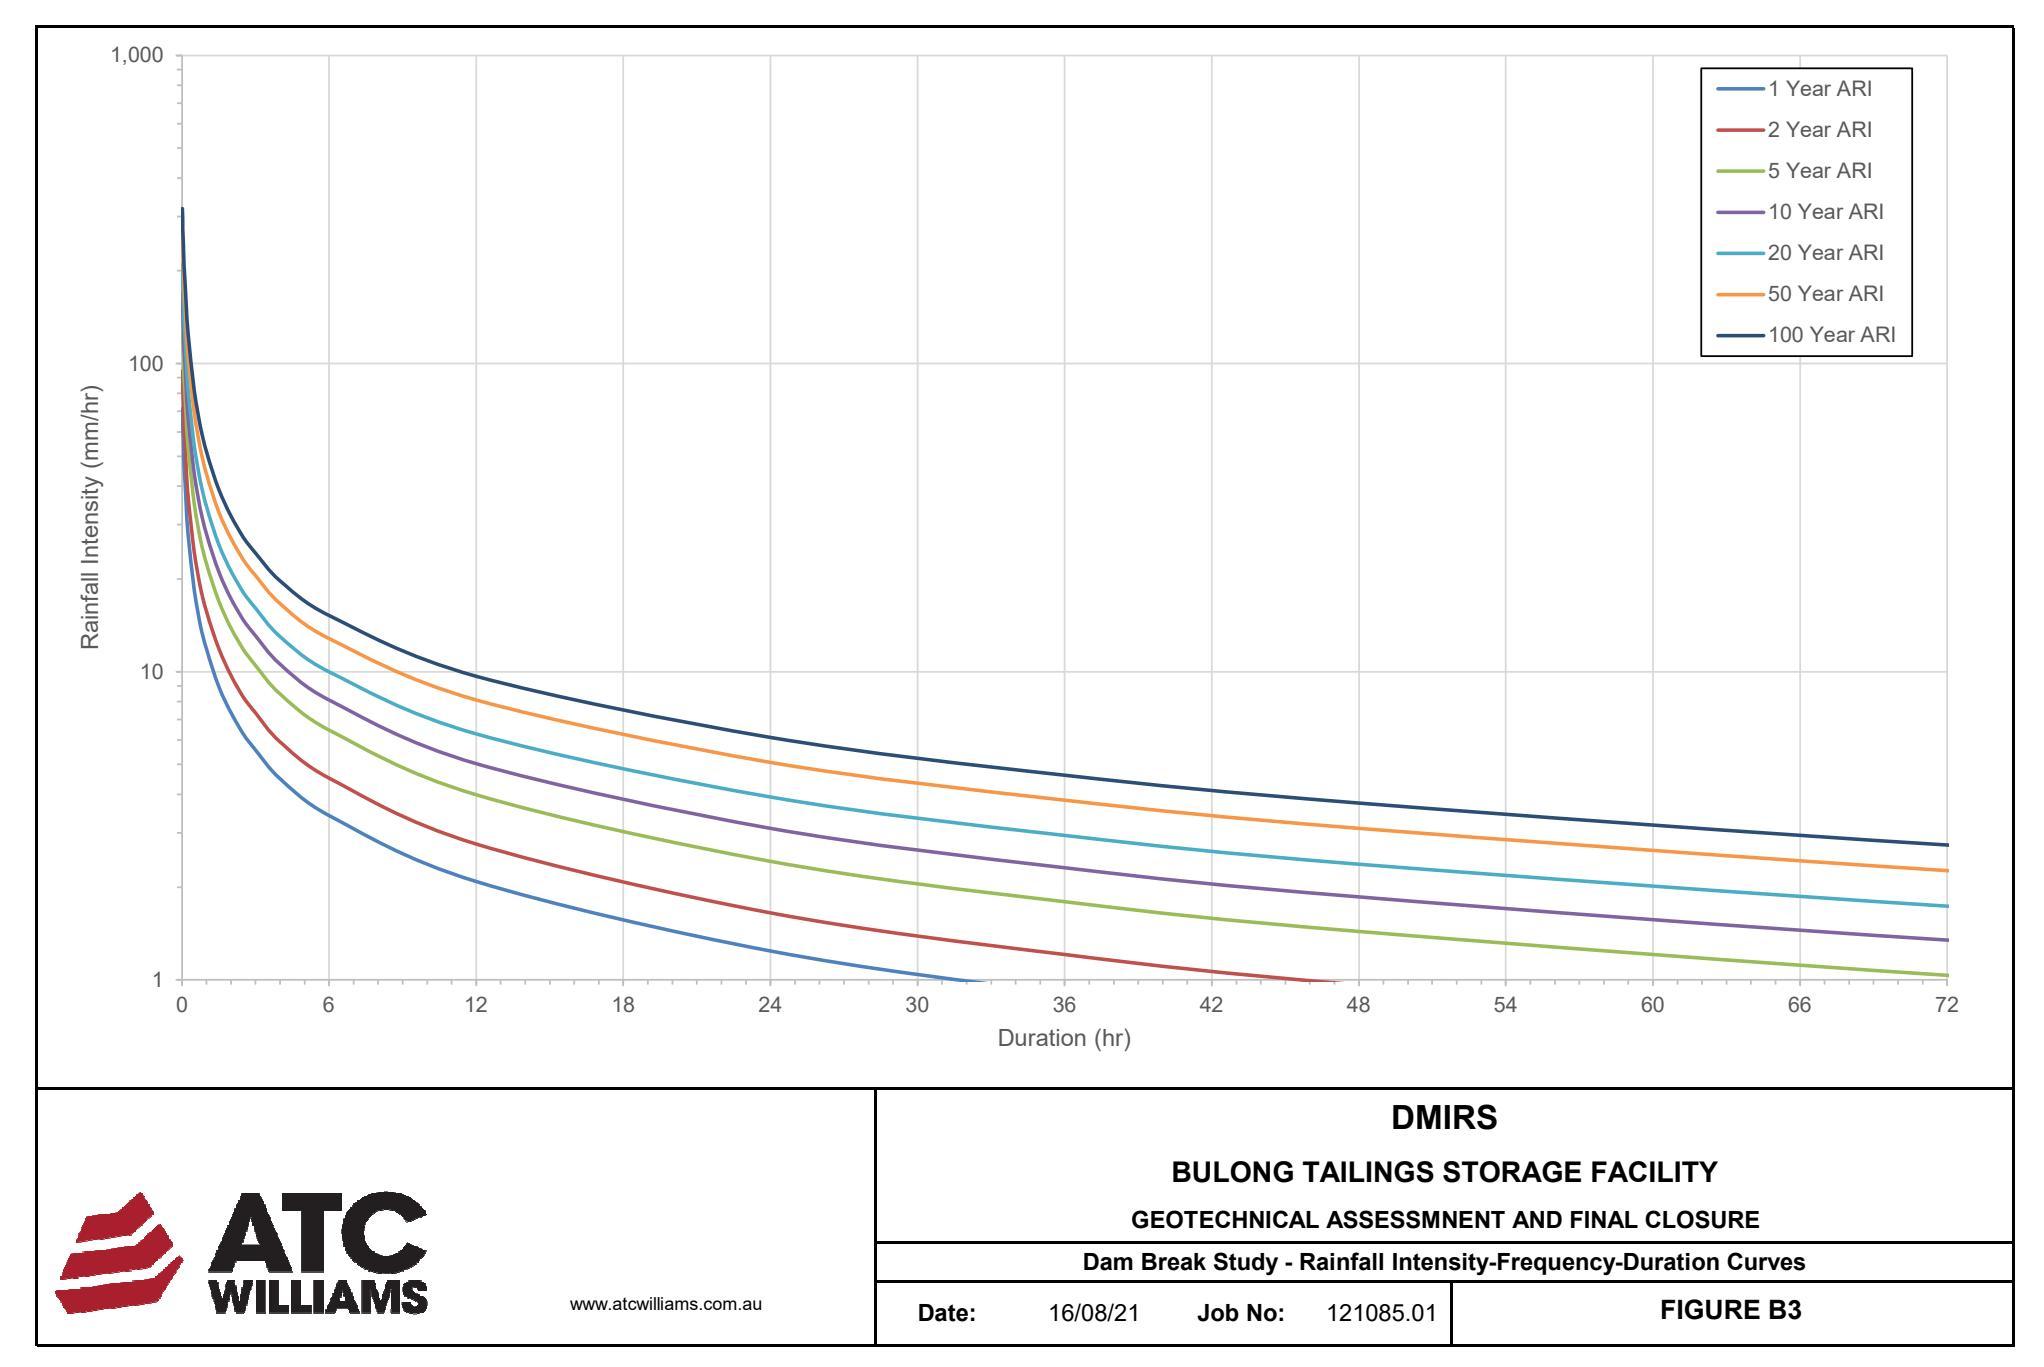
K:\Projects\121\121085 DMIRS Abandoned Mines Program\01 Bulong TSF Assessment\Data and Calcs\Rainfall\PMP Estimate Bulong TSF.xlsx Fig3

A chart of the design rainfall depths is presented in Figure B3 & B4 of Appendix B.
