Department of Energy, Mines,  
Industry Regulation and Safety

# Compliance Inspection Report Three

Timber roof tie-down and wall framing

January 2025

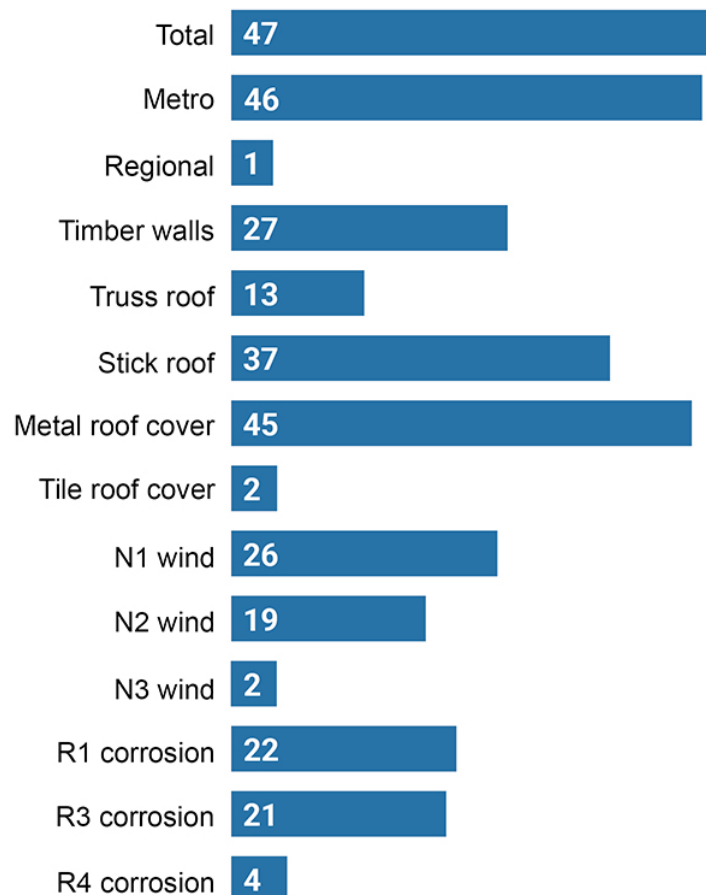
**Table 1. Building Characteristics**

Of the 47 buildings inspected, 46 were within the Perth metropolitan region, 27 included sections of timber wall framing, 13 included trussed roof parts, 37 included stick roof construction and 45 had metal roof cover. Additionally, the inspected buildings covered a range of wind classifications from N1 to N3 and corrosion classifications from R1 to R4.

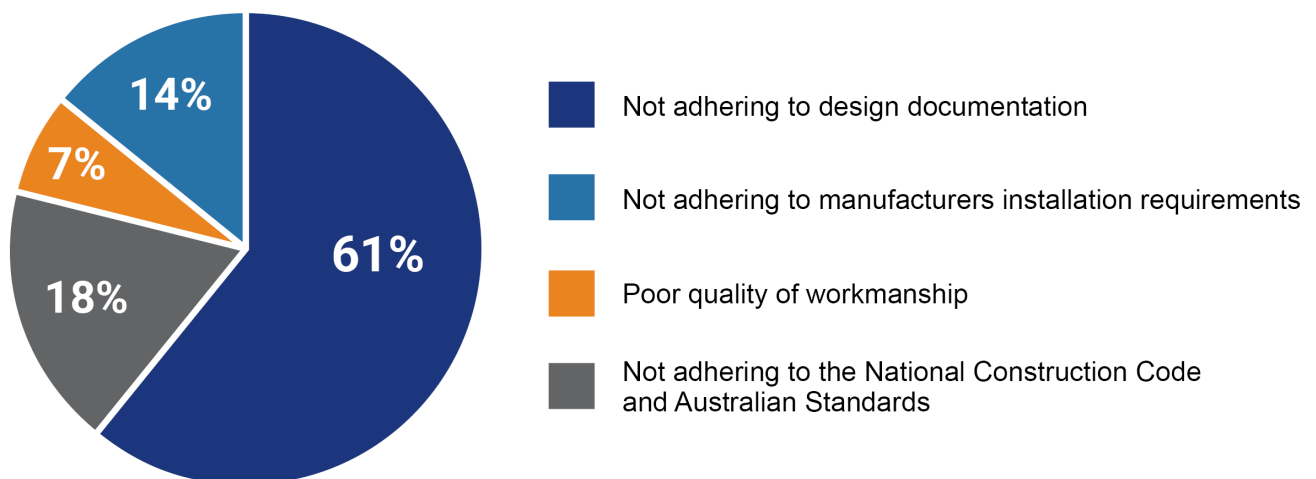
**Table 3. Unsatisfactory building work by category**

Table 3 shows percentages of the 237 items found to be unsatisfactory attributed to categories.

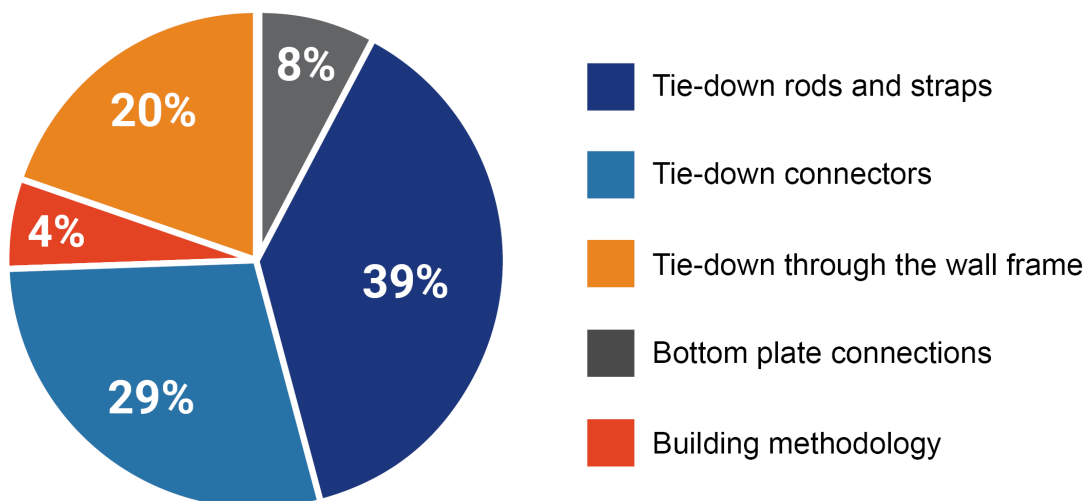
**Table 4. Non-adherence to design documentation by category**

Table 4 shows percentages of the 145 items of unsatisfactory work categorised by how they were observed to not adhere to the approved documentation.

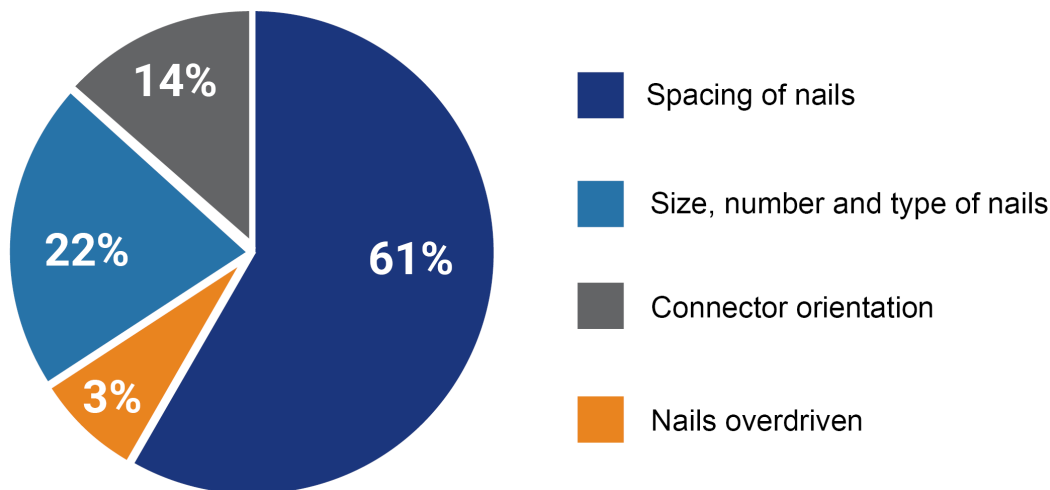
**Table 5. Unsatisfactory installation of timber connectors by category**

Table 5 shows percentages of the 34 items found to be attributed to not adhering to the manufacturer’s installation requirements against each one found to be unsatisfactory.
