AVON WATERWAYS COMMITTEE RIVER RECOVERY PLAN Section 14,15,16 – Beverley to Qualandary Crossing

Roger Underwood of York Gum Services for Water and Rivers Commission and Avon Waterways Committee

WATER AND RIVERS COMMISSION
RIVER RECOVERY PLAN
REPORT No RRP 5
JANUARY 2002

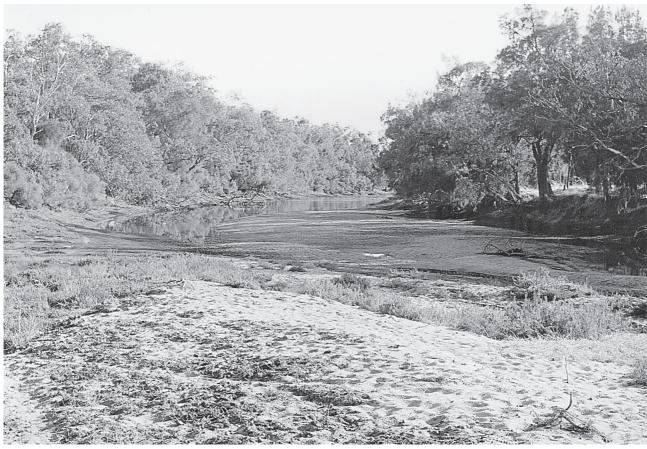
Sediment slug approaching Eyres Pool

A major cause of down-river sediment movement is the higher velocity of the river in the wake of the River Training Scheme.

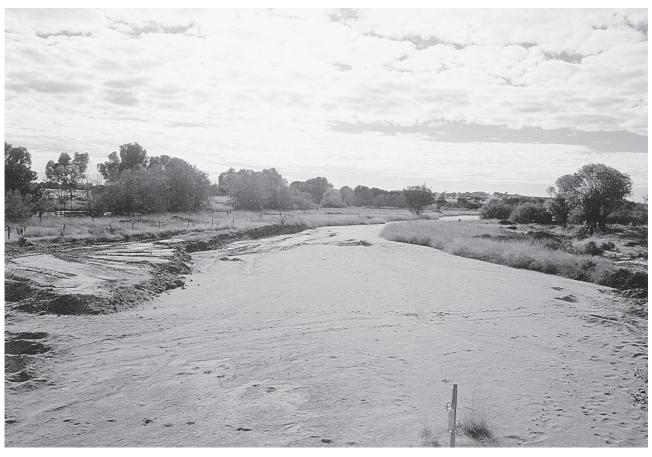
Monjerducking Gully

The three main tributaries of the river in this section are Monjerducking Gully, Turkey Cock Gully and Bally Bally Gully. A third 'tributary' is the South Branch of the river; this is covered in a Recovery Plan for Section 18. There are a number of minor tributaries, generally without names, including the swampy drainage line running east and north of Kokeby townsite which flows into Kellerberin Lake (an ephemeral lake close to the Avon, just north of Kokeby).

The management of tributaries is critical, as they are the principal source of new sediment entering the river. However, any work on tributaries requires cooperation of landowners through whose land they flow.

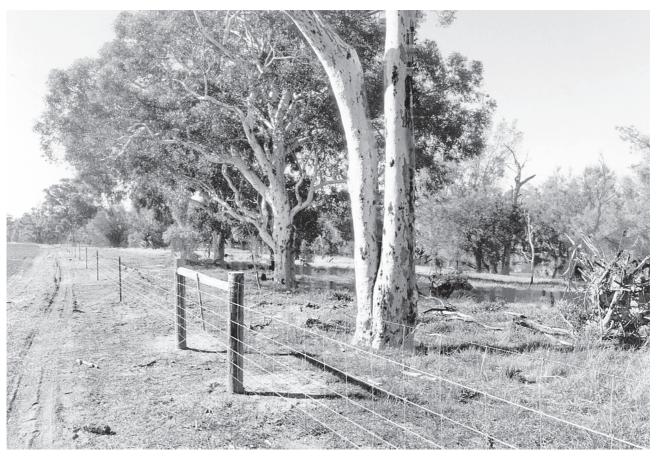
Fencing along the Avon River

- Fenced both sides = 29.5 km
- Fenced one side = 9.5 km
- Fenced neither side = 2 km
- 24.5 km of existing fencing require maintenance/ replacement in order to be stock (sheep) proof.
