# *Structure Plan 'Serpentine Special Rural'*

*Lot 9001 Utley Road and Lot 9002 Wattle Road, Serpentine*

Prepared by  
Hex Design and Planning

This report represents an application to the Shire of Serpentine Jarrahdale to consider a proposed Structure Plan Comprising Lot 9001 Utley Road and Lot 9002 Wattle Road, Serpentine.

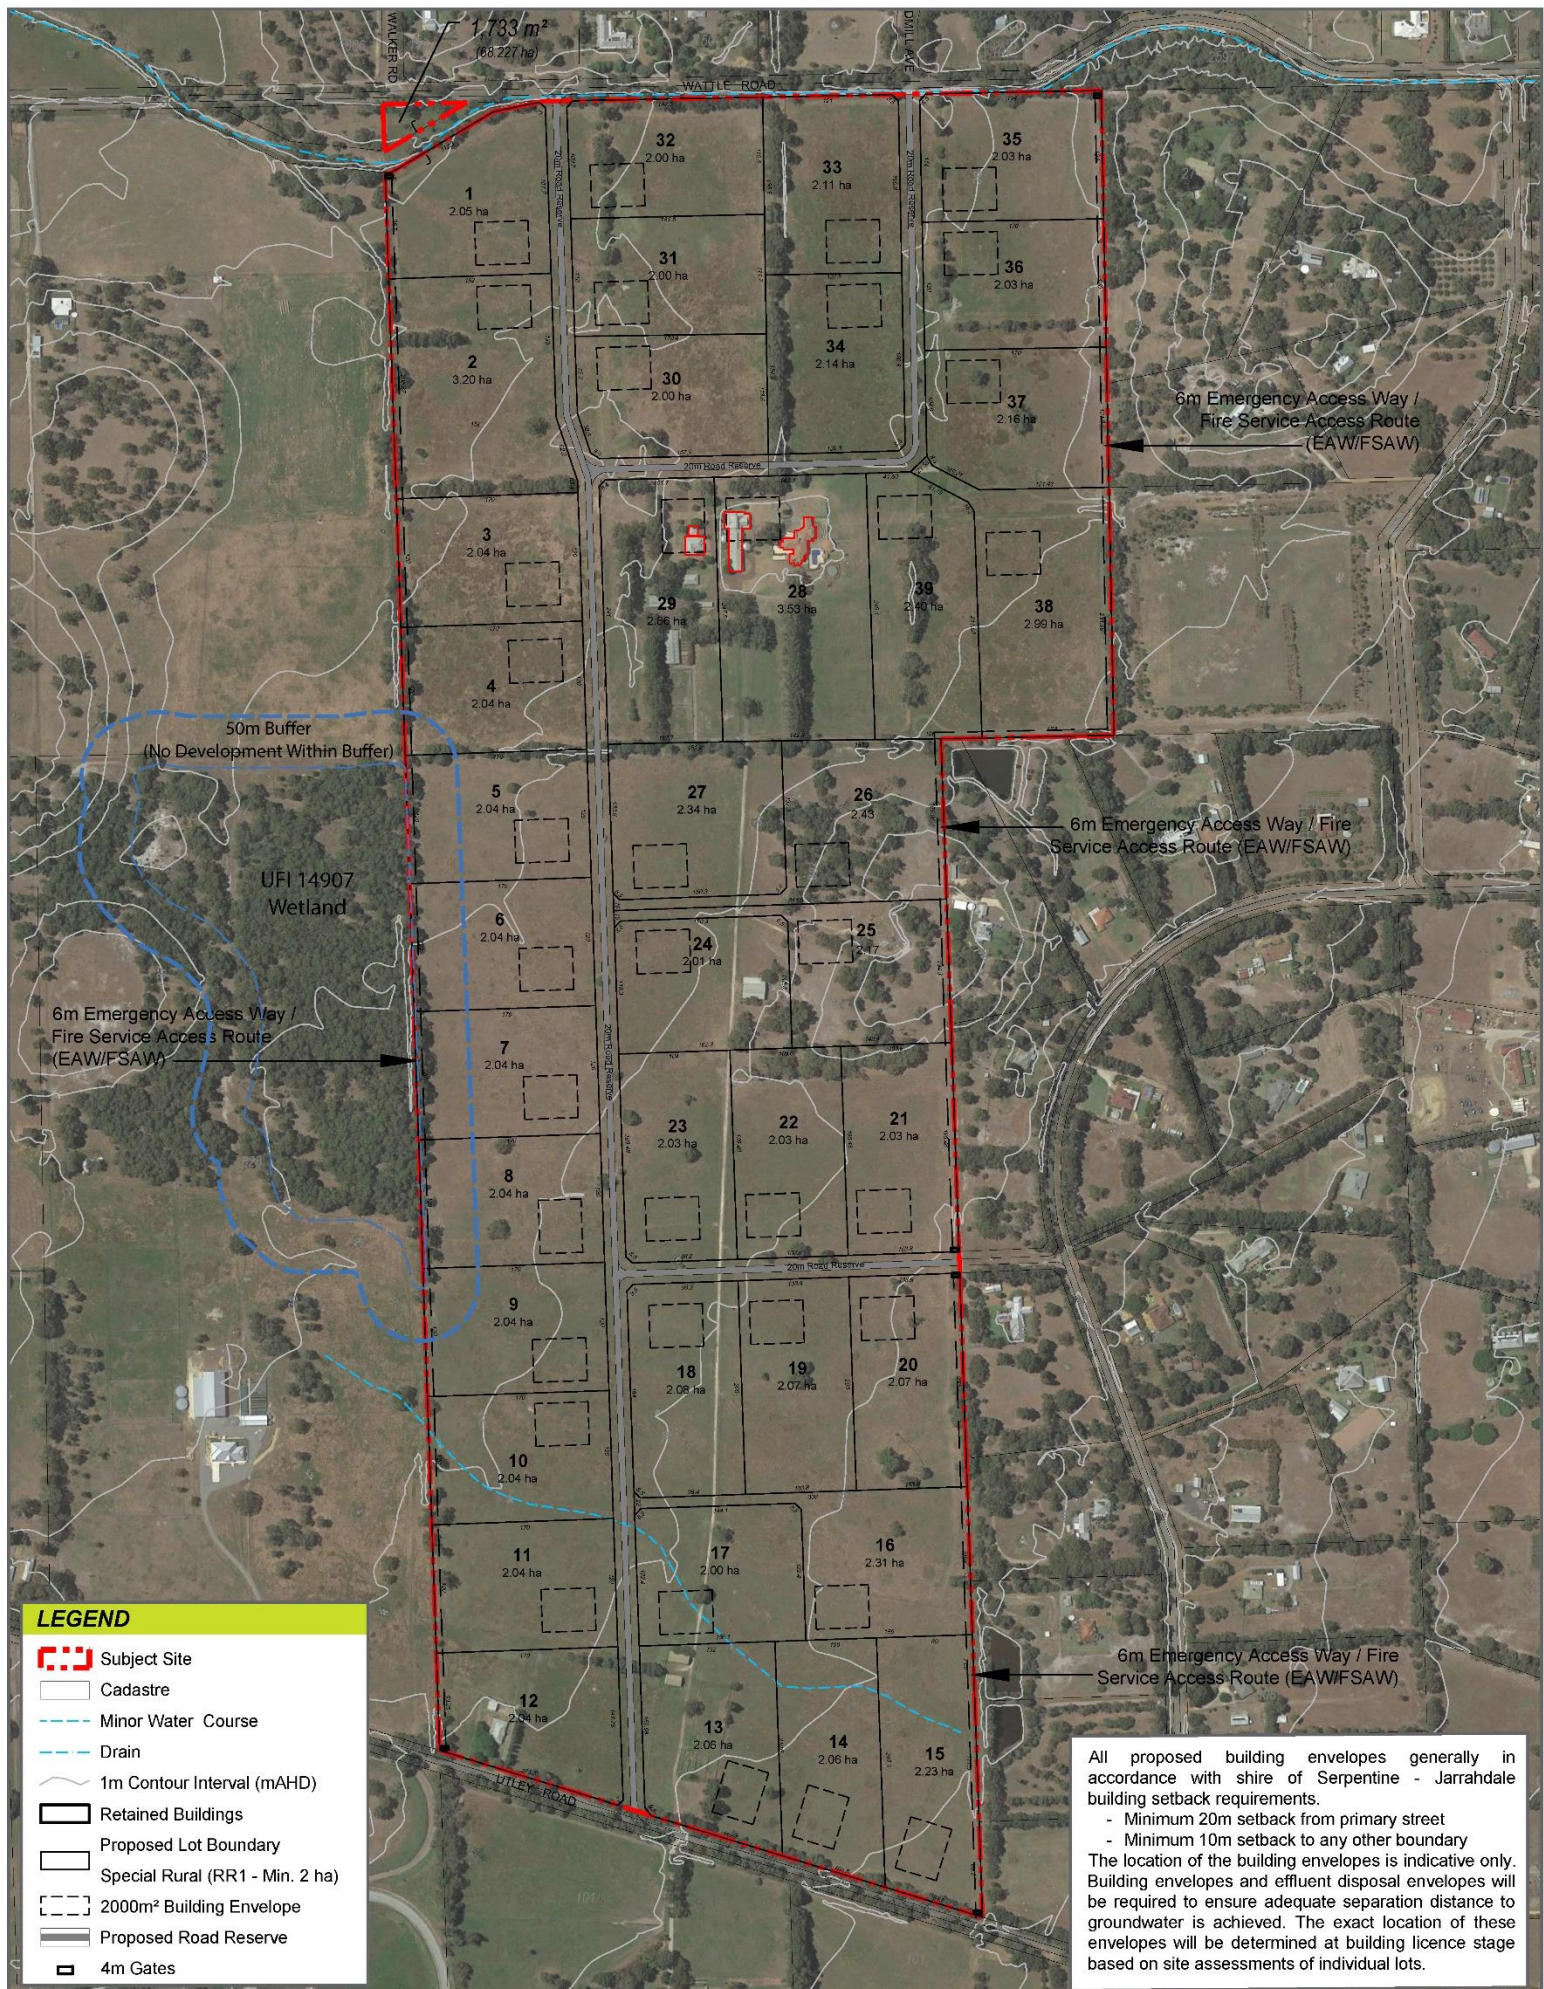
## STRUCTURE PLAN

Lot 9001 Utley Road & Lot 9002 Wattle Road - Serpentine

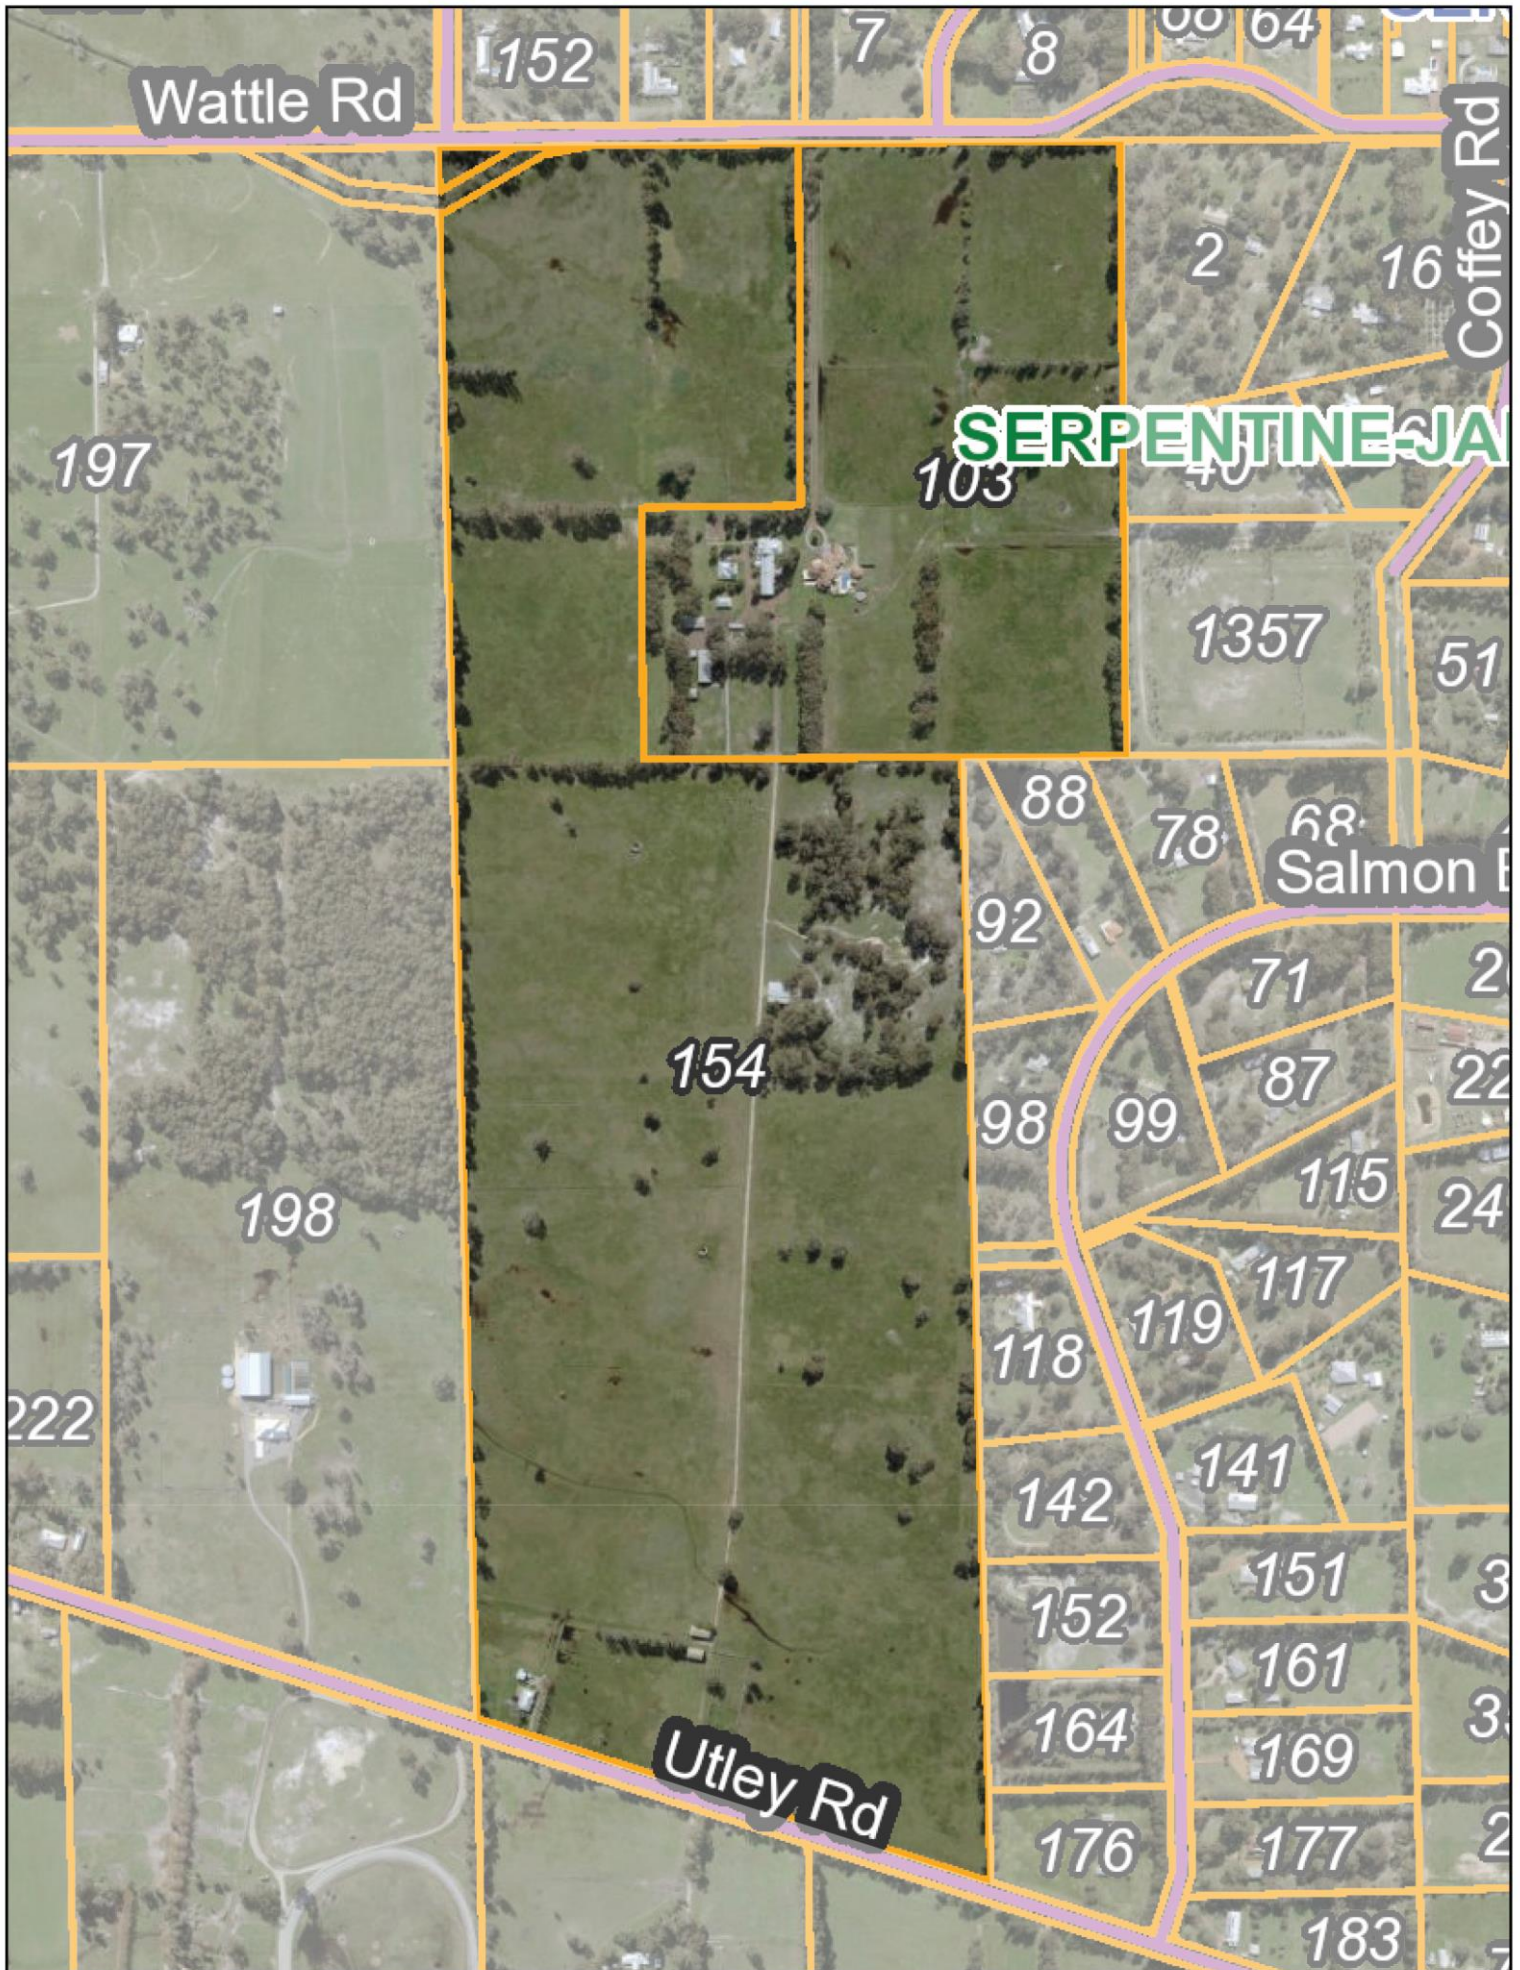
**Site Aerial Figure 3**  
 Lot 9001 Utley Road and Lot 9002 Wattle Road, Serpentine

The Aerial Photograph (*Figure 3*) shows the current state of the subject site.

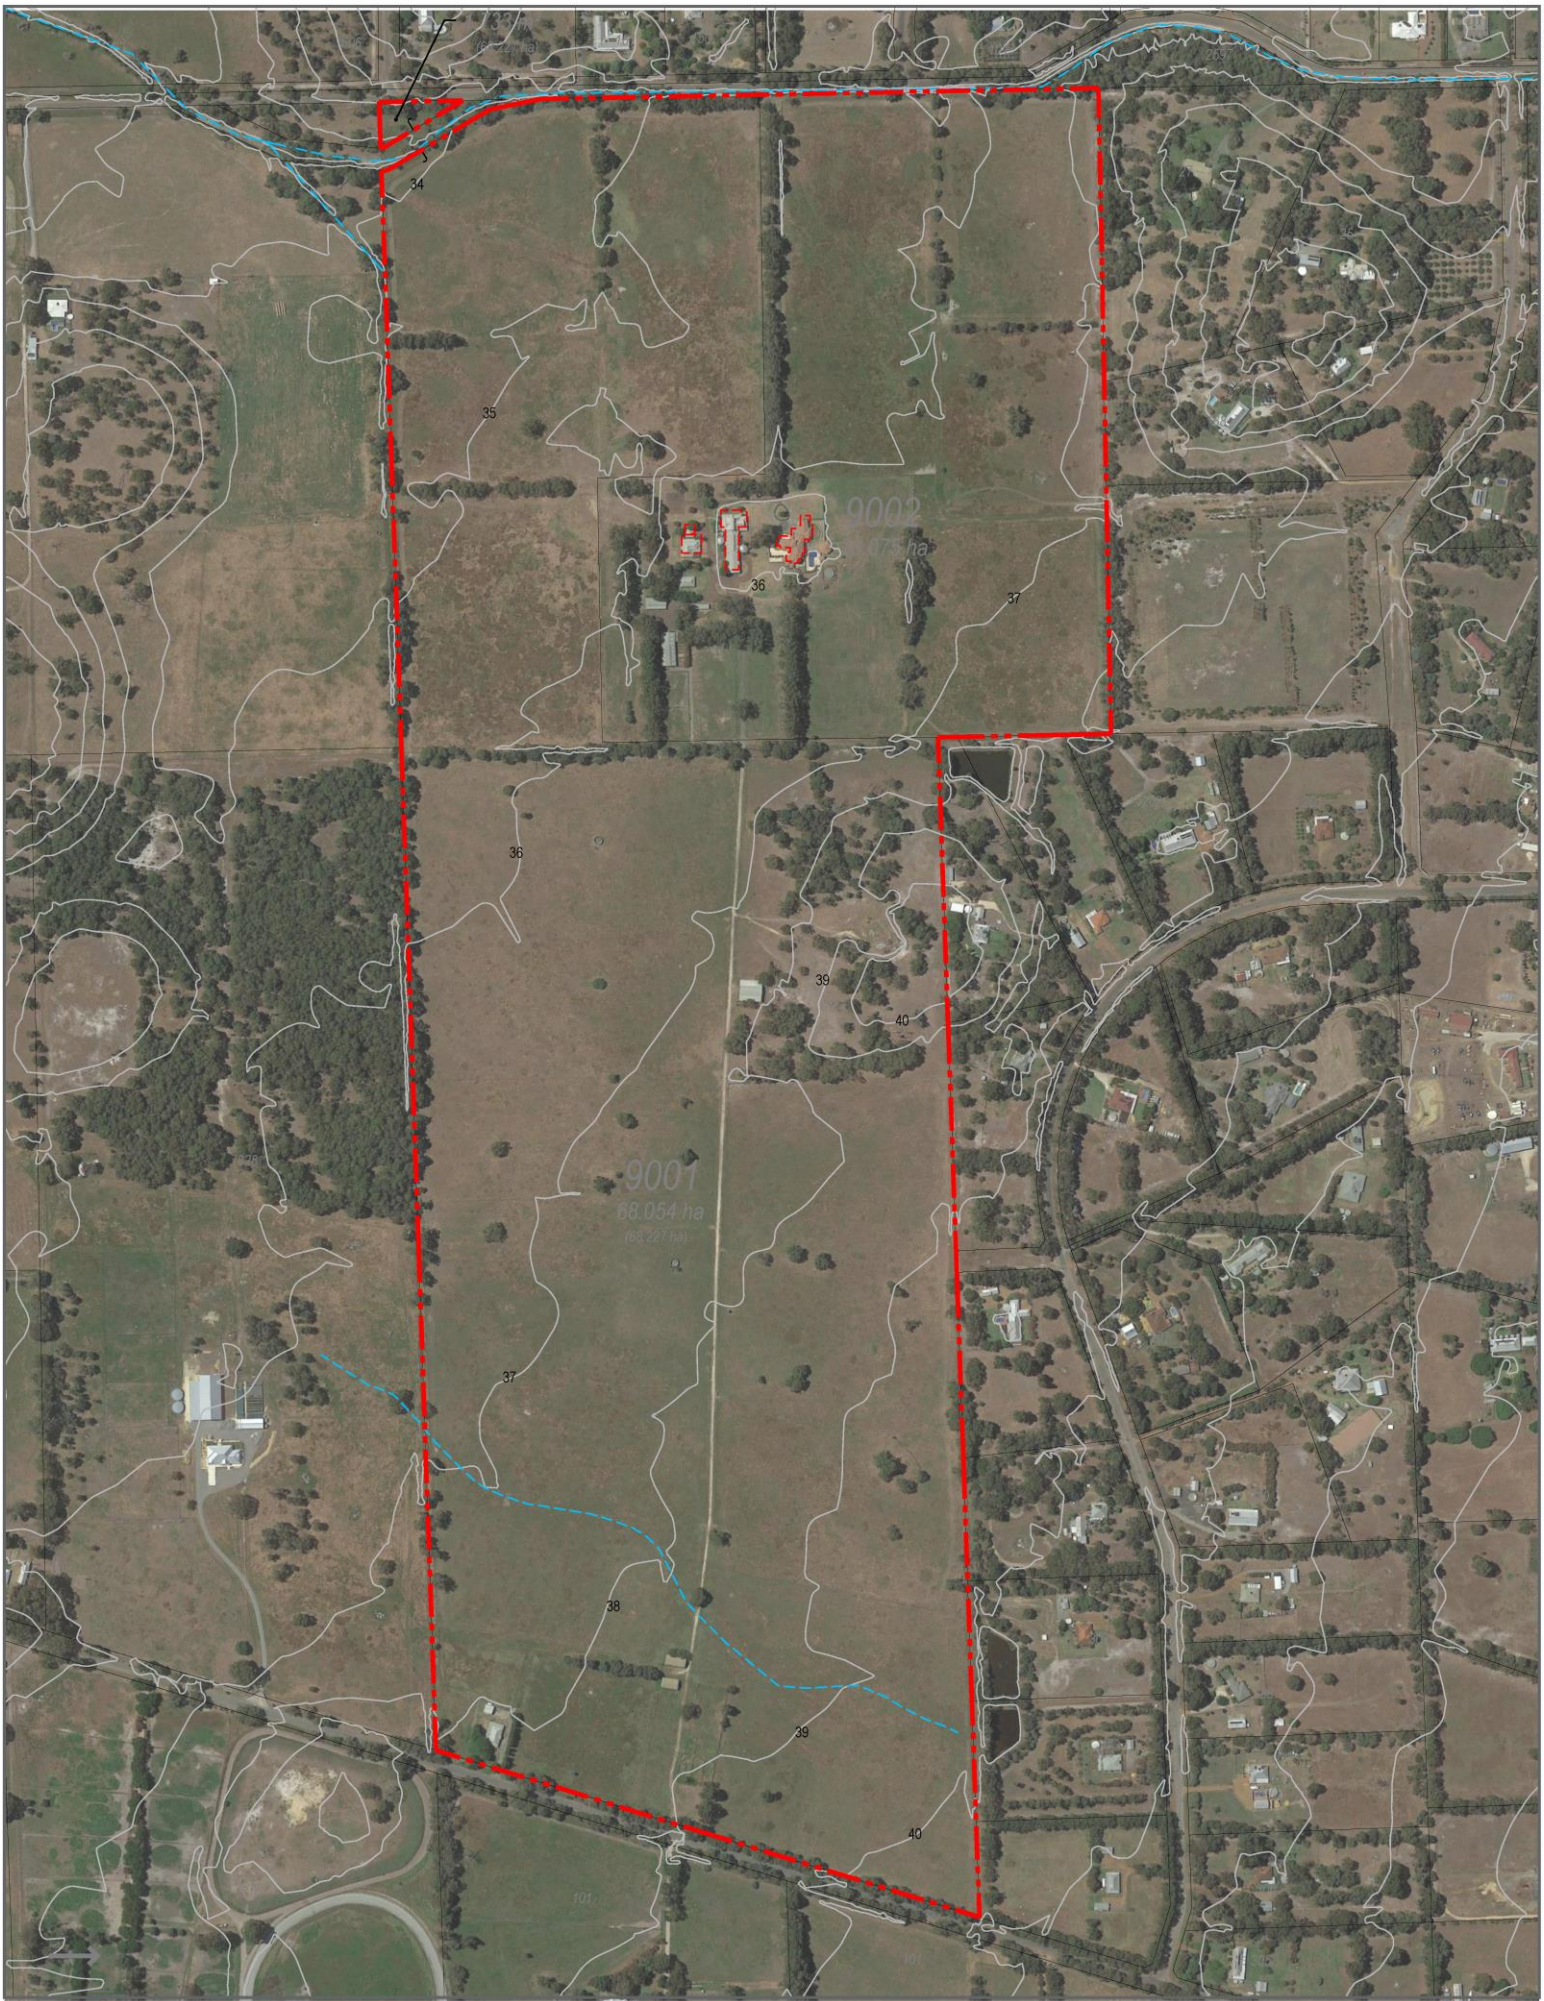
# Ortho Photo - Contours

- Topography across the site is relatively uniform, with elevation ranging between 34 and 40 m Australian Height Datum (m AHD).
- The majority of the site has been historically cleared to allow for agricultural activities. This has resulted in over 97% (88.3ha) of vegetation within the site identified as being in 'completely degraded' condition and 3% (2.99 being classified as degraded, using methods from Keighery (1994).

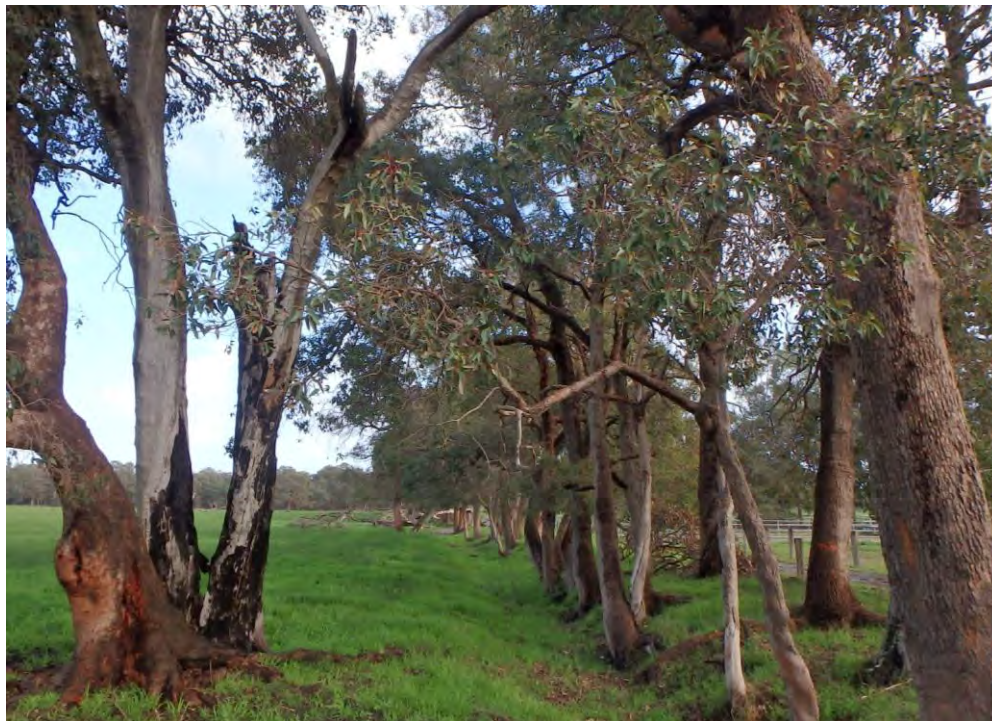
Plate 1: Plant community Cc in 'degraded' condition

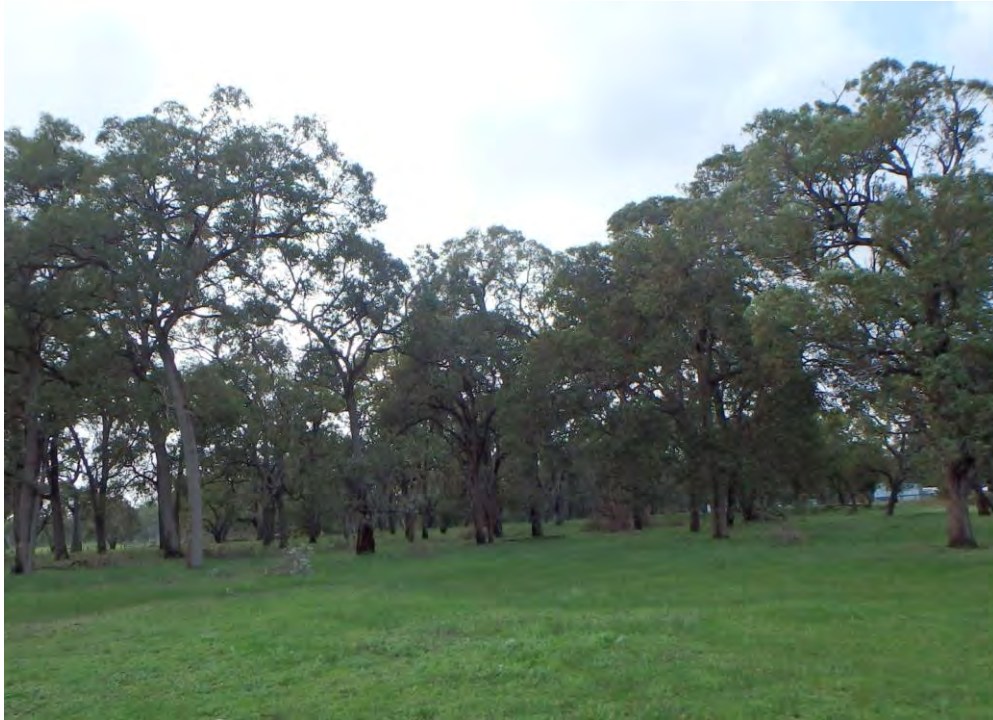
*Plate 2: Plant community **CcEm** in 'degraded' condition*

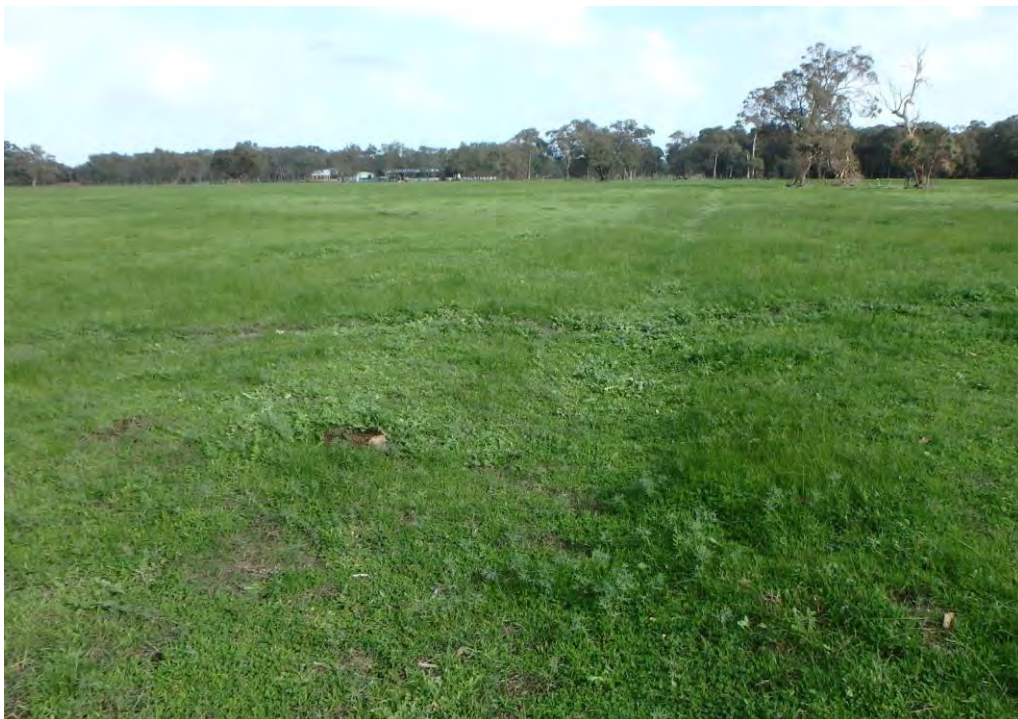
| Plant community | Description | Area (ha) |
|---|---|---|
| <b>Non-native</b> | Occasional <i>Corymbia calophylla</i> , planted non-native trees such as <i>Eucalyptus camaldulensis</i> and <i>Eucalyptus grandis</i> and planted native trees such as <i>Eucalyptus rudis</i> over non-native closed grassland * <i>Ehrharta</i> sp. and herbland * <i>Arctotheca calendula</i> ( <b>Plate 3</b> ) | 88.25 |

*Plate 3: Plant community **non-native** in 'completely degraded' condition*

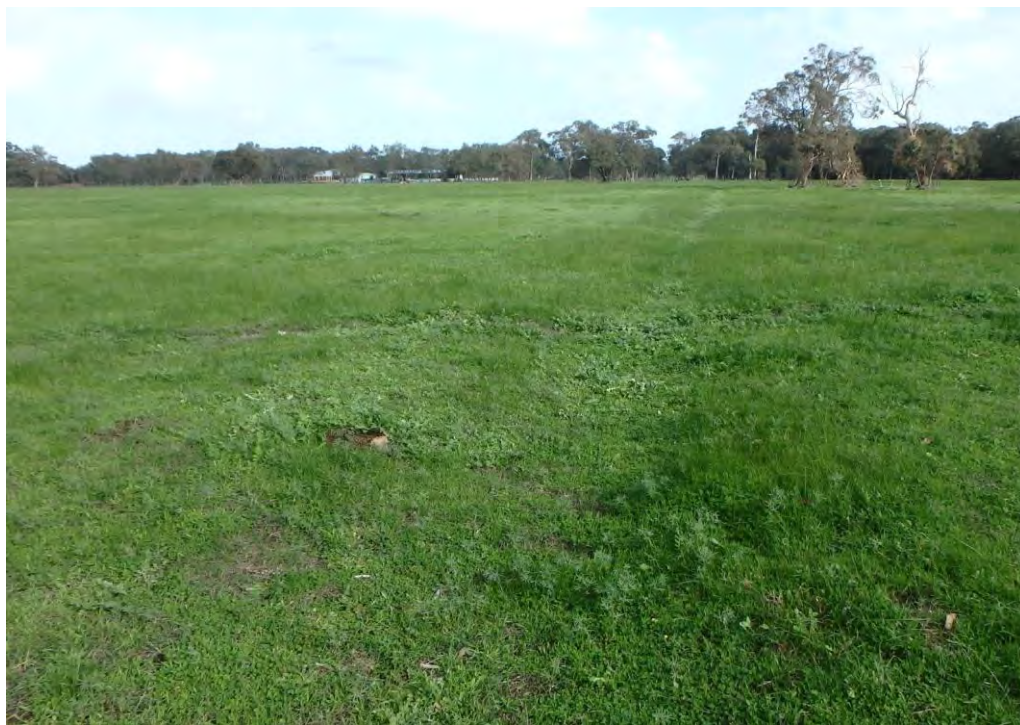
Plate 4: Grassland with scattered trees habitat

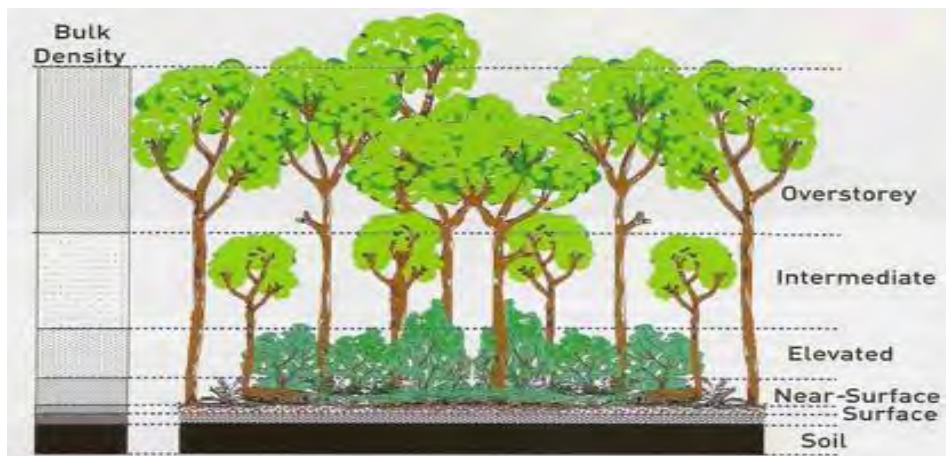
*Plate 2: The five fuel layers in a forest environment that could be associated with fire behaviour (Gould et al. 2007)*

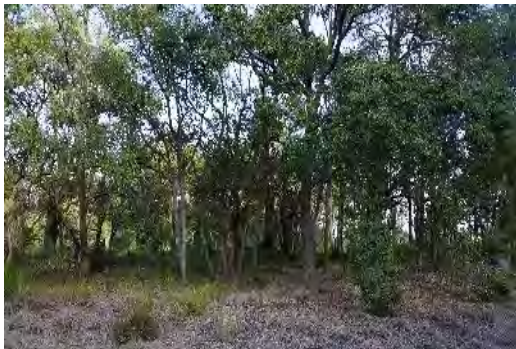
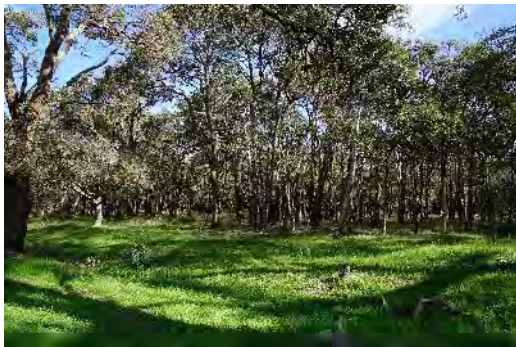
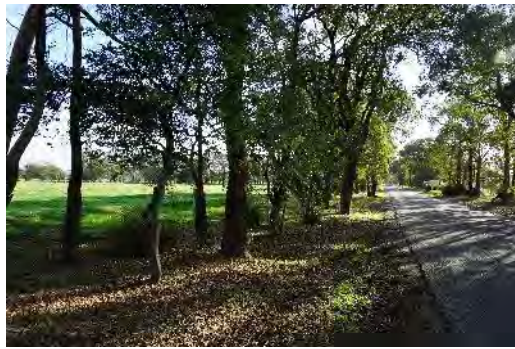
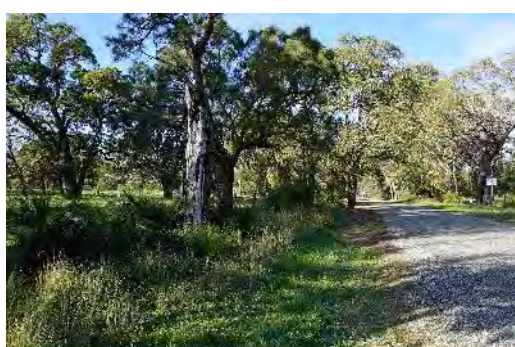
| Pre-development (see Figure 2) | | | Post development (see Figure 3) | |
|---|---|---|---|---|
| 1-3 | <p><b>AS 3959 classification (Figure 2):</b> Forest (Class A)</p> <p><b>Bushfire hazard level:</b> Extreme</p> <p>Patches of forest vegetation are located external to the site within adjacent rural-residential landholdings and the Wattle Road and Utley Road reserves to the north and south. This vegetation is characterised by a mixture of planted <i>Eucalyptus spp.</i> and native <i>Corymbia calophylla</i> (marri) trees in addition to an understory of native shrub species.</p> <p>Areas of forest vegetation are characterised by surface, near-surface, elevated, intermediate and overstory fuel layers.</p> <p>A small stand of juvenile <i>Eucalyptus spp.</i> trees, less than 6 m in height are located to the east of the site. This patch of vegetation has been classified as Forest (Class A) vegetation based on the future growth of the trees to a height greater than 6 m.</p> | <p>Photo location 1: Forest vegetation to the north of the site abutting Wattle Road.</p> <p>Photo location 3: Forest vegetation to the west of the site.</p> <p>Photo location 2: Forest vegetation to the south of the site within the Utley Road reserve.</p> <p>Photo location 24(20): Forest vegetation to the north of the site within the Wattle Road reserve.</p> | 1-3 | <p><b>AS 3959 classification (Figure 3):</b> Forest (Class A)</p> <p><b>Effective slope (Figure 4):</b> Flat/upslope</p> <p>Forest vegetation external to the site within adjacent rural-residential landholdings and within the Wattle Road and Utley Road reserves will be retained as future development progresses. Therefore, this vegetation will pose a permanent bushfire risk to the site.</p> |

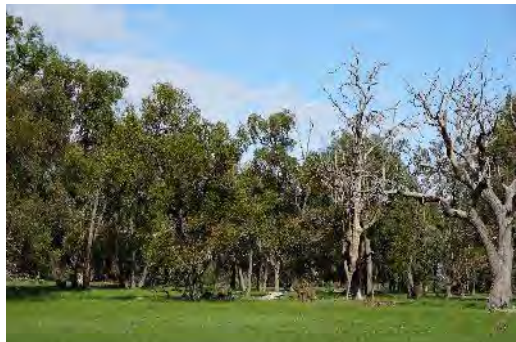
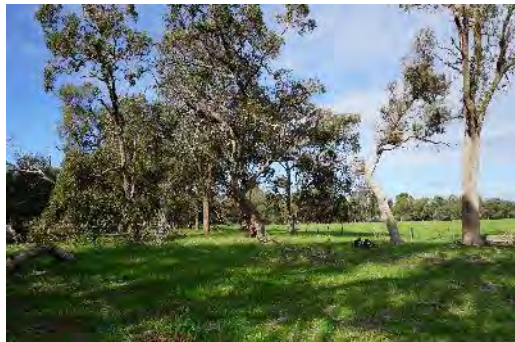
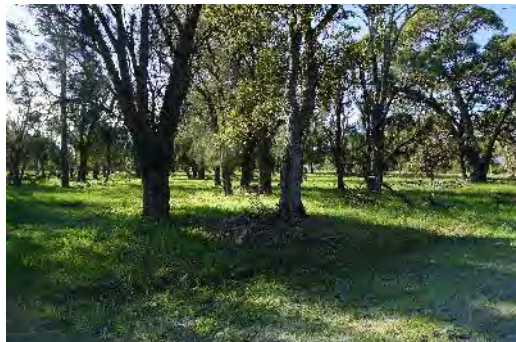
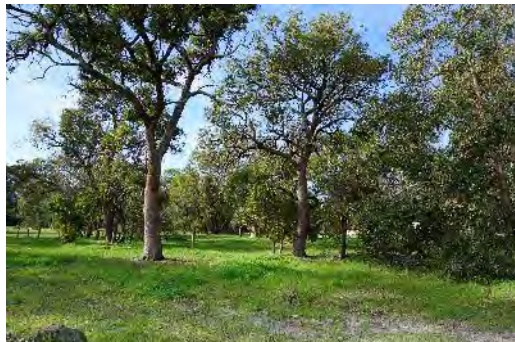
| Pre-development (see Figure 2) | | | Post development (see Figure 3) | | |
|---|---|---|---|---|---|
| 4 & 5 | <b>AS 3959 classification (Figure 2):</b><br>Woodland (Class B)<br><br><b>Bushfire hazard level:</b> Extreme<br><br>Woodland vegetation is located within the central portion of the site surrounding an existing residential dwelling. Woodland vegetation within the site is characterised by an open woodland of <i>Corymbia calophylla</i> (marri) and <i>Eucalyptus marginata</i> (jarrah) with a 10 - 30% foliage cover over the area, growing to a height of 10 – 20 m with an understory of non-native grassland and isolated shrubs.<br><br>Woodland vegetation has also been identified to the north, east and west of the site within adjacent rural-residential landholdings and is characterised principally by an overstorey of marri over an understory of unmanaged grassland and occasional scattered native shrubs. | | 10 | <b>AS 3959 classification (Figure 3):</b> Low threat vegetation (Exclusion 2.2.3.2(f))<br><br><b>Effective slope (Figure 4):</b> Not applicable<br><br>The woodland vegetation within the site (Plot 4) will be converted to low threat vegetation within future lots that will be managed to a low threat standard in accordance with the Shire of Serpentine Jarrahdale Firebreak and Fuel Hazard Reduction Notice. These lots are likely to include non-vegetated areas (e.g. dwellings, private driveways and firebreaks), however as the siting of these are currently unknown, it has been identified as low threat vegetation. | |
| | | | | 5 | <b>AS 3959 classification (Figure 3):</b><br>Woodland (Class B)<br><br><b>Effective slope (see Figure 4):</b><br>Flat/upslope<br><br>Woodland vegetation located to the north, east and west of the site is assumed to remain in its existing state and is therefore assumed to remain a bushfire risk to the site. |

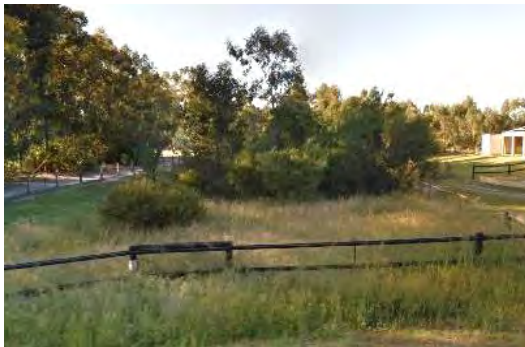
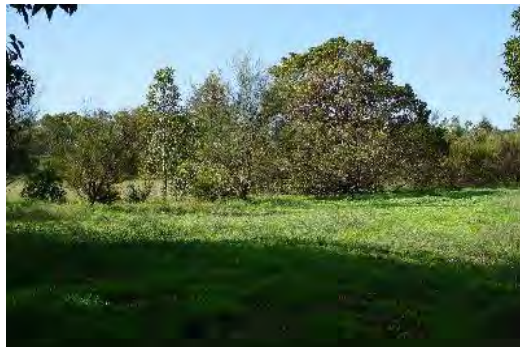
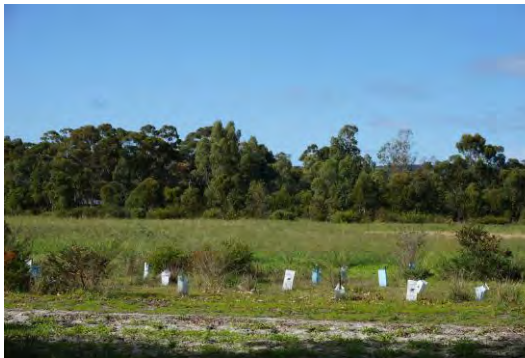
| Pre-development (see Figure 2) | | | Post development (see Figure 3) | |
|---|---|---|---|---|
| 6 | <b>AS 3959 classification (Figure 2):</b> Scrub (Class D)<br><br><b>Bushfire hazard level:</b> Extreme<br><br>Scrub vegetation is located to the north and east of the site within adjacent rural residential lots.<br><br>Scrub vegetation to the north of the site is characterised by series of planted/regrowth scrub species growing to a height of 2 - 4 m, less than 6 m in height with continuous fuel loads from the surface and near-surface fuel layers through to the intermediate and overstorey fuel layers.<br><br>Scrub vegetation to the east of the site within an adjacent rural-residential lot ( <b>Photo location 9, 27</b> ) comprises a ring of planted low shrub species with isolated occurrences of juvenile <i>Eucalypt spp.</i> . When mature, the <i>Eucalypt spp.</i> will form less than 10% of the mature canopy, and based on the current growth (i.e. existing conditions) and in accordance with AS 3959 the vegetation has been classified based on the dominant growth form which is scrub as the predominant vegetation will be less than 6 m in height. | <p>Photo location 8: Scrub vegetation to the north of the site.</p> | 6 | <b>AS 3959 classification (Figure 3):</b> Scrub (Class D)<br><br><b>Effective slope (see Figure 4):</b> Flat/upslope<br><br>Scrub vegetation located to the north of the site ( <b>Photo location 8</b> ) is assumed to remain in its existing state and is therefore assumed to remain a bushfire risk to the site. |
| | | <p>Photo location 9: Scrub vegetation in the foreground comprising a majority of low shrub species.</p> | 11 | <b>AS 3959 classification (Figure 3):</b> Forest (Class A)<br><br><b>Effective slope (Figure 4):</b> Flat/upslope<br><br>With regards to the scrub vegetation to the east of the site ( <b>Photo location 9, 27</b> ); DFES have indicated concern about the presence of juvenile eucalypts potentially at a density that may affect the vegetation classification when the trees mature. Based on site observations, the eucalypts are likely to be less than 10% of the mature canopy cover. However, to address the DFES concern, this vegetation has been identified as forest in the post development scenario. |
| | | <p>Photo location 27: Scrub vegetation to the east of the site showing the ring of planted shrub species</p> | | |

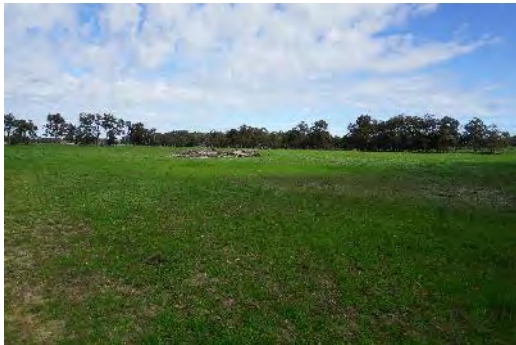
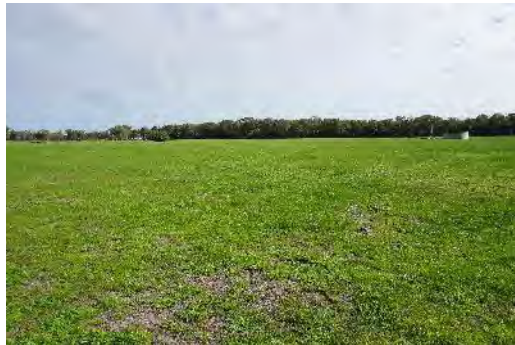
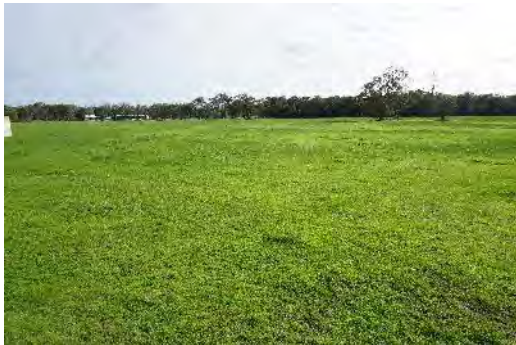
| Pre-development (see Figure 2) | | | Post development (see Figure 3) | |
|---|---|---|---|---|
| 7 | <b>AS 3959 classification (Figure 2):</b><br>Grassland (Class G)<br><br><b>Bushfire hazard level:</b> Moderate<br><br>Grassland vegetation has been identified within the majority of the site associated with open areas of unmanaged rural-residential paddocks. Areas of grassland are characterised by grasses growing to a height of ~ 50 cm, with occasional scattered trees (less than 10% foliage cover). In accordance with AS 3959, this vegetation has been classified based on the understorey, due to the low overall canopy cover. | | 10 | <b>AS 3959 classification (Figure 3):</b> Low threat vegetation (Exclusion 2.2.3.2(f))<br><br><b>Effective slope (Figure 4):</b> Not applicable<br><br>The grassland vegetation within the site will be converted to low threat vegetation within future lots that will be maintained in accordance with the Shire of Serpentine Jarrahdale Firebreak and Fuel Hazard Reduction Notice. These lots are likely to include non-vegetated areas (e.g. dwellings, private driveways and firebreaks), however as the siting of these are currently unknown, it has been identified as low threat vegetation. |
| | | | 7 | <b>AS 3959 classification (Figure 3):</b> Non-vegetated area (Exclusion 2.2.3.2(e))<br><br><b>Effective slope (see Figure 4):</b> Not applicable<br><br>Grassland vegetation within the site will be removed to facilitate the future sealed public road network which will result in currently vegetated areas being converted to non-vegetated areas comprised of bitumen. |

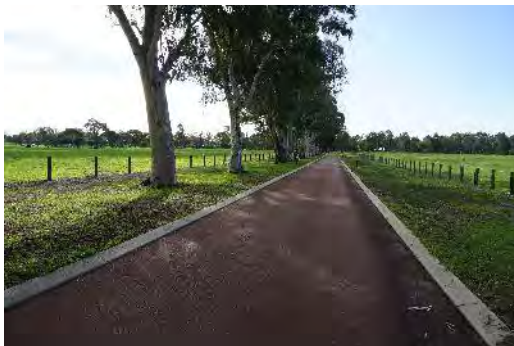
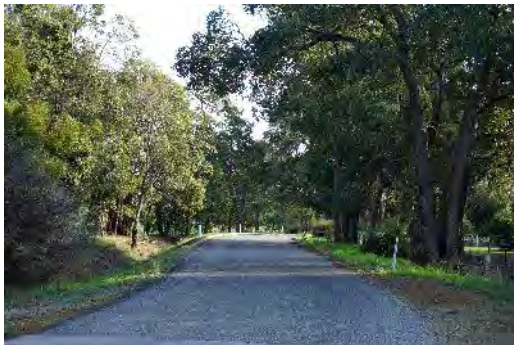
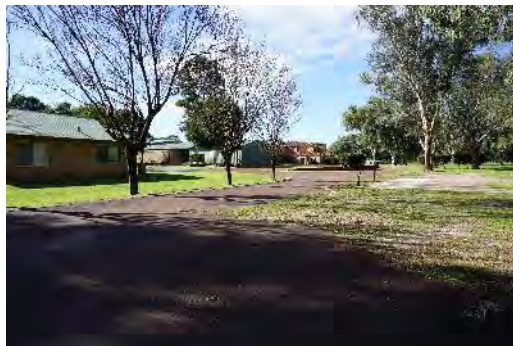
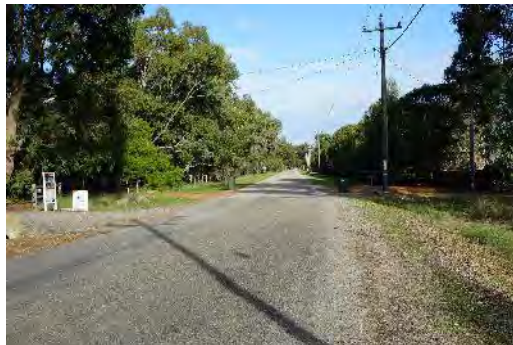
| Pre-development (see Figure 2) | | | Post development (see Figure 3) | |
|---|---|---|---|---|
| 9 | <p><b>AS 3959 classification (Figure 2):</b> Non-vegetated area (Exclusion 2.2.3.2(e))</p> <p><b>Bushfire hazard level:</b> Low. As required under the Guidelines, any areas within 100 m of moderate or extreme hazards have been shown as moderate, to reflect the potential increased risk.</p> <p>Non-vegetated areas such as roads, driveways, existing residential buildings and areas of mineral earth within and surrounding the site have been excluded in accordance with Clause 2.2.3.2(e) of AS 3959.</p> | <p>Photo location 16: Non-vegetated driveway within the northern portion of the site.</p> <p>Photo location 18: Non-vegetated sealed Wattle Road to the north of the site.</p> | <p>Photo location 17: Non-vegetated residential area within the central portion of the site.</p> <p>Photo location 19: Non-vegetated sealed Salmon Bark Road to the east of the site.</p> | <p>9</p> <p><b>AS 3959 classification (Figure 3):</b> Non-vegetated area (Exclusion 2.2.3.2(e))</p> <p><b>Effective slope (see Figure 4):</b> Not applicable</p> <p>The existing maintenance regimes for all existing non-vegetated areas surrounding the site are assumed to continue in the long-term based on current land uses and management arrangements and/or future proposed land uses.</p> |

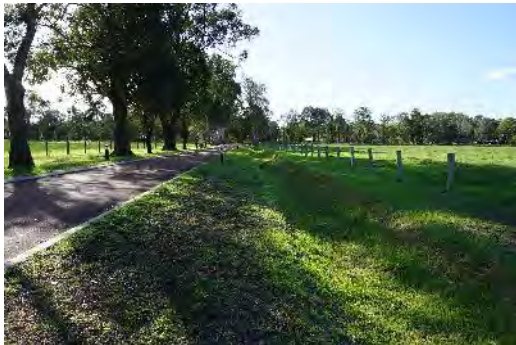
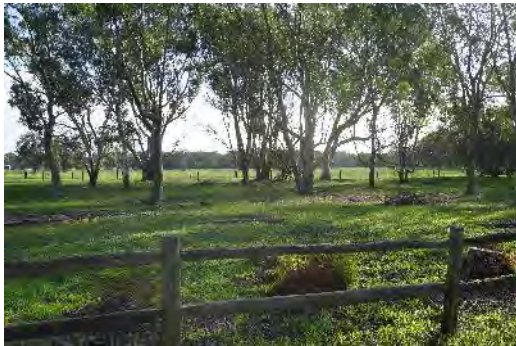
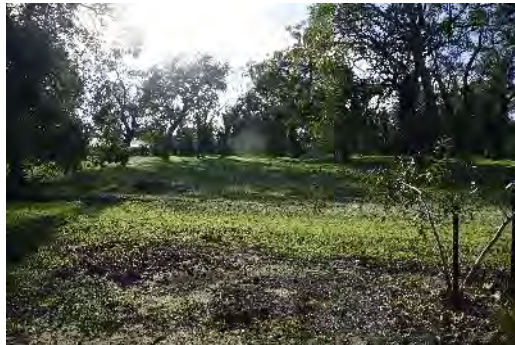
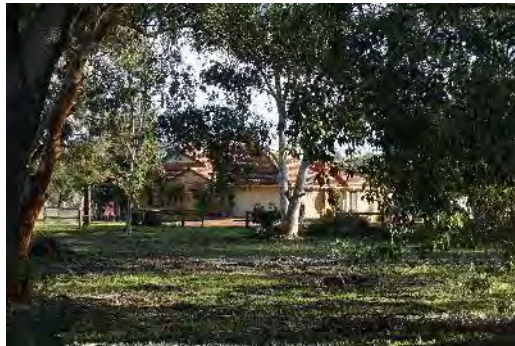
| Pre-development (see Figure 2) | | | Post development (see Figure 3) | |
|---|---|---|---|---|
| 10 | <p><b>AS 3959 classification (Figure 2):</b> Low threat vegetation (Exclusion 2.2.3.2(f))</p> <p><b>Bushfire hazard level:</b> Low. As required under the Guidelines, any areas within 100 m of moderate or extreme hazards have been shown as moderate, to reflect the potential increased risk.</p> <p>Low threat vegetation has been identified within the site to the north and east associated with open paddocks managed to a low threat standard in accordance with the Shire of Serpentine Jarrahdale Firebreak and Fuel Hazard Reduction Notice.</p> | <p>Photo location 20: Low threat vegetation within a roadside swale within the northern portion of the site.</p> <p>Photo location 22: Low threat vegetation to the east of the site.</p> | <p>Photo location 21: Low threat vegetation to the north of the site.</p> <p>Photo location 23: Low threat vegetation to the east of the site.</p> | <p><b>AS 3959 classification (Figure 3):</b> Low threat vegetation (Exclusion 2.2.3.2(f))</p> <p><b>Effective slope (see Figure 4):</b> Not applicable</p> <p>The maintenance regimes for all existing managed areas outside the site are assumed to continue in the future based on current land uses and management arrangements.</p> |

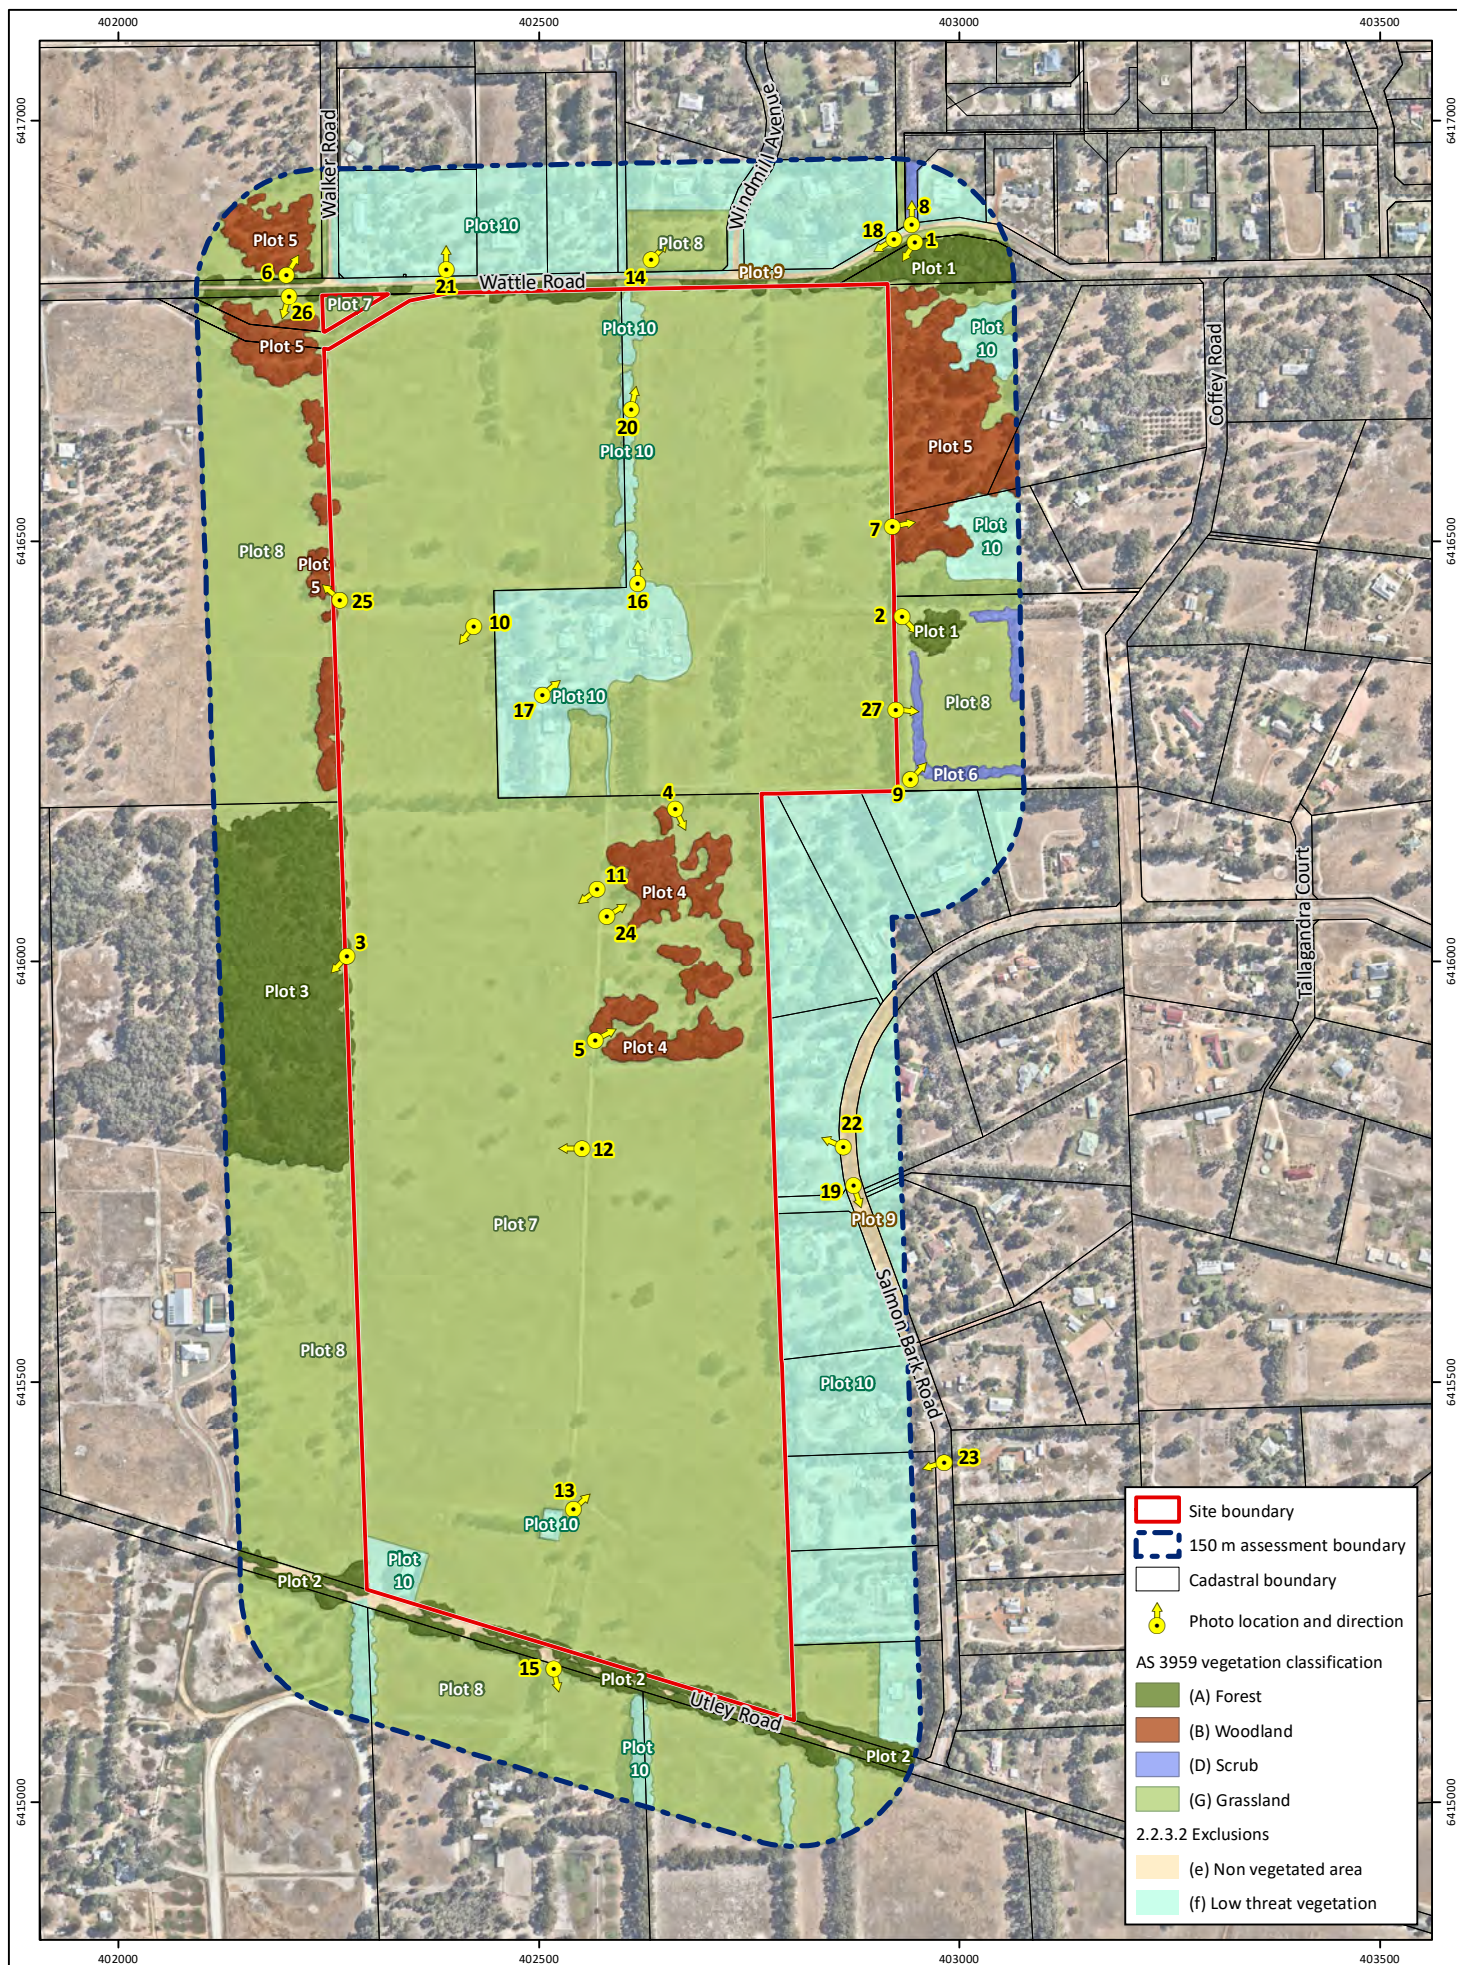
**Figure 2: Existing Site Conditions - AS 3959 Vegetation Classifications**
