# *Structure Plan 'Serpentine Special Rural'*

*Lot 9001 Utley Road and Lot 9002 Wattle Road, Serpentine*

Prepared by  
Hex Design and Planning

This report represents an application to the Shire of Serpentine Jarrahdale to consider a proposed Structure Plan Comprising Lot 9001 Utley Road and Lot 9002 Wattle Road, Serpentine.

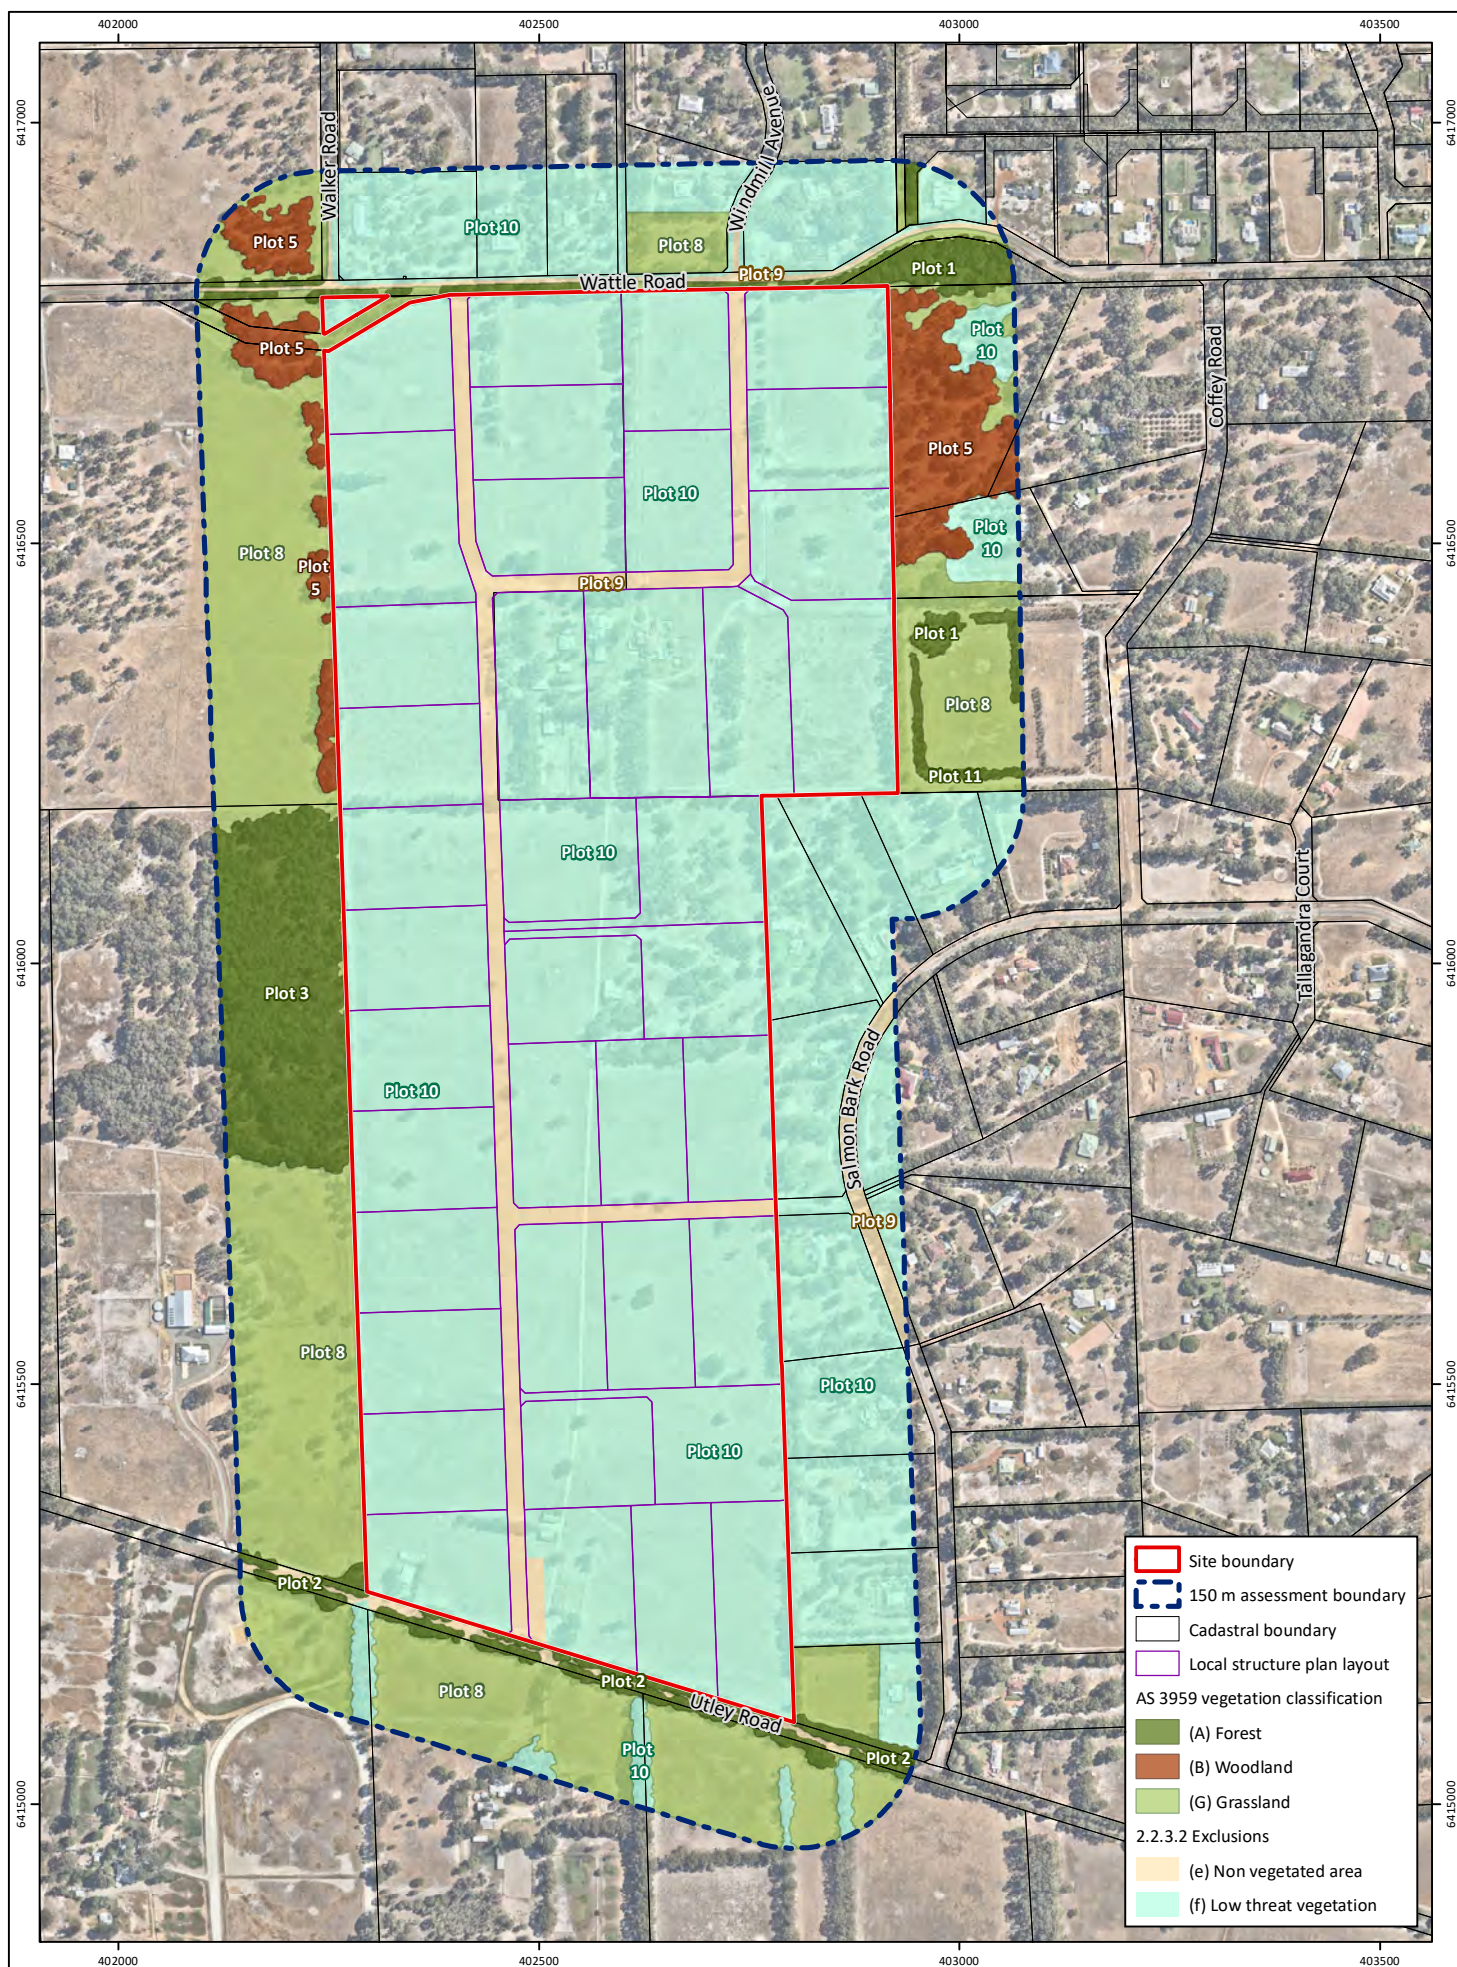
**Figure 3: Post Development Site Conditions - AS 3959 Vegetation Classifications**

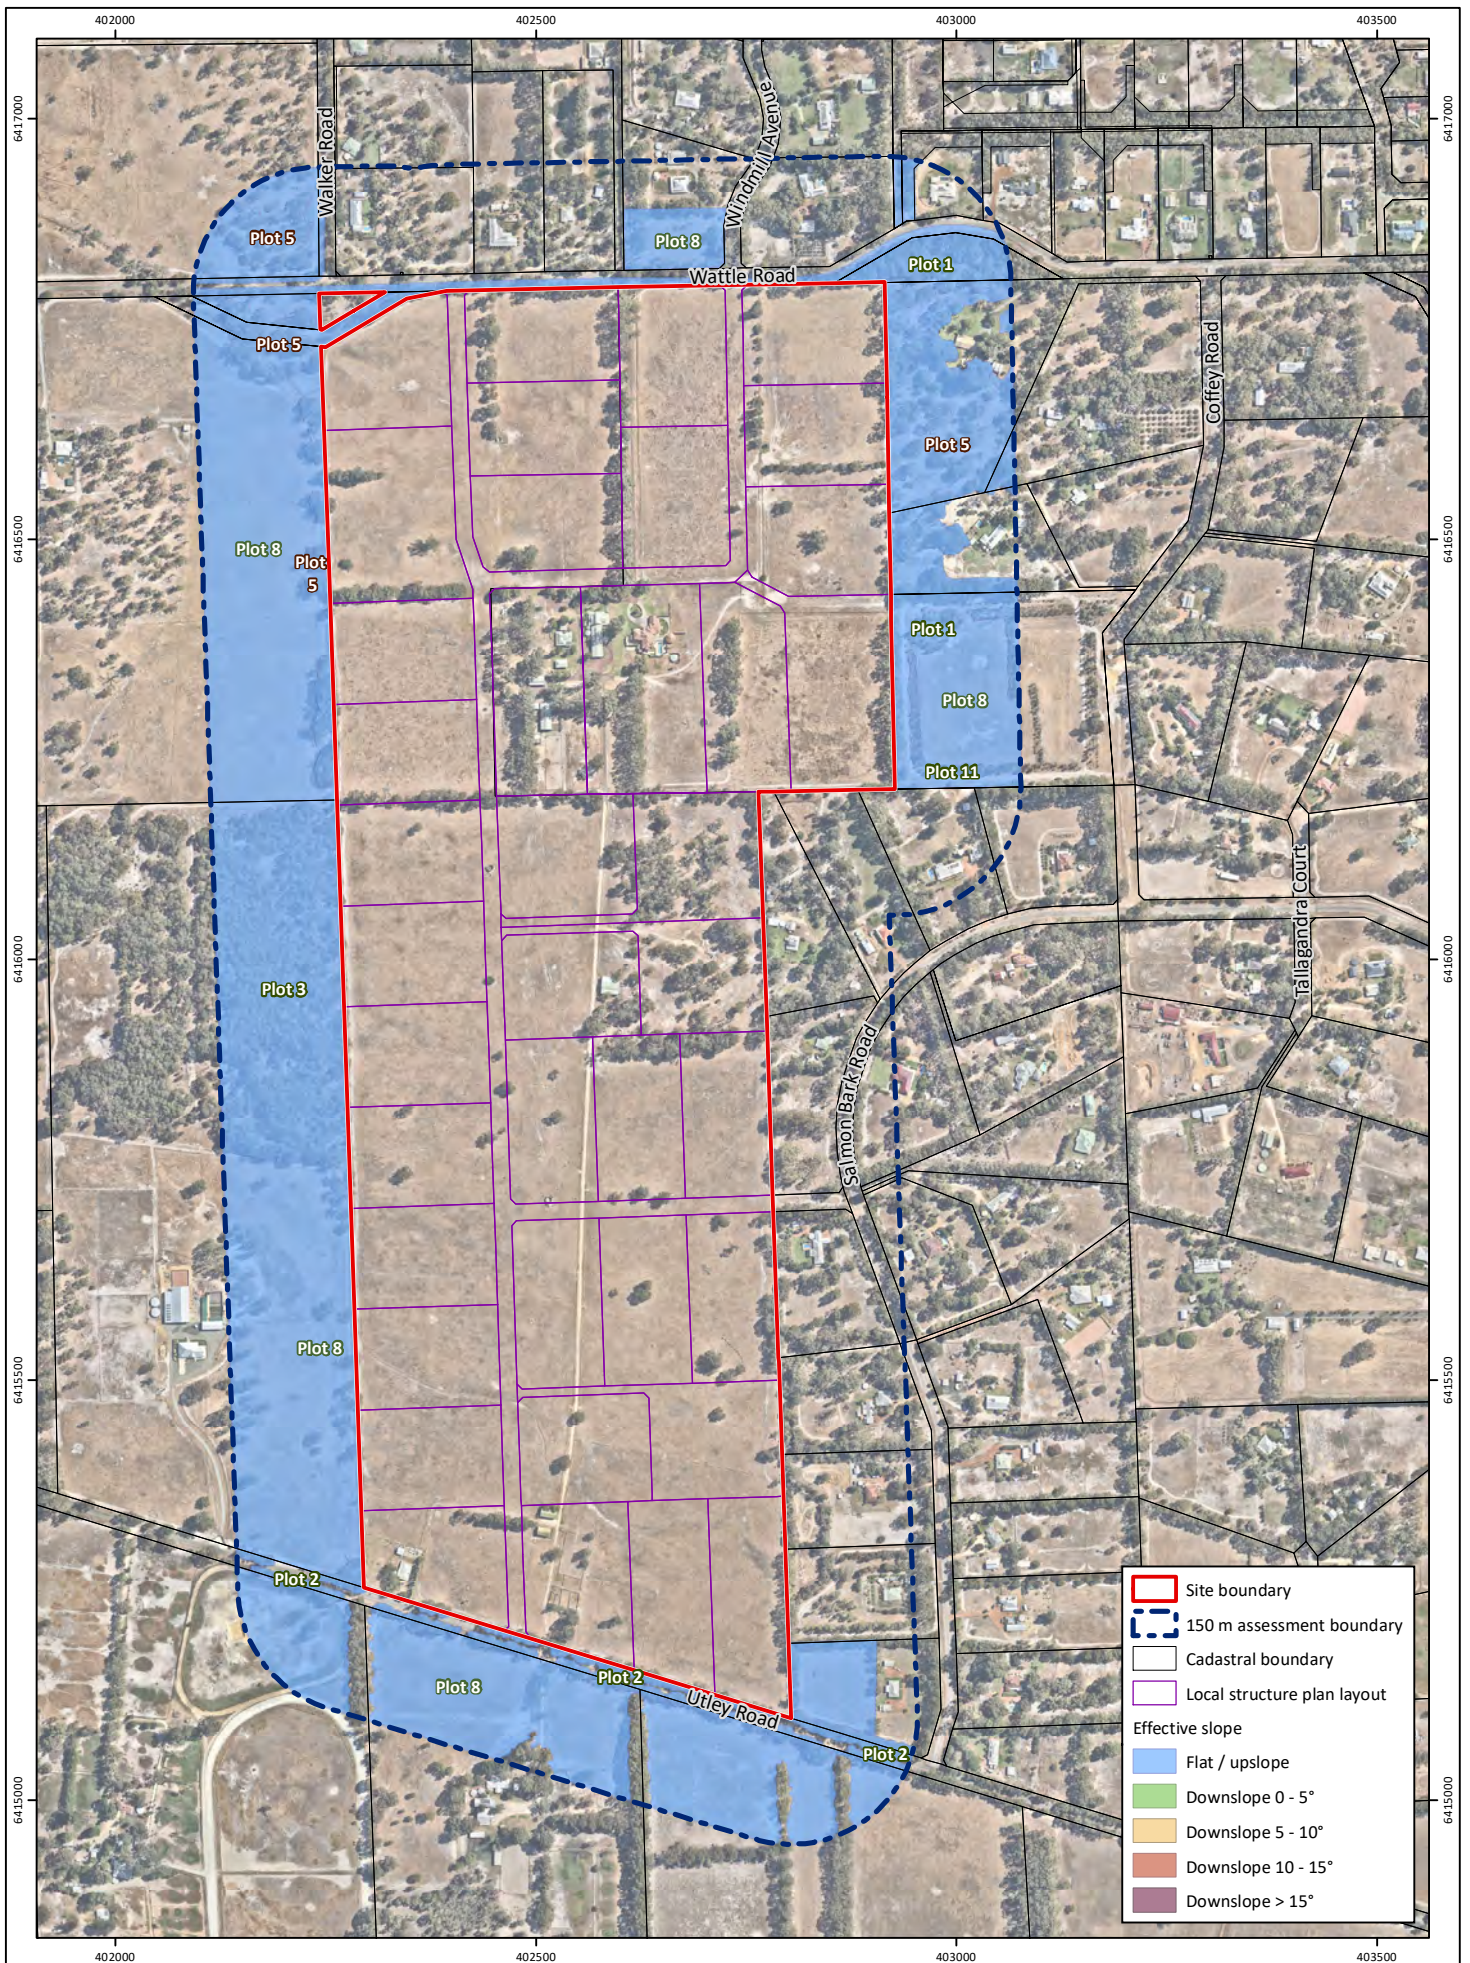
**Figure 4: Post Development Site Conditions - Effective Slope**

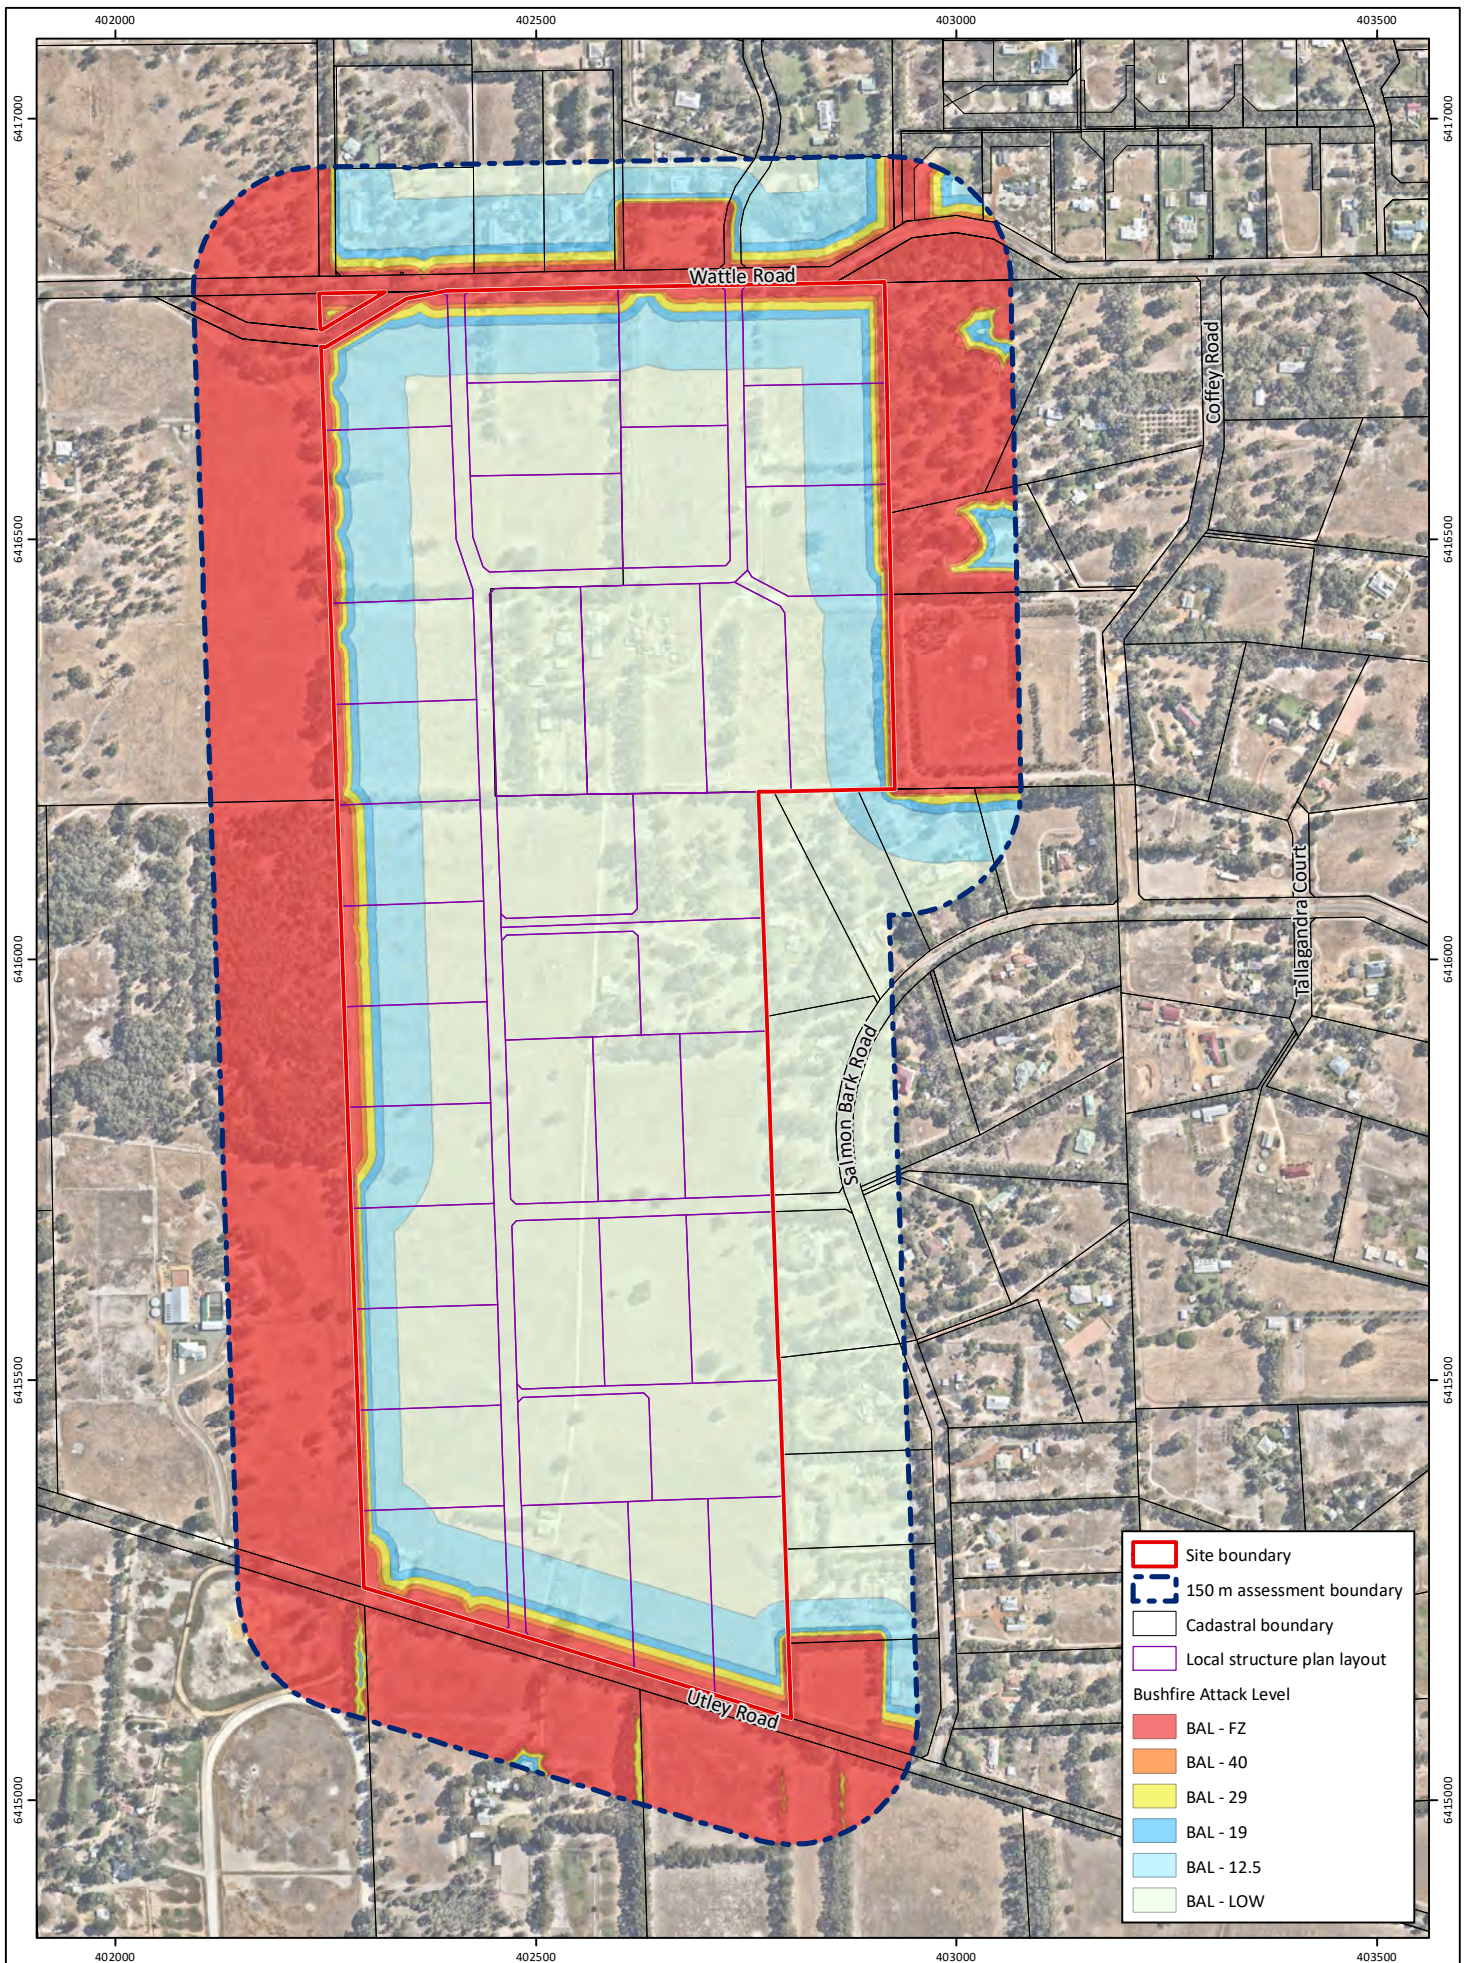
**Figure 5: Bushfire Attack Level Contours**

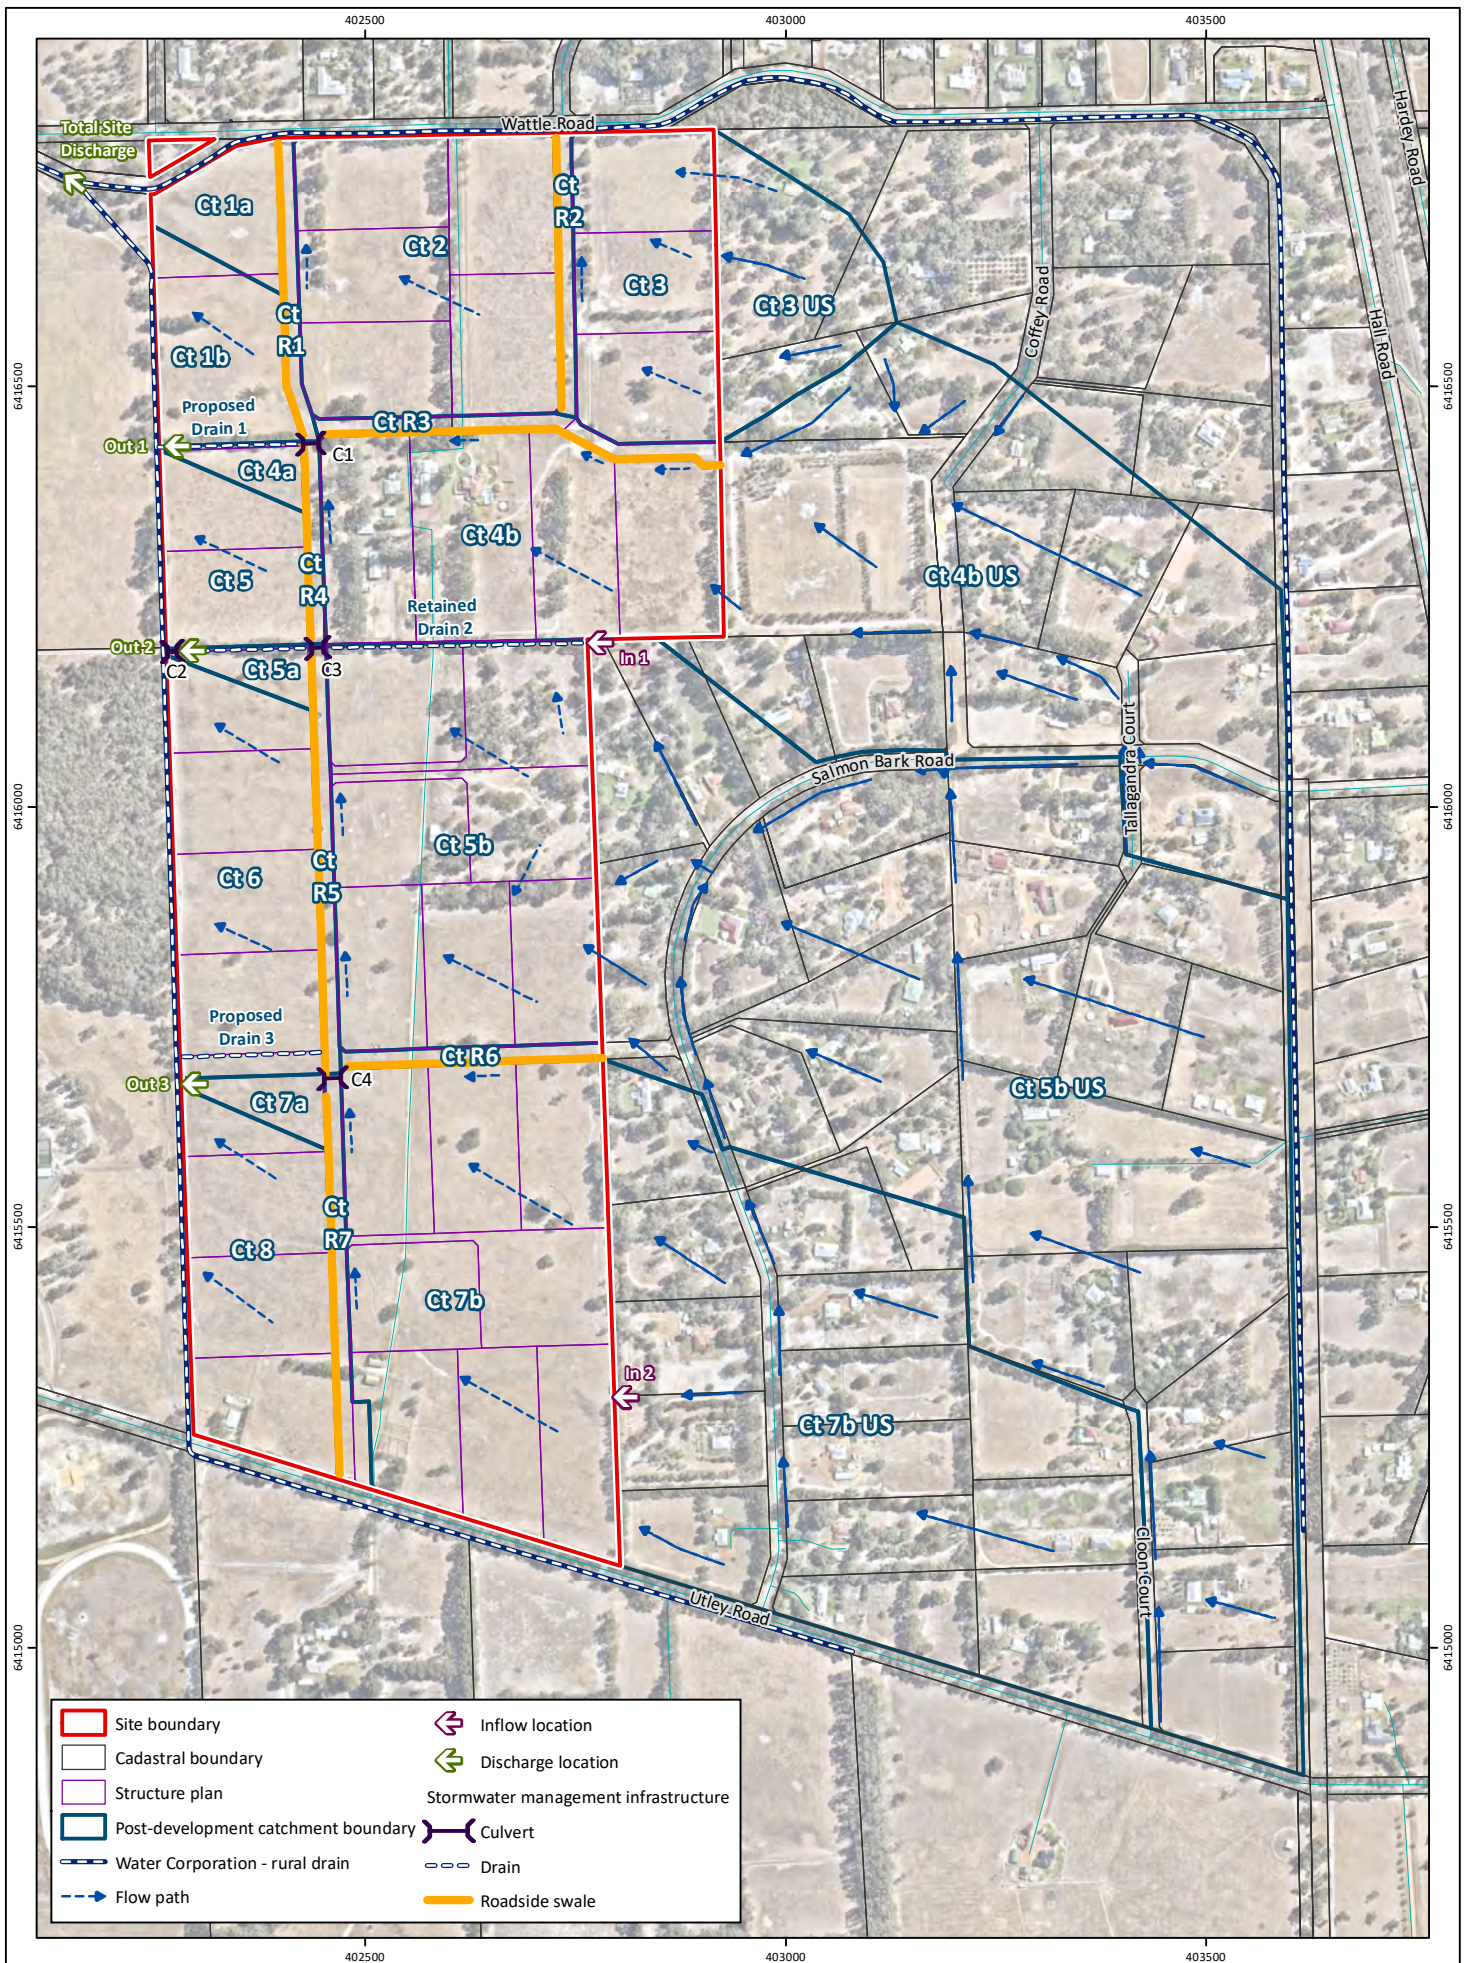
**Figure 9: Stormwater Management Plan**

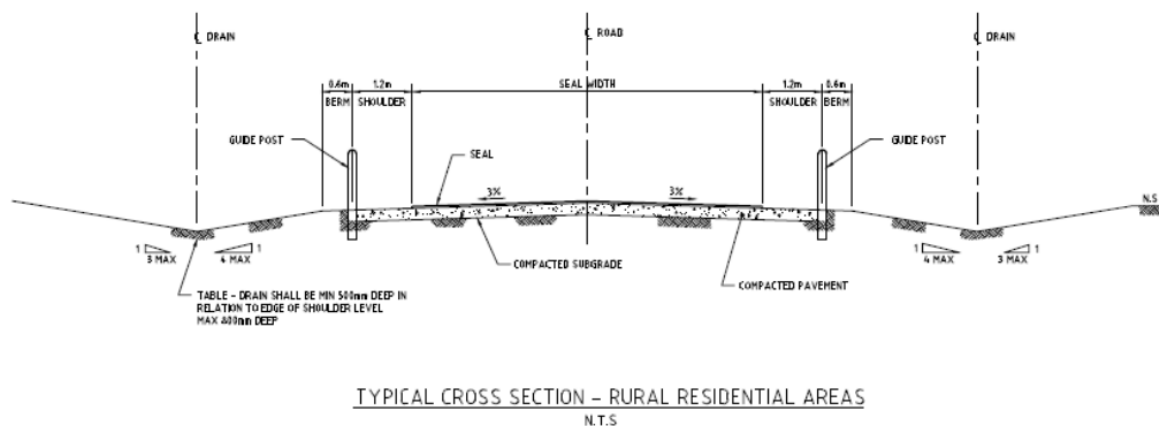
The IPEWA “*Local Government Guidelines for Subdivisional Development*”, November 2017, recommend a minimum pavement width of 6.0m with 1.2m wide shoulders for local roads which provide lot frontage and property access as the internal roads within the proposed subdivision. The road formation shall also provide a berm with a minimum width of 600mm between the shoulder edge and start of the table drain. This road cross section is shown in **Figure 9**.

**Figure 9. Indicative Road Cross Section for Internal Road Network (IPEWA)**

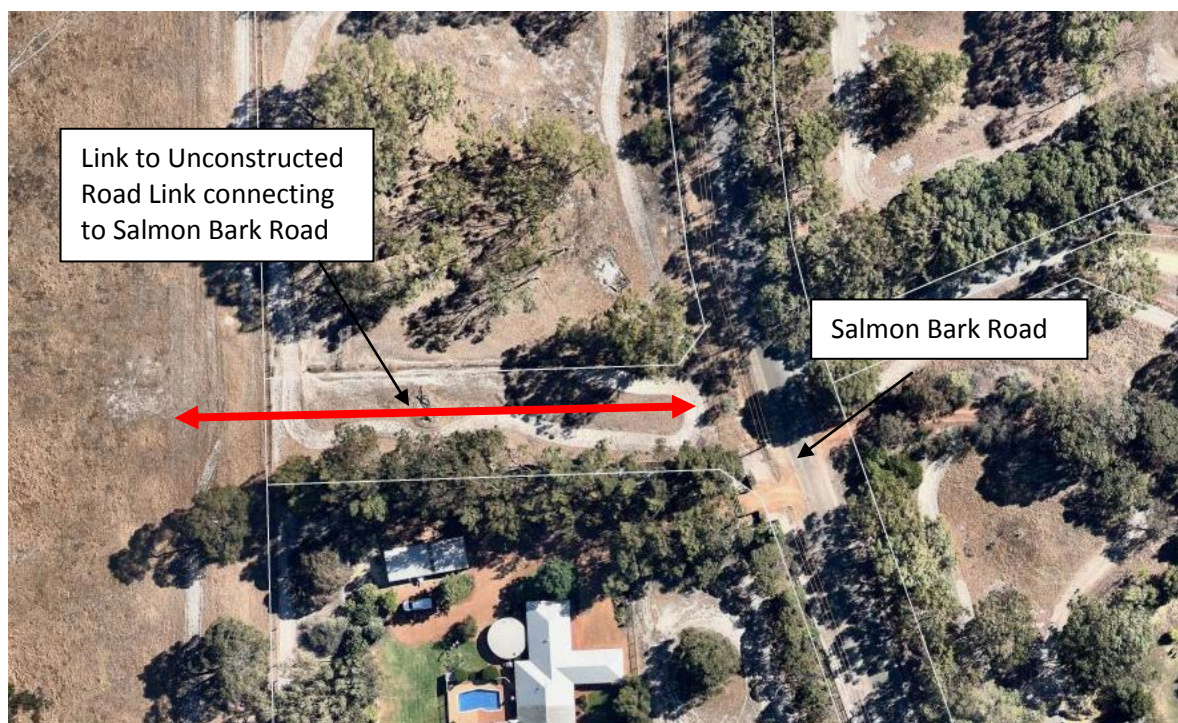
The Wattle Road western connection is located approximately 120m to the east of Walker Road. The Wattle Road eastern connection is proposed to connect at Windmill Avenue to create a new 4-way intersection. The proposed 4-way intersection is considered acceptable due to the low volumes of traffic anticipated to use the intersection and the very low demand for cross movements at this location. By creating a 4-way intersection instead of installing a new t-junction, there is still only the one potential point of conflict compared to two should a separate intersection be constructed.

**Figure 10. Proposed Connection to Unconstructed Road Link to Salmon Bark Road**

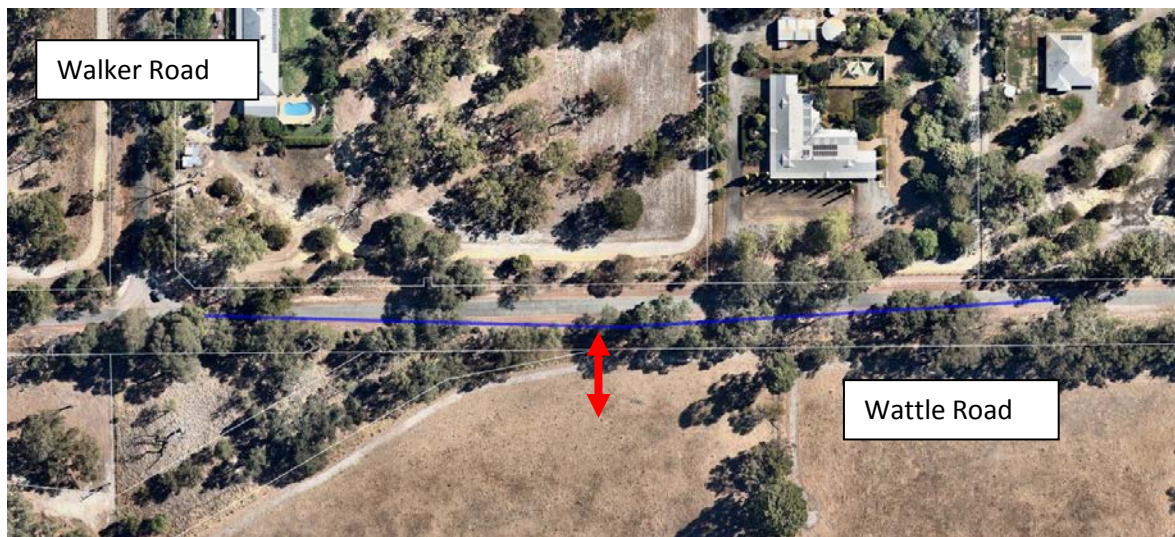
Sight distance to the east along Wattle Road is limited at the new proposed four way connection with Windmill Avenue however safe intersection sight distance of 131m is provided from the new road connection. It is apparent that the existing sight distance from Windmill Avenue is restricted below the desirable 131m (based on 2.5 seconds) due to the horizontal road alignment on Wattle Road and the existing heavy verge vegetation. It is recommended that the Shire of Serpentine Jarrahdale trim vegetation and install advanced warning signage of the approaching intersection to alert westbound drivers on Wattle Road to the presence of the intersection and potential conflict.

**Figure 11. Safe Intersection Sight Lines (131m) from indicative Wattle Road western Connection**
