CONDITION REPORT

Australind Jetty

Government of **Western Australia**
Department of **Water and Environmental Regulation**

9738

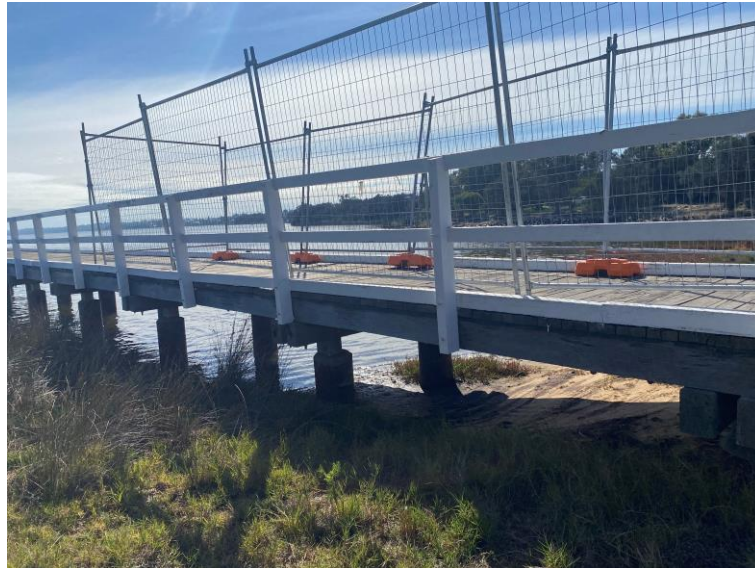
Figure 1. General at the Shore

It has approximately 60 circular concrete piles encased with a wrapping or liner, with timber stumps, half-caps and joists spanning between them (Figure 1). The timber joists are located at approximately third points across the width of the walkway. These half-caps are fixed to the timber stumps via two bolts. Also, the joists are bolted to the half-caps (Figure 7). Supported on these timber joists are the deck boards, which have a toe board bolted around the edge.

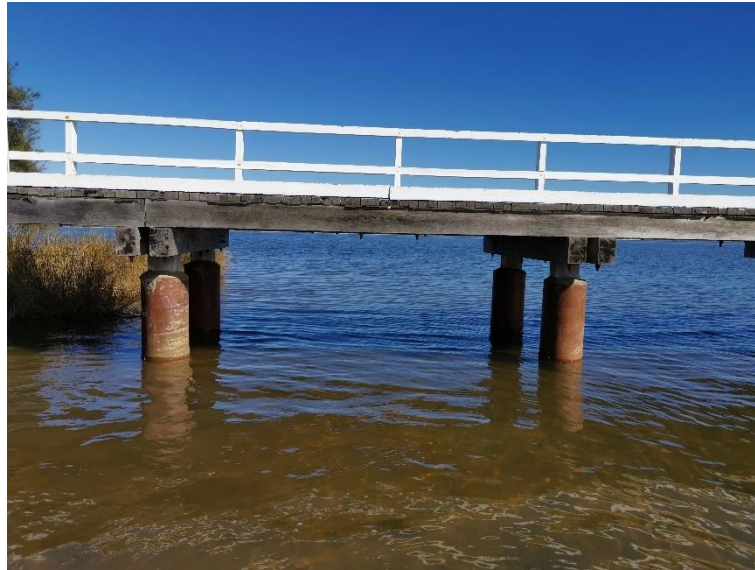
Figure 3. Piles

All the bolts observed are rusted. The timber stumps appear to be a bit weathered, but are not affecting the structural performance. Concrete piles seem to be in a good condition because of the wrapping encasing the piles (Figure 5).

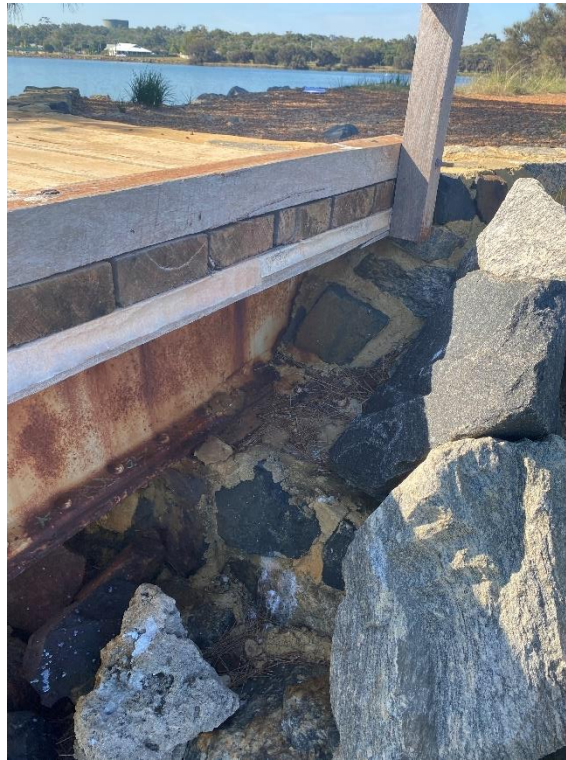
Figure 13. Abutment

Whilst the abutment is sound, there has been some erosion behind it. We recommend providing a new surface for an extent beyond the abutment to protect the ground from erosion.

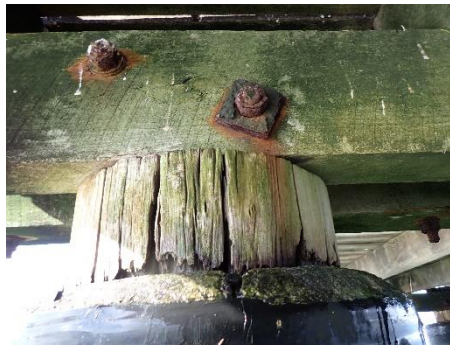
Image 2. Example of Typical Halfcap Connection at each pile

Piles within each bent share two timber halfcaps that are fastened with a through-bolts on a notch out groove on the tops of each pile, as shown in image 1, below.

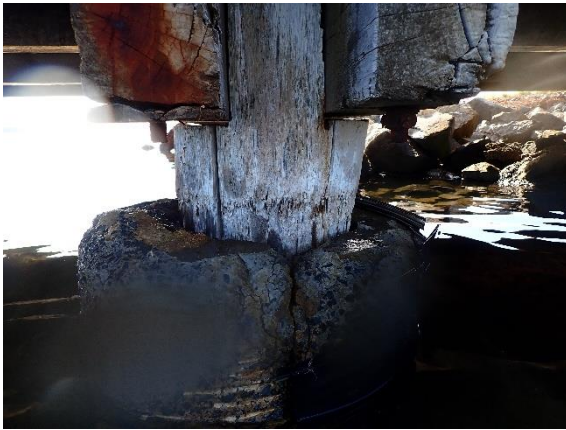
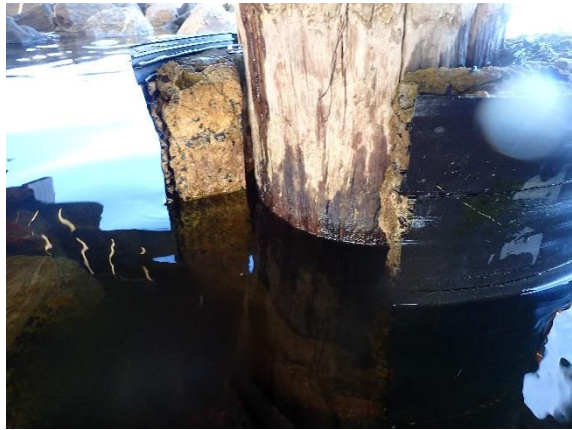
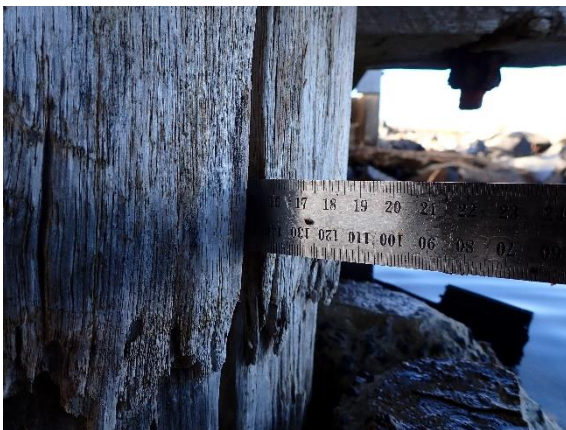
1.4 – Severe cracking and spalling on concrete encapsulation

Although no information could be found on the existing encapsulations, they have proved to be unsuitable and were likely installed in the absence of an appropriate specification. To provide a structural repair on the timber piles, the existing encapsulations will need to be removed in their entirety, from the top of the column down to a minimum of 500mm below the seabed. All piles could then have a suitable encapsulation poured, in accordance with the sketch displayed in Image 2, on the following page. Any future encapsulations should utilize specialist underwater high strength grout and incorporate a reinforcement cage.

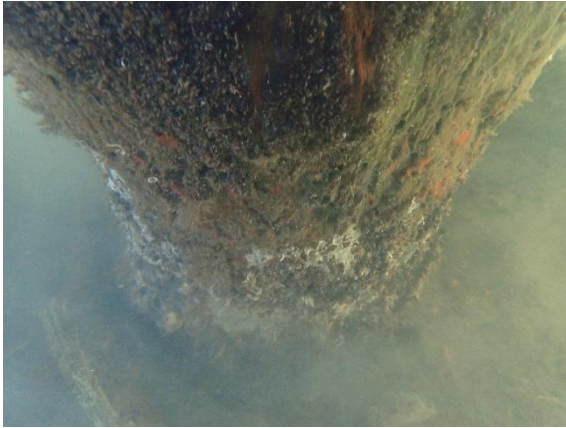
3.3 & 3.4 – Encapsulation has completely failed to seabed level, severe wood rot and marine borer attack

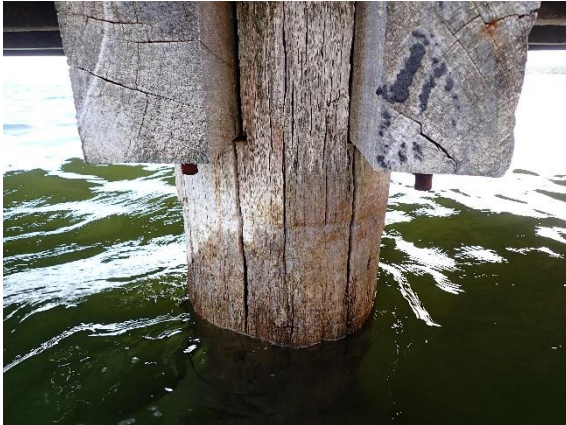
5.1 – Encapsulation has failed on top 900mm

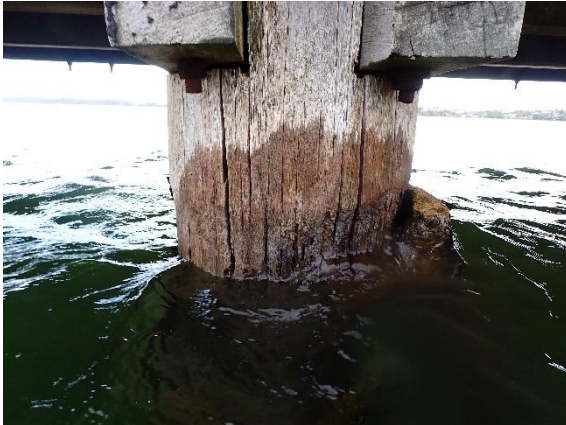
7.1 – Encapsulation extends below seabed. Severe section loss to encapsulation at top 800mm of pile

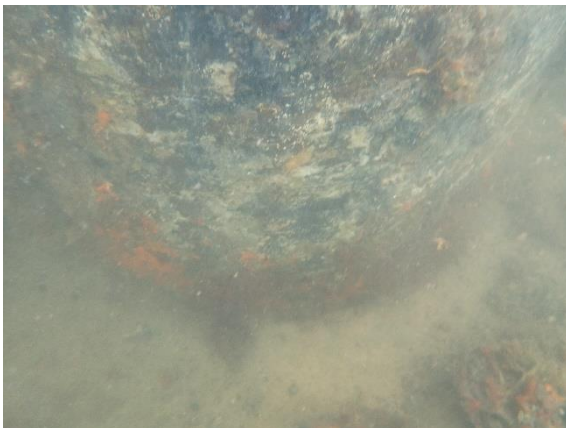
7.5 – Seabed level encapsulation, presenting in fair condition

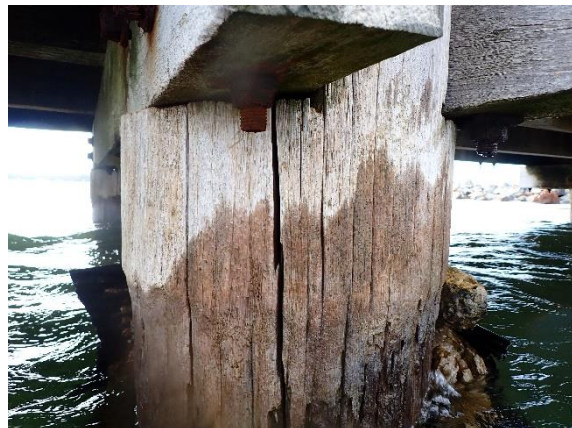
7.6 – Large split in pile, large section loss to encapsulation

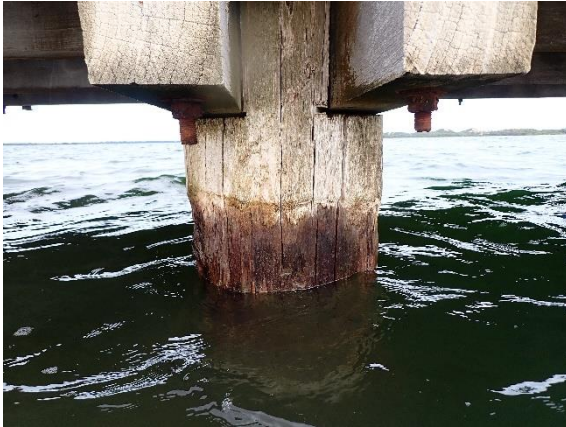
8.1 – Encapsulation has completely failed to seabed level, top of pile presenting in good condition

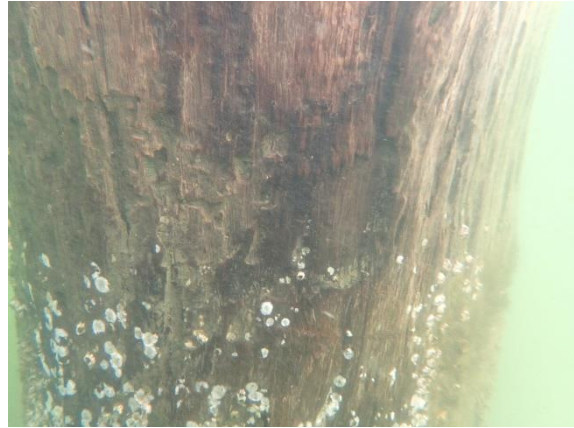
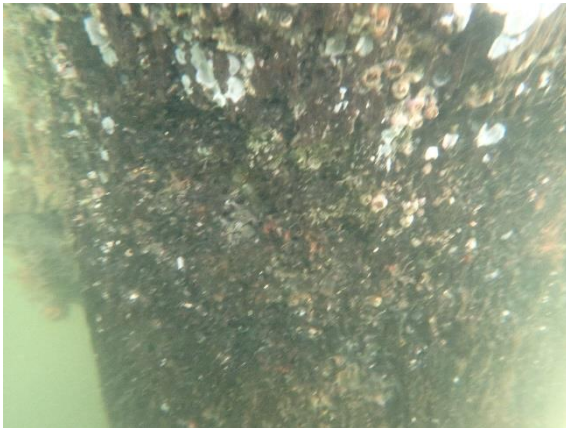
8.4, 8.5 & 8.6 – Severe wood rot & borer present throughout subsea portion of timber pile

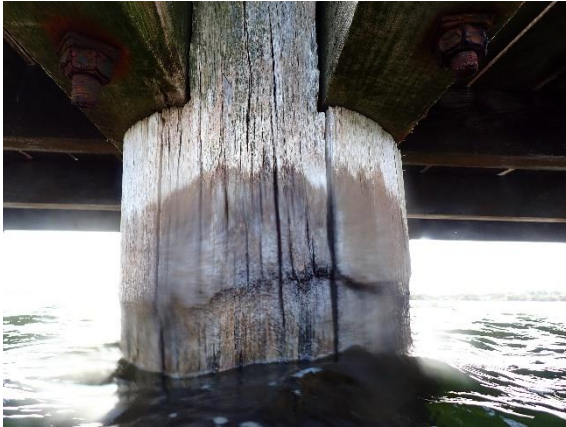
9.1 – Severe section loss at top of encapsulation 900mm wide extending down 1300mm, pile presenting with moderate splitting & necking on upper section

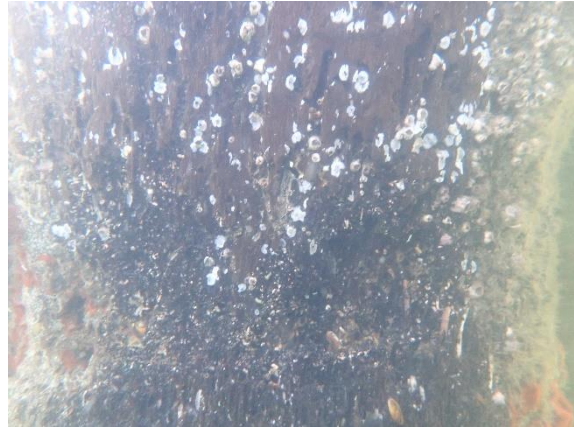
9.2 – Moderate necking & rot at I/T

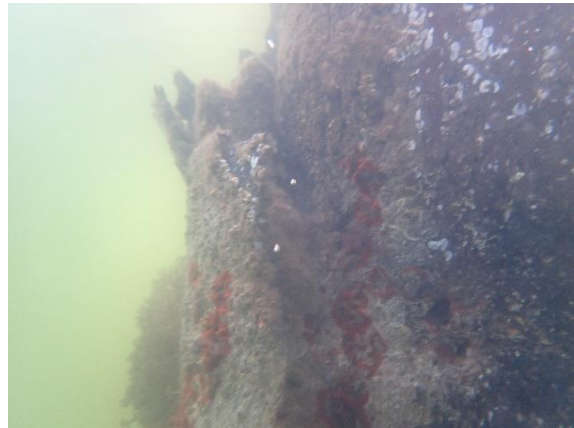
9.4 – Example of moderate wood rot & borer attack. Complete failure of pile encapsulation evident

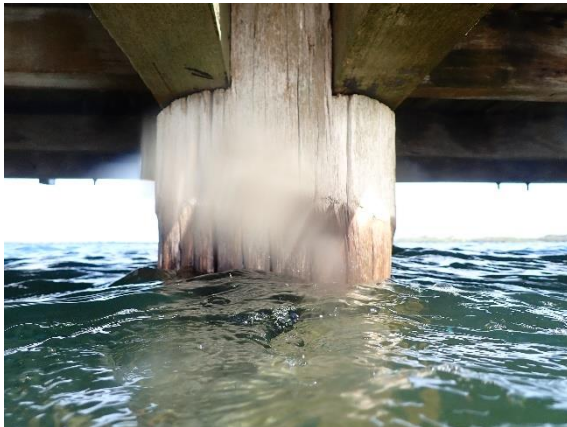
10.1 – Encapsulation is completely missing down to seabed level. Top above water section of pile presenting in good condition with minor-moderate splitting

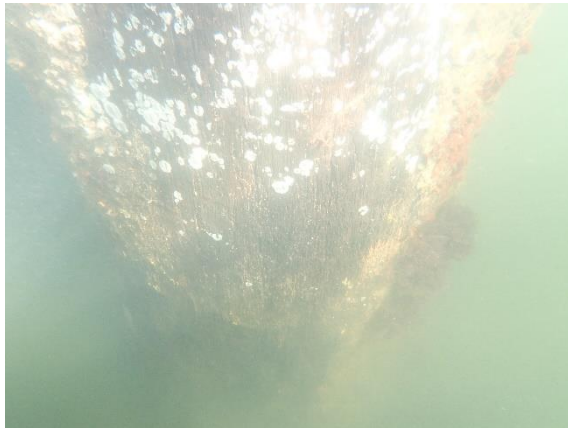
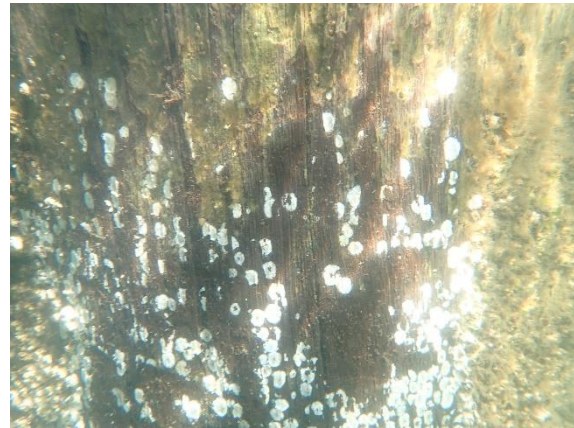
10.3 & 10.4 – Typical example of minor wood rot

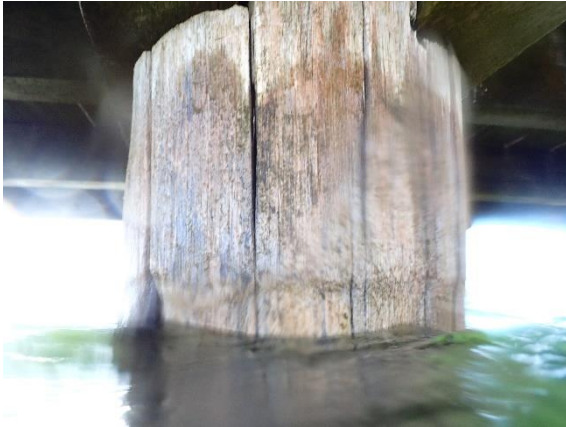
11.1 – Encapsulation is completely missing down to seabed level. Top above water section of pile presenting in good

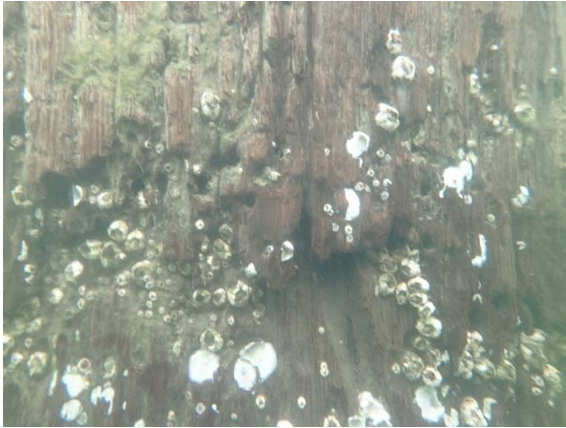
11.3 – Example of timber rot and borer attack on exposed section of subsea timber pile

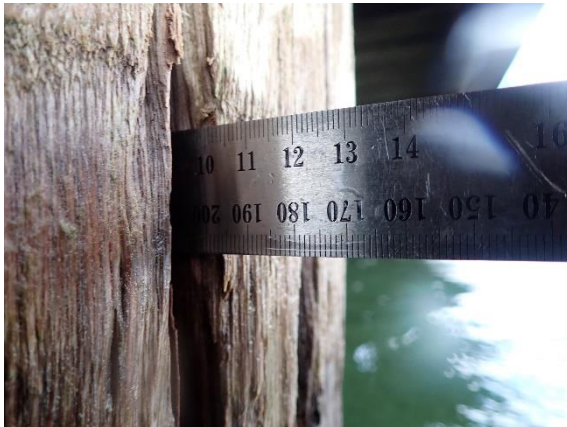
12.1 – Large split in pile

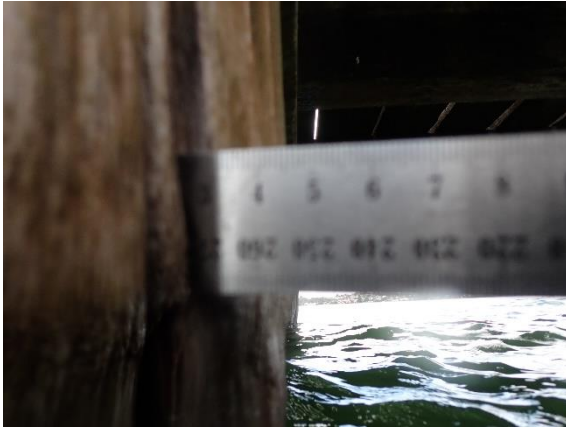
13.2

13.1 – Example of moderate split in above water section of pile

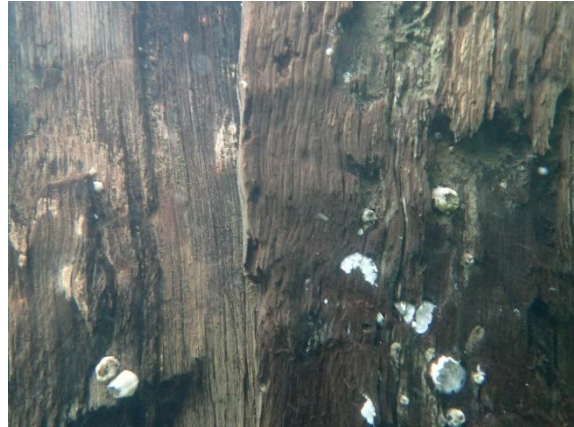
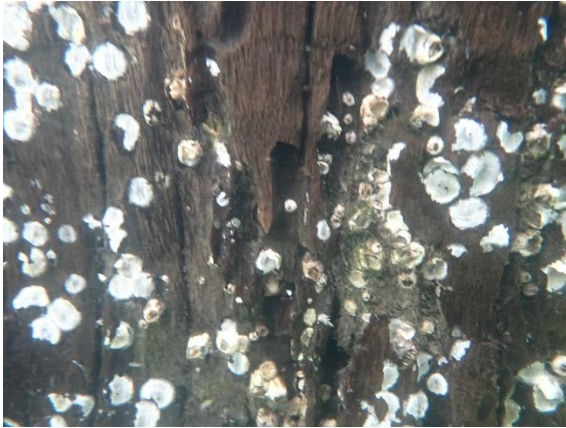
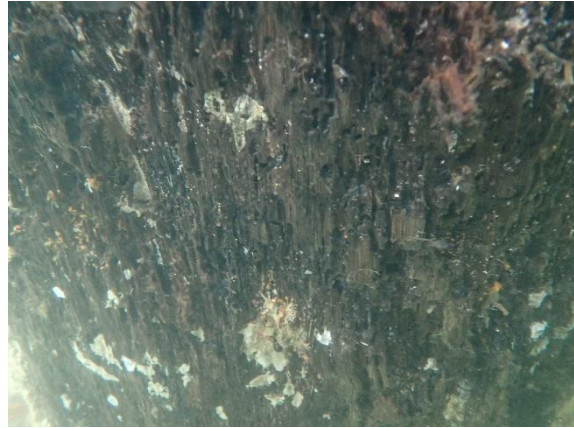
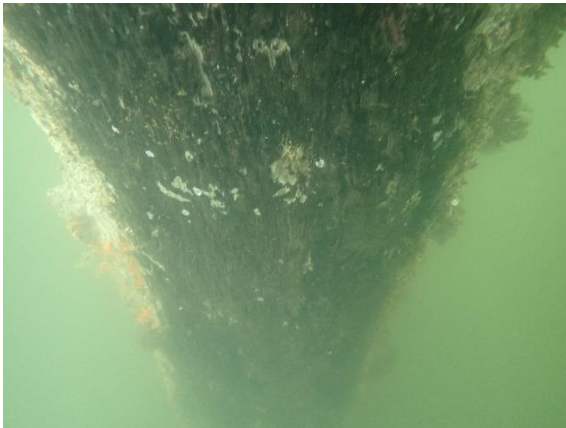
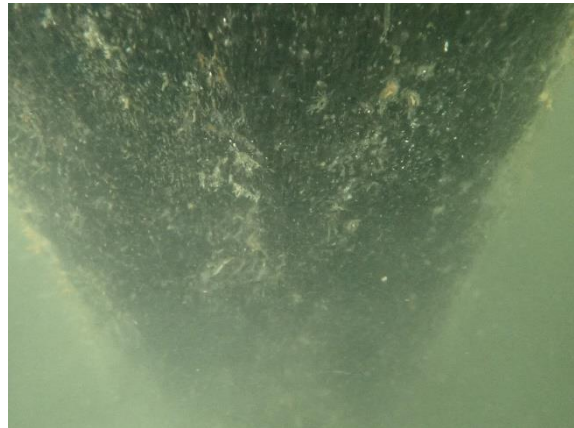
13.2 – 13.6 Typical wood rot and marine borer attacked throughout pile

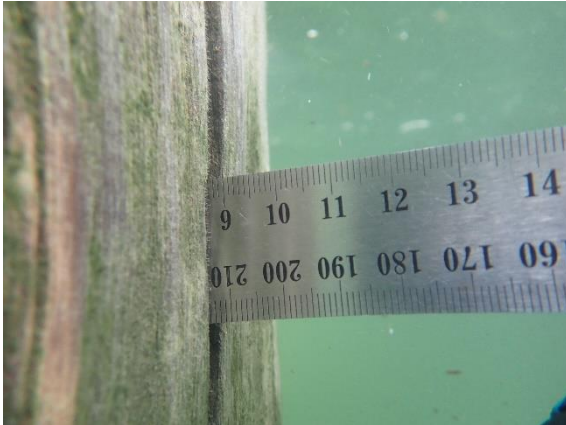
14.1 – Example of moderate split in pile

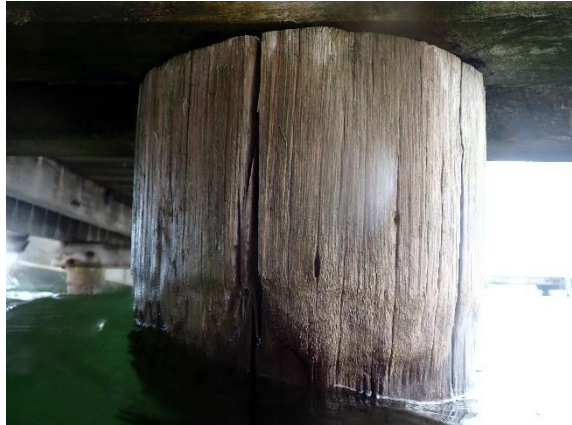
14.2 – Above water section of pile presenting in fair condition, with minor-moderate splitting

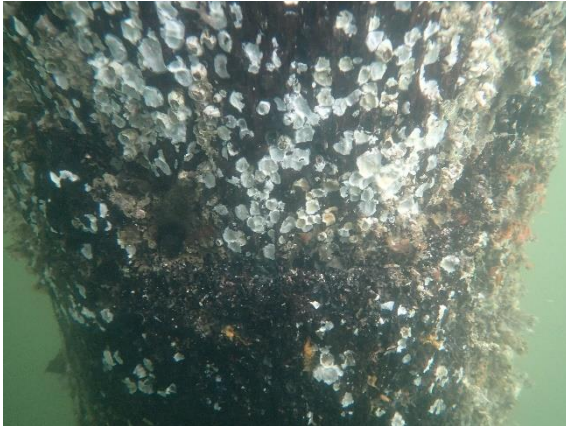
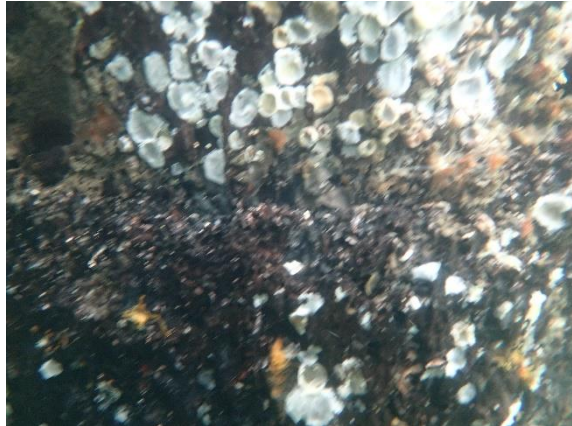
14.3 & 14.4 – large section loss of encapsulation below LAT. Underlying timber presenting with minor-moderate rot.

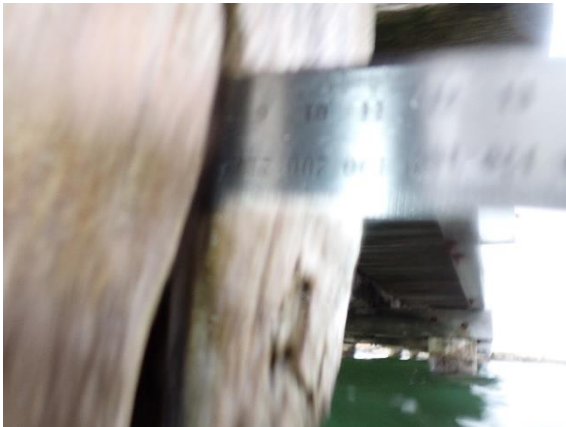
15.1 – Above water section of pile presenting in fair condition, with minor-moderate splitting

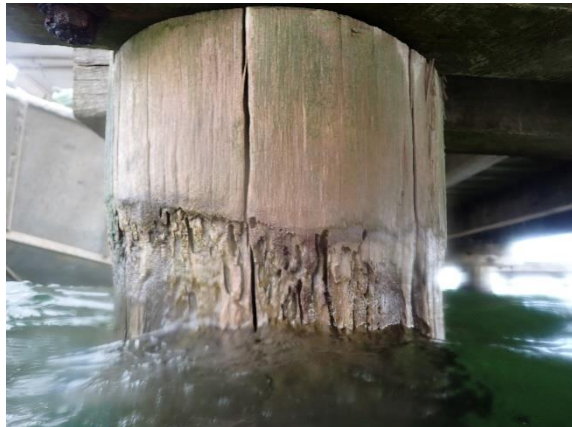
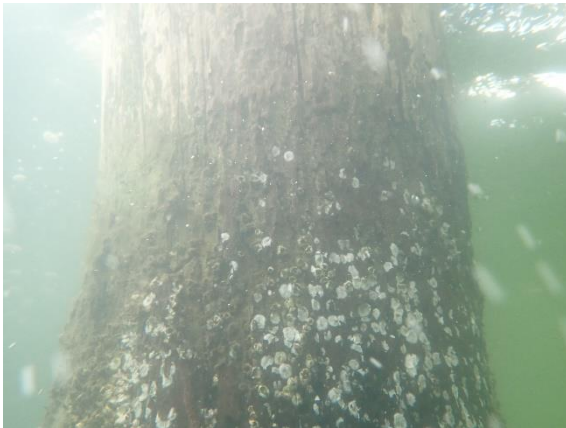
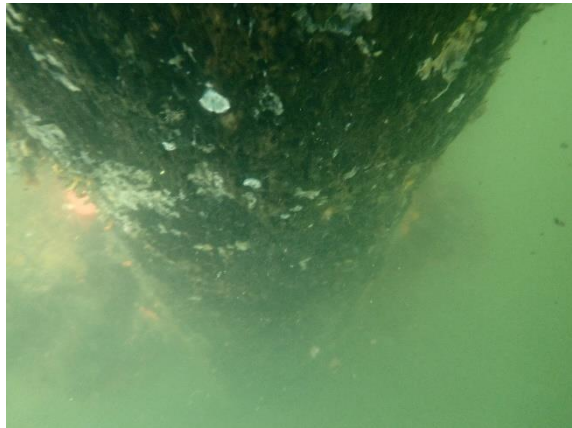
15.2, 15.3, 15.5 & 15.4 – Moderate timber rot and marine borer attack throughout intertidal area

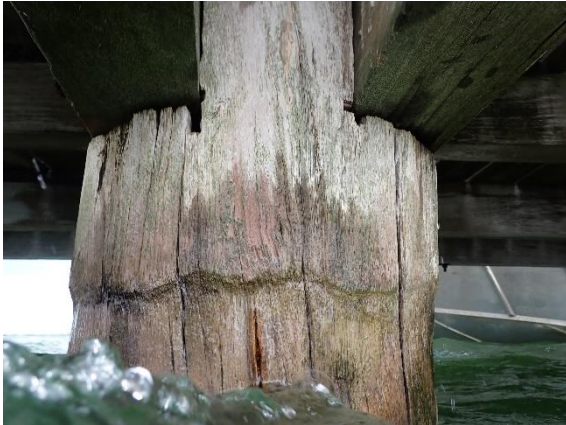
16.1 – Above water section of pile presenting in fair condition, with minor-moderate splitting

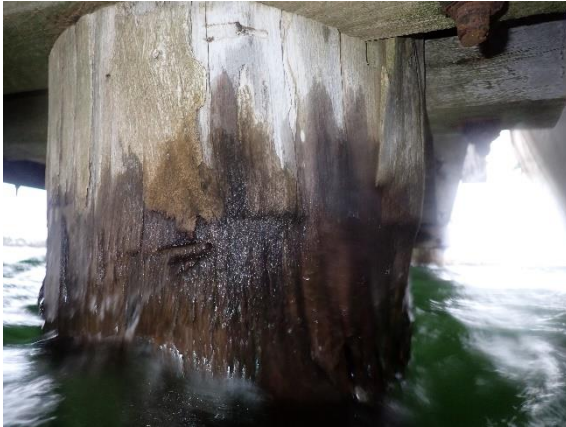
17.1 – Above water section of pile presenting in fair condition, with minor-moderate splitting

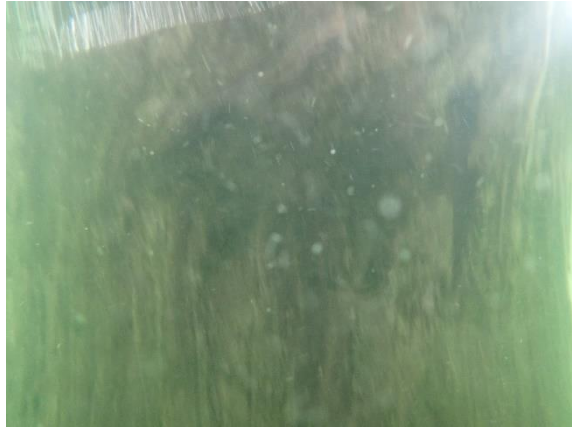
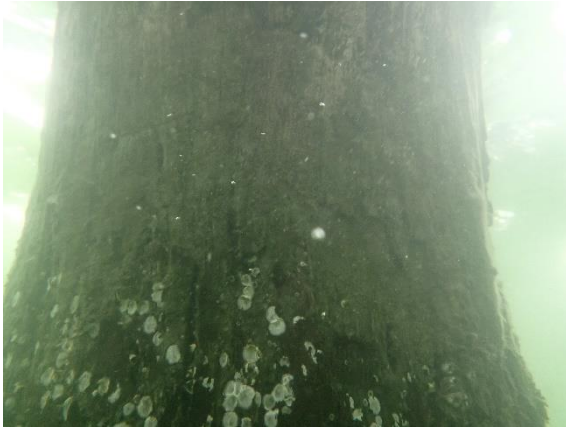
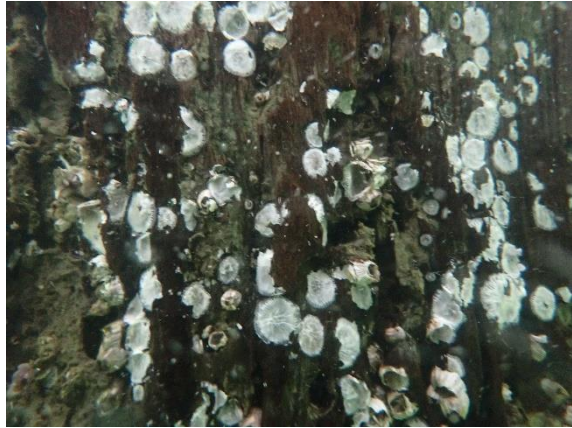
17.2 – 17.6 Moderate timber rot and marine borer attack throughout intertidal area

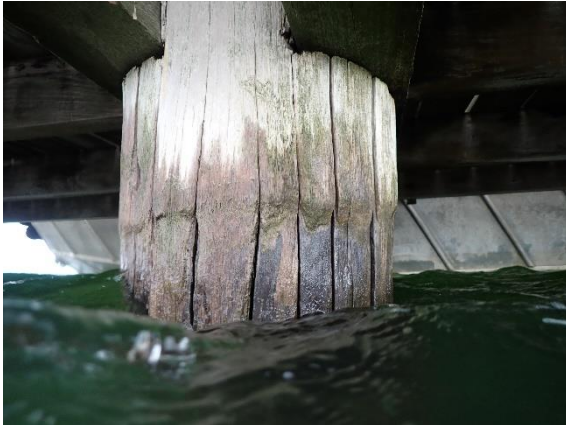
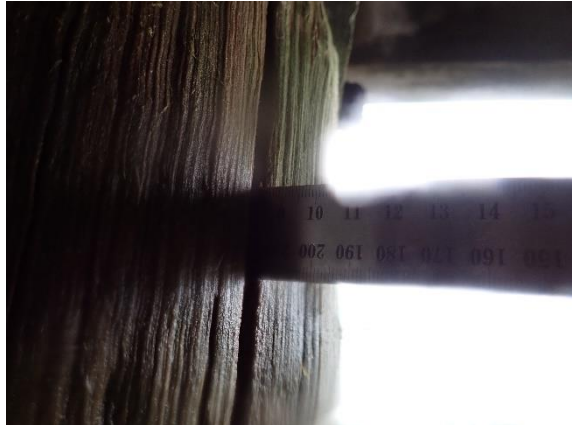
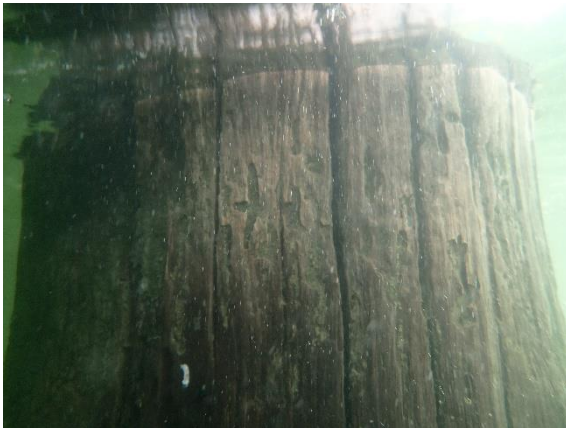
18.1, 18.2 & 18.3 – Encapsulation has completely failed to 1200mm above seabed, then failed around one half to seabed level. Top of pile presenting in fair condition, with moderate splitting, which worsens towards the intertidal area

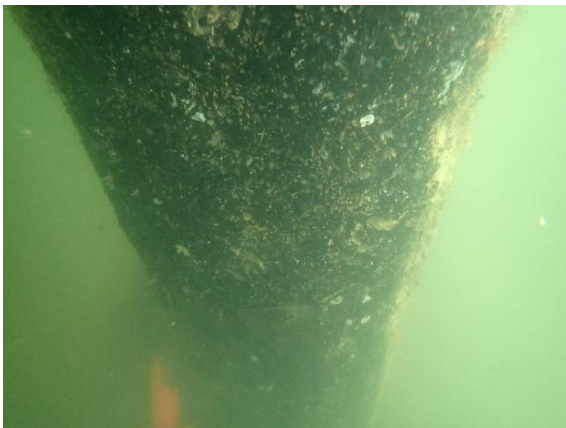
18.5 & 18.6 – Concrete grout column, presenting with absent formwork, and moderate deterioration of concrete.

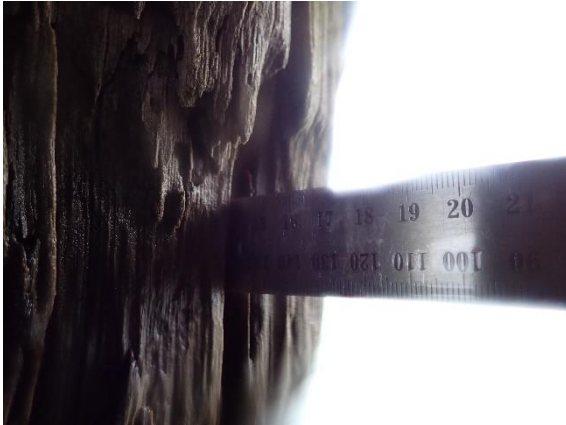
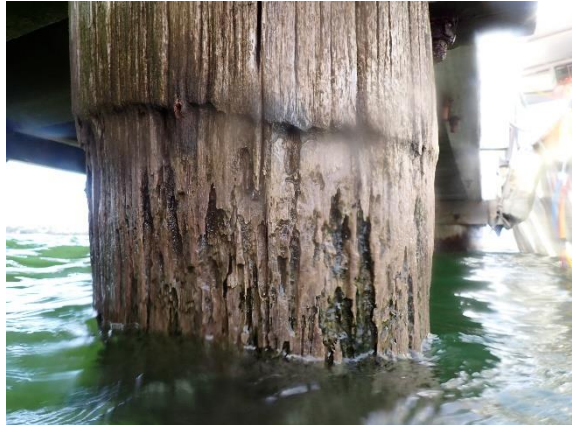
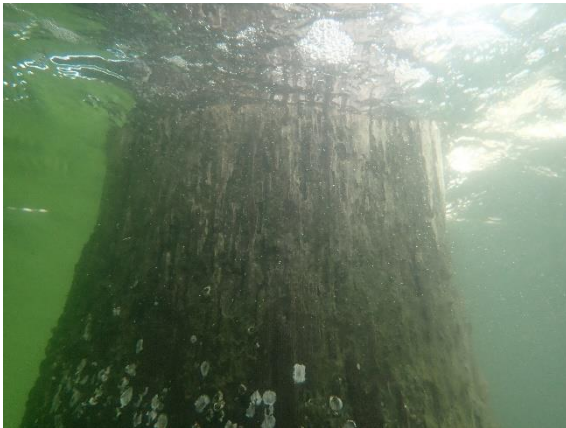
19.1, 19.2 & 19.3 – Encapsulation has completely failed on upper section of pile. Top of pile presenting in poor condition, with moderate splitting, which worsens towards the intertidal area

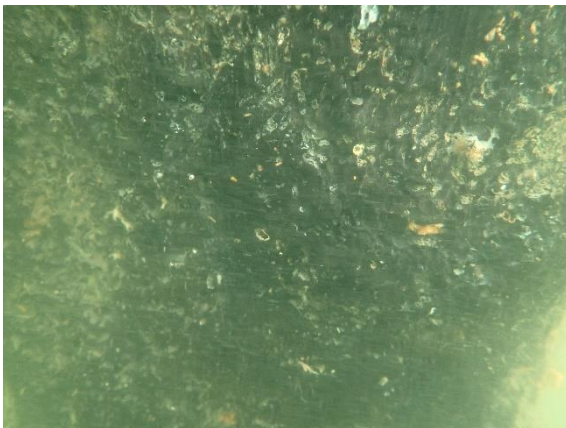
19.5 & 19.6 – Concrete grout column, presenting with absent formwork, and moderate deterioration of concrete.

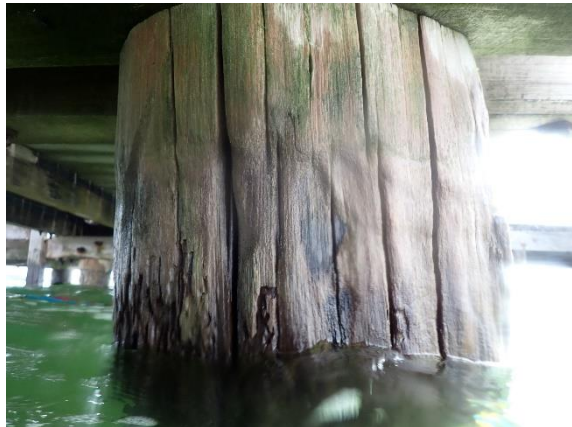
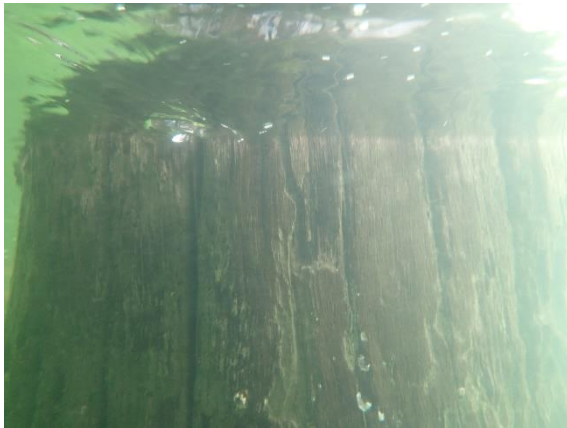
20.1, 20.2 & 20.3 – Example of large split in pile

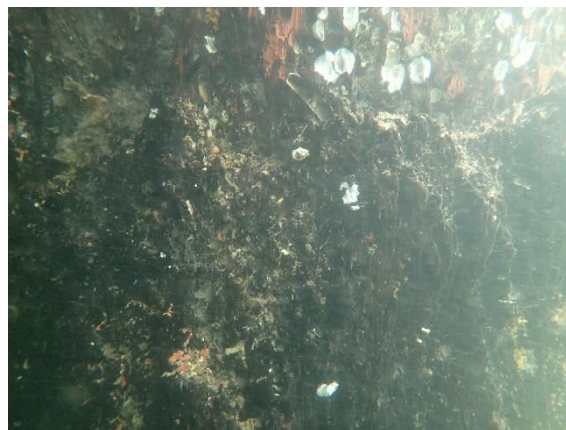
20.5 – Example of Wood rot & borer on exposed section of timber pile

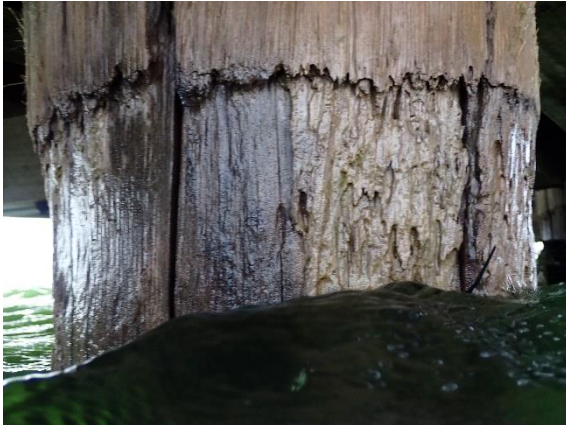
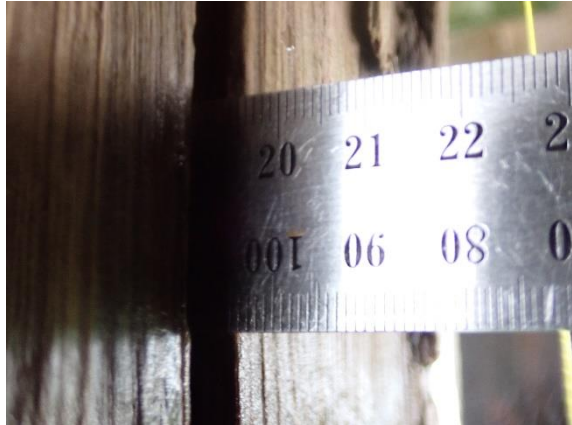
21.1 & 21.2– Example of large splits in pile

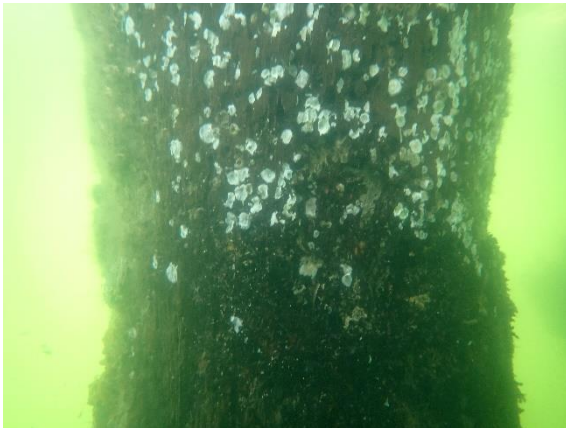
21.3 – Moderate necking, rot and marine borer attacked throughout I/T

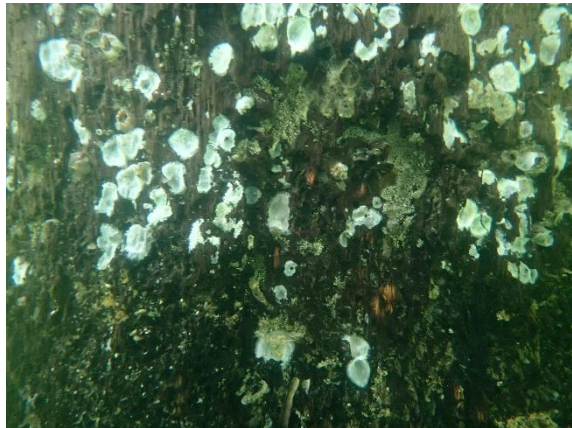
21.4 – Moderate necking, rot and marine borer attacked throughout I/T

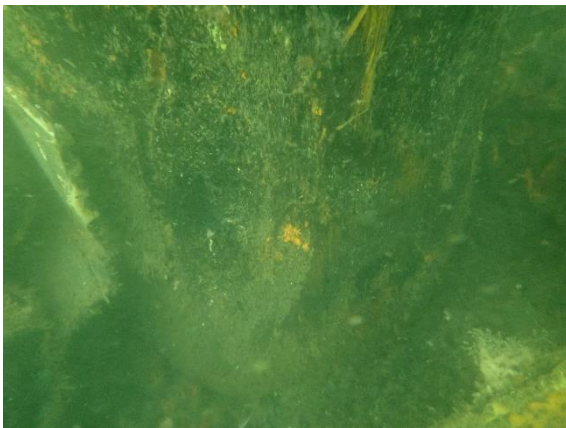
21.5 – Moderate necking, rot and marine borer attacked throughout I/T

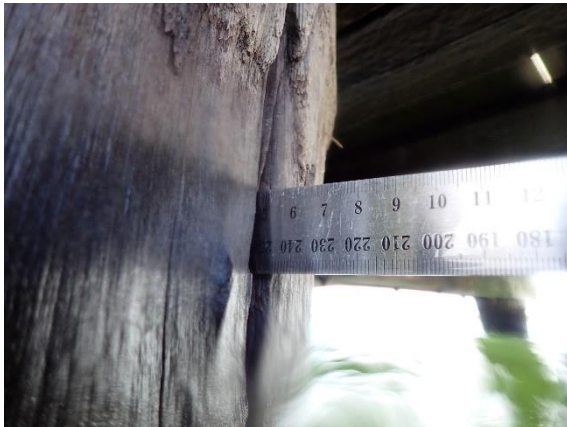
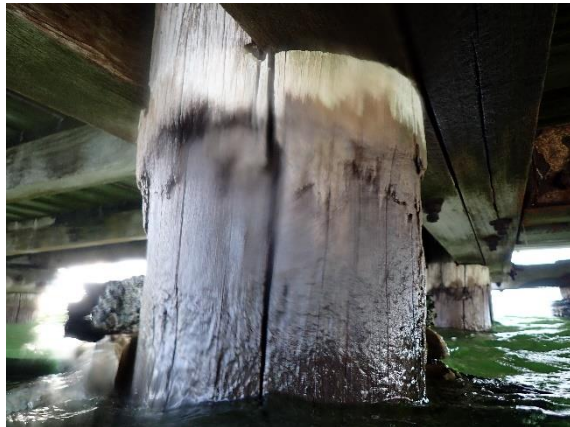
22.1 & 22.2– Example of large splits in pile

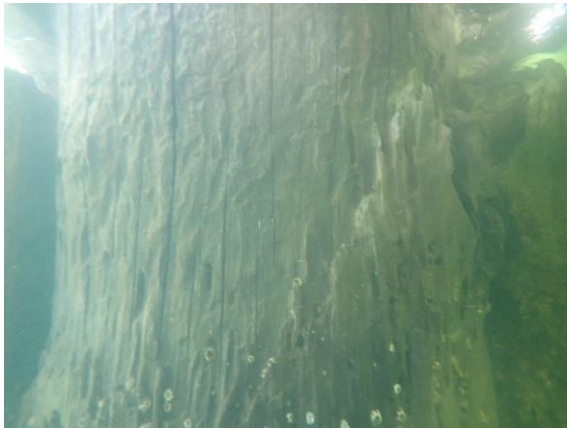
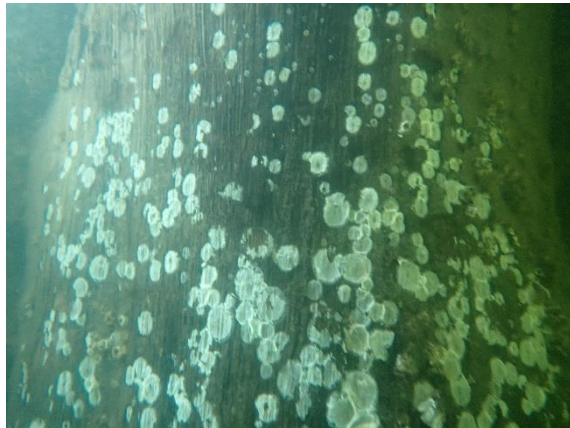
22.3 & 22.4 – Wood rot & borer

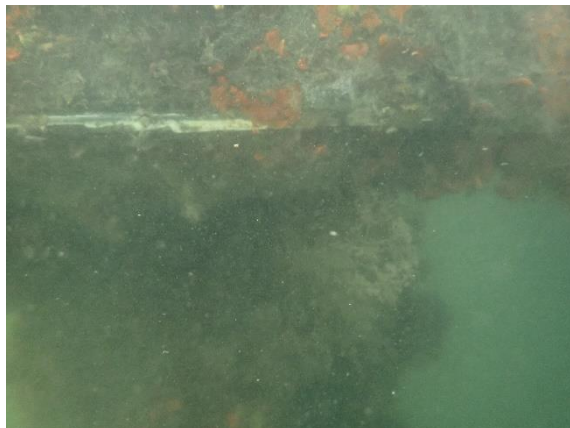
26.6

22.6 – Bottom 600mm feels like loose rubble underneath plastic wrap

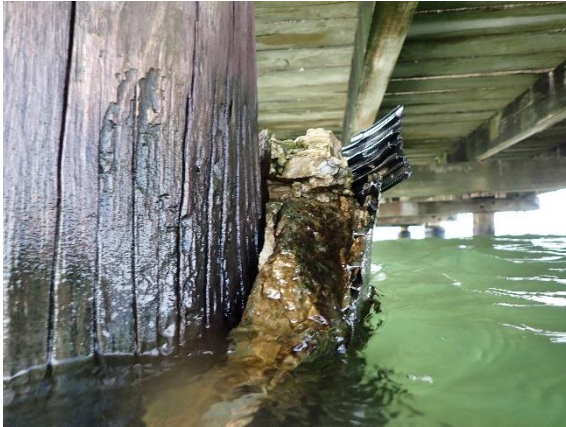
23.1 – Encapsulation extends below seabed. Section loss 500mm x 600mm at top of pile.

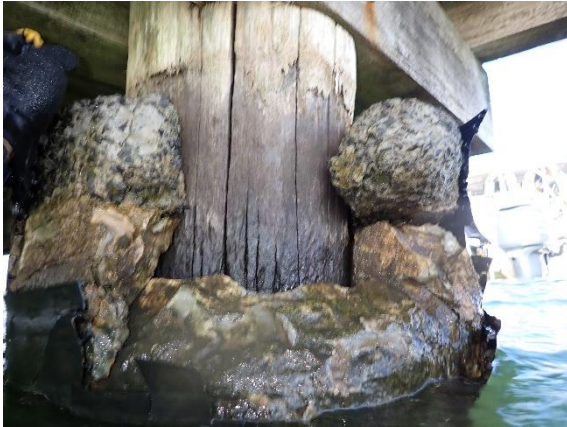
24.1 – Encapsulation extends to midwater and then has completely failed down to seabed. Section loss 240mm x 300mm at top of pile

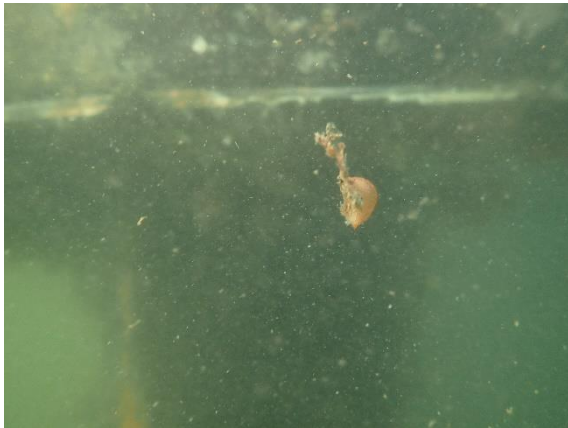
24.3 – Minor necking above I/T and seabed

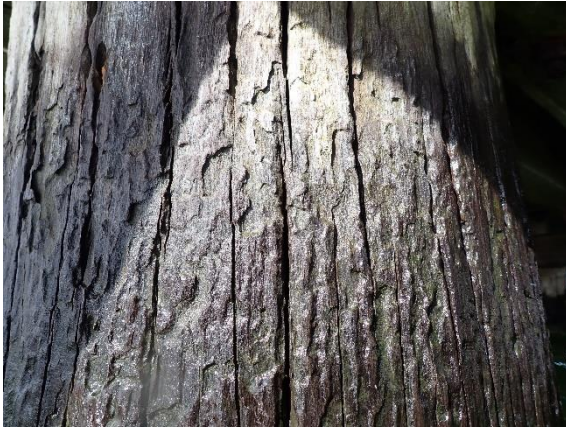
25.1 – Above water section of pile, presenting with minor splitting

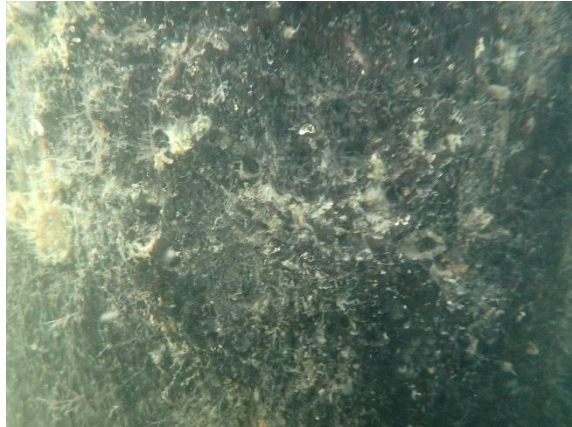
25.2 – Example of timber rot and marine borer attack

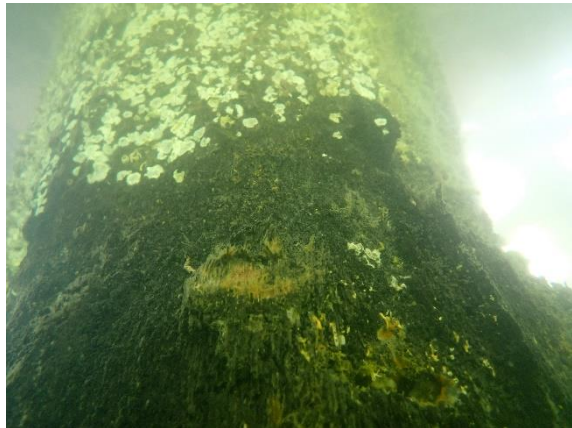
25.6 – Example of encapsulation failure subsea exposing timber pile

The majority of existing timber encapsulations have failed entirely and are providing no benefit to the structure. In addition to this, the timber piles have deteriorated past the point wherein a preventative timber protection system would be suitable, such as the Denso Seasheild 80 series system. Instead, it is anticipated that a structural repair is required.

It was noted during the inspection works that the pile tops where halfcaps attach remain in good condition, any future encapsulations should finish directly below this level, to ensure all vulnerable sections of the pile are adequately protected by the grout column.

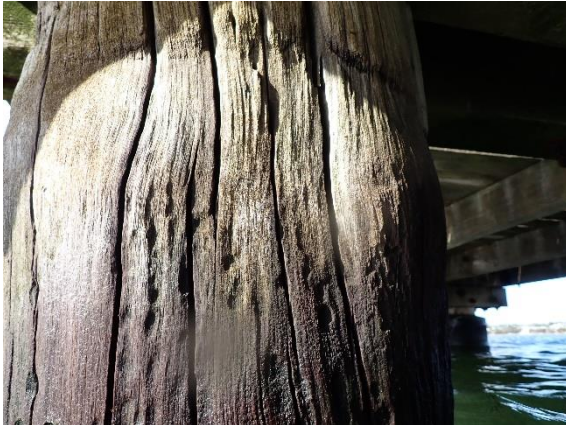
26.1 – Example of minor-moderate splitting on above water section of pile

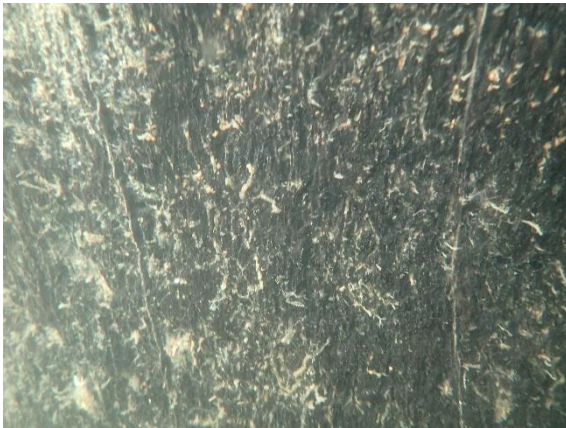
26.3 – Example of timber rot on subsea section of pile

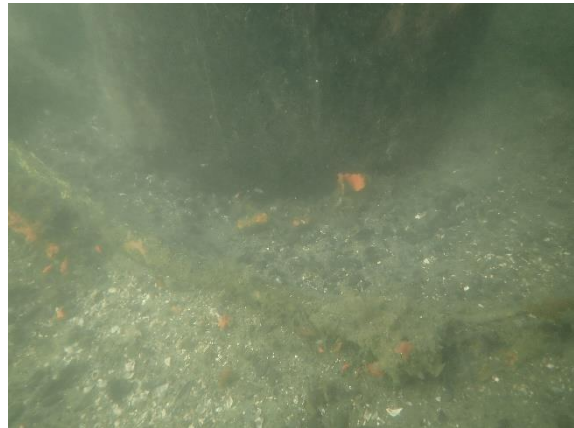
26.4 – Encapsulation failure around seabed level

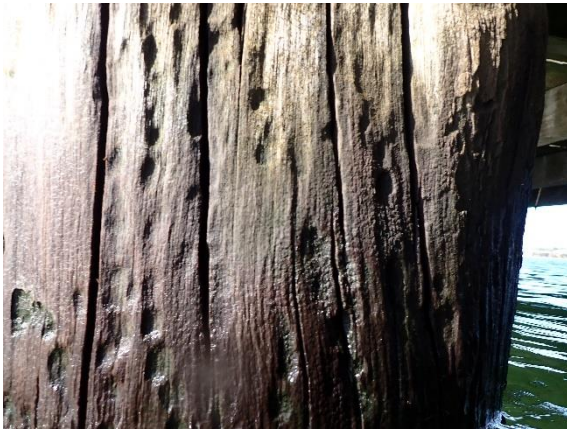
27.1 – Example of minor-moderate splitting on above water section of pile

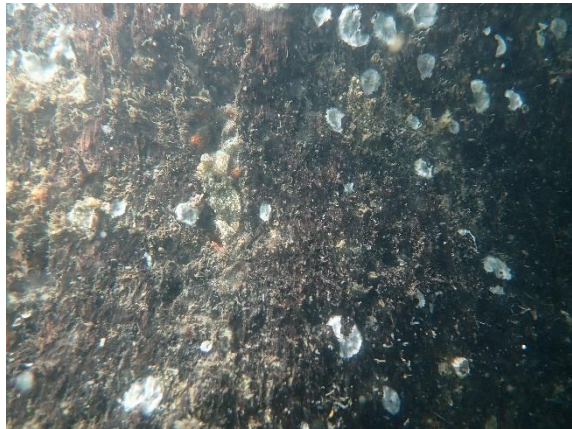
27.2 – Example of timber rot and borer on subsea section of pile

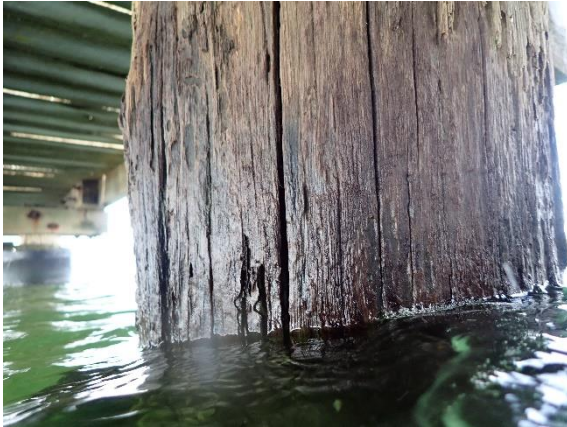
28.1 – Example of minor-moderate splitting on above water section of pile

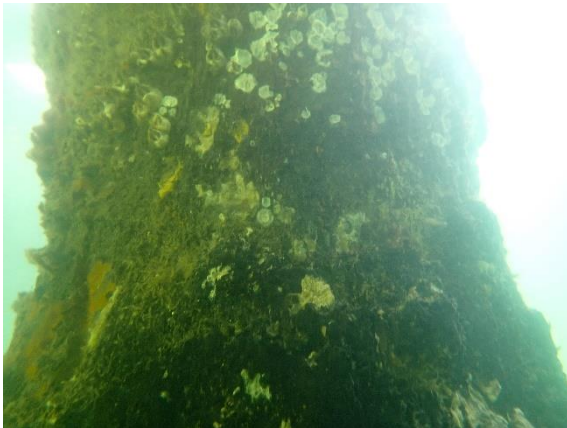
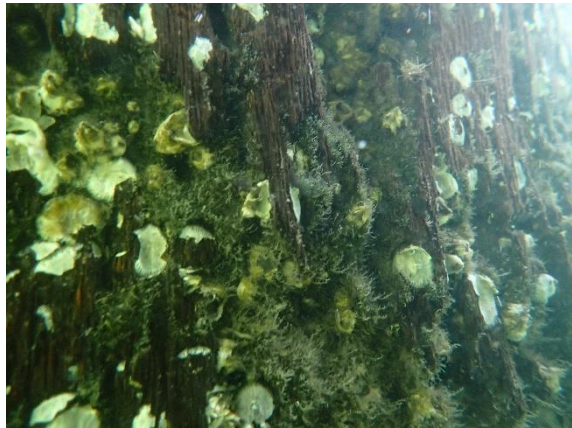
28.3 – Example of severe timber rot and borer on subsea section of pile 28.4 – Wood rot & borer

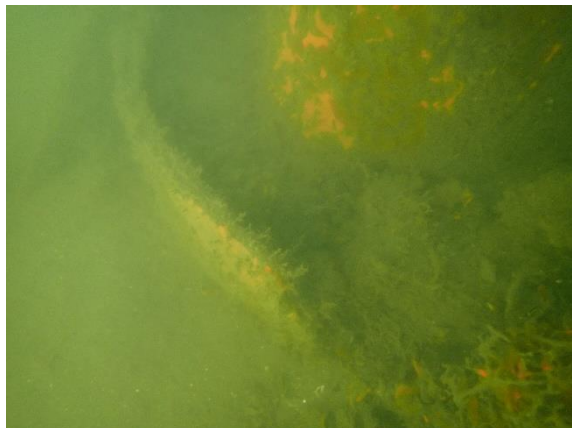
28.6 – Encapsulation has completely failed to seabed level

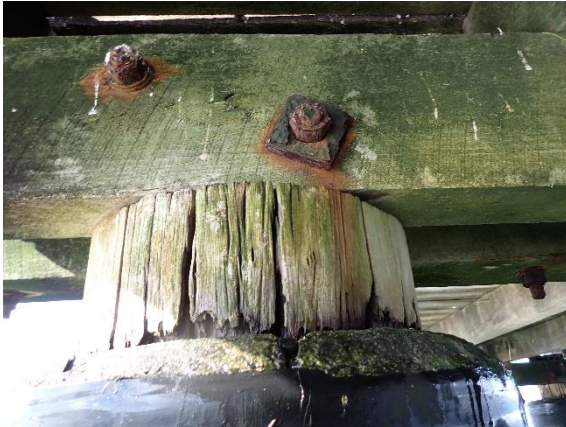
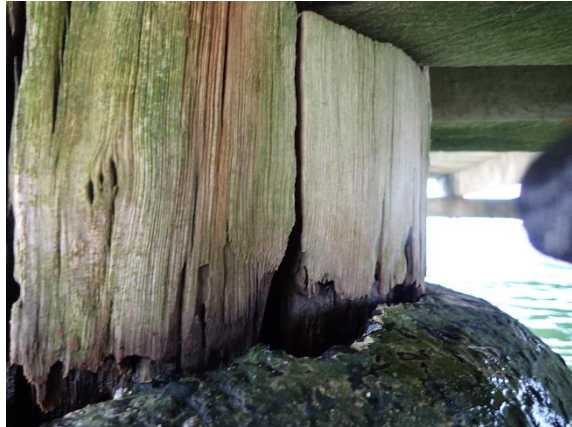
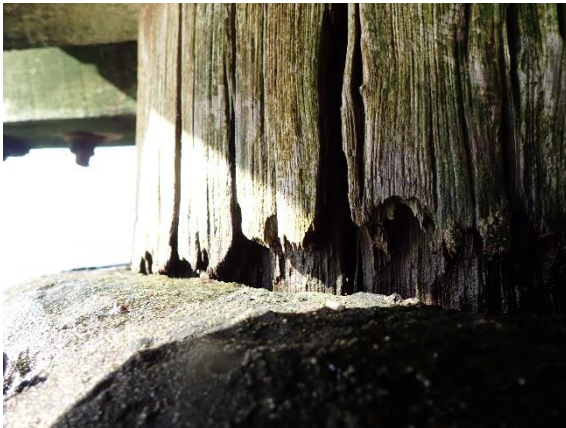
29.1 – 29.3 Top of timber pile presenting with severe section loss around top of pile where encapsulation terminates

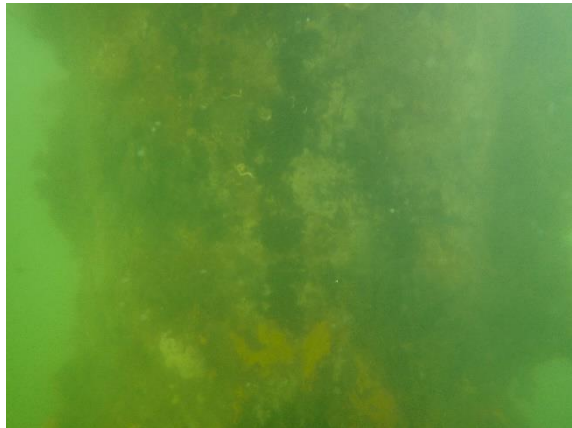
30.3 – Encapsulation extends below seabed and is completely intact. Wrap appears in good condition

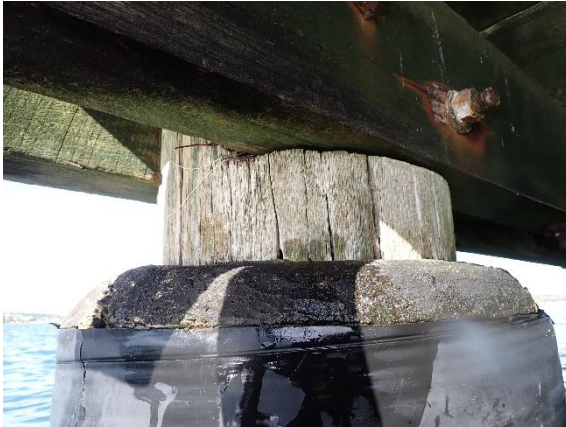
31.1 – Minor necking above encapsulation.
