CONDITION REPORT

Australind Jetty

Government of **Western Australia**
Department of **Water and Environmental Regulation**

9738

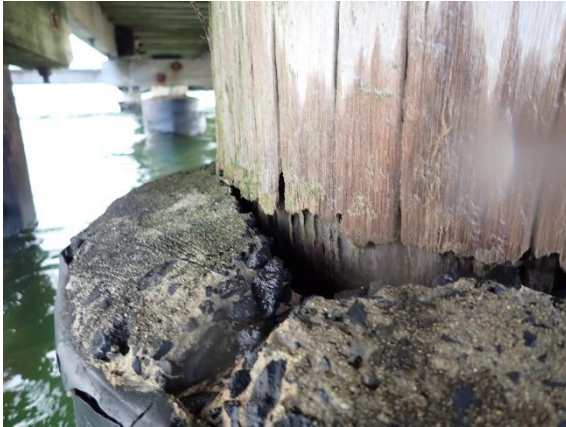
32.1 – Moderate necking above encapsulation visible on one side of the pile with moderate encapsulation section loss

Although no information could be found on the existing encapsulations, they have proved to be unsuitable and were likely installed in the absence of an appropriate specification. To provide a structural repair on the timber piles, the existing encapsulations will need to be removed in their entirety, from the top of the column down to a minimum of 500mm below the seabed. All piles could then have a suitable encapsulation poured, in accordance with the sketch displayed in Image 2, on the following page. Any future encapsulations should utilize specialist underwater high strength grout and incorporate a reinforcement cage.

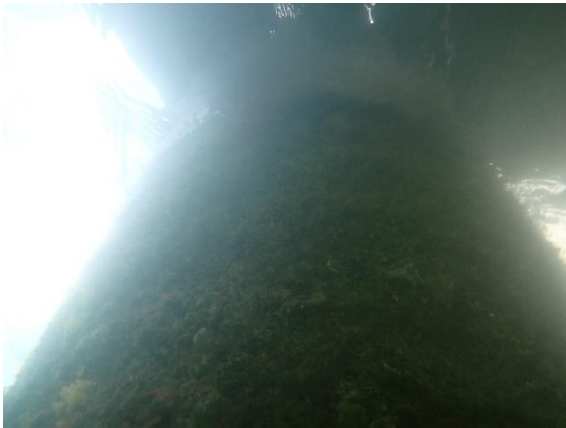
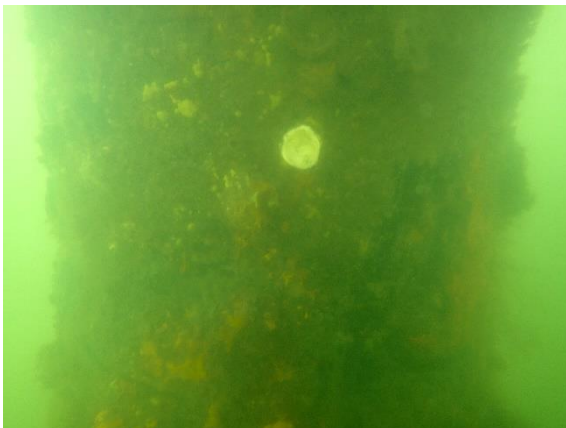
32.3 – Encapsulation extends below seabed and is completely intact. Wrap appears in good condition

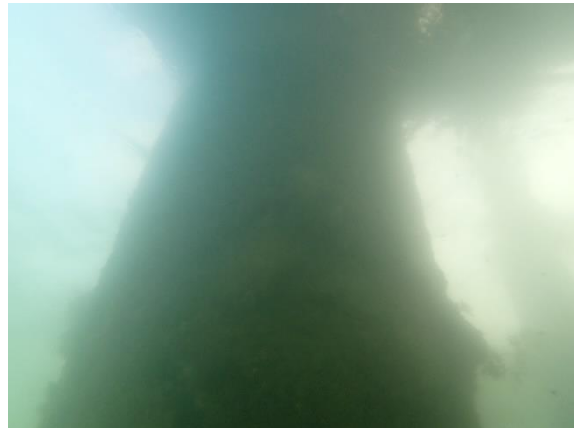
32.4 – Encapsulation extends below seabed and is completely intact. Wrap appears in good condition

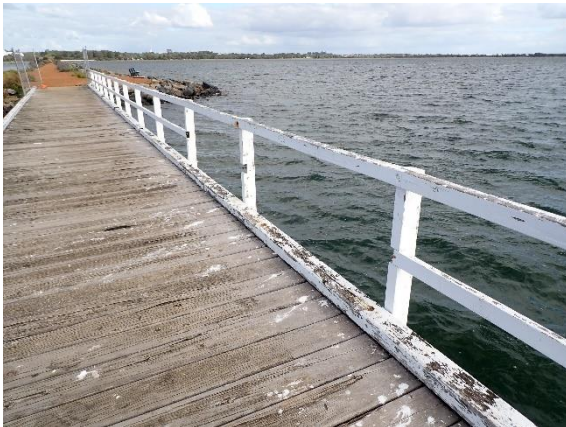
33.1 – Missing sections of handrail

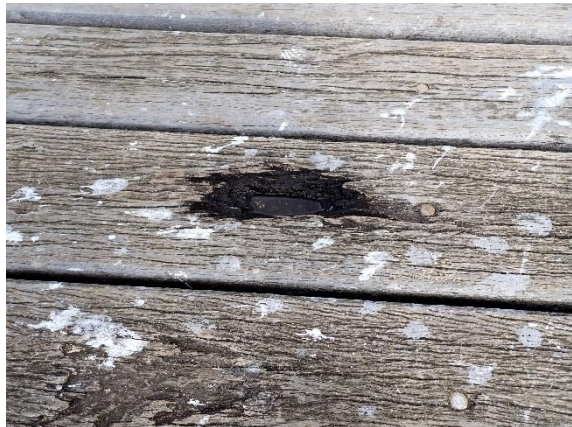
33.2 – Section loss and localised rot on deck boards

About 25% of the decking timber presented with severe rot with several ends of kerbing in the same condition. These should be replaced on a like basis.

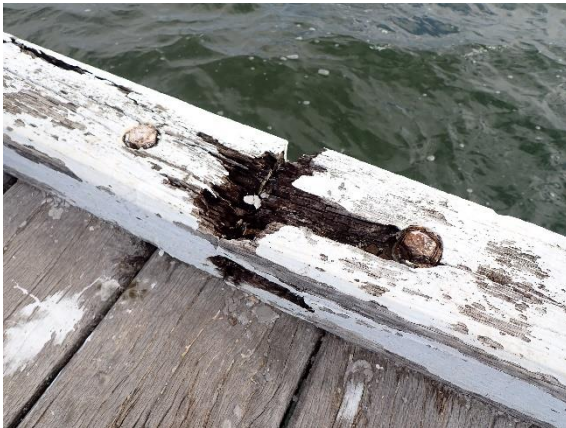
33.3 – Example of wood rot on timber kerbing
